**2014 Monitoring Report**  
**Helmet Creek Restoration**  
**Adak Petroleum Diesel Spill**

**December 18, 2014**

This Compliance Inspection Report is timely submitted to the Trustee Council for approval in accordance with paragraph 9 of the Consent Decree, No.3:13-cv-00121-HRH.

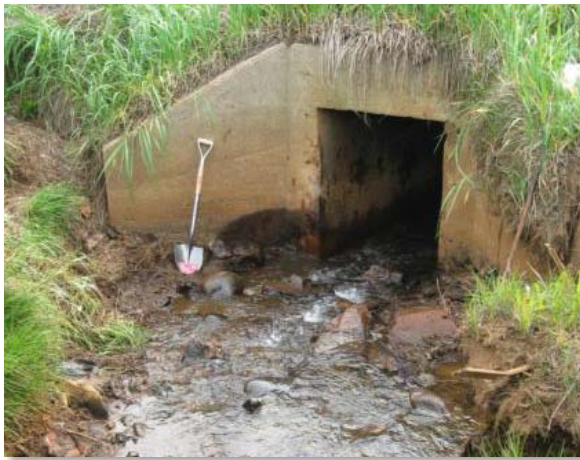
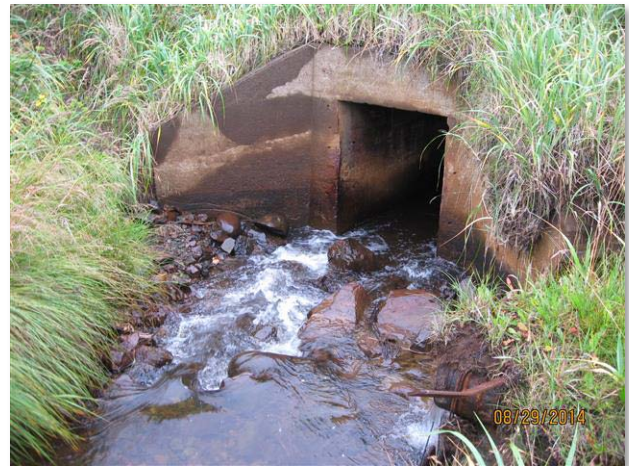
Trash racks at Culvert #2 (Figure 3) and Culvert #3 (Figure 4) were removed to facilitate upstream fish movement. The bed upstream of Culvert #2 was also regraded to reduce a steep grade caused by an accumulation of material against the trash rack.

Figure 3: Culvert #2 after restoration 2013 (L); 2014 (R).

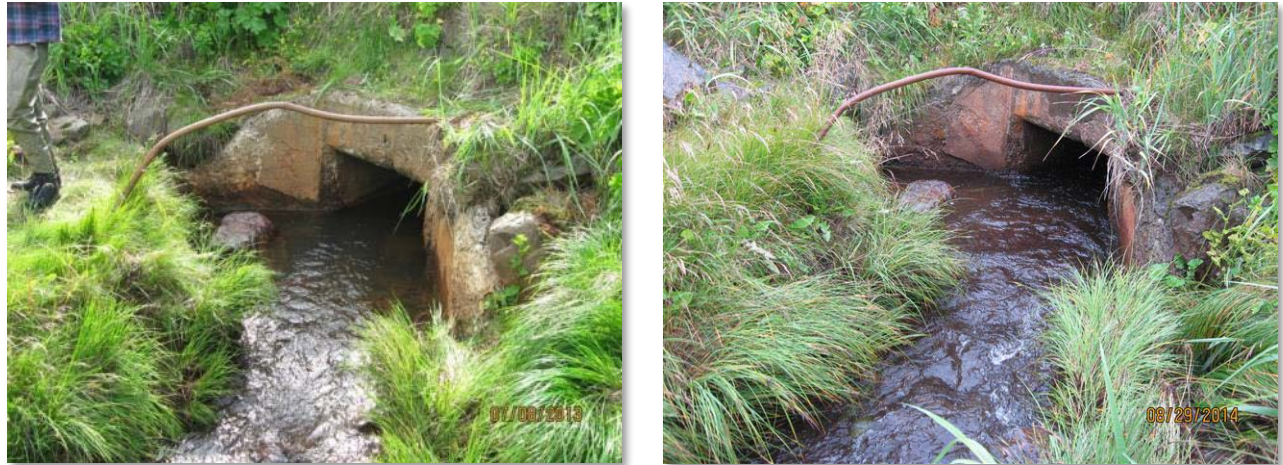
**Figure 4: Culvert #3 after trash rack removal 2013 (L); 2014 (R).**

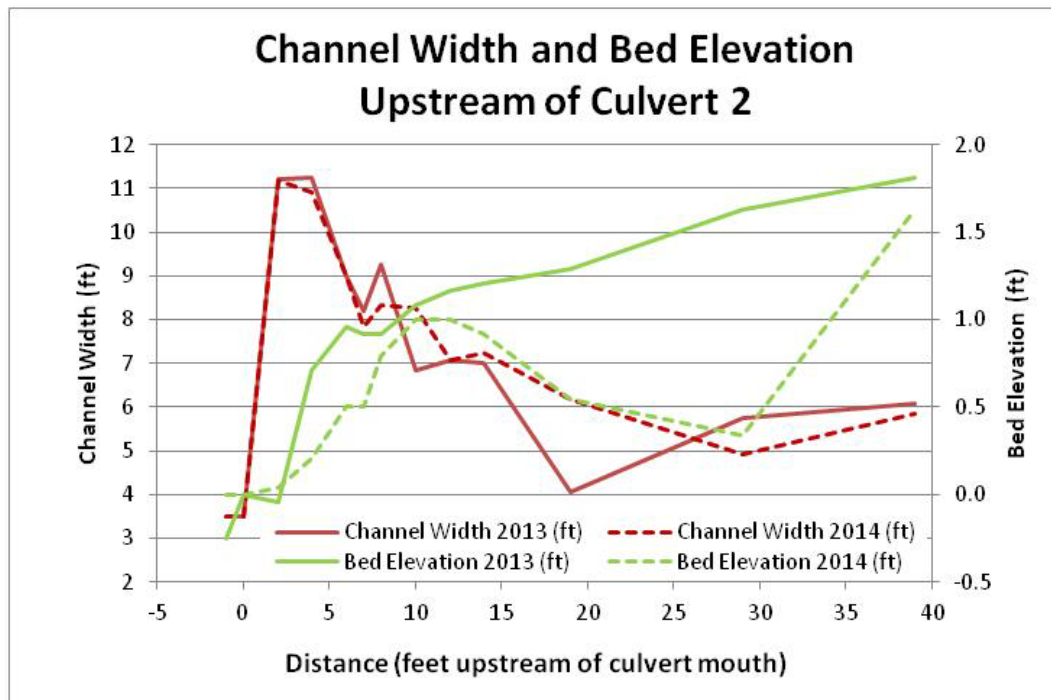
- Transect measurements of in-stream parameters including stream width, depth, and grade were collected (See Figure 5 for Culvert #2 and Figure 6 for Culvert #3).
- Monitoring confirmed that the streambed upstream of both culverts was still in stable condition with no jump heights in excess of 10-inches. While the beds had changed somewhat, the change was within expected natural variability and did not cause an adverse effect on fish passage.
- The largest change was observed about 30-feet upstream of Culvert #2 where a 2-foot deep hole had formed in the streambed (Figure 5). This may have been a result of removing the old wood stave pipe just downstream. In any case, the new pool was seen as a benefit in this area where deep holding habitat for fish is relatively scarce.

Figure 5: Post-Construction channel measurements (Culvert #2)

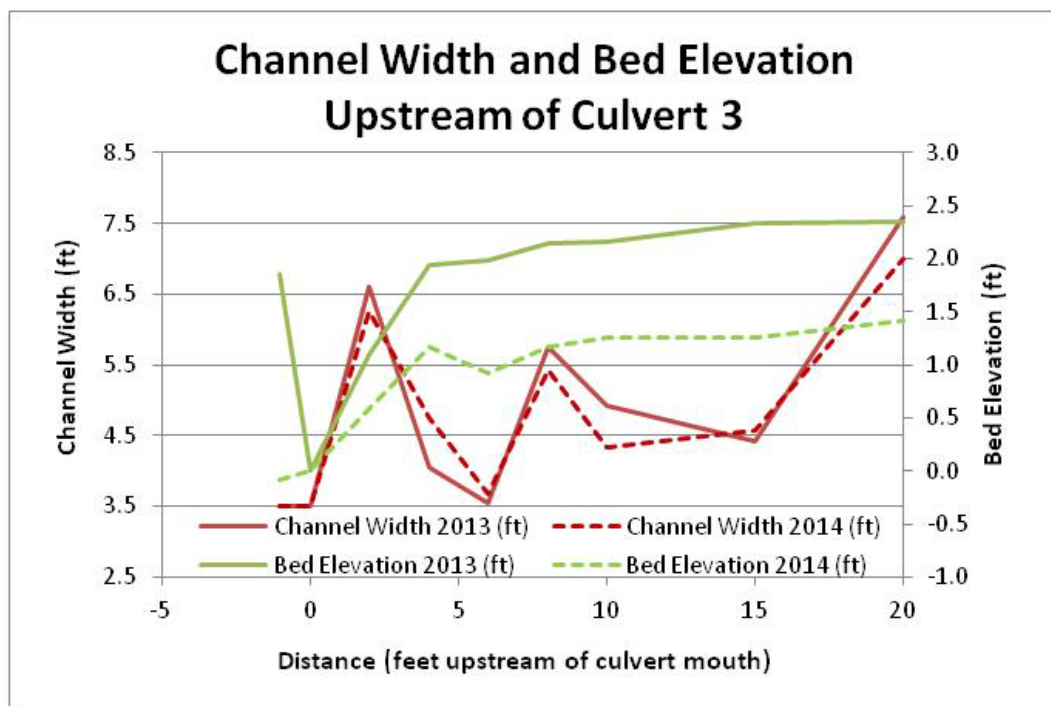
Figure 6: Post-Construction channel measurements (Culvert #3)

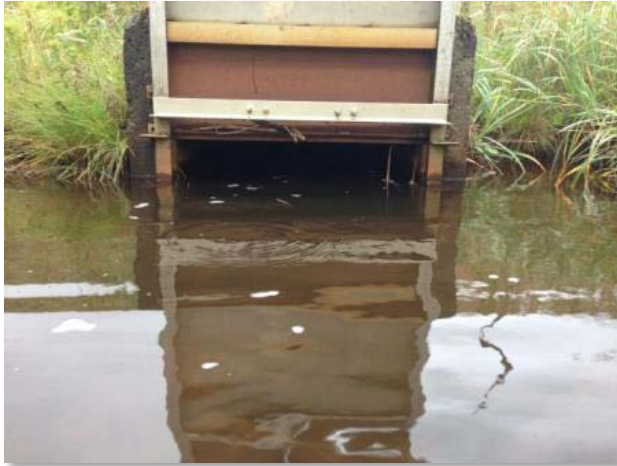
- In 2014 the spill control structure on the downstream end of Culvert #3 was approximately 6 inches above the current water level (Figure 7). The upstream end of Culvert #5 was still approximately 6 inches above the current flow level on Aug 30, 2014 (Figure 8). The spill control structure on the downstream end of culvert #5 was still approximately 4 inches above the current water level. The original marks set last year were not visible and were replaced (Figure 8).

**Figure 7: Spill control gate on Culvert #3 and new reference mark 2014.**

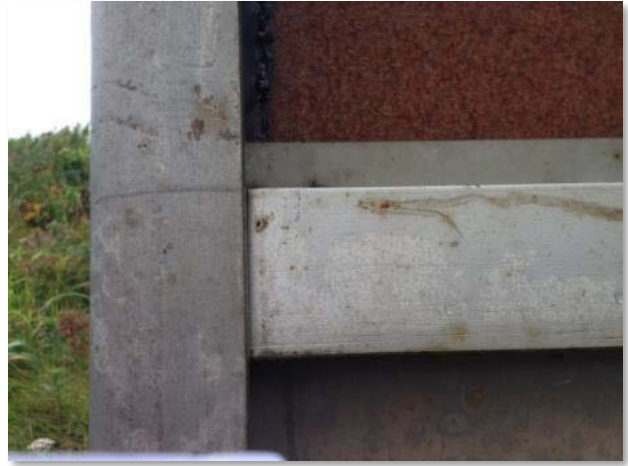
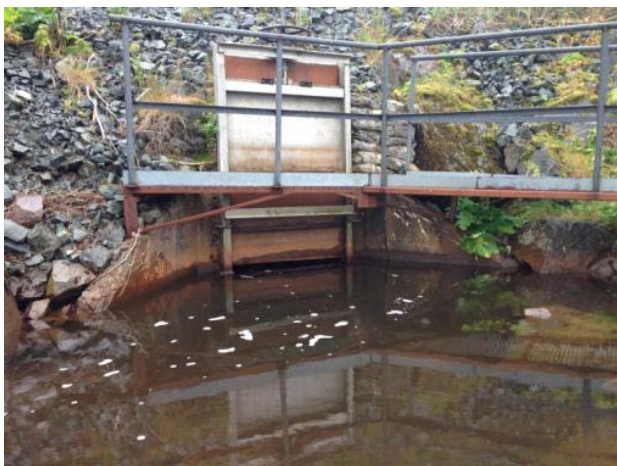
**Figure 8: Spill control gate on Culvert #5 (lower and upper) 2014.**

All three spill control gates were examined. Two were found to be open 6-inches above the peak water surface elevation. The gate on the downstream end of Culvert #5 was open about 4-inches above the water surface. This gate was examined last year by Adak Petroleum staff and found to be at its uppermost limit of travel. Because adult pink salmon were observed swimming into the culvert, and over one hundred adult salmon were observed upstream of this culvert, the 4-inch level is deemed to meet the fish passage standard. This performance standard was met.

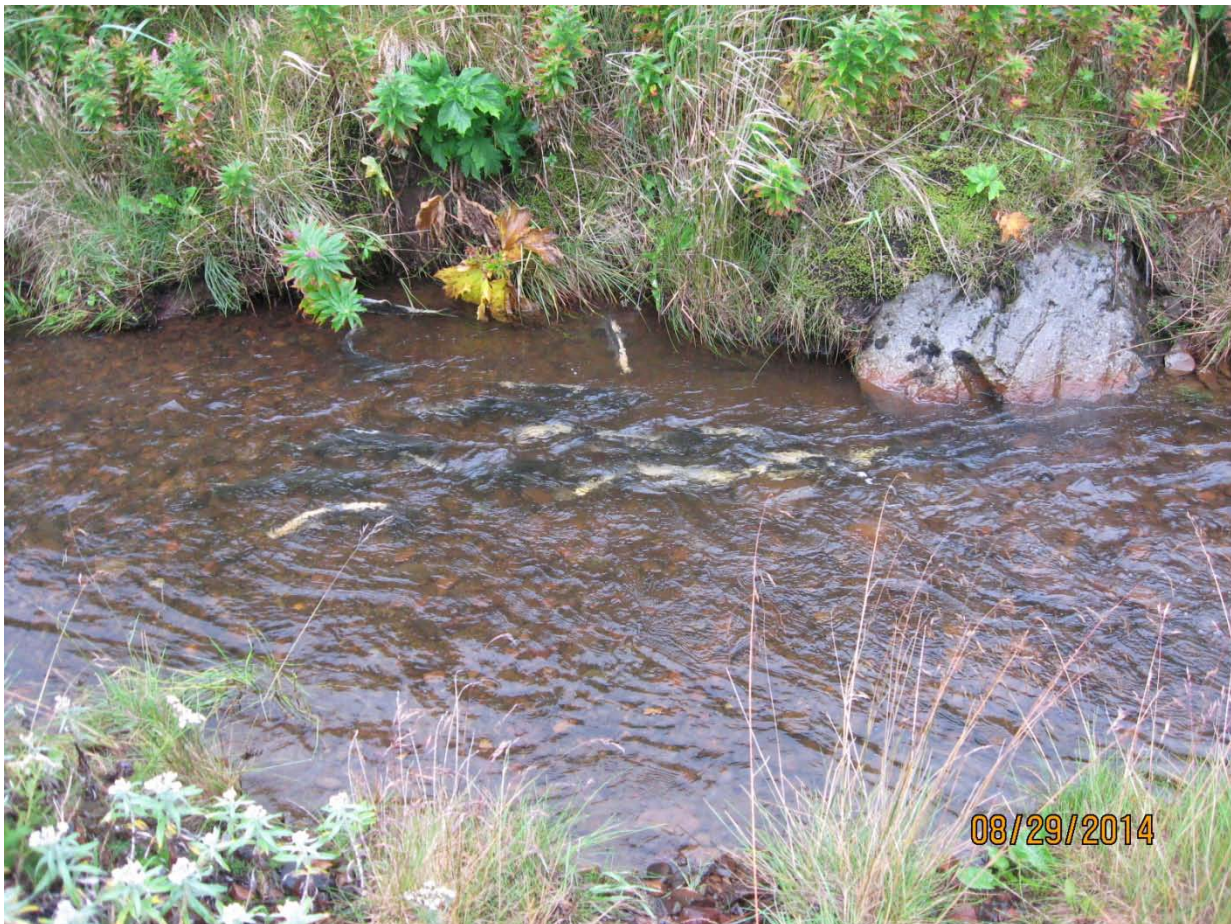
- On the August 2014 monitoring trip Pink and Chum salmon were seen throughout Helmet Creek up to the location of a natural fish passage barrier west of the tank farm at RK 2.1 (Figure 9). A count was conducted by the two field personnel walking the entire creek from the mouth to the barrier. The count was approximate as a secondary focus of the work, but roughly 1,626 salmon were seen. This was a mix of mainly pink salmon and some chum. The count of fish above Culvert #5 was 141 salmon indicating all barriers to fish passage have been removed.

**Figure 9: Group of about a dozen pink salmon observed between Culverts #4 and #5 (2014)**

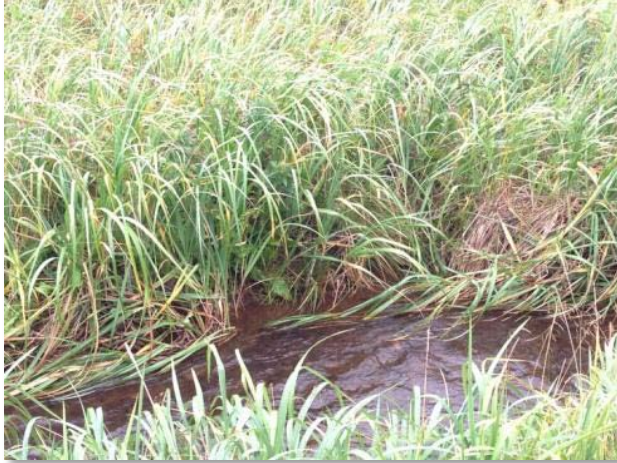
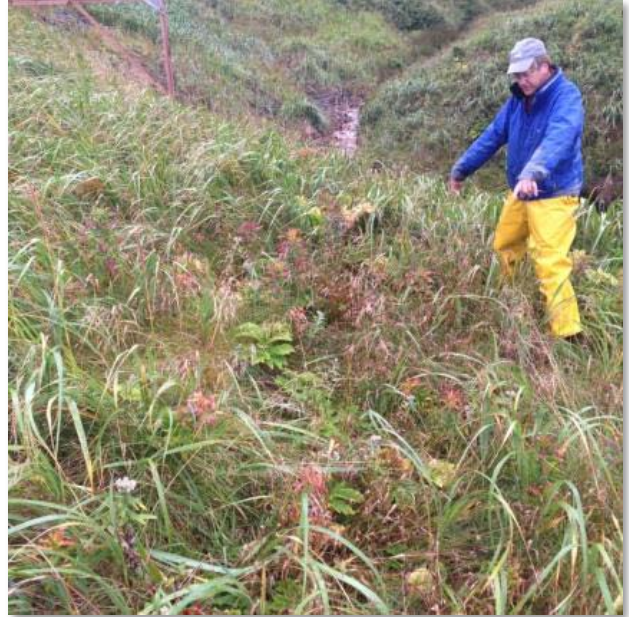
had not left a footprint and that adequate revegetation had occurred at each removal site. Figure 10 shows the locations of the pilings that were instream near RK 0.5, and upstream of Culvert #5. These areas also no longer showed removal activity and the bank area had good vegetation growth.

**Figure 10: Location of instream (L) and upper bank pilings (R) in 2014.**

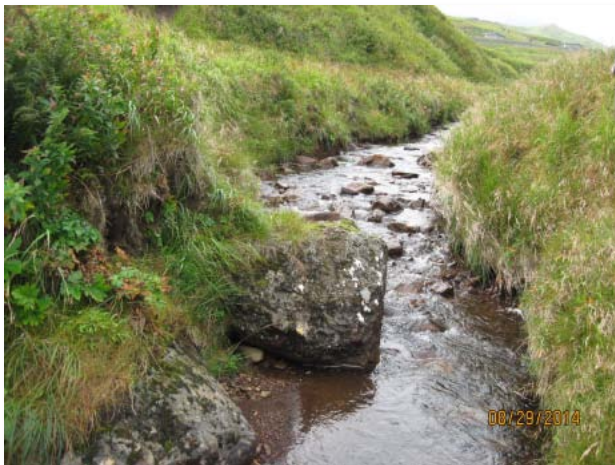
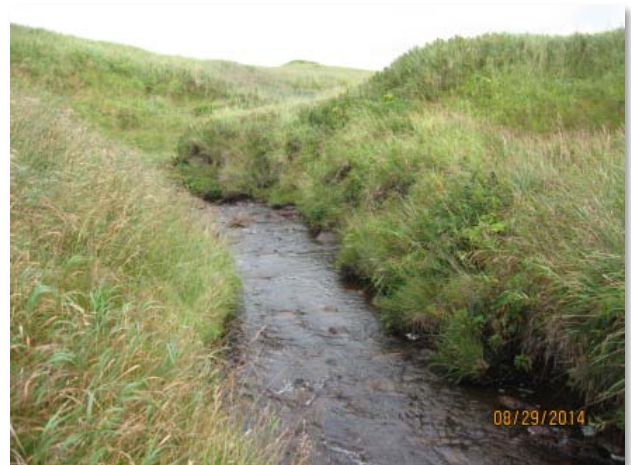
- Monitoring in 2014 found banks were stable with no signs of unusual erosion. Even though the area was heavily trampled during the 2013 restoration work, no evidence of this activity was seen in 2014 (Figures 12 and 13). Revegetation showed root formation and stable banks (Figure 13). There were some differences in the creek flow due to shifts of some large rocks and the removal of constrictions, but none of these changes were determined to be detrimental but rather indication of the creek adjusting to a more natural substrate and bank than what was previously provided by the drums (Figure 14). One pink salmon was seen in the area.

Figure 12: Site #1 – Post Construction 2014 looking upstream (L) and downstream (R)

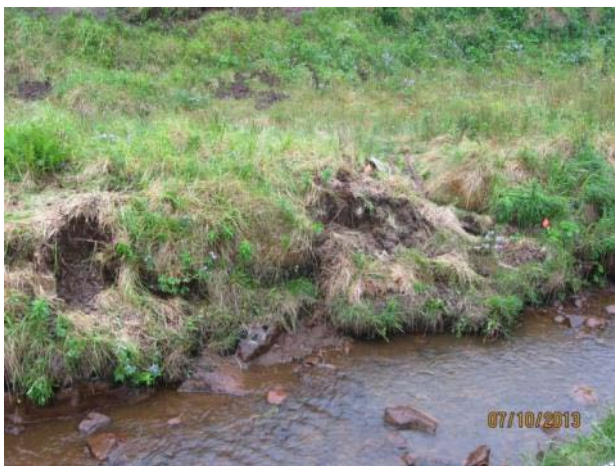
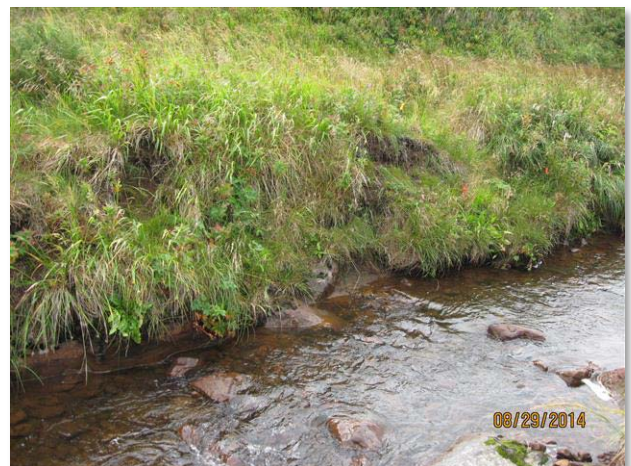
Figure 13: Site #1 – Barrel removal location 2013 (L) and 2014 (R)

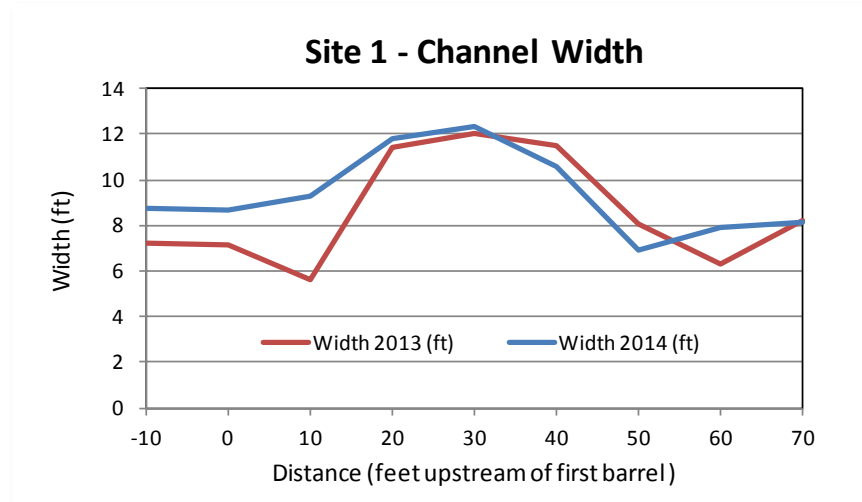
**Figure 14: Site #1 – Post Construction channel width measurements (2013 and 2014)**

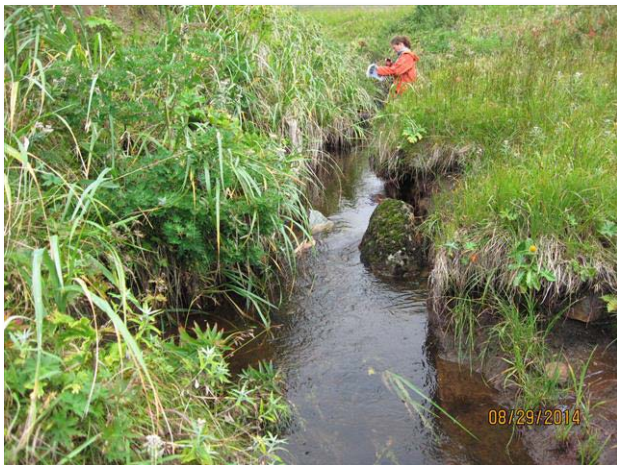
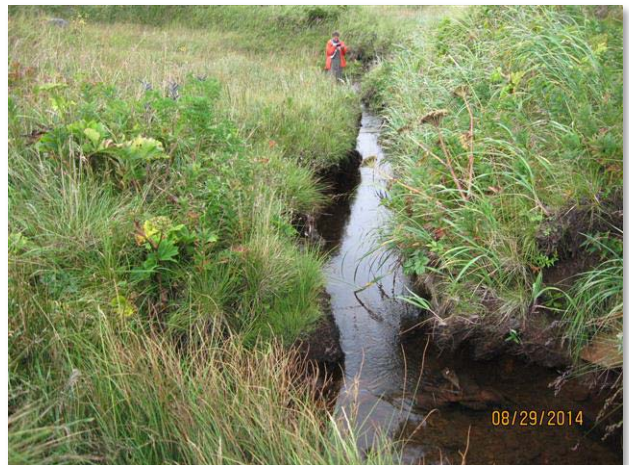
- 2014 Monitoring - Site #2: Observation of the stream channel at Site #2 showed that the stream substrate had less fine sediment than previously observed. It is thought that the stream was able to move through areas where the drums had previously been thereby carrying away some of the fines. It was also noted that the large boulder was not seen and may have dropped into one of the holes created by removal of the barrels, perhaps during spring high flows. The stream seemed to be adjusting to the absence of the barrels and other debris and the banks are stable (Figure 16). The stream depth and width changed a little but not in any significant or harmful way (Figure 19). The largest change was due to movement of the large rock.

Figure 16: Site #2 – Post Construction 2014 looking upstream (L) and downstream (R)

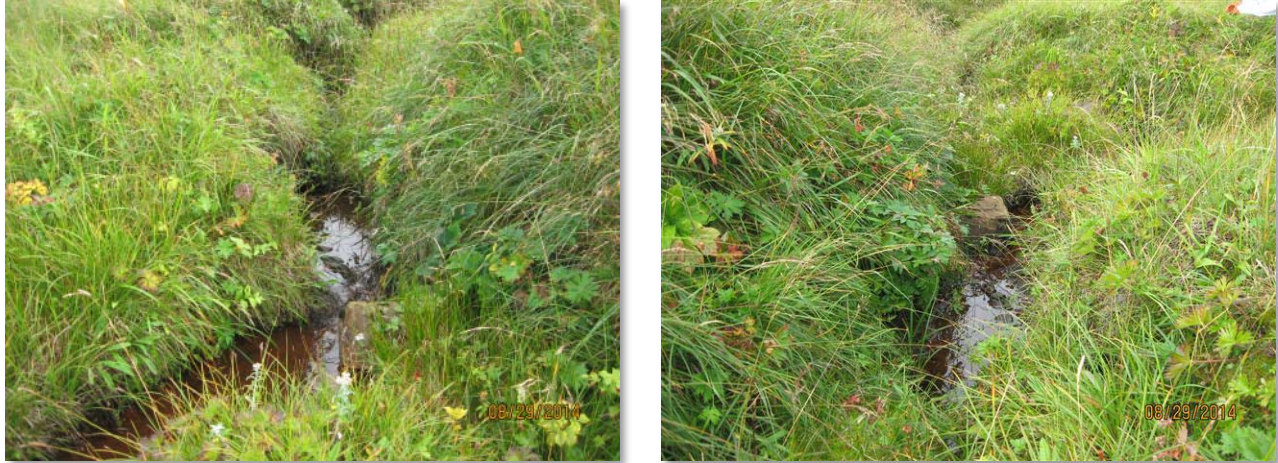
- 2014 Monitoring - Site 3: At this site a barrel was removed and the vegetation mat that had been growing over the barrel was laid over the bare bank post removal. Monitoring revealed that the vegetation had taken root and no major shifts had taken place in the channel (Figures 18 and 19).

Figure 18: Site #3 – Post Construction 2014 looking upstream (L) and downstream (R)

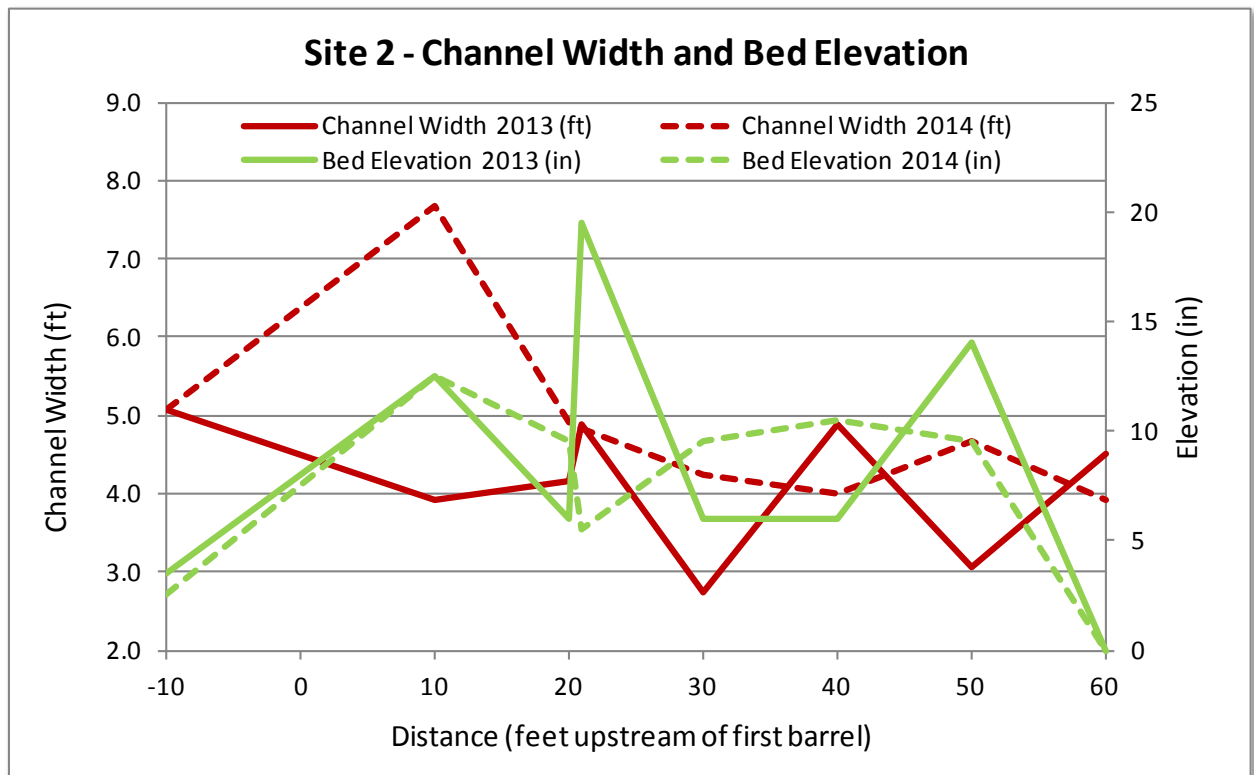
Figure 19: Site #2 – Post Construction channel measurements (2013 and 2014)

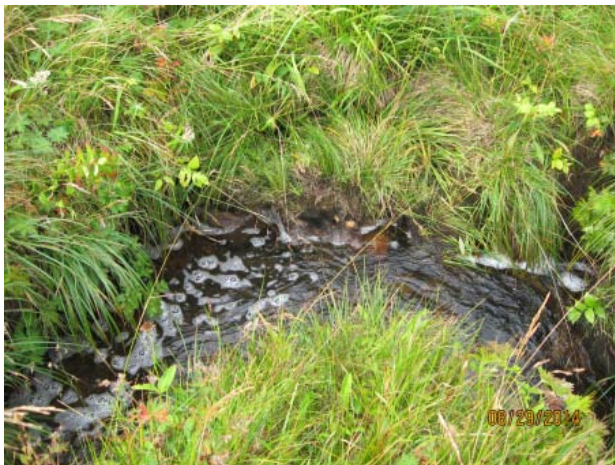
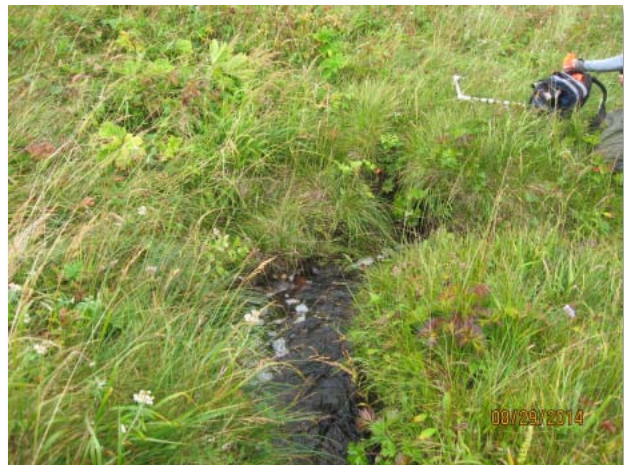
- 2014 Monitoring: The cap site was functioning and seemed to be diverting almost all of the flow to the main channel. Revegetation over the top of the capped culvert was taking root (Figure 21).

**Figure 21: Site #4 – 2014 Monitoring looking directly at cap site (L) and downstream (R)**

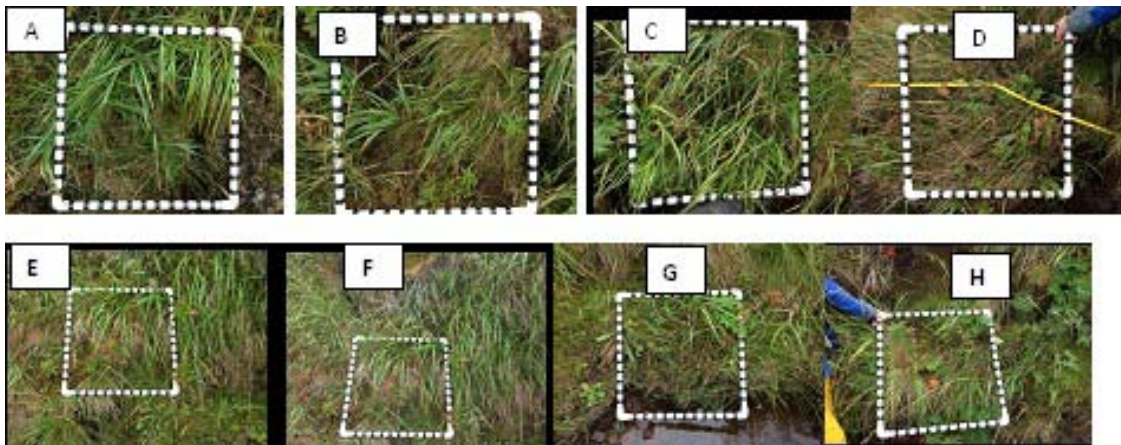
Bank Location	Percent Cover Estimate	
	2013	2014
a	30	80
b	90	85
c	85	90
d	55*	90
e	5*	85
f	90	90
g	10*	80
h	5*	90
Average -	46	86

Figure 23: 2014 Photo Quadrats for Trash Rack #1

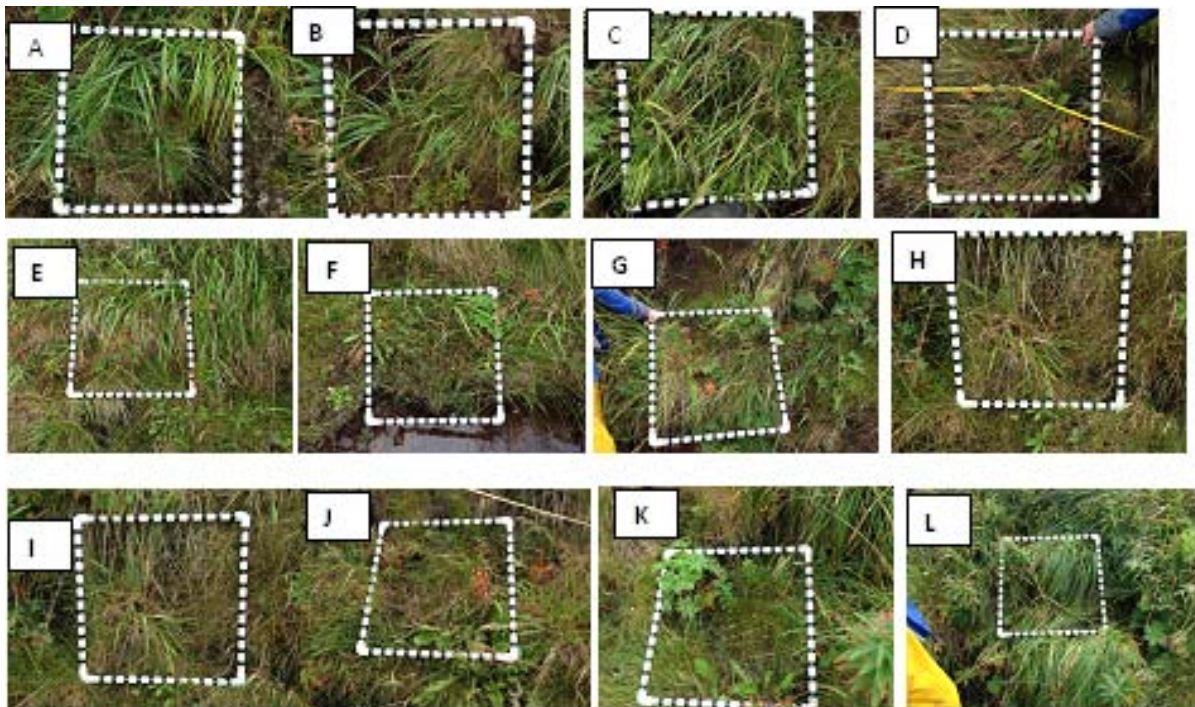
Bank Location	Percent Cover Estimate	
	2013	2014
a	6	75
b	4 <sup>a</sup>	70
c	20 <sup>b</sup>	90
d	5 <sup>a, b</sup>	80
e	10 <sup>a</sup>	80
f	2 <sup>c</sup>	90
g	6 <sup>d</sup>	90
h	5 <sup>a, c</sup>	70 <sup>c</sup>
i	15 <sup>d</sup>	70 <sup>c</sup>
j	7 <sup>a, b</sup>	80
k	7 <sup>b, c</sup>	80
l	7 <sup>b, c</sup>	80 <sup>c</sup>
Average -	8	80

Figure 25: 2014 Photo Quadrats for Barrel Removal Site #1

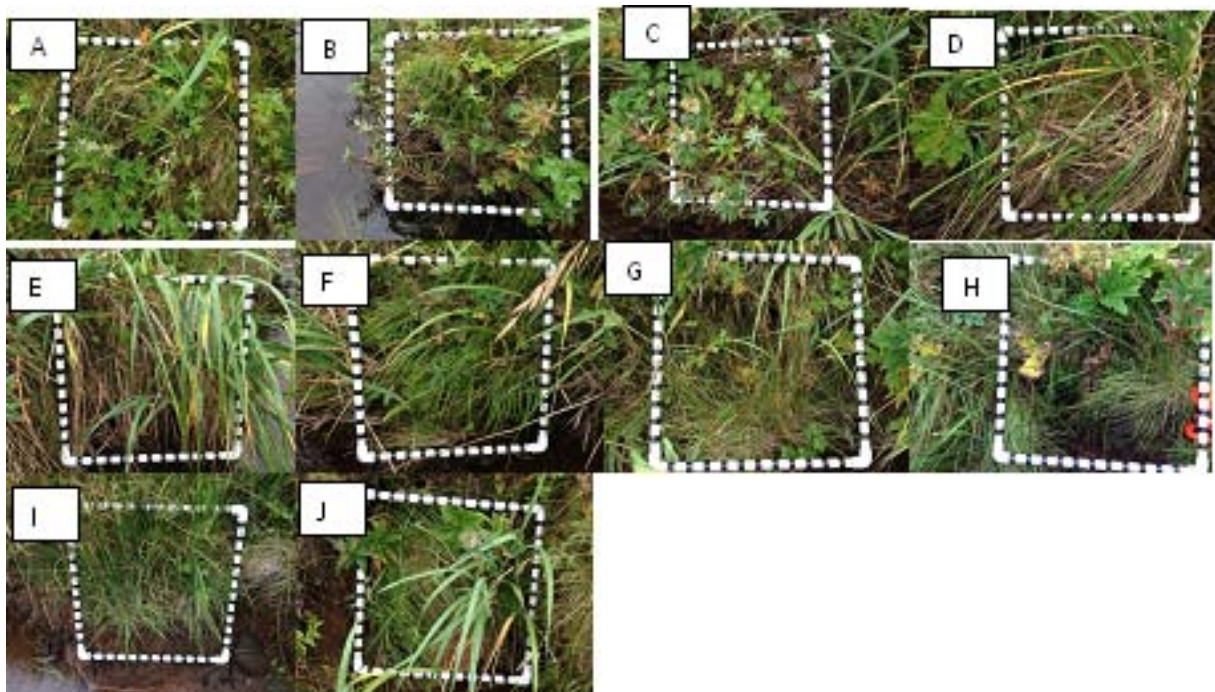
Bank Location	Percent Cover Estimate	
	2013	2014
a	10	80
b	40	75
c	3	75
d	40	80
e	25	75
f	30	75
g	25	80
h	40	75
i	35	75
j	15	70
Average -	26	76

Figure 27: 2014 Photo Quadrats for Barrel Removal Site #2

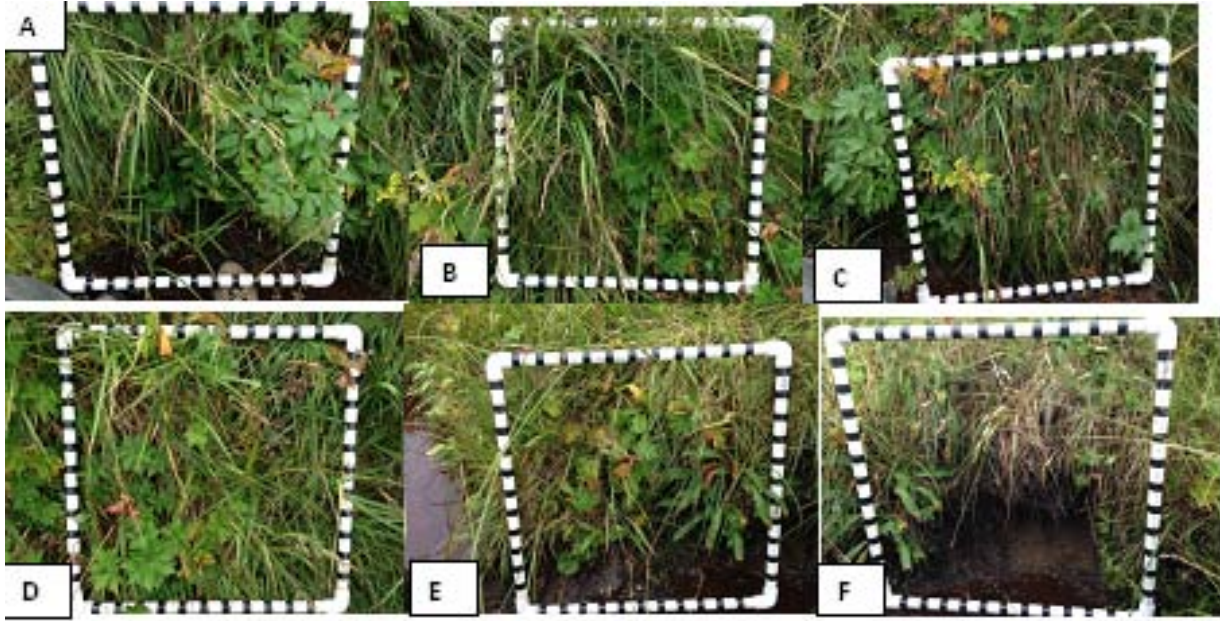
Bank Location	Percent Cover Estimate	
	2013	2014
a	25	75
b	30	80
c	40	70
d	20	75
e	35	65
f	15	50*
Average -	27	69

**Figure 29: 2014 Photo Quadrats for Barrel Removal Site #3**

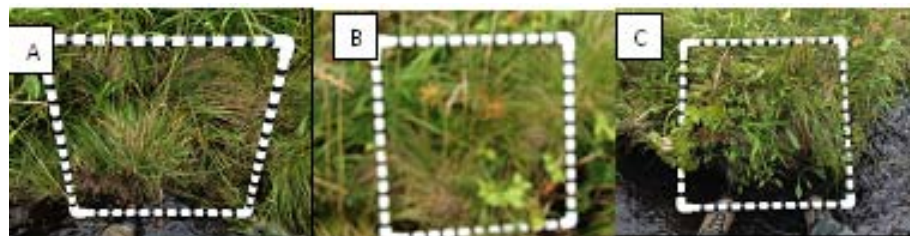
Bank Location	Percent Cover Estimate	
	2013	2014
a	25	80
b	30	80
c	25	65*
Average -	27	75

Figure 31: 2014 Photo Quadrats for Barrel Plug Site #4
