**Initial Observations on Biological Damage Arising from the Cape Flattery Ship  
Grounding at Barbers Point, Oahu with Recommendations for Quantitative  
Surveys and Substrate Stabilization to Minimize Further Loss of Coral Reef  
Resources**

Steven P. Kolinski

13 February 2005

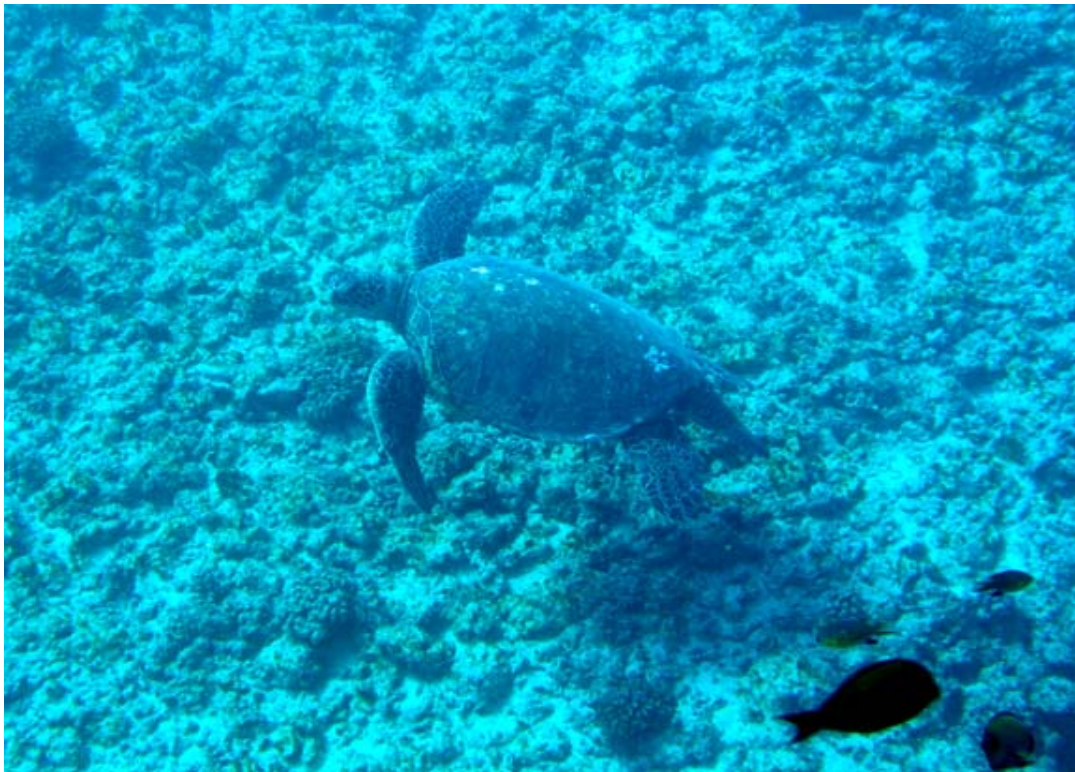
Figure 1. Male green turtle, *Chelonia mydas*, swimming from a resting area at the edge of the escarpment (55 ft depth).

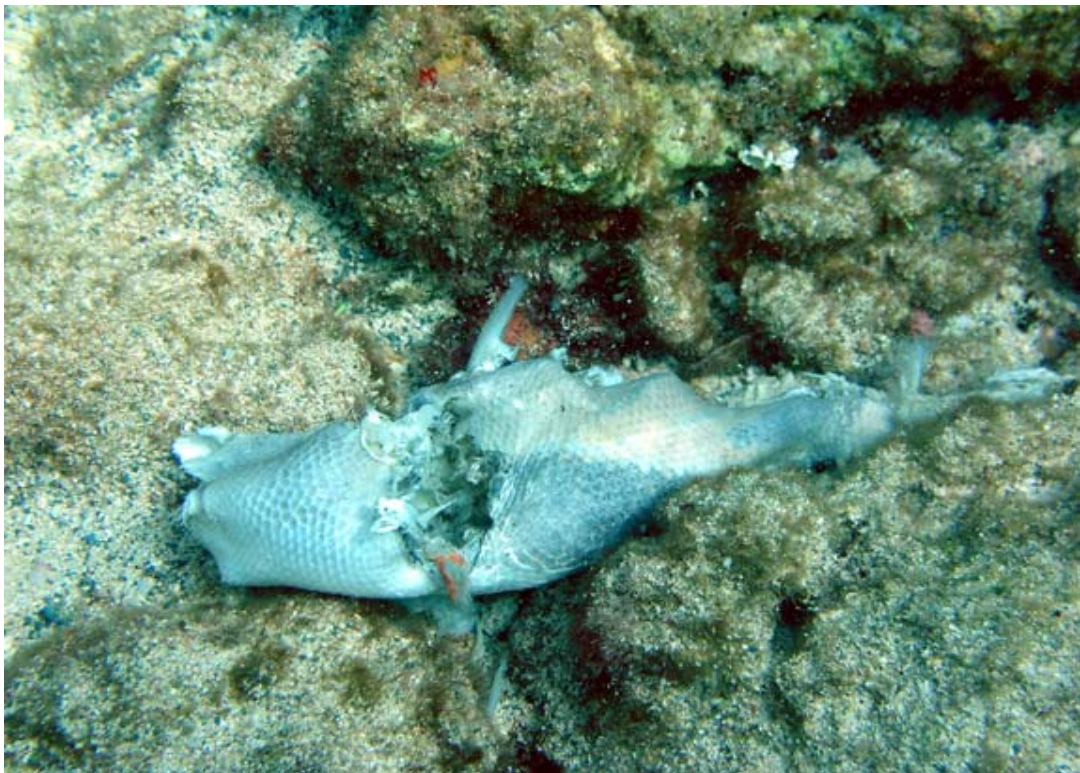
At 23 ft (7 m), corals, macro-invertebrates and even fish were pulverized by direct contact with the ship and related equipment (Figures 2 and 3). In addition, large numbers of colonies were broken/sheared, apparently from lines and anchors used in ship stabilization and towing (Figures 4 and 5). Collision and burial by loose substrate and colonies was observed (Figure 6). Reef organisms also succumbed to cement deposited during removal from the ship (Figures 7 and 8). Damage along the upper escarpment was extensive and appeared to result mainly from the use of tow lines and anchors in the area (Figures 9 - 11).

Figure 3. Pulverized fish (23 ft depth).

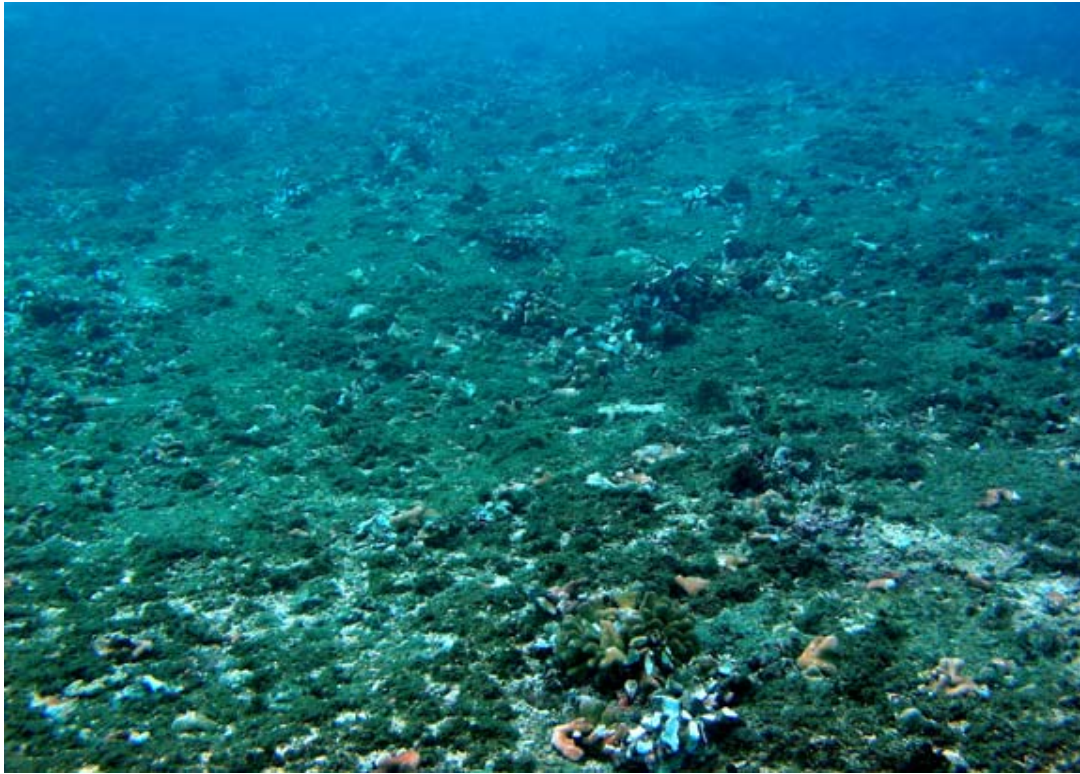
Figure 4. Field of sheared *Pocillopora meandrina* (23 ft).

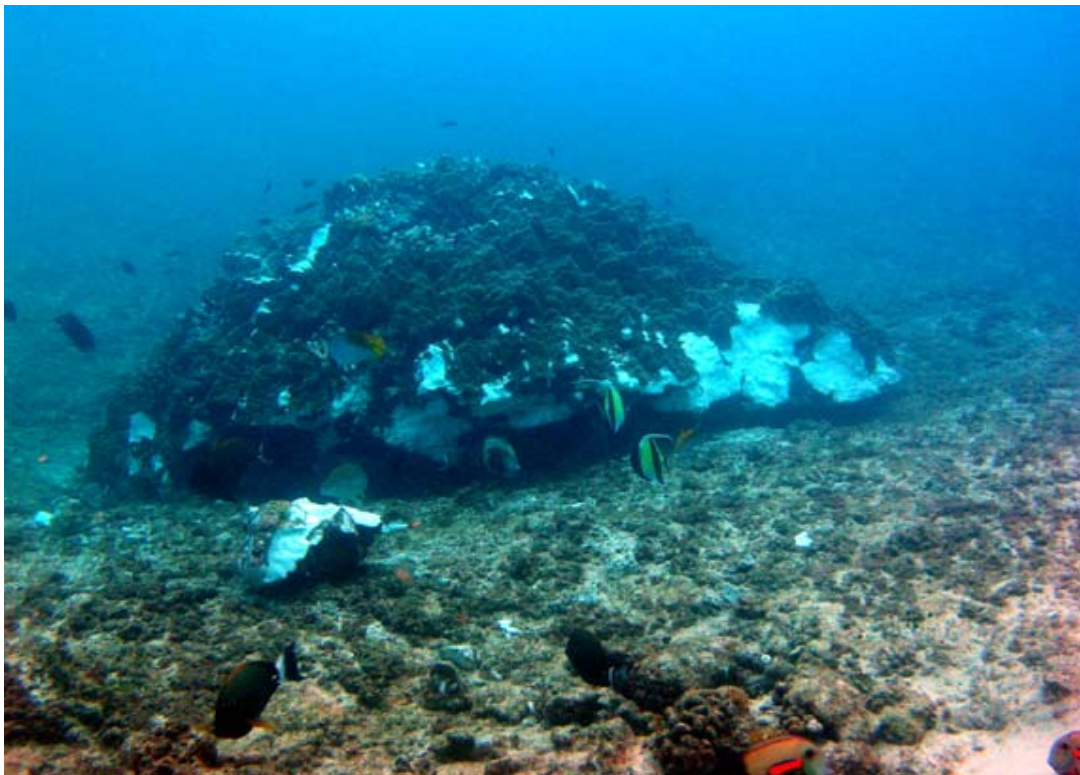
Figure 5. Damage to *Porites evermannii* (colony size = 3.2 m; 23 ft depth).

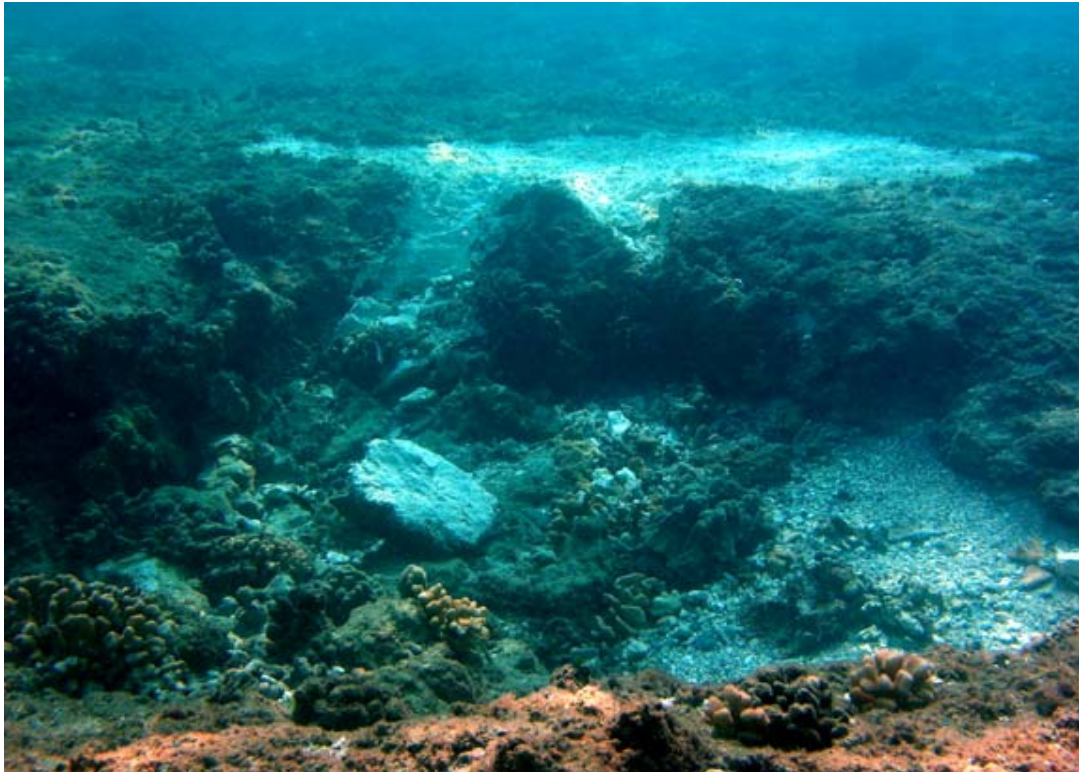
Figure 6. Deposition of loosened material on organisms which escaped initial injury.

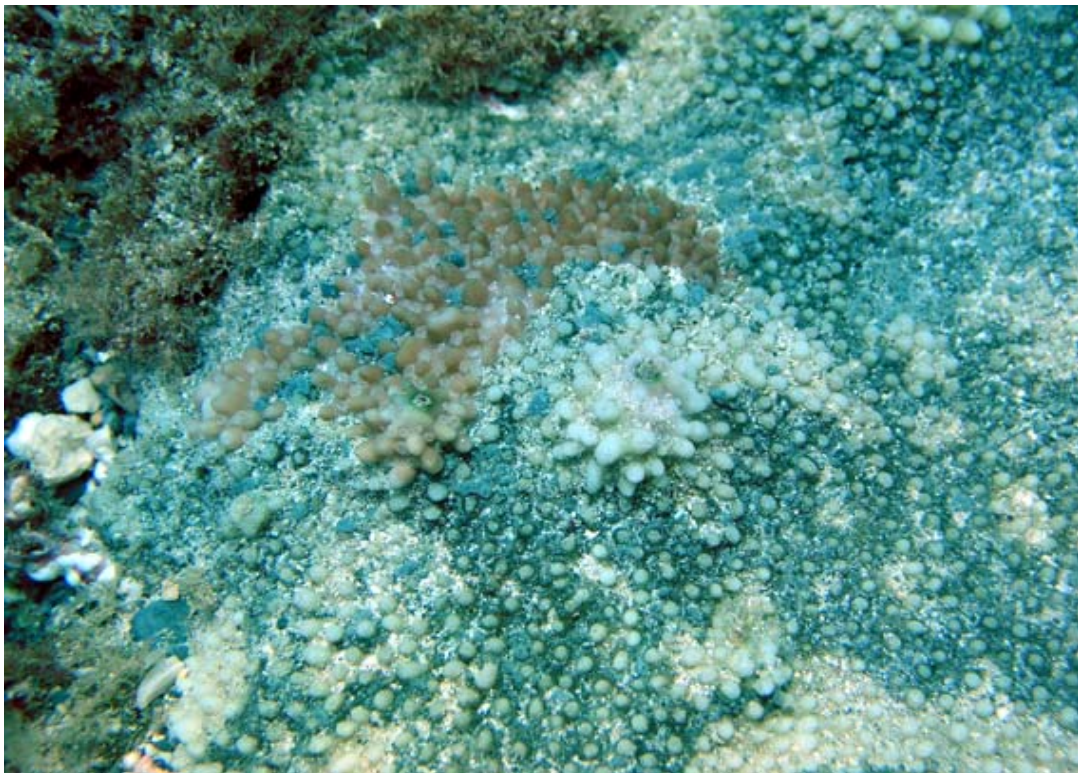
Figure 7. Cement damage to *Montipora capitata* (23 ft depth)

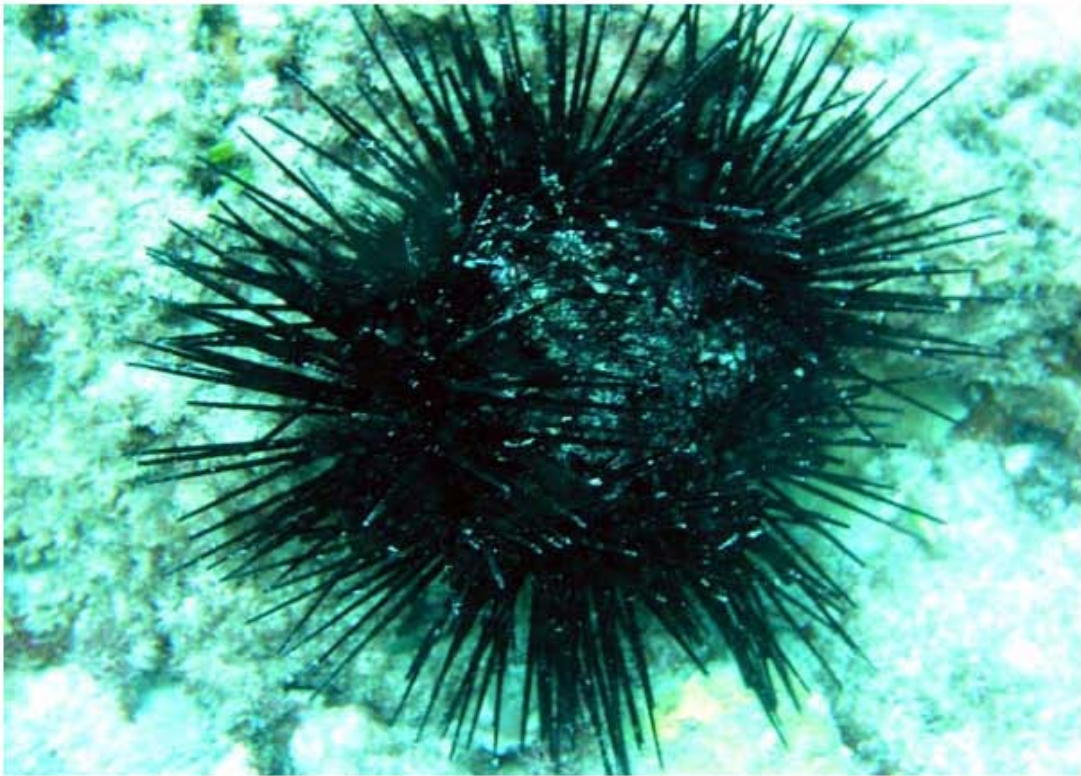
Figure 8. Ailing sea urchin, *Echinothrix calamaris* (23 ft depth).

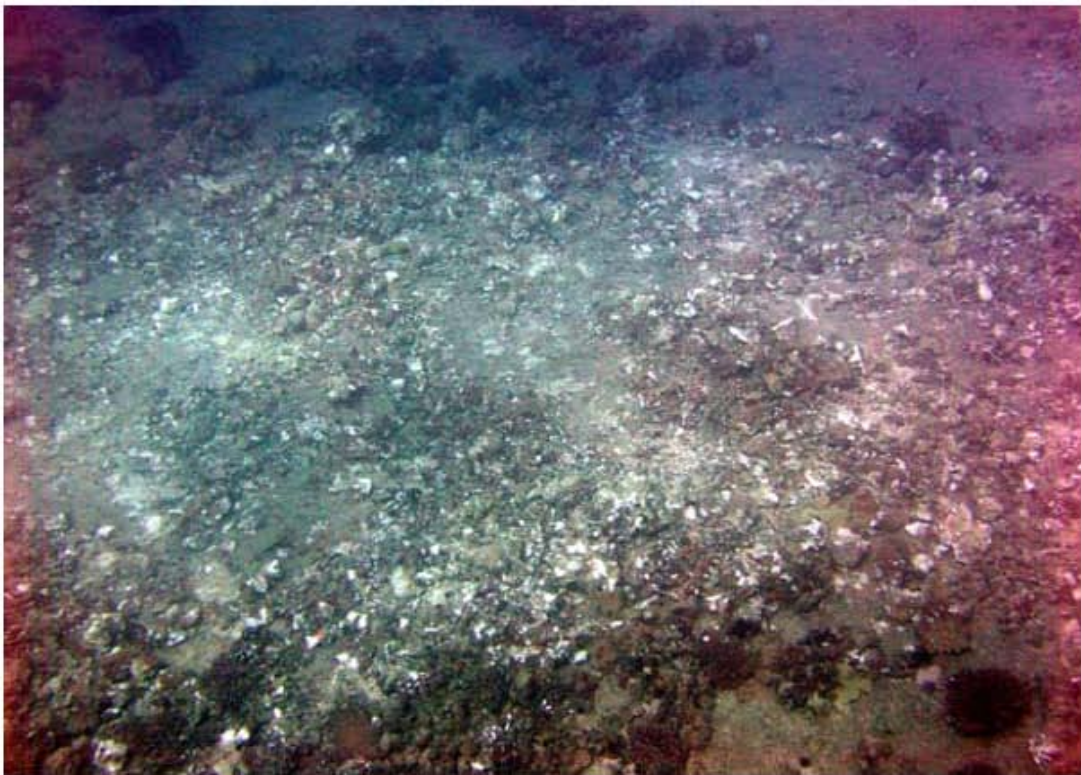
Figure 9. Tow-line damage along reef escarpment (50 ft depth).

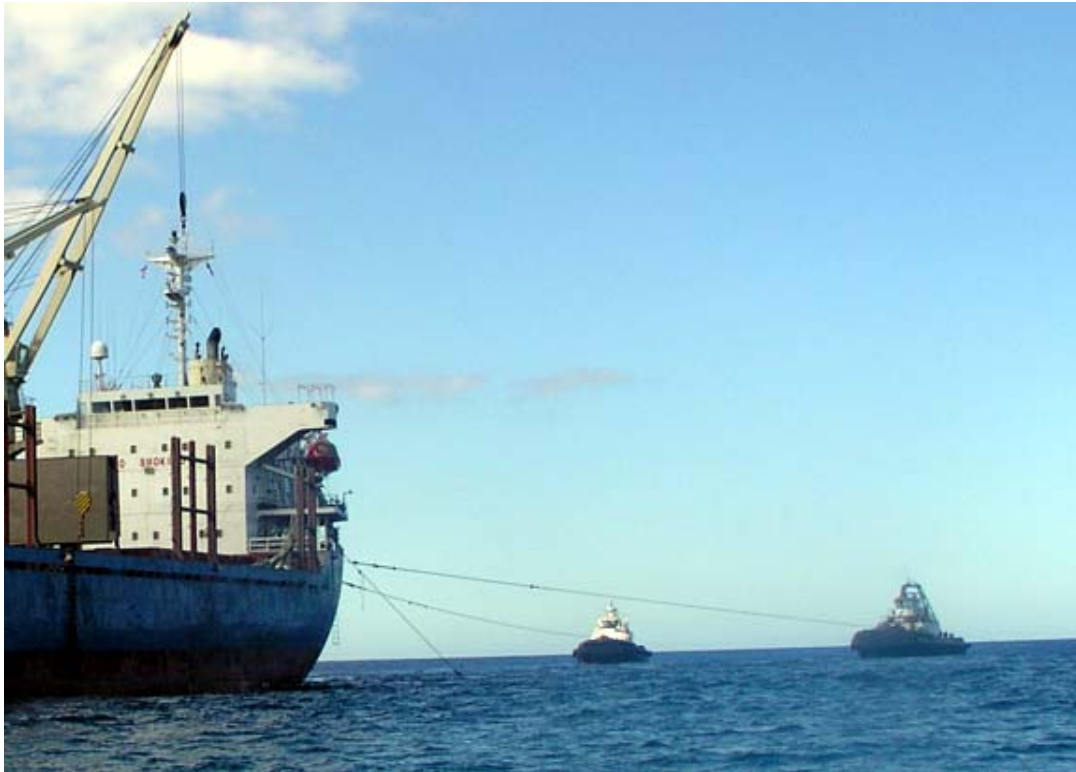
Figure 10. Tow line and chain trailing far below the waters surface.

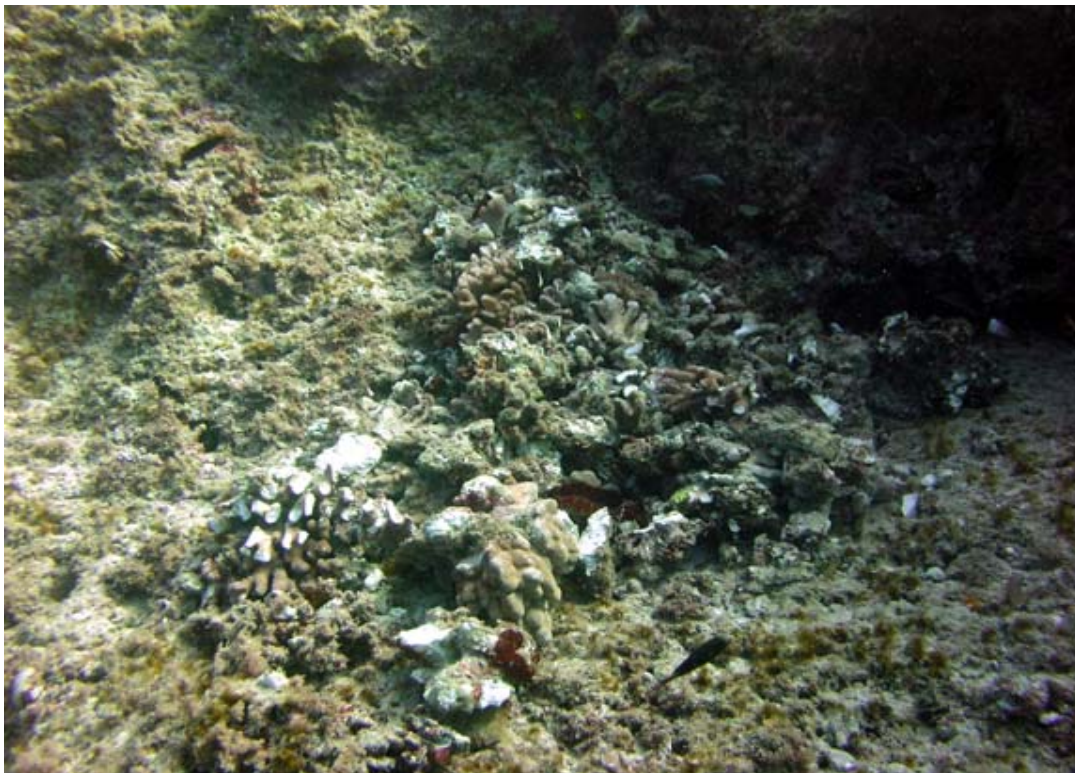
Figure 11. Detached colonies and fragments accumulating below the escarpment (74 ft depth).

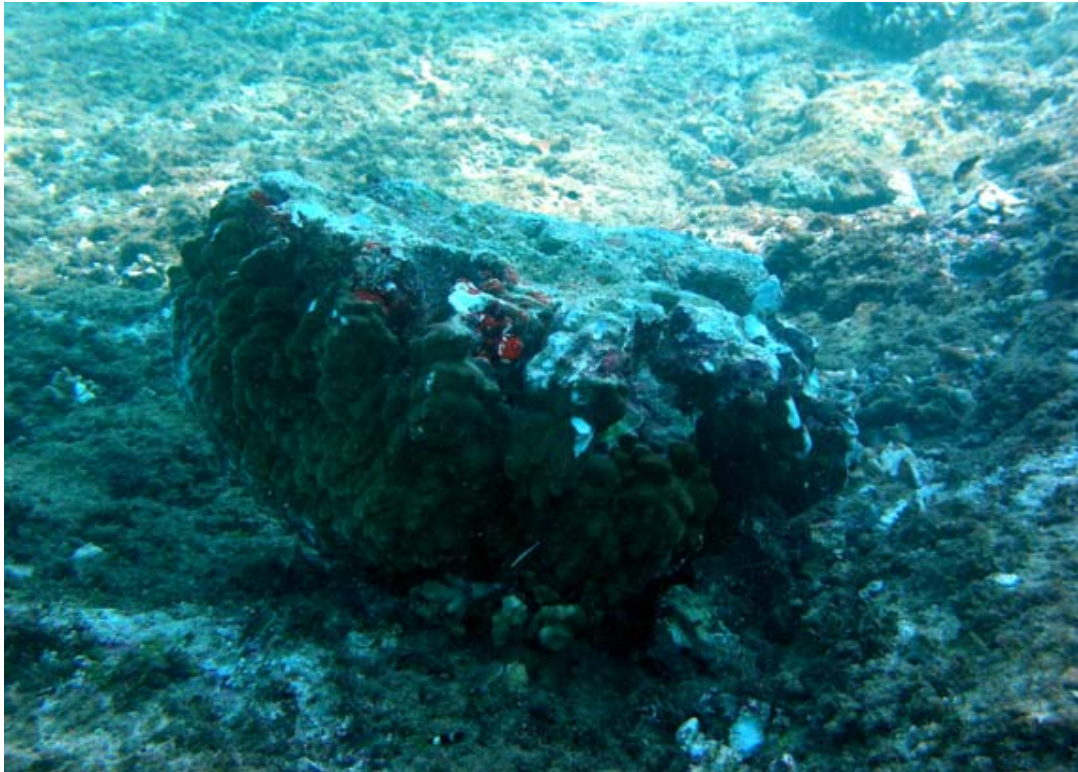
Detached colonies, fragments, cobble, rubble and sediment were generated in an area typically exposed to high wave energy. Movements of these materials have the potential to cause damage to macro-invertebrates survivors through collision and scour. Stabilization of large living corals should enhance their probability of survival (Figures 12 and 13).

Figure 12. Stabilization of this *Porites* head will enhance its potential to survive while reducing its capacity for collision with other colonies in the region.

3. **Detached Colony and Substrate Stabilization:** Large coral colonies and pieces of substrate that became detached as a result of ship grounding activities should be reattached using cement (Portland Type II and Molding Plaster mixture) and/or epoxy (Zspar) to reduce further mortality and limit collisions with previously non-impacted corals in the area. Efforts should also be made to remove excess debris from turtle resting holes.

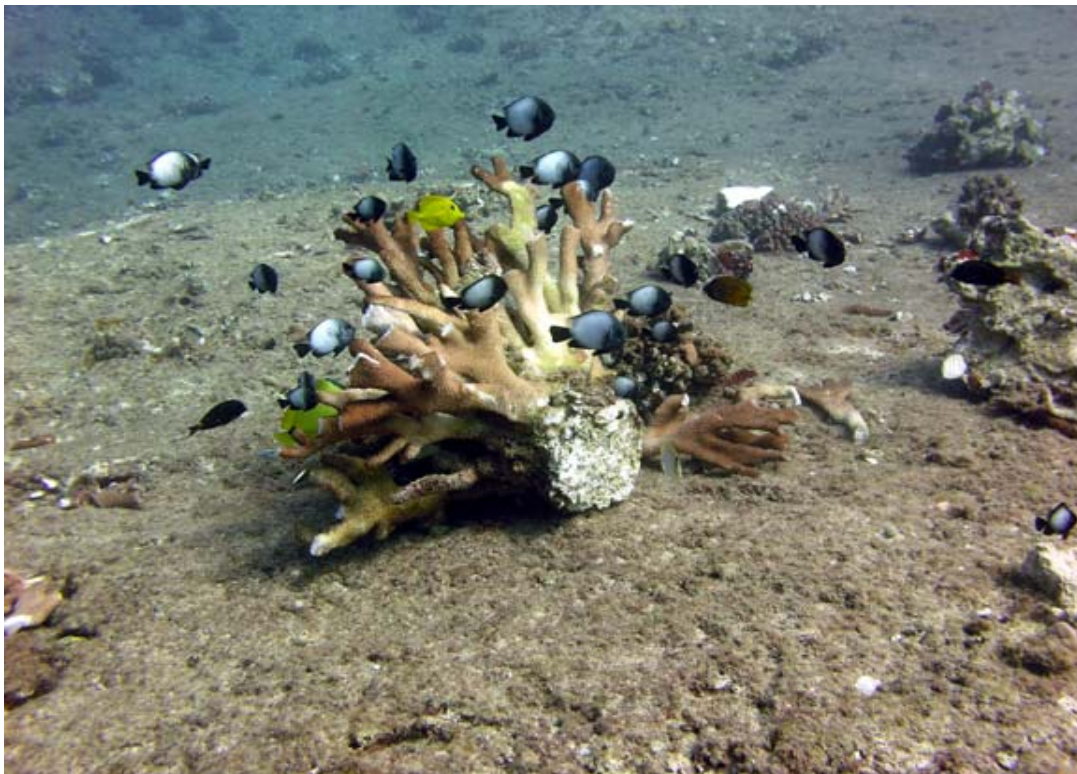
Figure 13. *Pocillopora eydouxi* colony that may survive if reattached.
