## **NATURAL RESOURCE RESTORATION**

Enbridge-Cohasset Project (# 0387)

### **Interim Report**

October 29, 2014

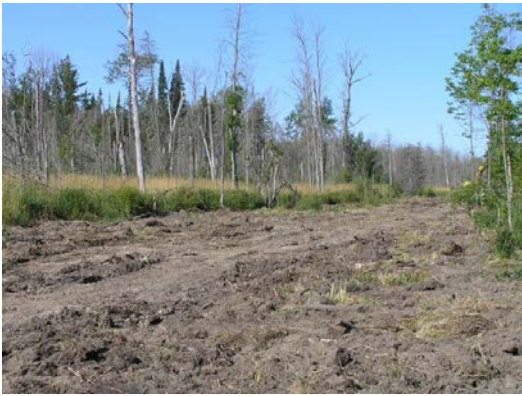
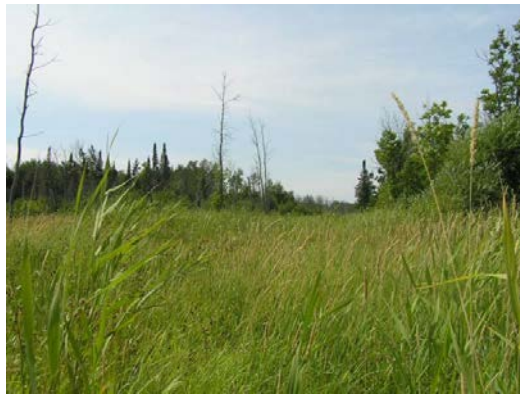
**Figure 1. (left to right) Mixed shrub and forested wetland along the east portion CNF Site 3 West dating August 2008 and July 2014 (USDA Forest Service David Morley).**

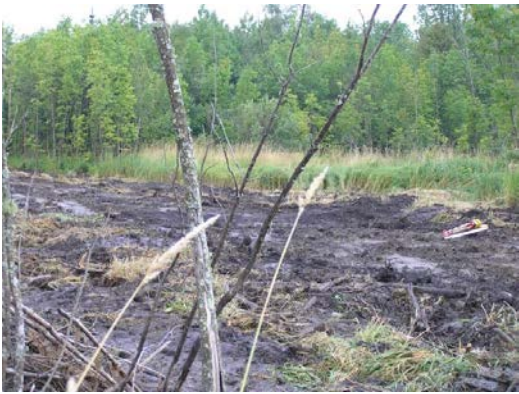
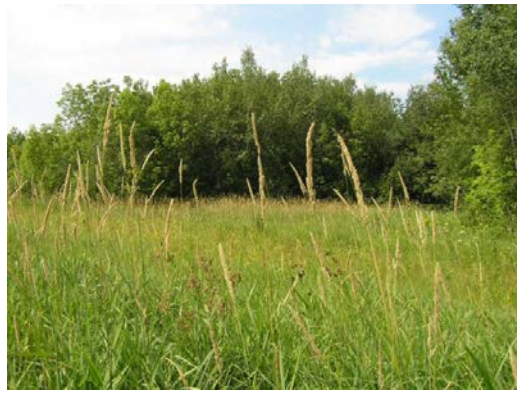
**Figure 2. (left to right) Easternmost flowage on CNF Site 3 West dating August 2008 and July 2014 (USDA Forest Service David Morley).**

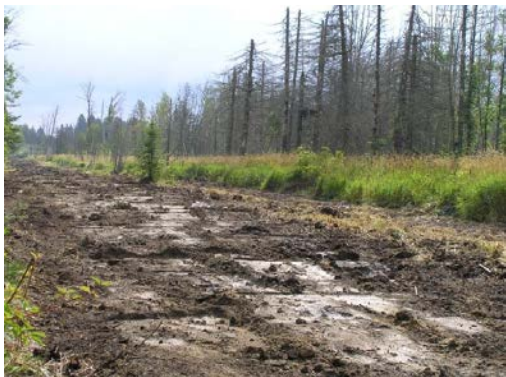
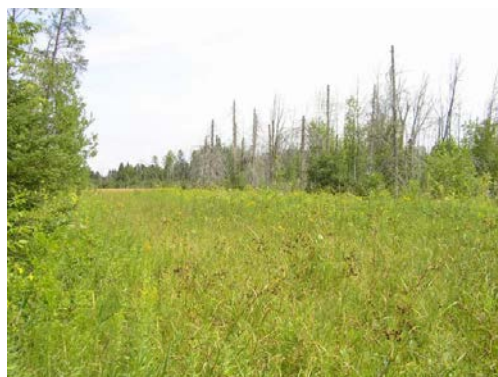
**Figure 9. (left to right) Forested wetland along the western portion of CNF Site 3 West dating August 2008 and July 2014 (USDA Forest Service David Morley).**
