# **Santa Clara River Steelhead Trout: Assessment and Recovery Opportunities**

**December 2005**

**Matt Stoecker**

**The Santa Clara River Trustee Council and The Nature Conservancy**

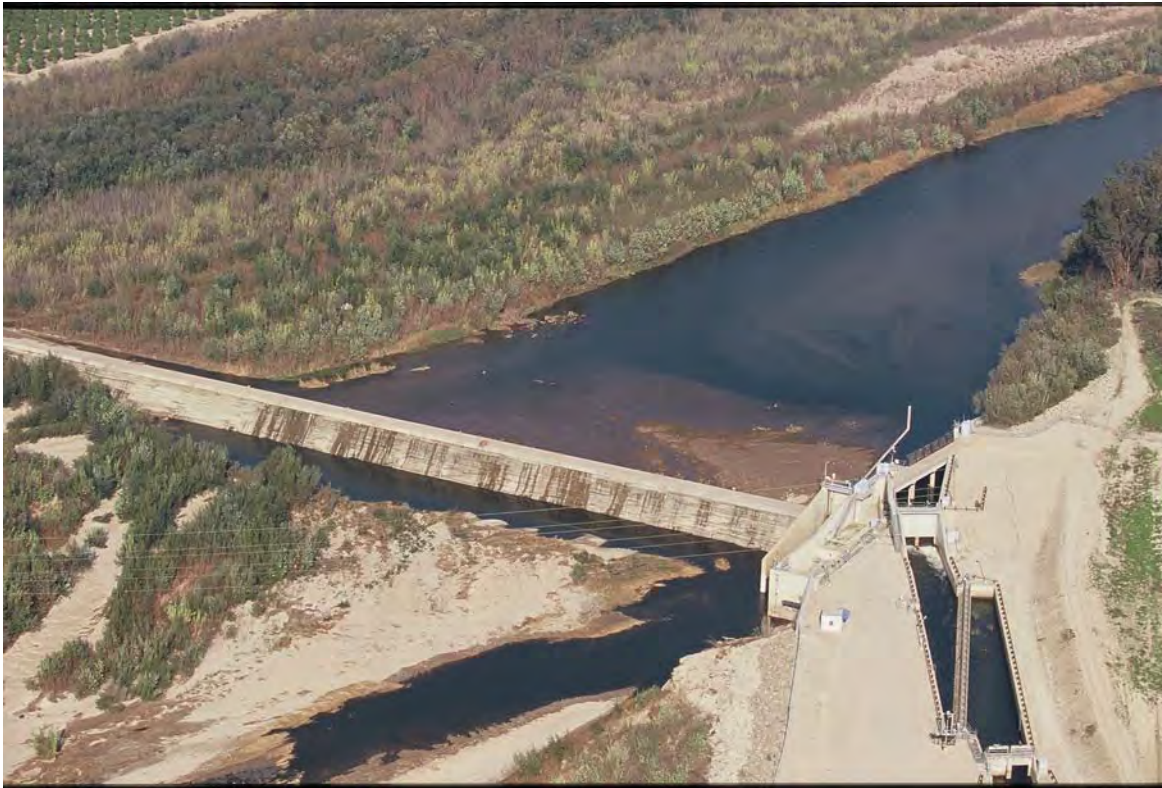
**Description:** The structure is owned and operated by Bureau of Reclamation and United Water Conservation District (UWCD). The current dam measures 1200 feet across and 20 feet tall from the crest to the downstream concrete apron. The dam extends an additional 50 feet down through the substrate and keys into bedrock. The current Vern Freeman Diversion Dam and associated Denil Fishway were built in 1990. Prior to the construction of this concrete dam, various temporary earthen diversion dams existed and occurred upstream from the current diversion dam location. These older dams diverted flows into an earthen channel built along the side of the river and water moved downstream to near the existing holding ponds by gravity. Murray McEachron of UWCD reported that the first company to divert water started operation in 1875. UWCD bought the operation in 1927 and at this time surface flows were generally only diverted during lower flows encountered in the summer and fall with a temporary earthen dam that blew out during the winter. In the 1940's winter flows started being diverted and a steel and piling diversion structure was built in 1968 to increase the ability to withstand the high winter flows and expand the diversion season. The flood of 1969 reportedly destroyed this new structure. From 1970 to 1990, UWCD reportedly operated an earthen dam that could survive mainstem flows up to 2000 cfs at which point the dam was blown out. This dam reportedly diverted all steelhead smolts into the diversion channel when operating and was also impassable to upstream migrating adult steelhead due to the excessive outlet drop. For twenty years upstream steelhead passage could only occur during high flow years that exceeded 2000 cfs and destroyed the dam.

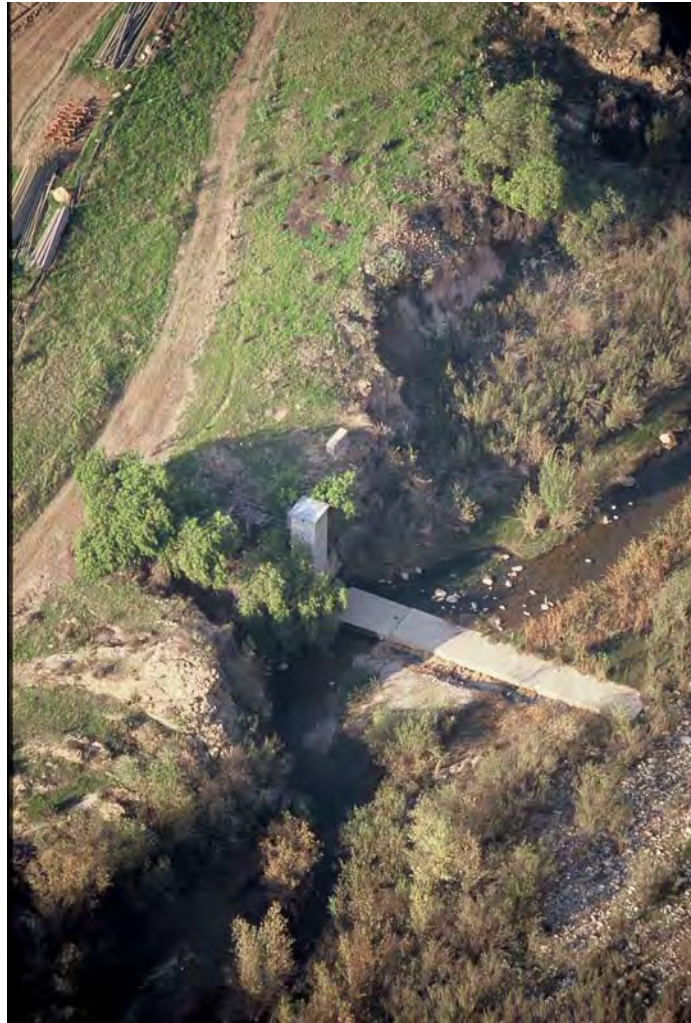
**Description:** Access to survey this structure was not obtained and limited observations were made from the air. This structure appears to be a gaging weir with a tall gaging-type structure occurring adjacent to the concrete weir on the river-right bank. Surface flows were observed to be focused across the weir on the far river-right side. Flows appeared to drop at least 2 feet 6 inches from the weir outlet to the surface of the downstream pool.

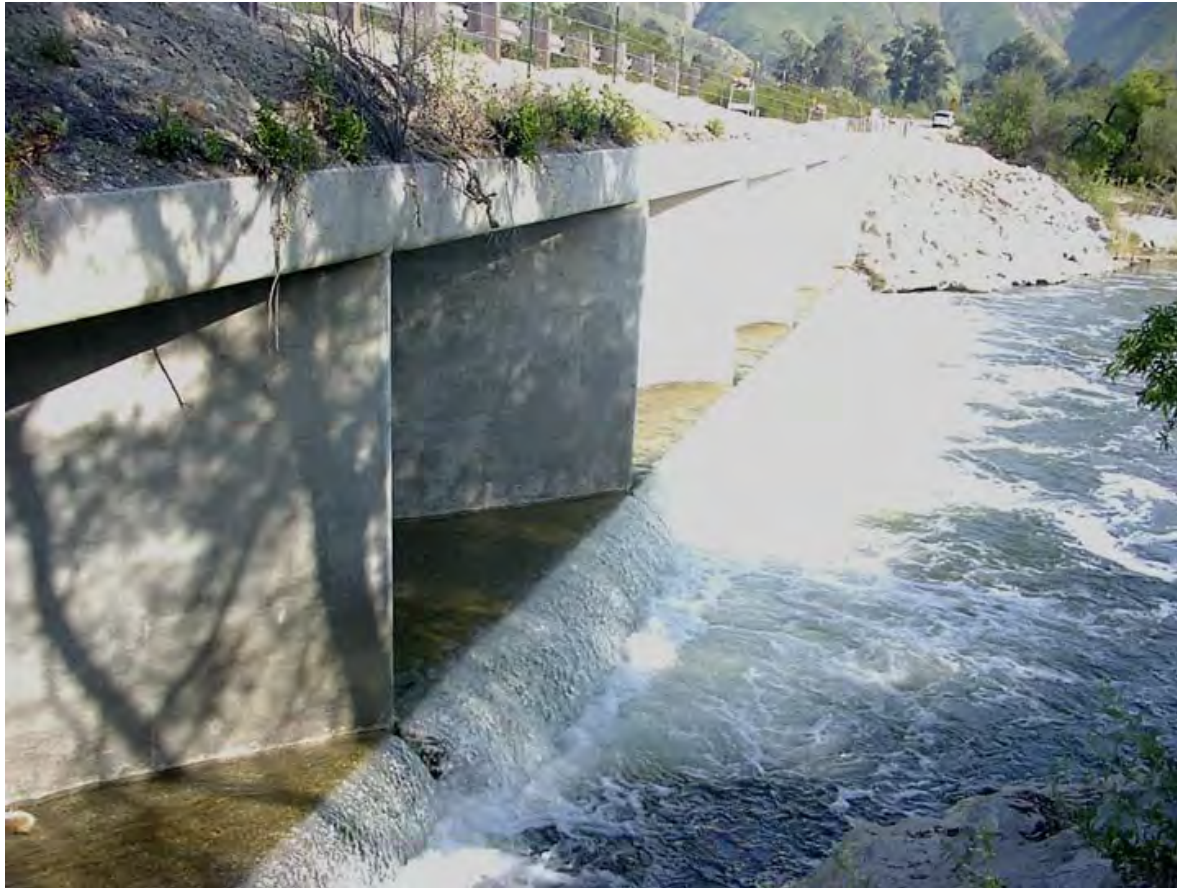
**Description:** Due to lack of access to adjacent private land, limited observations of this culvert were made. This 6-box concrete culvert appears to have a mild gradient and approximately 12-inch outlet drop during the fall of 2004. The structure appears to be in good condition.

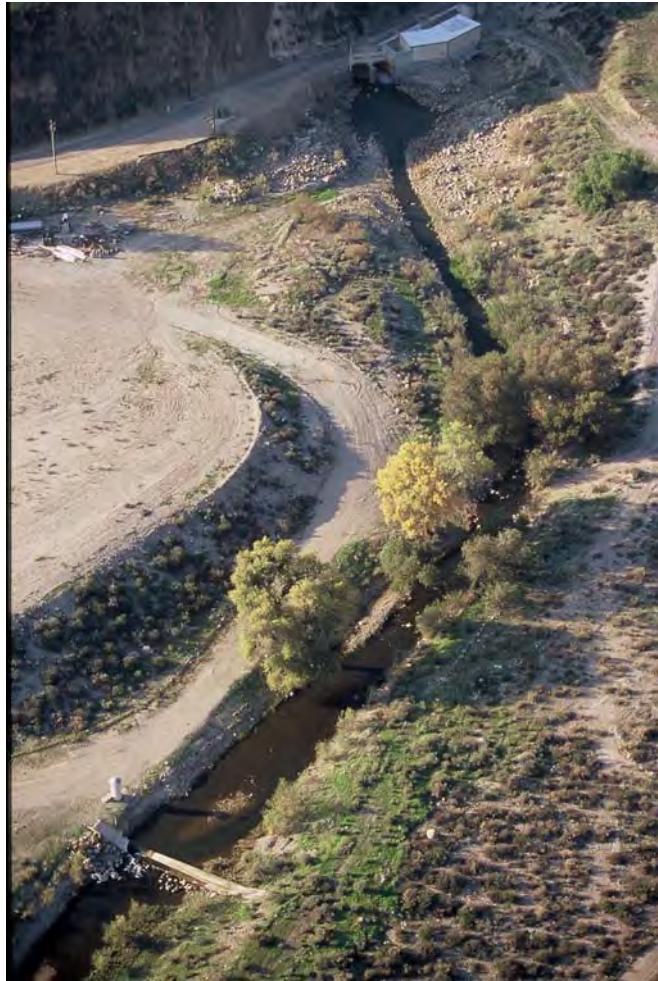
### Weir/Dam (SC\_PU\_3) - Piru Creek

**Description:** Access to survey this structure was not obtained and limited observations were made from the air. This structure appears to be a concrete weir or possible obsolete diversion dam. An outlet pipe was observed on the downstream side. The structure is approximately 4 feet thick with 6 feet of boulder rip-rap protection forming a cascade-like apron on the downstream side. The total height of the structure from the downstream pool surface to the outlet lip of the dam is approximately 4 feet 6 inches.

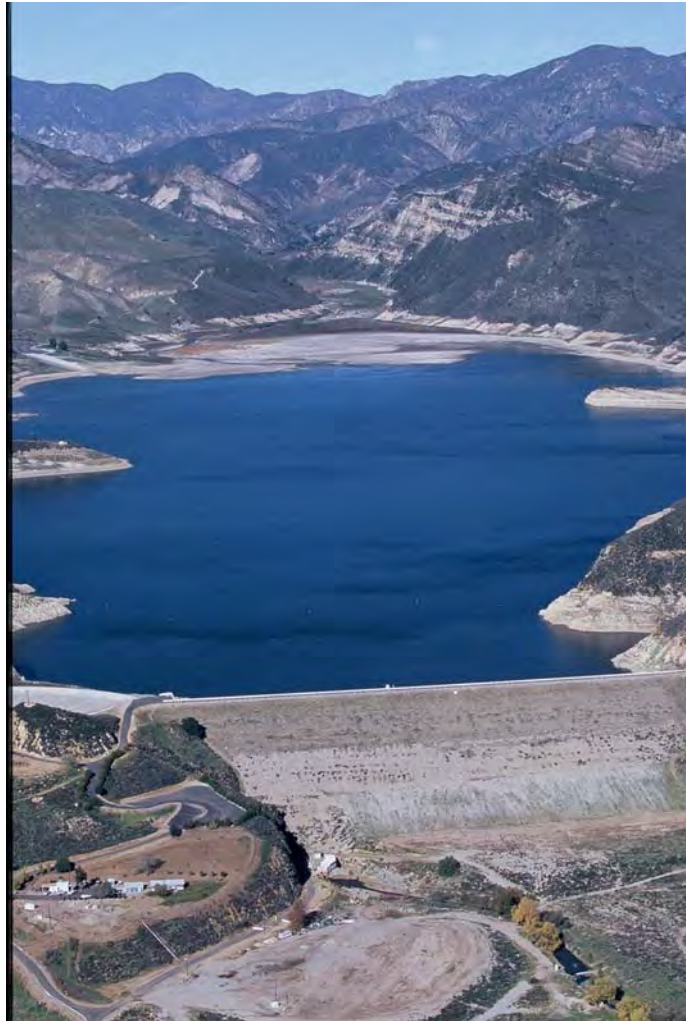
**Description:** Santa Felicia Dam was built in 1954. United Water Conservation District (UWCD) operates the Santa Felicia Dam in conjunction with the California State Water Project (Pyramid Dam) located upstream and the Vern Freeman Diversion Dam located approximately 15 miles downstream on the mainstem of the Santa Clara River (USDC-NOAA, 2005). This large dam was constructed without fish passage facilities and currently does not have any facilities or programs to allow upstream fish passage. A small hydro-project is associated with the facility.

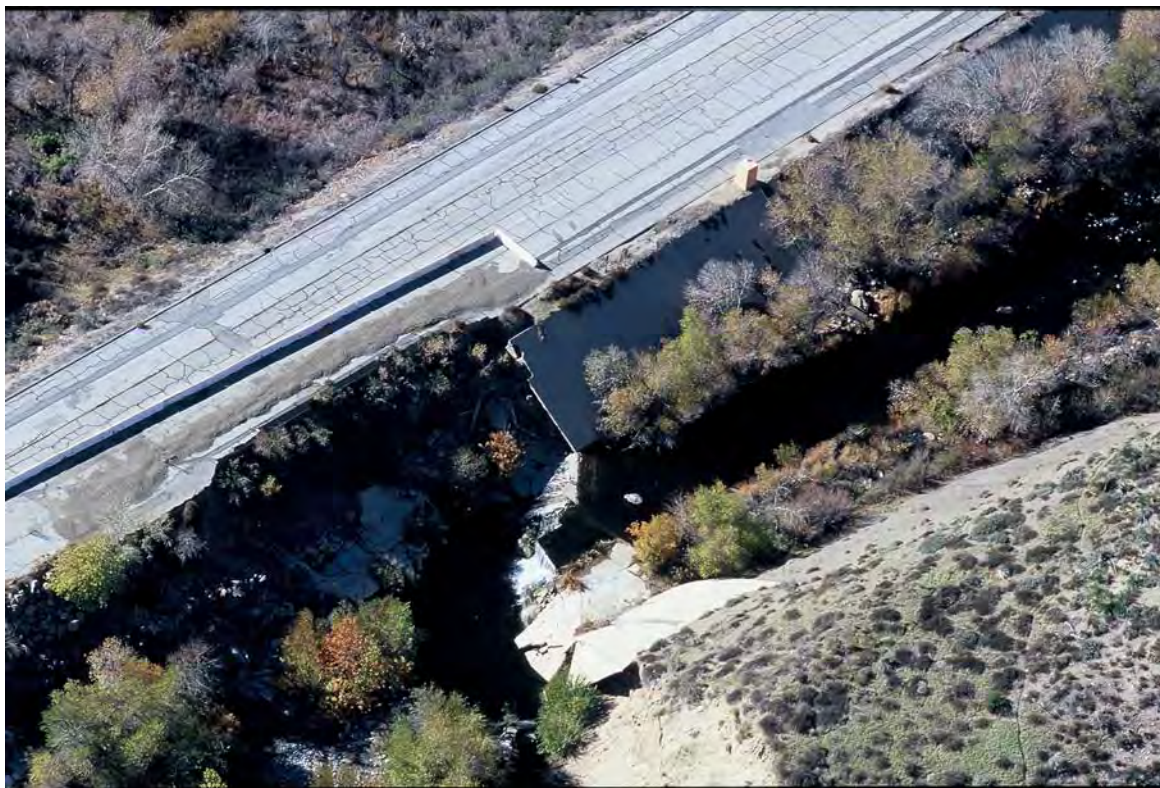
**Description:** Access to survey this structure was not obtained and limited observations were made from the air. This concrete channel appears to be several hundred feet long and is in poor condition with sediment deposits and riparian vegetation occurring within the channel. Concrete appears to be broken in several locations and an outlet drop of at least 5 feet has considerable downstream scour associated with it that has eroded adjacent banks and undercut the concrete channel.

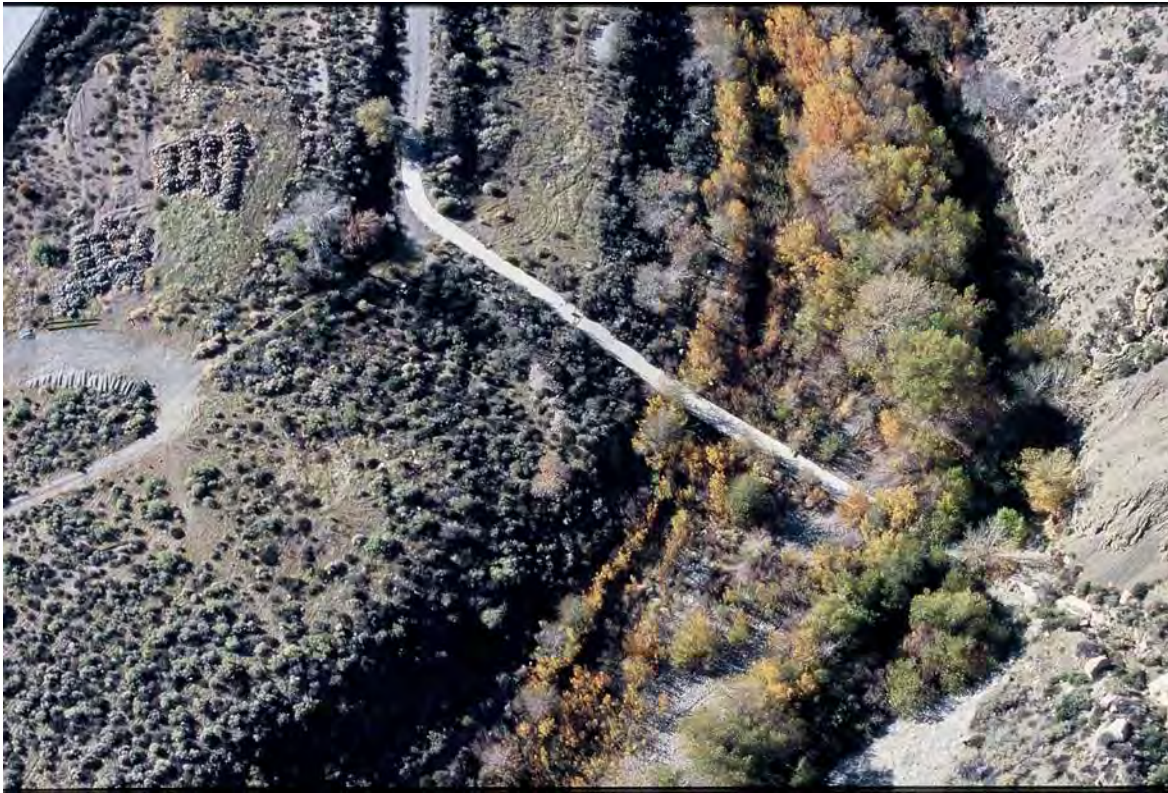
**Description:** Access to survey this structure was not obtained and limited observations were made from the air. The exact purpose of this structure could not be determined, but it appears to be a concrete crossing or some type of grade control structure or utility protection.

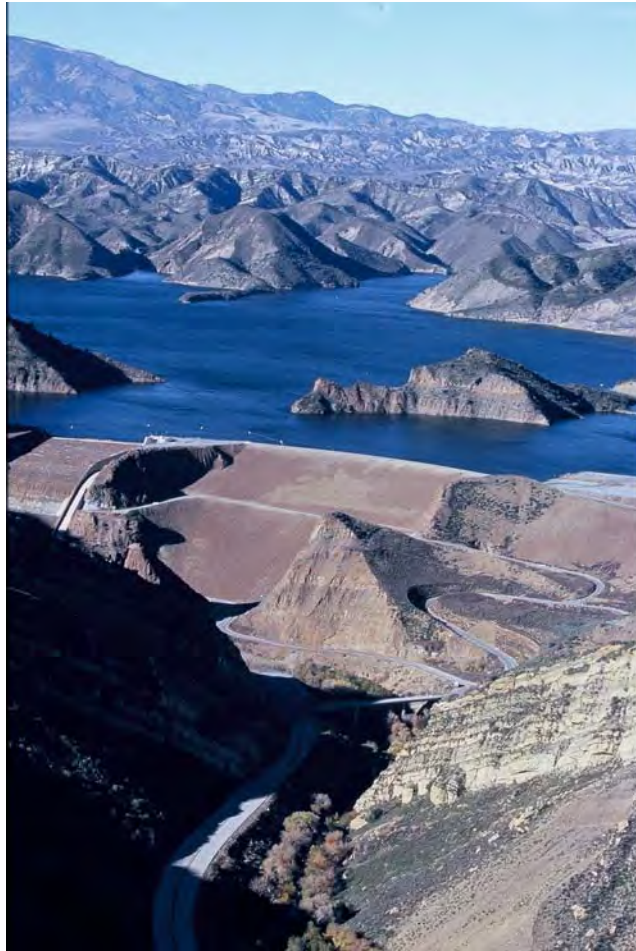
**Description:** Pyramid Dam was built in 1973 and is owned and operated by California Department of Water Resources. This large dam was constructed without fish passage facilities and currently does not have any facilities or programs to allow upstream fish passage.

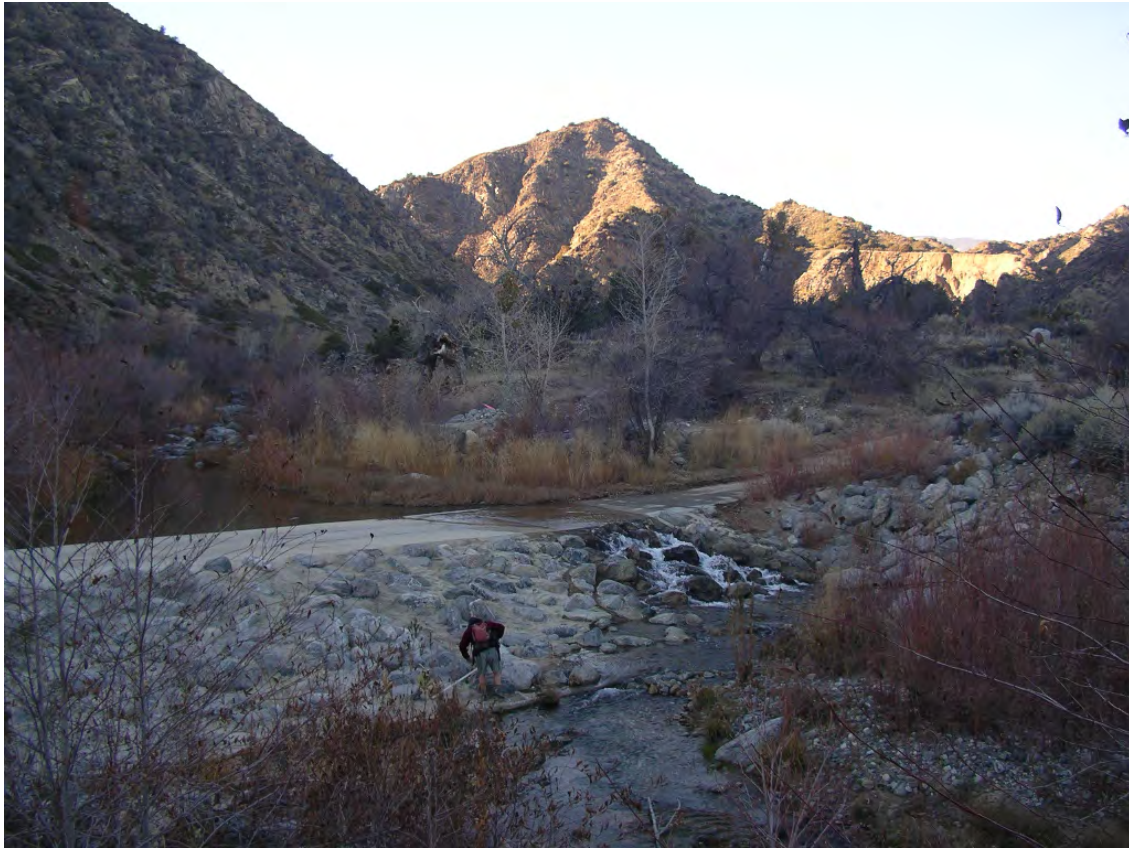
**Description:** This concrete crossing measured 135 feet across the channel and 46 feet wide including the downstream concrete and boulder apron. The slope of the 16-foot wide road surface crossing measured 1% and the slope of the 30-foot long downstream apron measured 18%. All surface flows are conveyed on top of the crossing and apron and then drop 10 inches to the surface of the downstream 1-foot deep pool. The total height of the crossing from the downstream pool surface to the top of the road crossing measured 6 feet 3 inches.

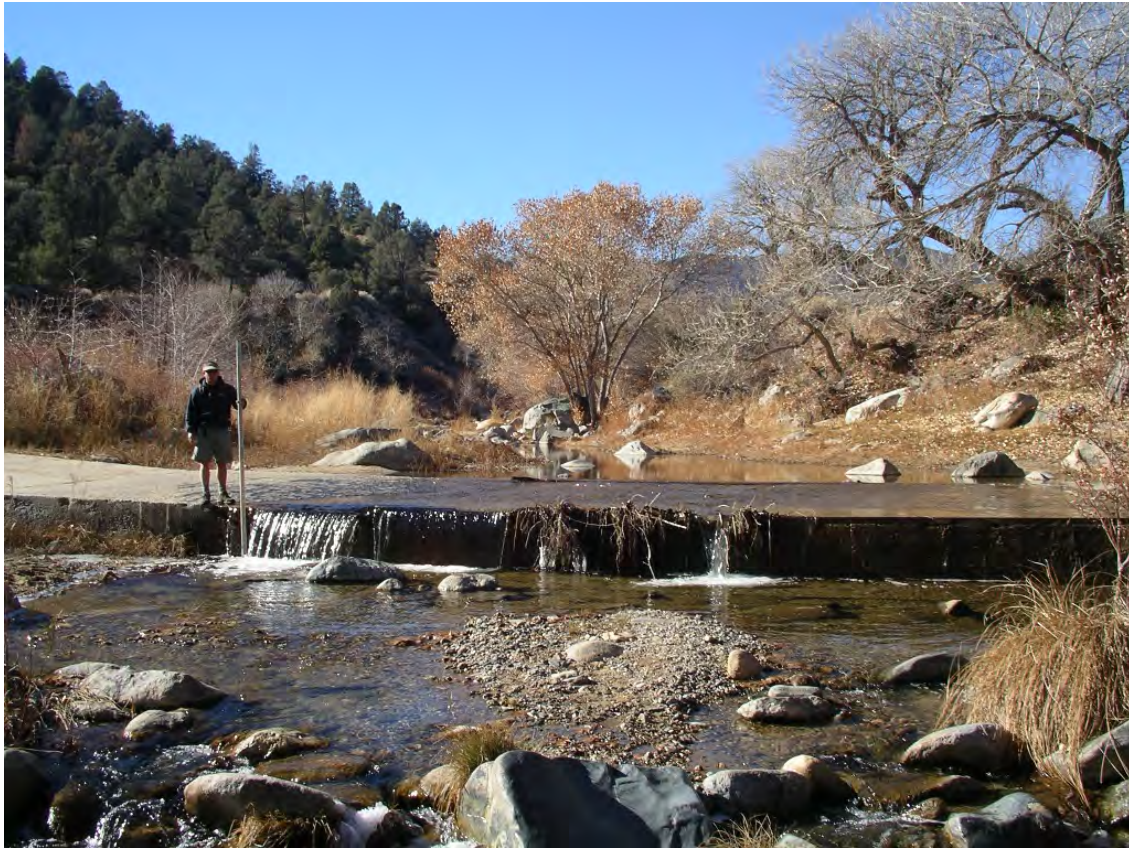
**Description:** The concrete crossing measured 19 feet wide with a slope of 1.3%. All surface flows are conveyed on top of the crossing and then drop 1-foot 9 inches to the surface of the downstream 8-inch deep pool. Exposed re-bar was observed on the downstream side of this crossing that appears to be in fair condition.

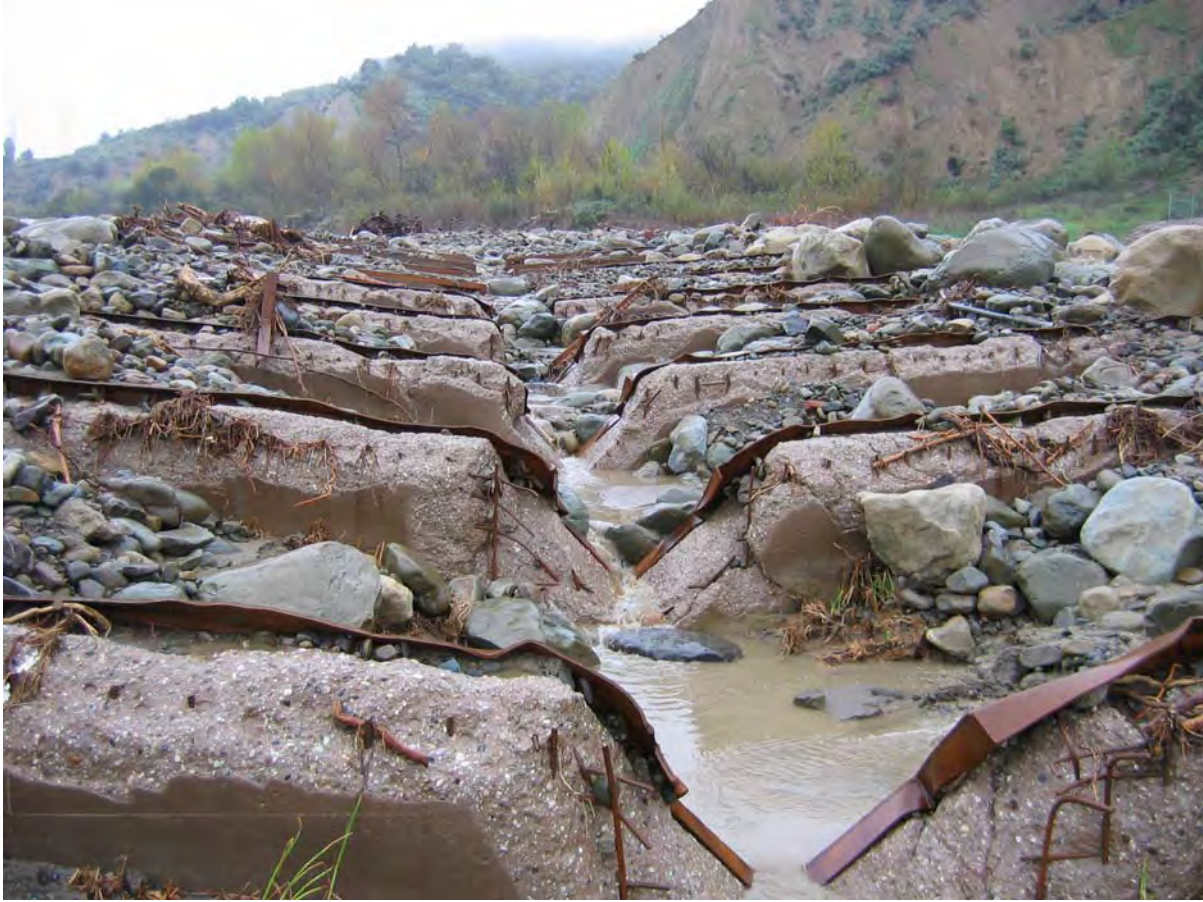
*Fishway failure following January 2005 flows*

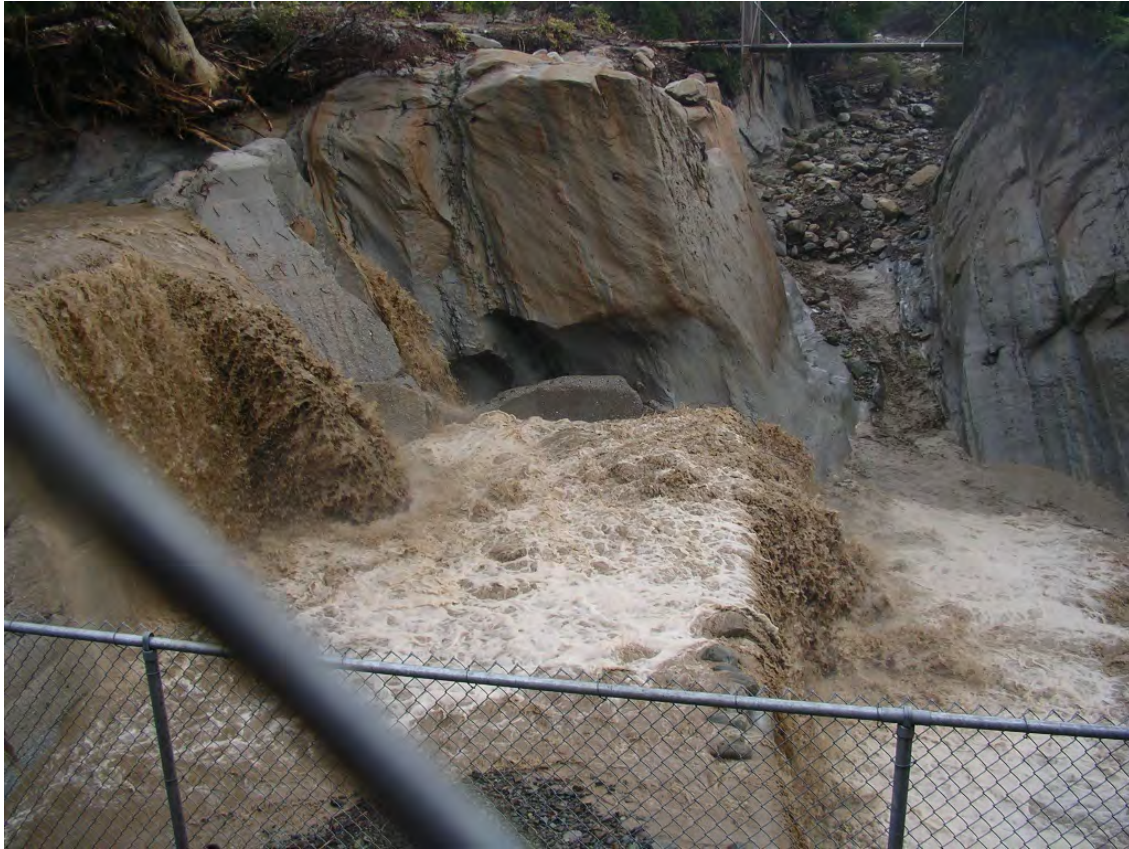
*Damage to dam during 2005 flood*

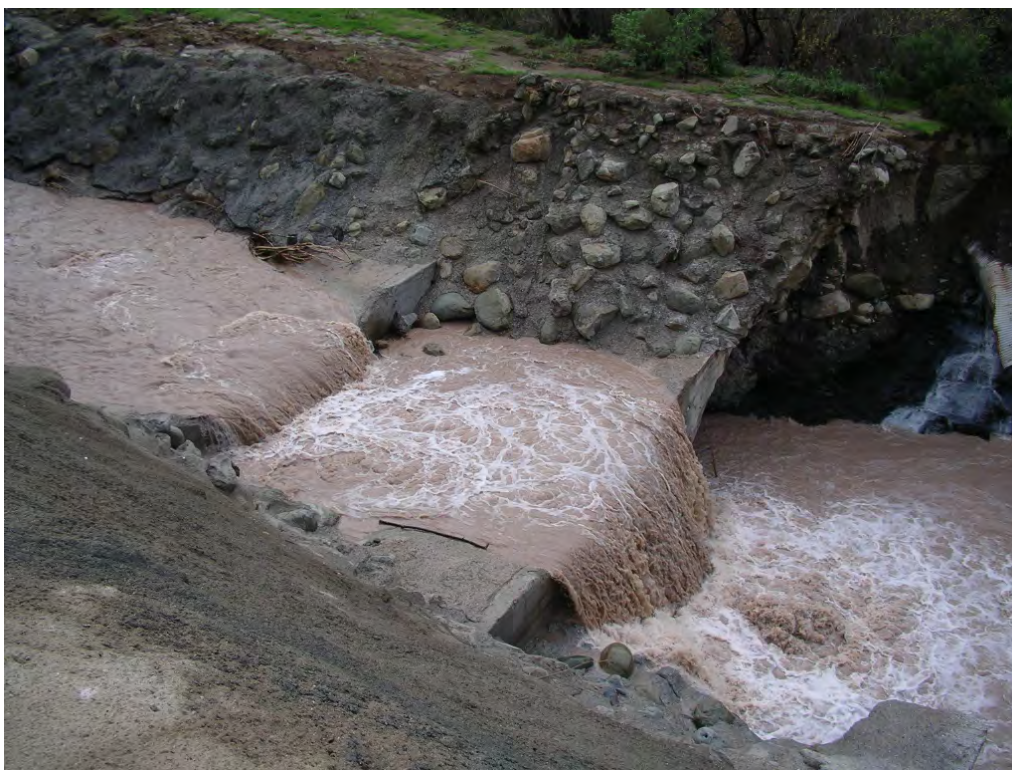
*Failure of downstream grade controls following 2005 flood*

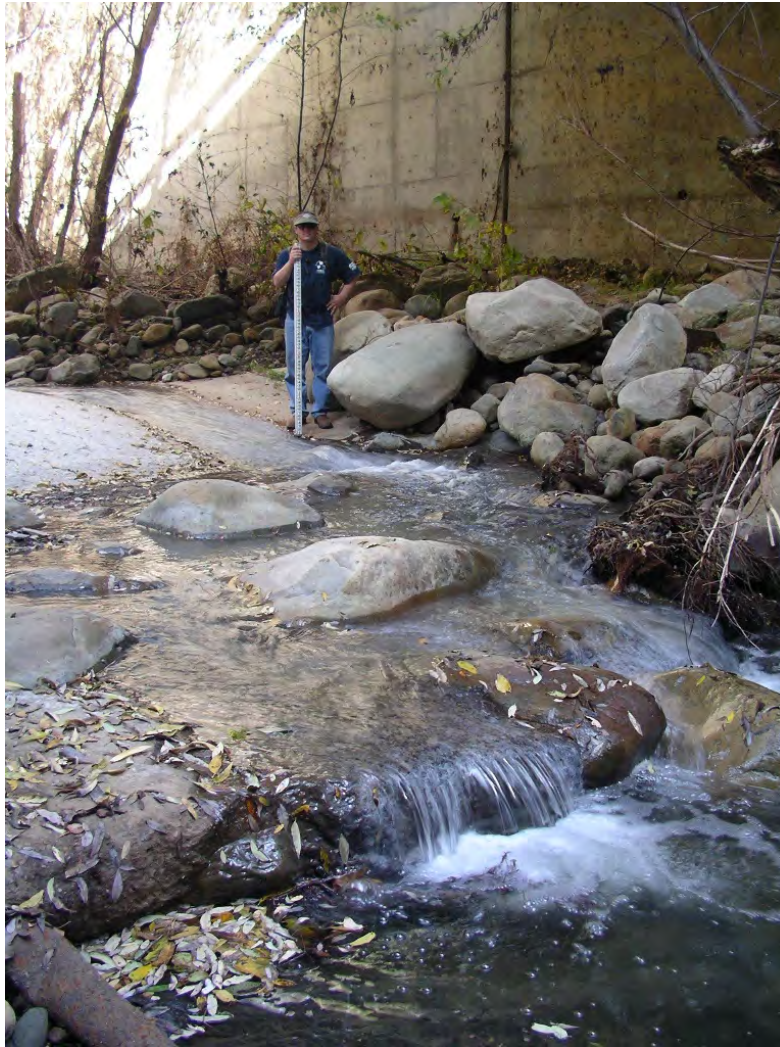
**Description:** This concrete grade control structure occurs under the Highway 150 Bridge and extends 25 feet 6 inches from the upstream lip to the sill of the downstream concrete and boulder apron. The upstream portion of concrete extends 13 feet with an elevation change of 1-foot 4 inches and a slope of 10%. The lower apron extends a maximum of 12 feet 6 inches and is relatively flat with numerous large embedded boulders. Flows drop 1-foot 2 inches off the apron into a pool with a maximum depth of 1-foot 2 inches. The structure ties into the vertical concrete bridge supports. Substrate occurs on top of the river-left side of the grade control structure.

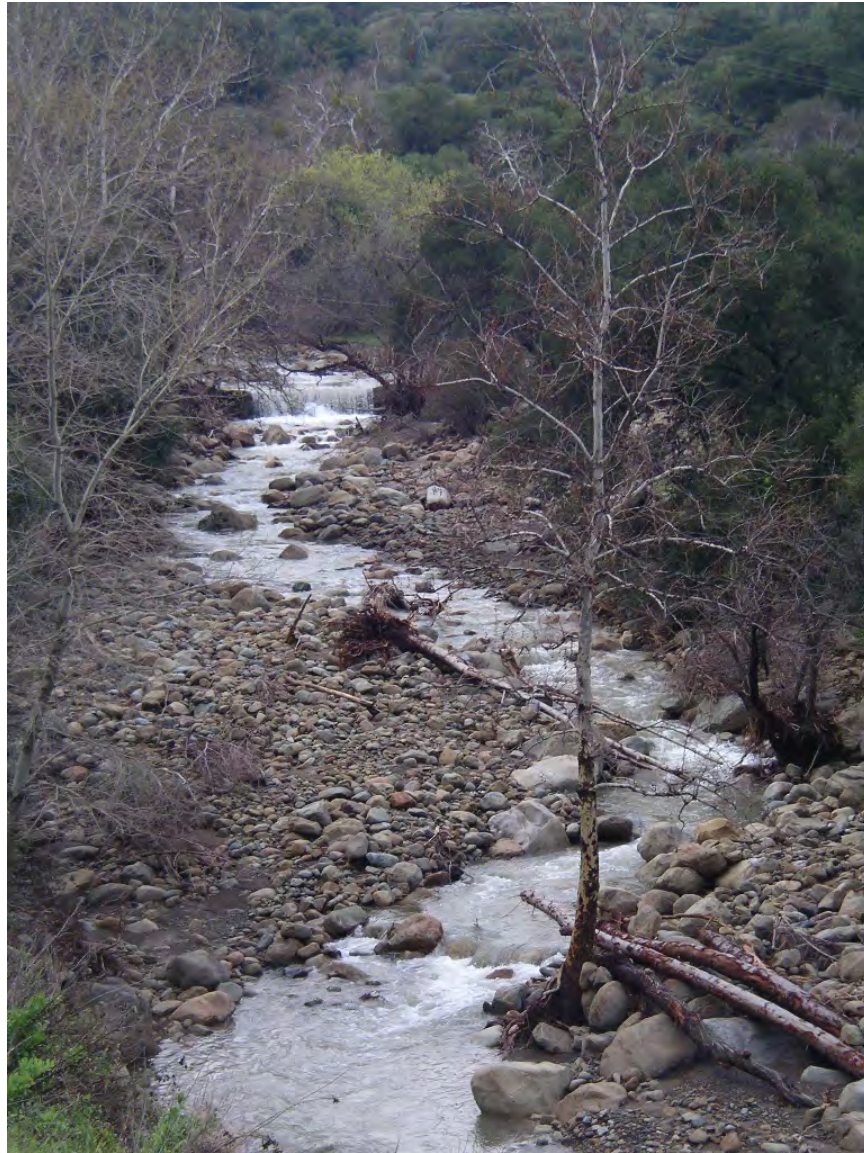
**Description:** Permission to survey this crossing was not obtained and observations were limited from Highway 150. Following the high stream flows of January 2005, an outlet drop of greater than 5 feet was observed on the downstream side of the concrete crossing.

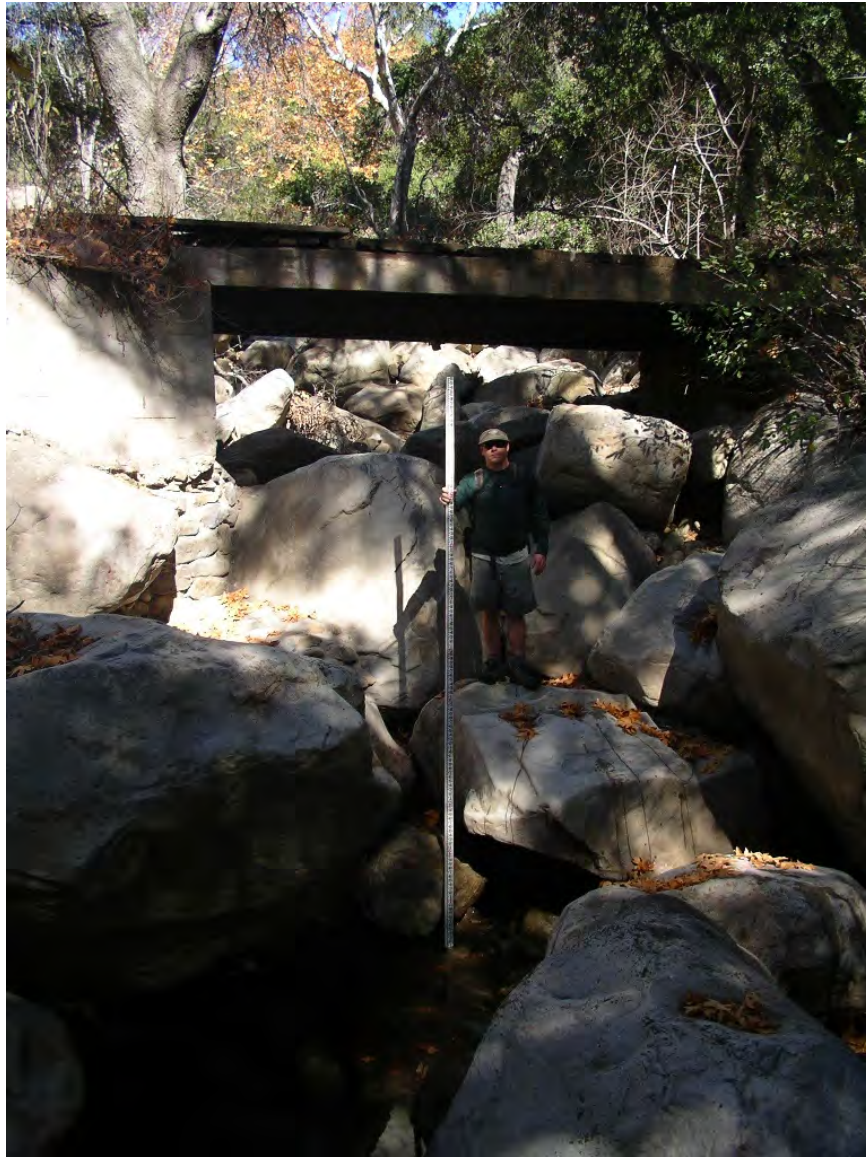
**Description:** This old, wood bridge spans 18 feet between concrete footings that are poured on large boulders within the stream channel. While the channel is natural underneath the bridge, the active channel width of the creek upstream and downstream is 24 to 28 feet across and the constricted bridge footings appear to have created a boulder blockage barrier. The concrete footings may be preventing large substrate mobility and exacerbating the steep boulder cascades occurring upstream and downstream of the bridge. Clearance under the bridge is only 5 feet 6 inches and the owner informed us that during the 1969 floods large boulders and flow by-passed the bridge on the river-right (pers. comm. B. Dron 2004). The original bridge was reportedly built in the 1930's. Surface flows also subside immediately upstream of the bridge for over 100 feet further indicating that substrate is being deposited upstream of the bridge. Downstream of the bridge a drop measuring 8 feet 8 inches occurs to a small 2-foot 1-inch deep pool. The bridge is partially burned from local fires and is in poor condition.

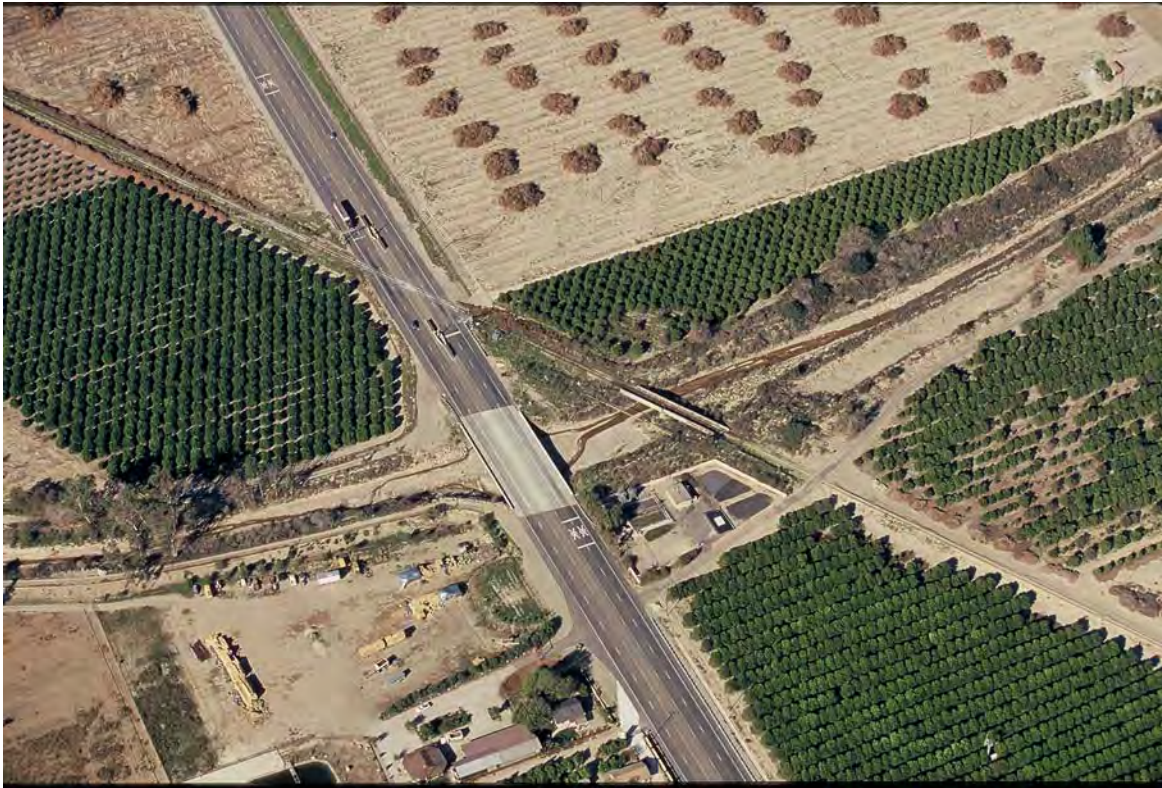
**Description:** Permission to access adjacent private lands to survey this crossing was not obtained and observations were limited from the bridge and air. The concrete apron occurs just upstream of the bridge and continues under the bridge. No drops were observed and the slope of the apron could not be determined.

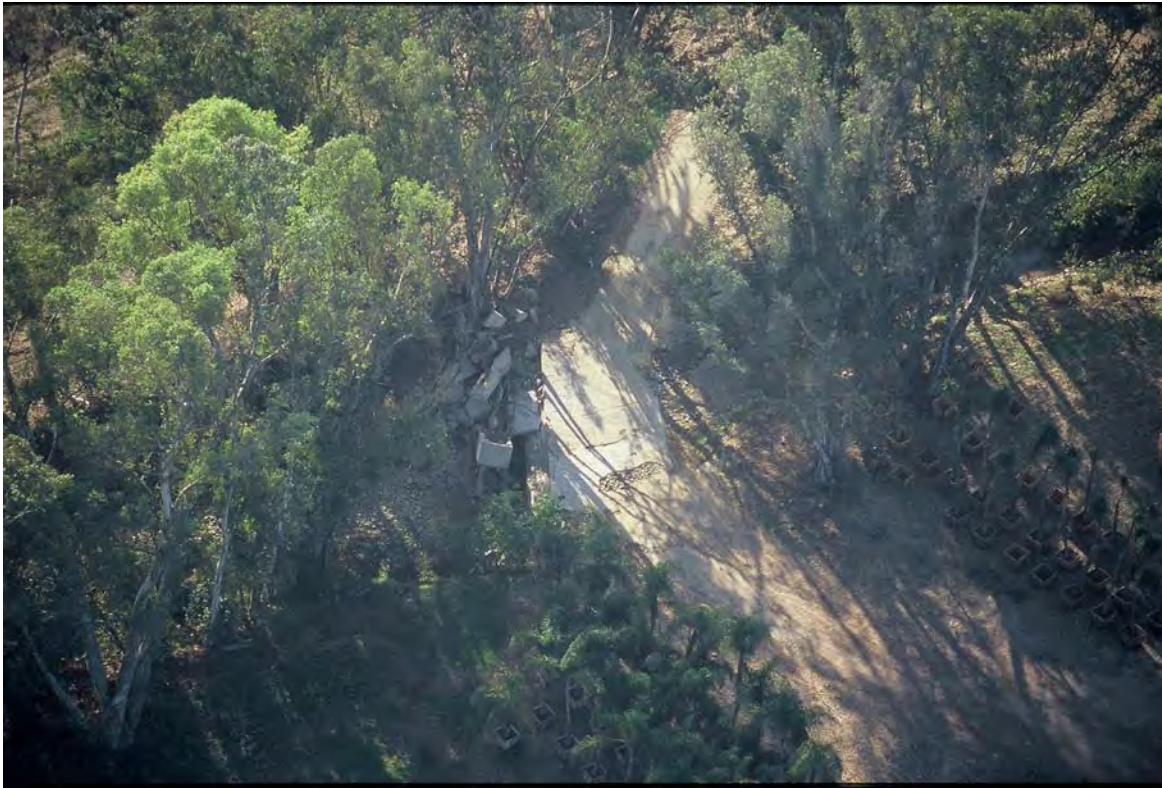
**Description:** Permission to survey this crossing was not obtained and observations were limited from the air. The concrete crossing occurs adjacent to a nursery just upstream from the confluence with Sespe Creek and the Santa Clara River flood plain. This private crossing appears to be in extremely poor condition with noticeable concrete failure and downstream scour and undercutting observed. An outlet drop of at least 5 feet occurs. The crossing appears to be approximately 12 feet wide and no culvert was observed from the air.

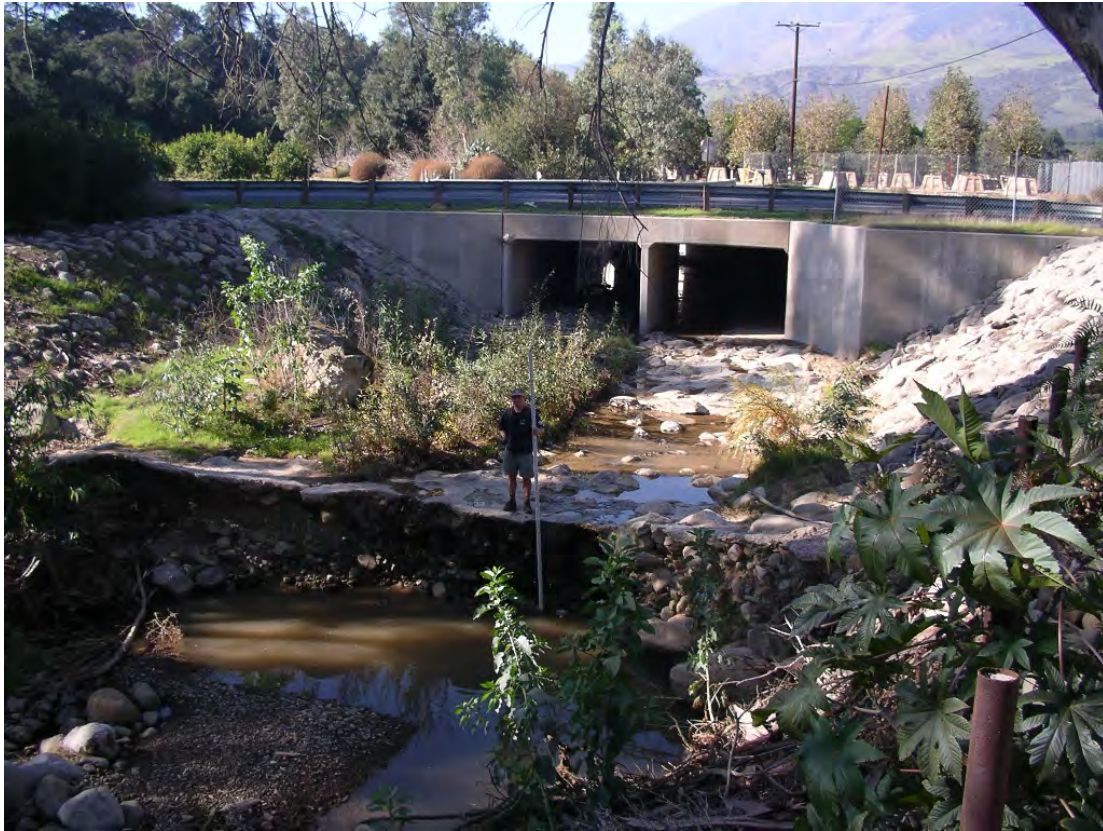
**Description:** This barriers total length measured 191 feet from the inlet apron to the sill of the downstream apron. The inlet apron measured 18 feet long with a rise of 4 feet above the culvert inlet bottom and steep slope of 22.2%. The double-box culvert measured 115 feet long with a slope of approximately 1%. Each box culvert measured 7 feet 11 inches tall by 12 feet wide. Downstream of the culvert a concrete and boulder rip-rap apron extends 58 feet and spans 39 feet across the channel to the base of sloping concrete and boulder bank revetment. Downstream of the apron flows drop 4 feet 2 inches into a 3-foot deep scour pool that is undermining the apron.

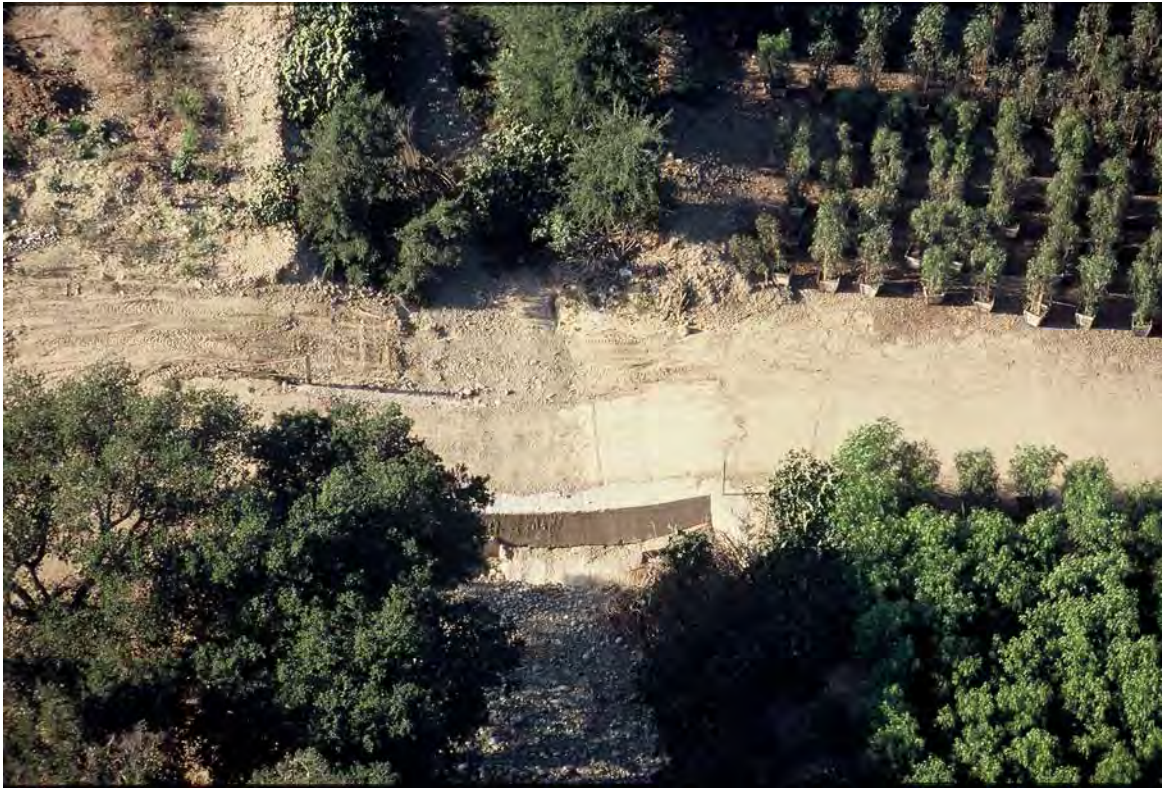
**Description:** Permission to survey this crossing was not obtained and observations were limited from the air. The crossing occurs just downstream from the railroad crossing culvert. This private crossing appears to be in poor condition. An outlet drop of at least 5 feet occurs. The crossing appears to be approximately 12 feet wide and no culvert was observed from the air.

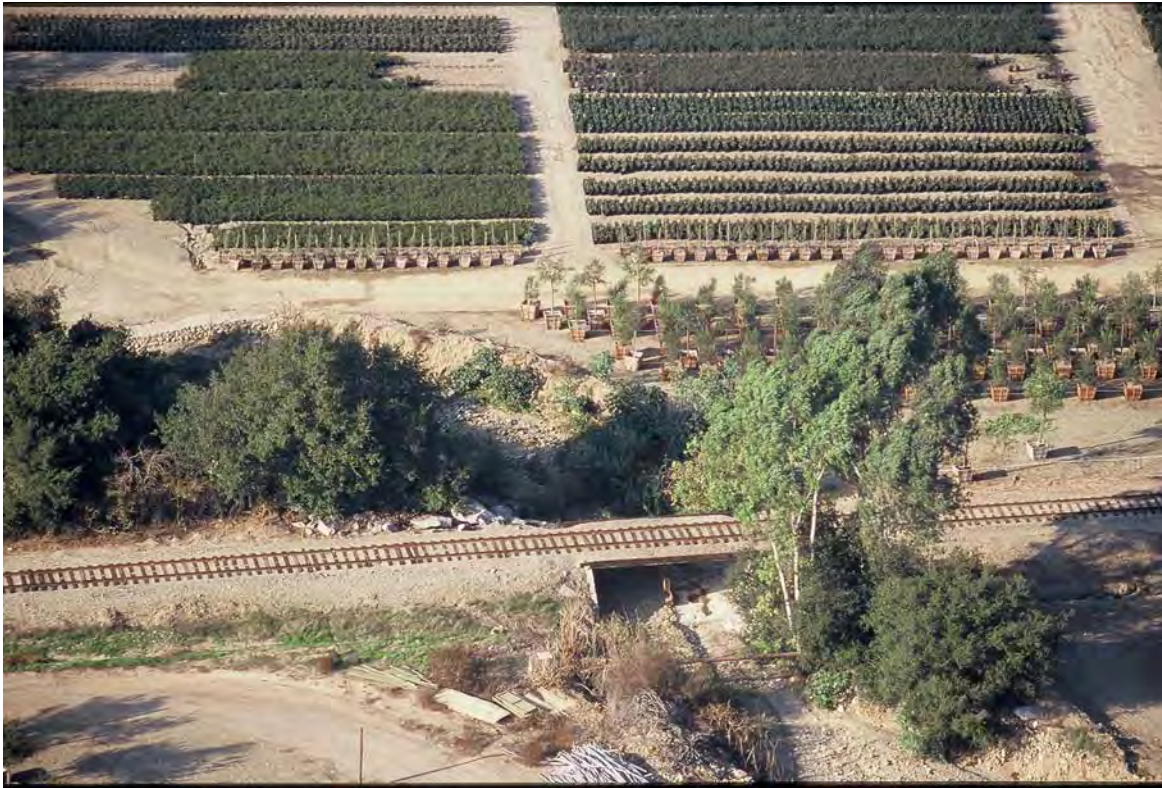
**Description:** Permission to survey this crossing was not obtained and observations were limited from the air. A concrete double-box culvert occurs under the railroad crossing. An outlet drop of approximately 1-foot occurs. The crossing appears to extend at least 25 feet underneath the railroad.

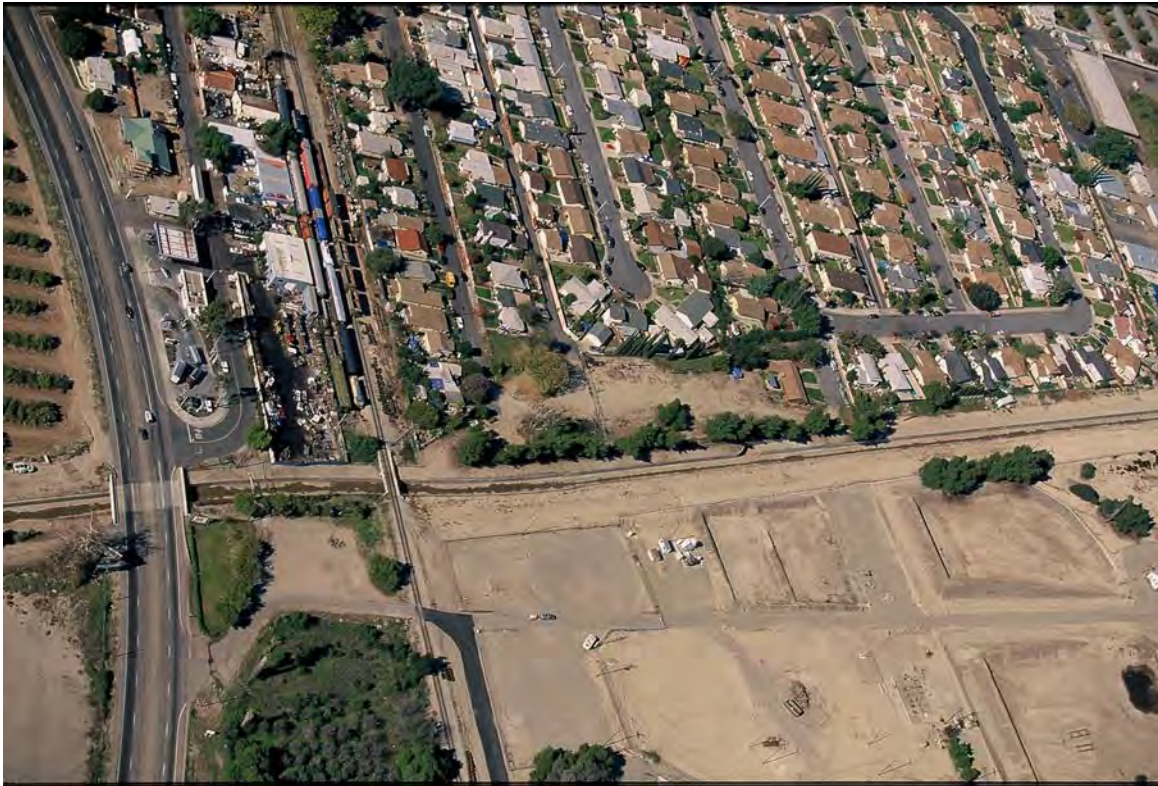
**Description:** Project budget and scope precluded ground surveying efforts on Pole Creek, but limited observations were made from the air. This concrete channel extends approximately 6,500 feet in length from the Santa Clara River upstream adjacent to the eastern end of Fillmore. The lower portion contains earthen levees, while the upper portion is a concrete box culvert with a steep inlet apron. The earthen and concrete channels appear to have mild gradients with deposited substrate present. The concrete inlet apron appears to be steeply sloped.
