# **Santa Clara River Steelhead Trout: Assessment and Recovery Opportunities**

**December 2005**

**Matt Stoecker**

**The Santa Clara River Trustee Council and The Nature Conservancy**

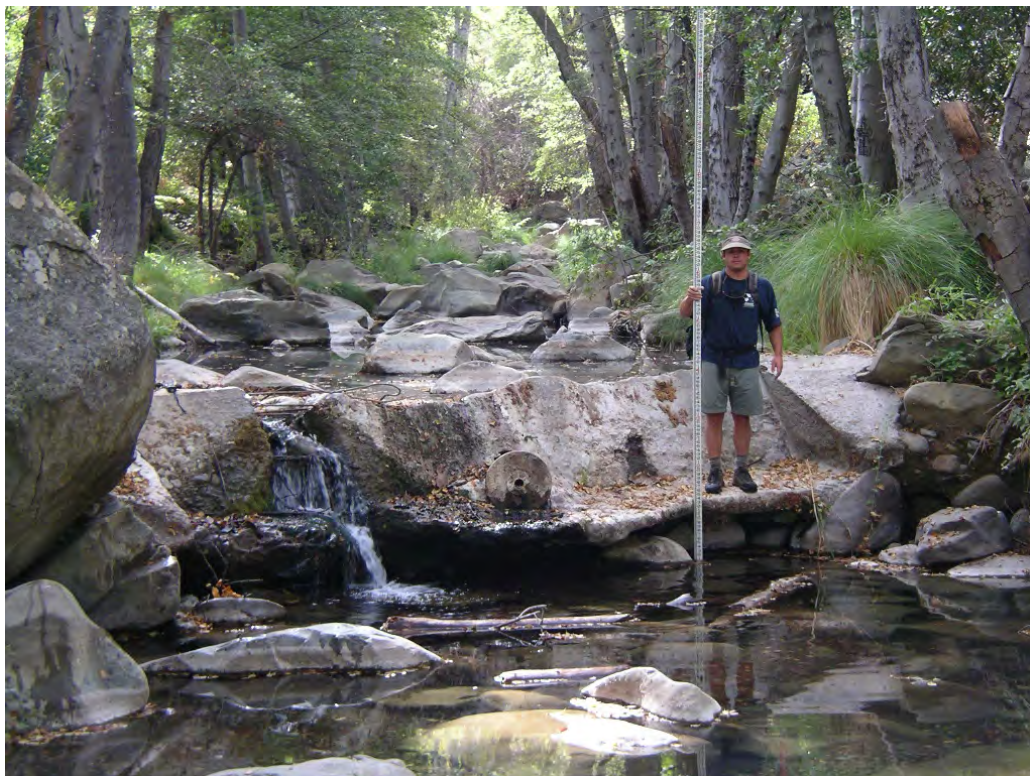
**Description:** This abandoned old diversion dam has an inscription in the concrete that appears seems to read “6/22/37 CO 2925”. It appears that this dam was built to divert water along the river-left banks downstream to Lower Lion Campsite almost 70 years ago. Remains of old metal pipes can be seen downstream. The dam measured 4 feet tall from the downstream tail-water control to the top of the dam. The dam measured 25 feet across the channel and 6 feet thick at its maximum point. The downstream pool measured 1-foot 9 inches at its maximum depth. A 12-inch diameter metal diversion pipefitting passes through the dam and is capped on the downstream side and buried with deposited substrate on the upstream side.

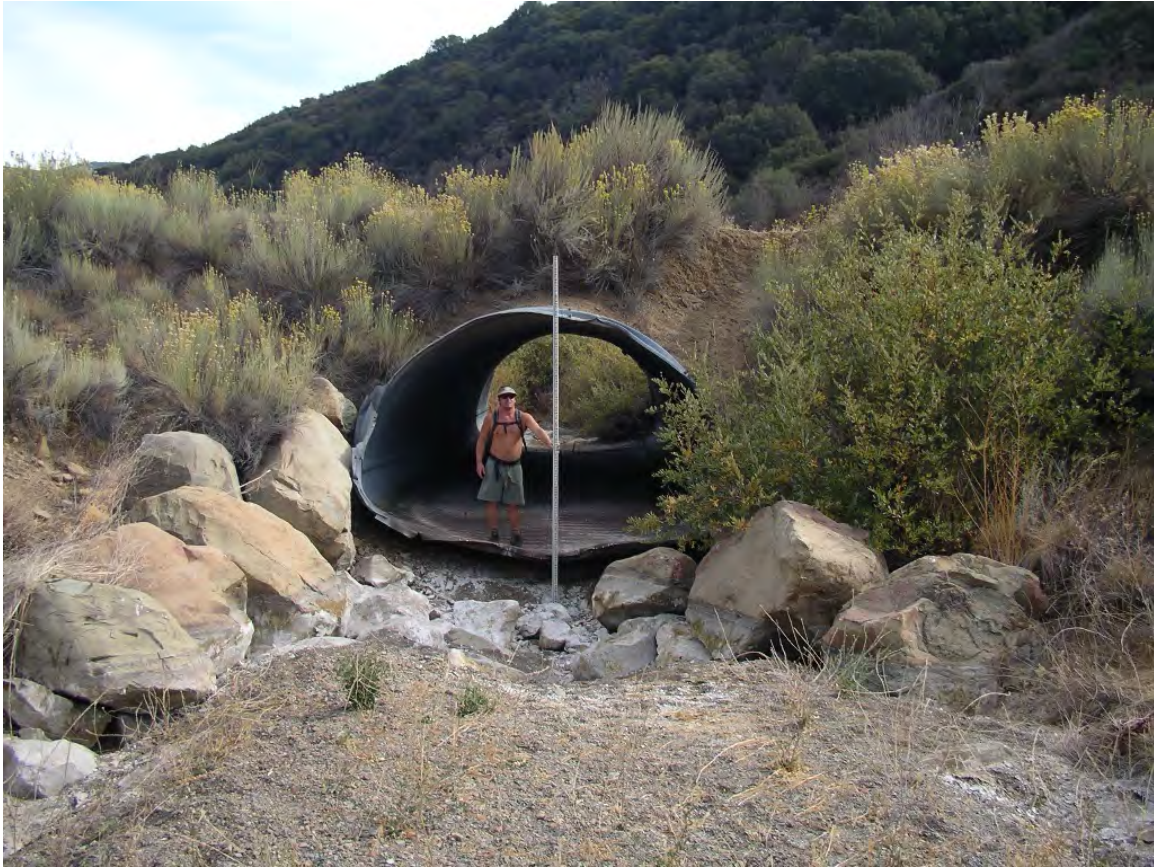
**Description:** This corrugated steel pipe-arch culvert measured 54 feet 8 inches long with an 8-inch rise and overall slope of 1.2%. The culvert outlet occurs at the same elevation as the outlet pools thalweg. The dry outlet pool's maximum depth measured 2 feet 3 inches below the thalweg elevation. The culvert measured 13 feet at the widest point and 7 feet 6 inches tall. No inlet or outlet aprons occur and the outlet of the culvert is significantly undercut. The culvert has significant rust and a damaged metal bottom.

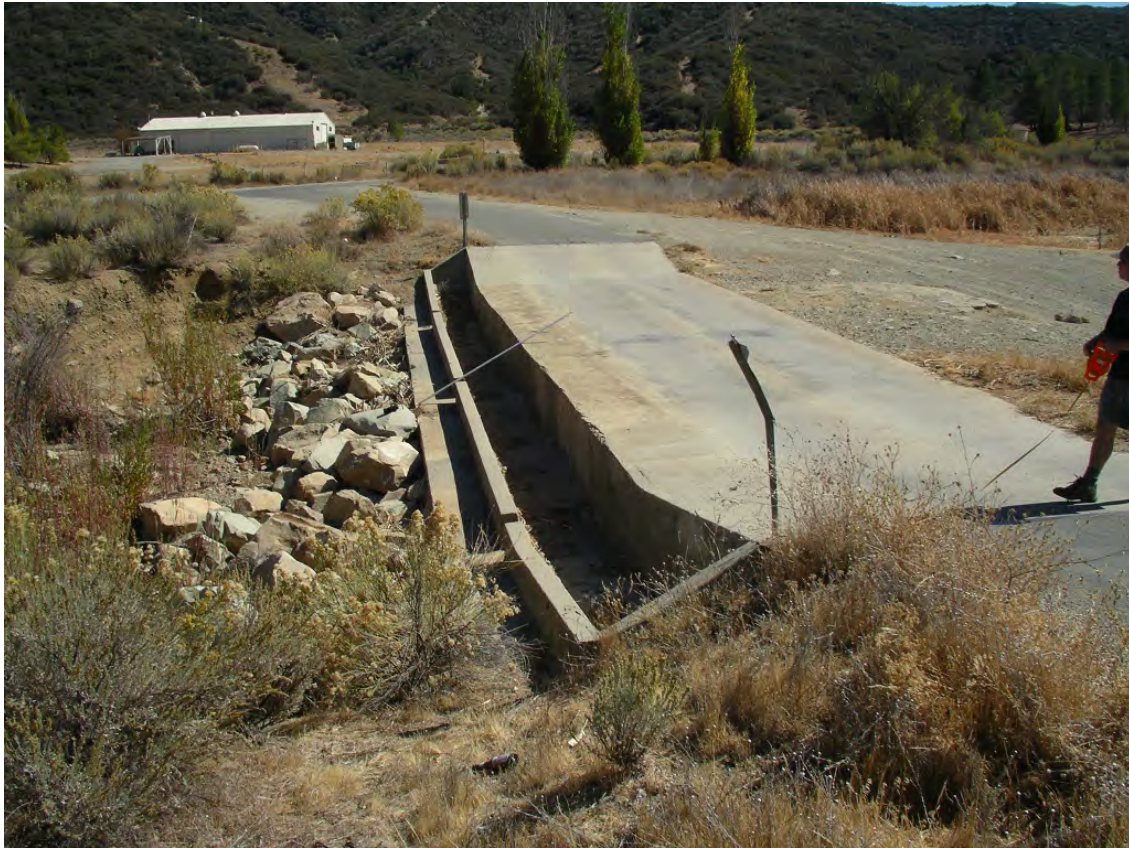
**Description:** This earthen dam has a concrete spillway that also serves as a road crossing. This spillway road measured 14 feet wide and 70 feet across. The total height of the dam measured 5 feet 3 inches from the spillway inlet to the downstream substrate. The slope on the spillway measured 2.3% and drops flows 2 feet 6 inches to a concrete shelf measuring 2 feet 7 inches out from the spillway. This shelf contains a 1-foot tall 6-inch wide concrete curb with 3 notches down to shelf level. Flows then drop 1-foot 9 inches to another concrete shelf and then spill onto a downstream boulder apron. This boulder apron measured 12 feet downstream from the concrete with an average slope of 40%.

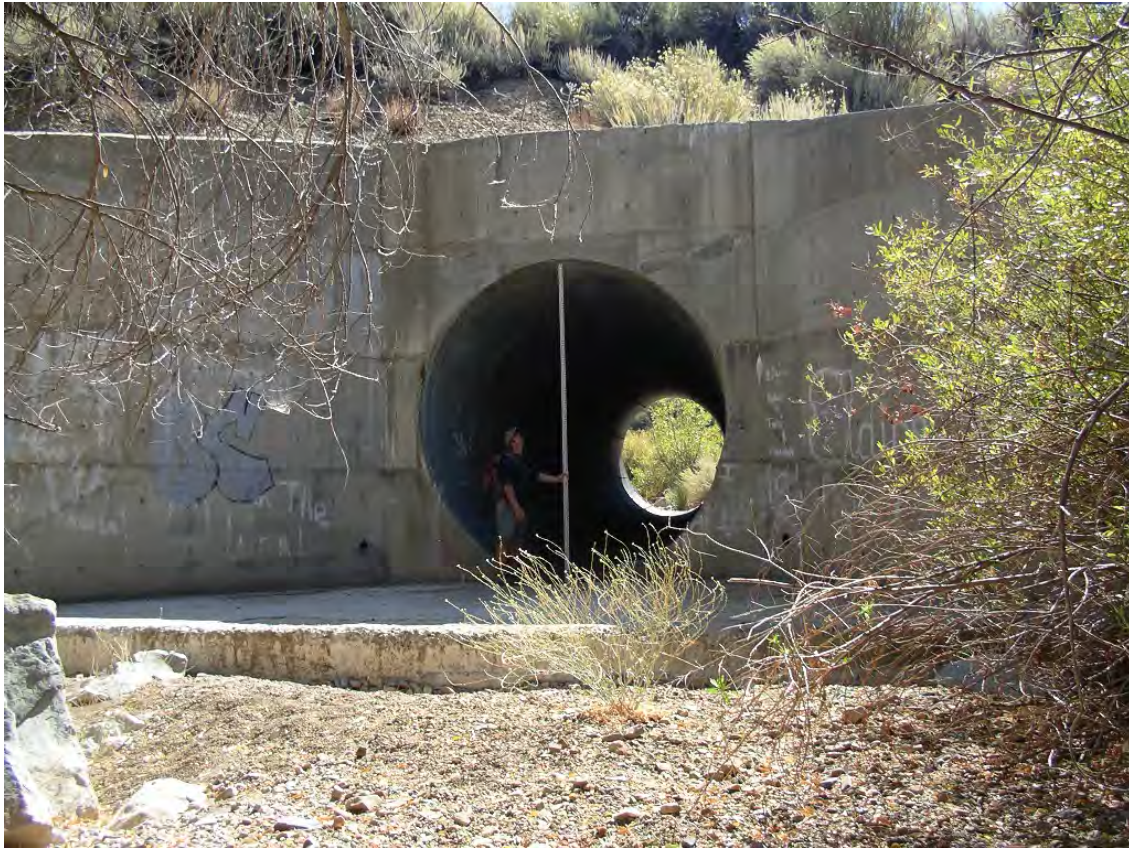
**Description:** This corrugated metal culvert pipe measured 84 feet long with 16-foot long concrete aprons at the inlet and outlet giving a total length of 116 feet. Concrete headwalls and wingwalls encase the culvert pipe and aprons. The culvert slope measured 3.3% with similar slopes occurring at both aprons. The culvert width measured 11 feet and the height measured 11 feet 8 inches. During dry survey conditions, a 1-foot 2-inch outlet drop occurred from the outlet apron to the downstream substrate. This loose downstream substrate is mainly smaller sand and gravel and will mobilized during moderate stream flows and scour may produce a greater outlet jump height for fish.

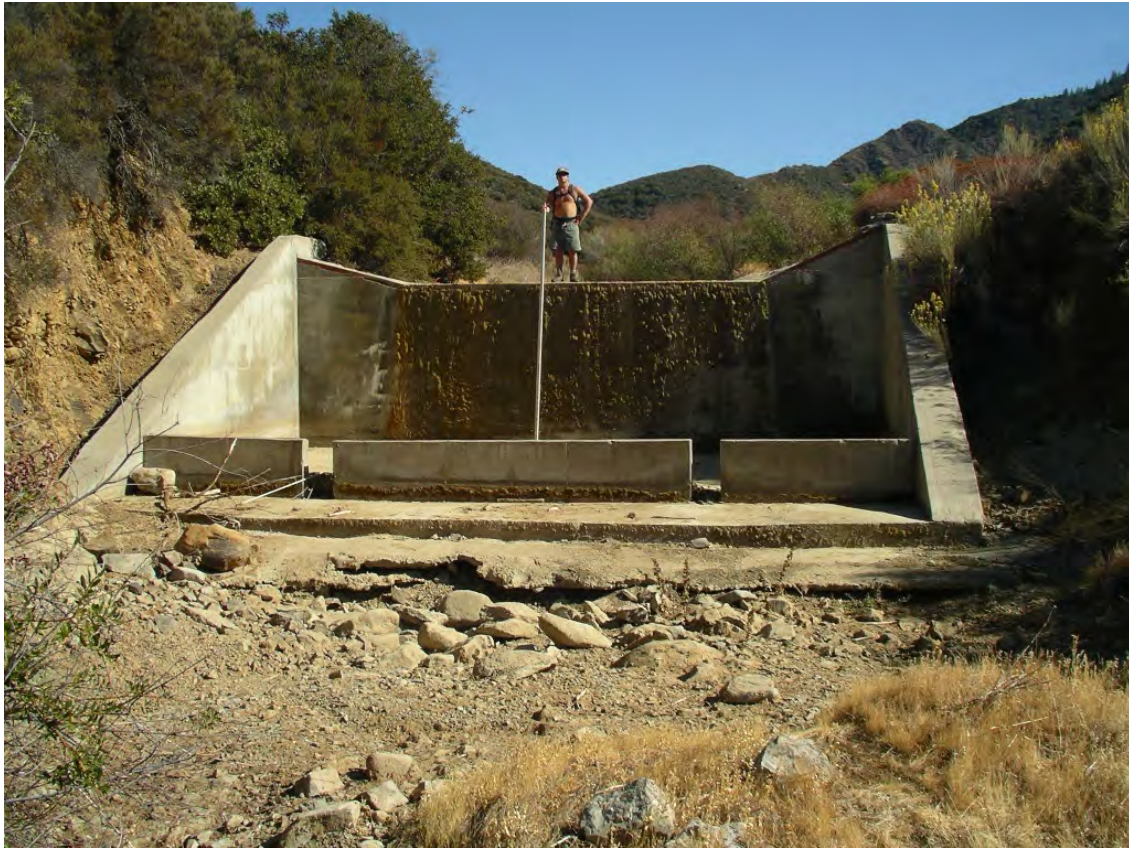
**Description:** This concrete dam measured 27 feet across the channel. The total height of the dam measured 10 feet 4 inches from the spillway inlet to the downstream substrate. The spillway drops 7 feet 8 inches to a concrete shelf measuring 21 feet out from the spillway. This shelf contains a 2-foot tall 6-inch wide concrete curb with 2 notches down to shelf level. Flows then drop 8 inches to a 5-foot long concrete apron and then spill 2 feet onto the downstream substrate.

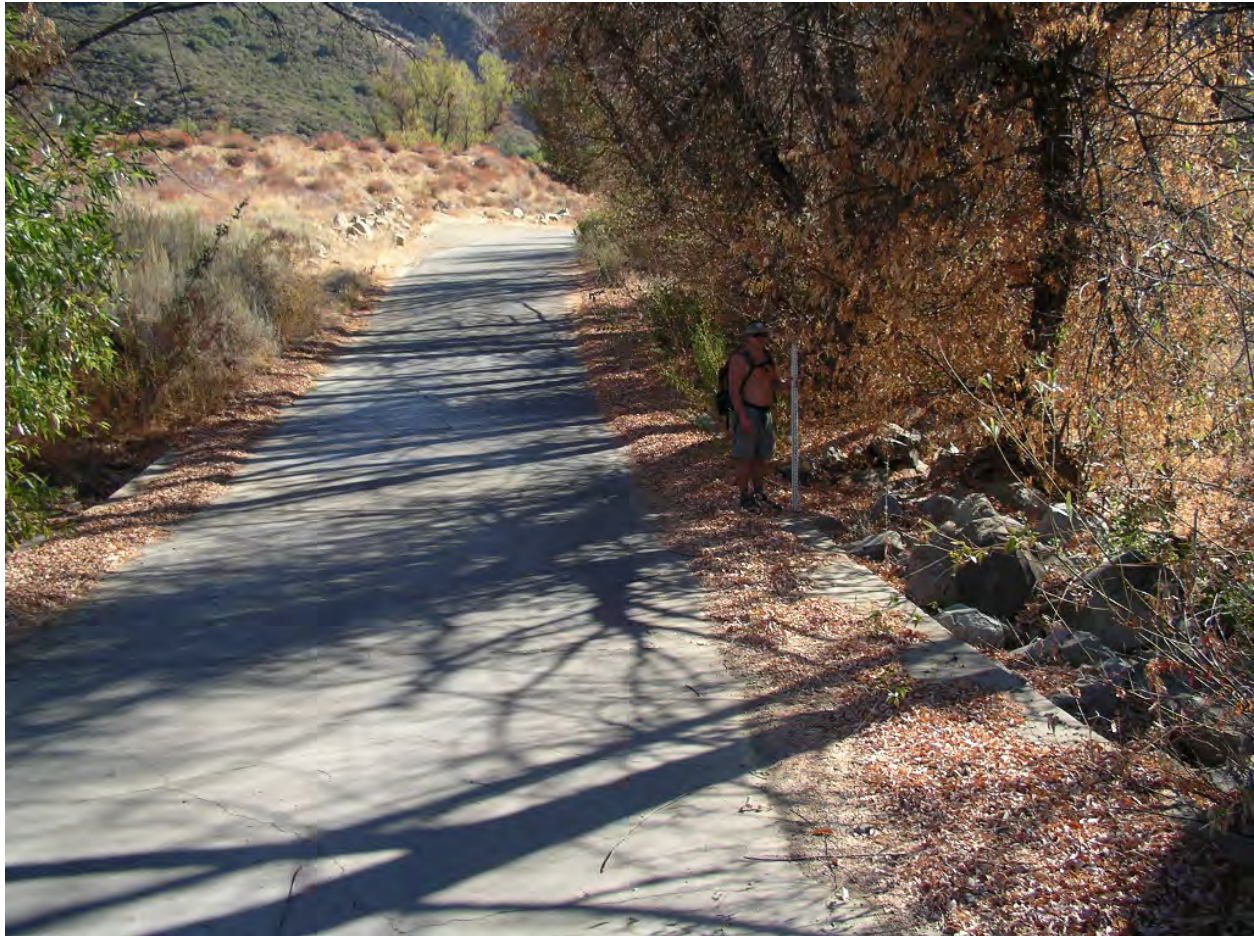
**Description:** The concrete crossing measured 67 feet 6 inches across the channel and 20 feet wide. The slope of the crossing is 1.5%. Surface flows are conveyed on top of the crossing and drop 3 feet onto the downstream substrate. Large boulders occur on a portion of the outlet and produce a 10-foot long apron with an average slope of 25%.

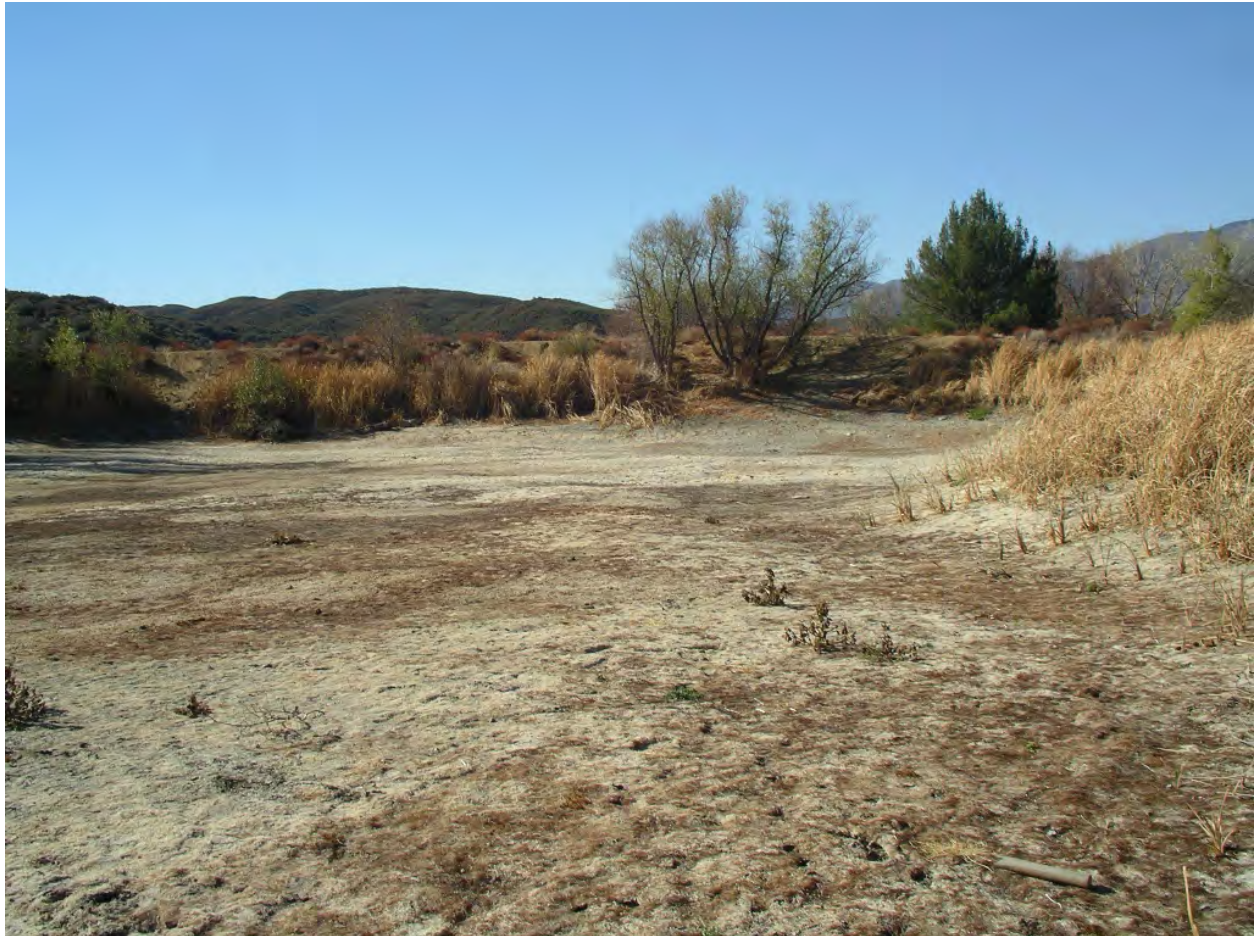
**Description:** This earthen dam does not have a concrete spillway similar to the downstream dams. Apparently the dam was built across Rose Valley Creek and then an outlet channel was dug around the east side of the dam. This new channel contains one significant drop that measured 8 feet tall with a dry downstream pool that likely fills up to 3 feet in depth. The side channel also appears to lack perennial flow due to its exposed location.

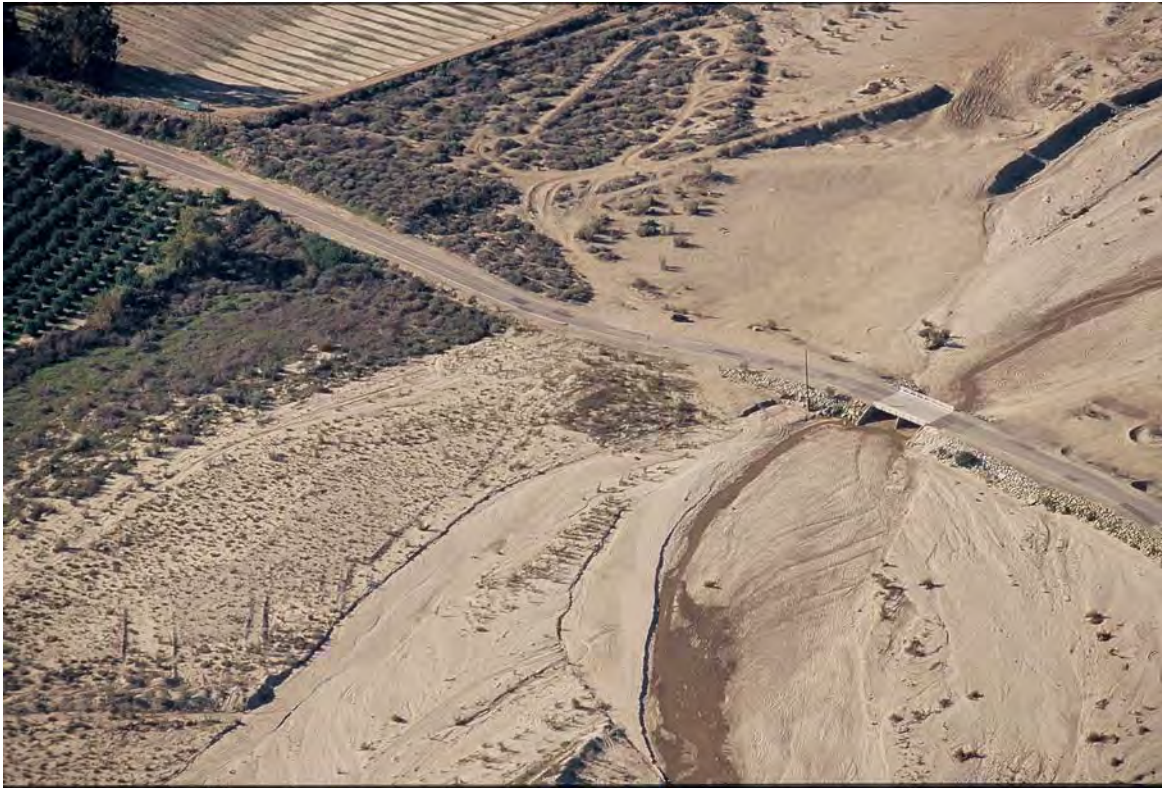
**Description:** This short-span bridge crossing occurs downstream from Piru Creek. Elevated dirt road fill occurs across much of the Santa Clara River channel on either side of the Torrey Road Bridge.

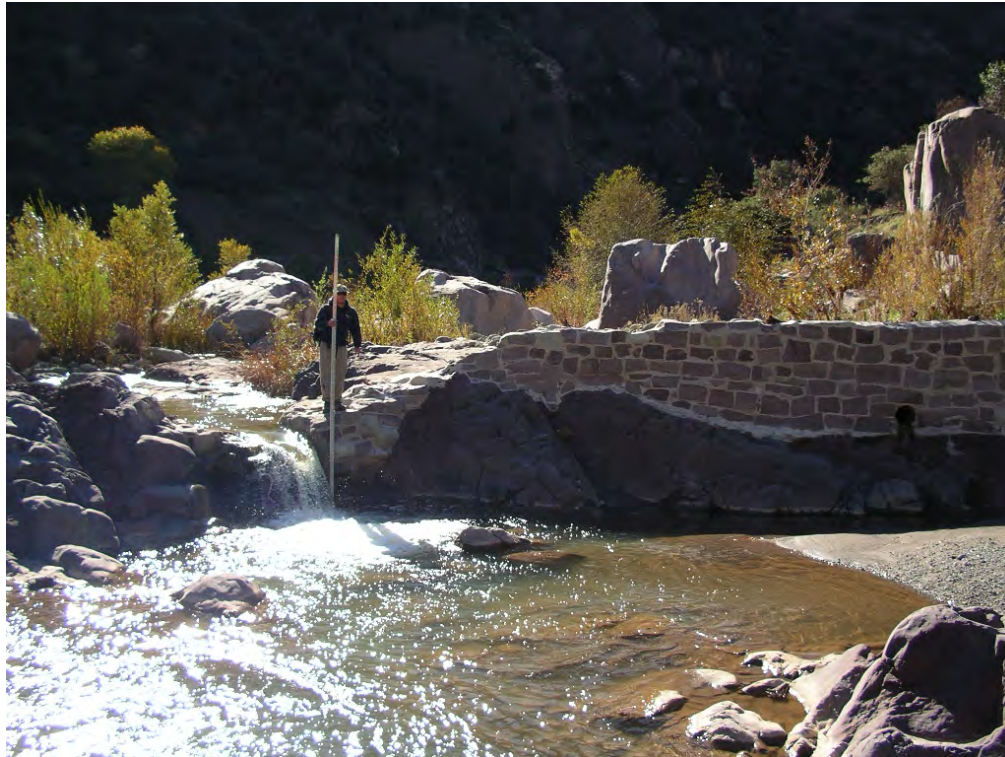
**Description:** James Van Trees, whose family has owned the lands adjacent to this dam for several generations, informed me that this historic, failed dam was built in the 1930's or 1940's by Los Angeles water figure William Mulholland (pers. comm. Van Trees 2004). The stone block and concrete diversion dam reportedly was destroyed in the 1969 flood and only remnants of the dam survived. The dam remains were reportedly buried by sediment for many years following 1969 and then were uncovered in recent decades. The original dam spanned approximately 200 feet across the stream channel and measured 5 feet thick and at least 10 feet in height above the substrate. Only 80 feet of the dam still remains on the river-left side and a small, stream-polished section occurs on top of a native boulder near the river-right side of the channel. Two 10-inch metal diversion pipes occur within each remaining part of the dam. Metal rebar anchors can also be observed protruding from some of the native boulders where the dam once stood.
