# **Pigg River Restoration at Power Dam**

## **Year-1 Monitoring Report**

DECEMBER 2017

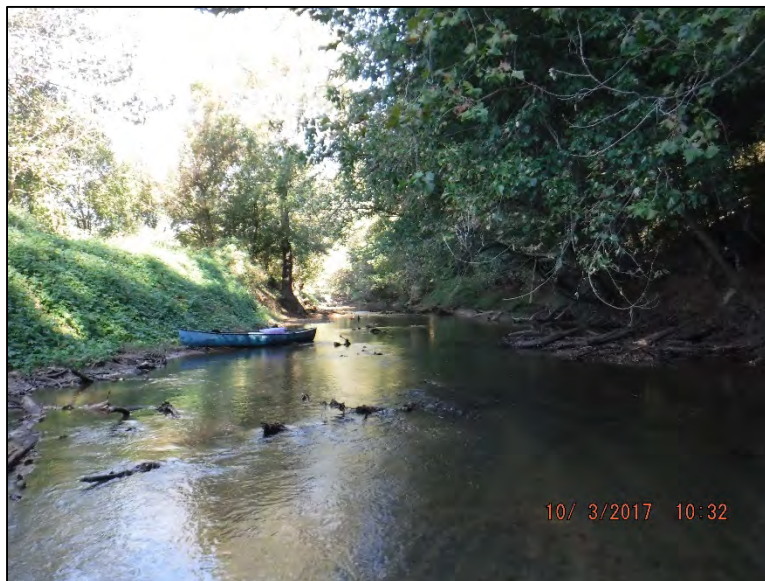
Photo 1-1

Description: View looking upstream from the middle of Cross Section 1  
Woody Debris: 10

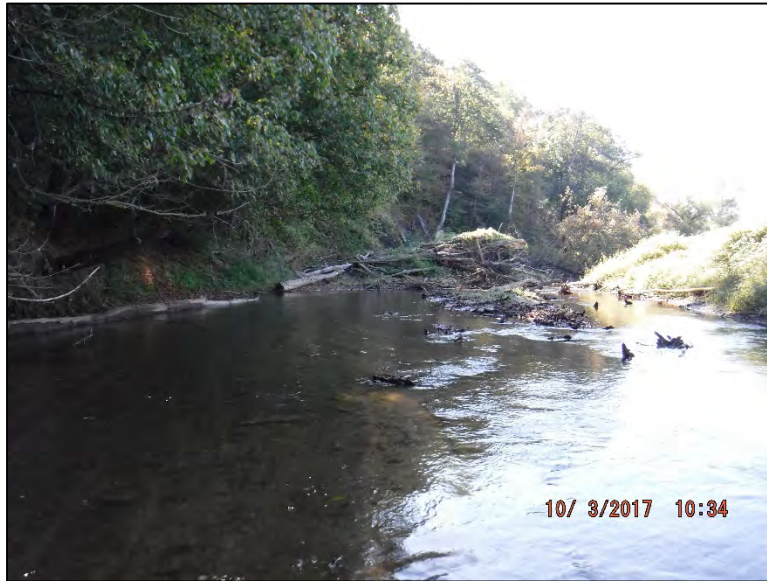
Photo 1-2

Description: View looking downstream from the middle of Cross Section 1

Woody Debris: 30

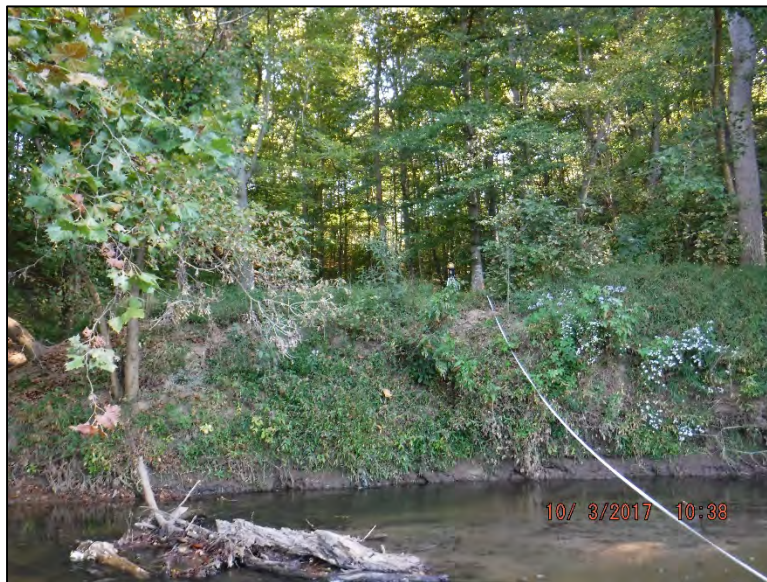
Photo 1-3

Description: View looking left from the middle of Cross Section 1

Vegetation: 70% herbaceous cover, few trees at top of bank

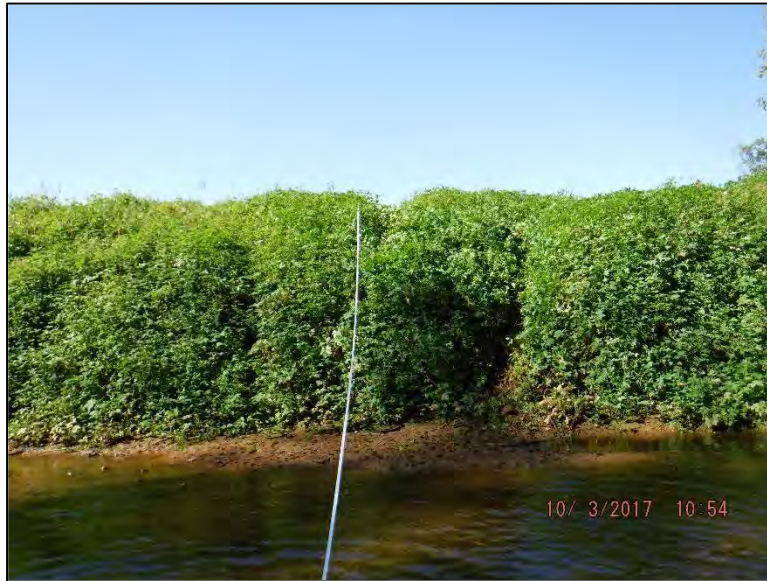
Photo 1-4

Description: View looking right from the middle of Cross Section 1

Vegetation: 90% herbaceous cover, no trees

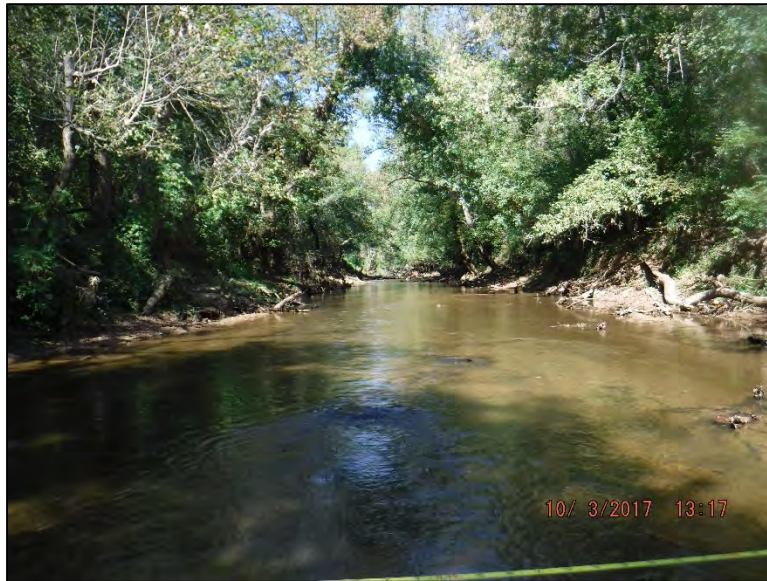
Photo 2-1

Description: View looking upstream from the center of Cross Section 2

Woody Debris: 20

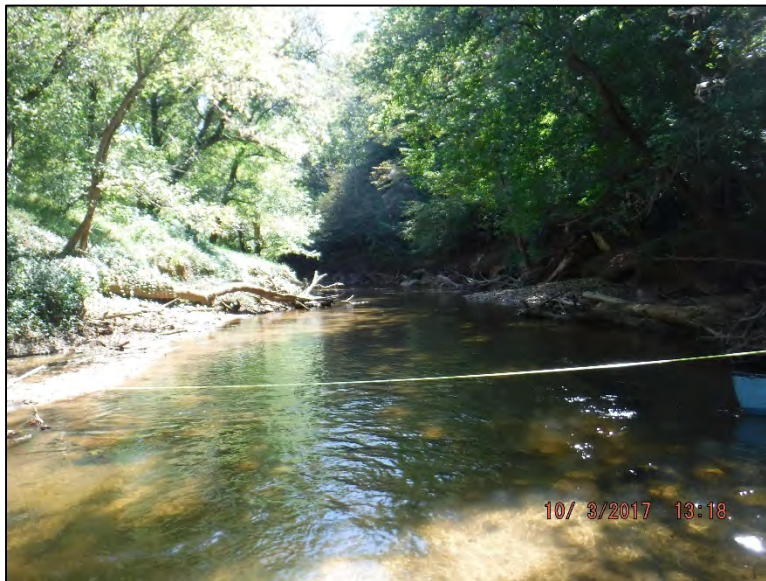
Photo 2-2

Description: View looking downstream from the middle of Cross Section 2

Woody Debris: 15

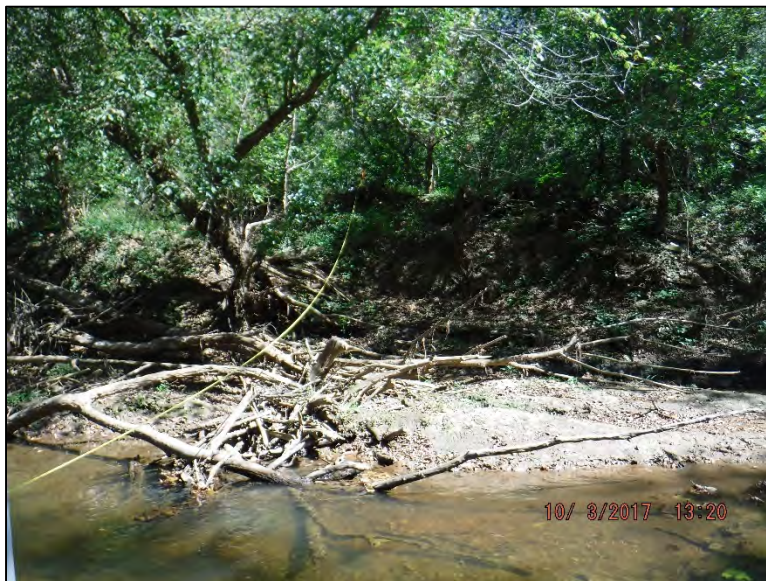
Photo 2-3

Description: View looking left from the middle of Cross Section 2

Vegetation: 40% herbaceous cover, few trees, woody debris

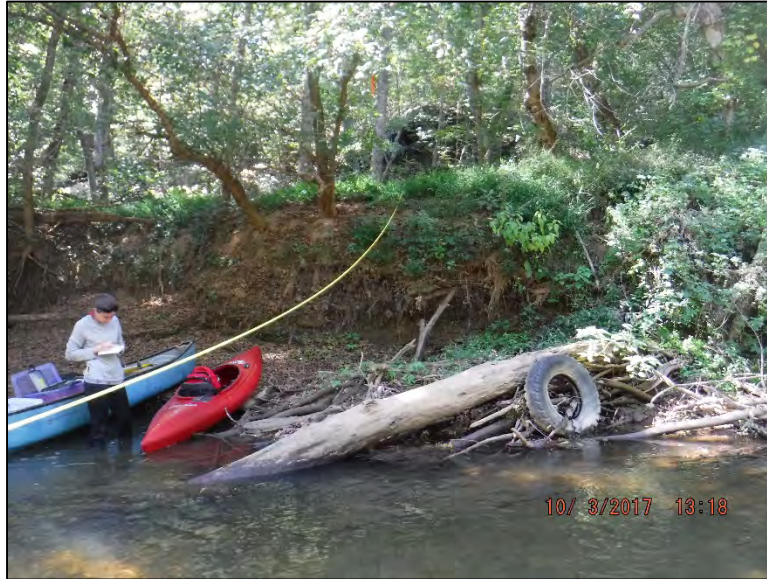
Photo 2-4

Description: View looking right from the middle of Cross Section 2

Vegetation: 50% herbaceous cover, few trees, woody debris

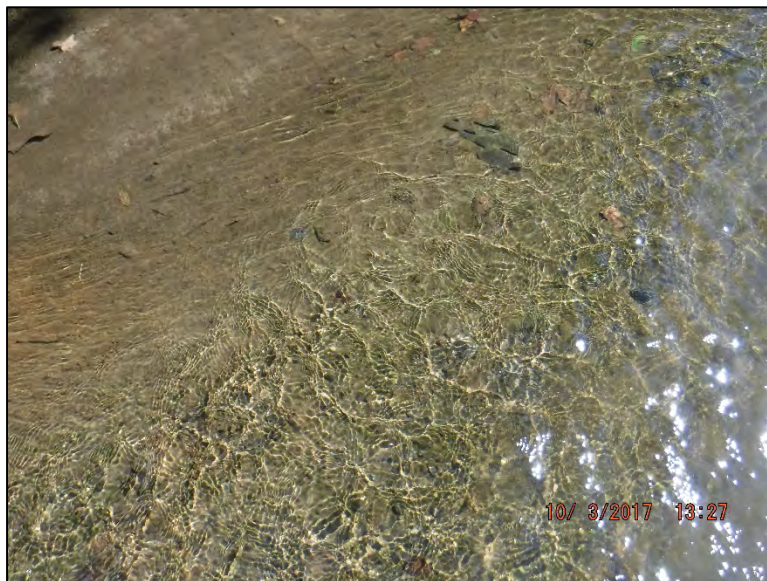
Photo 2-7

Description: Bed material at Cross Section 2 was almost entirely silt/sand

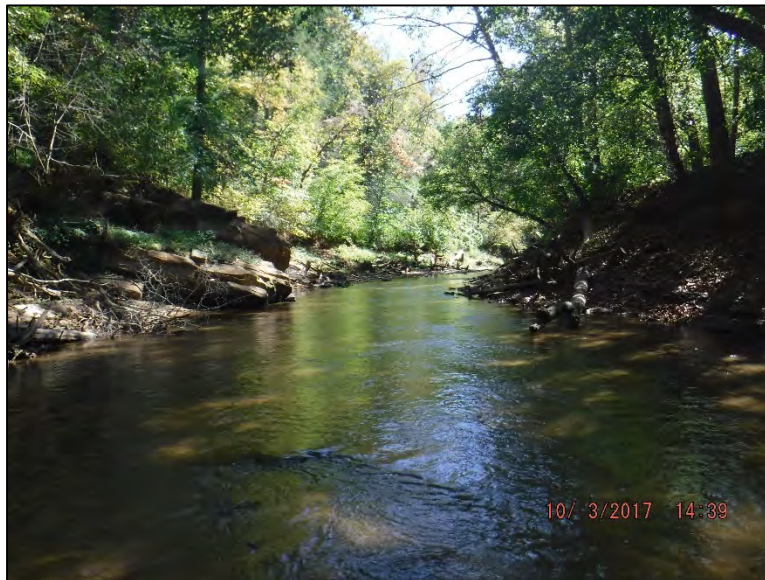
Photo 3-1

Description: View looking upstream from the center of Cross Section 3

Woody Debris: 15

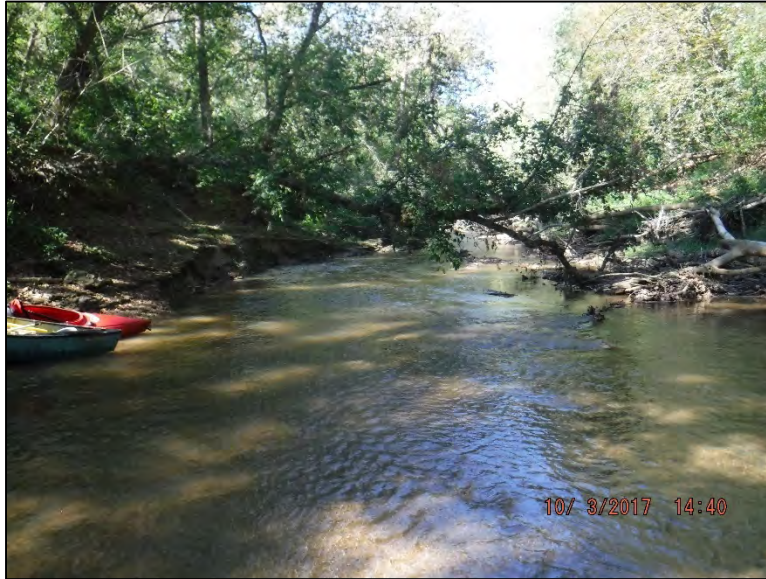
Photo 3-2

Description: View looking downstream from the middle of Cross Section 3

Woody Debris: 50

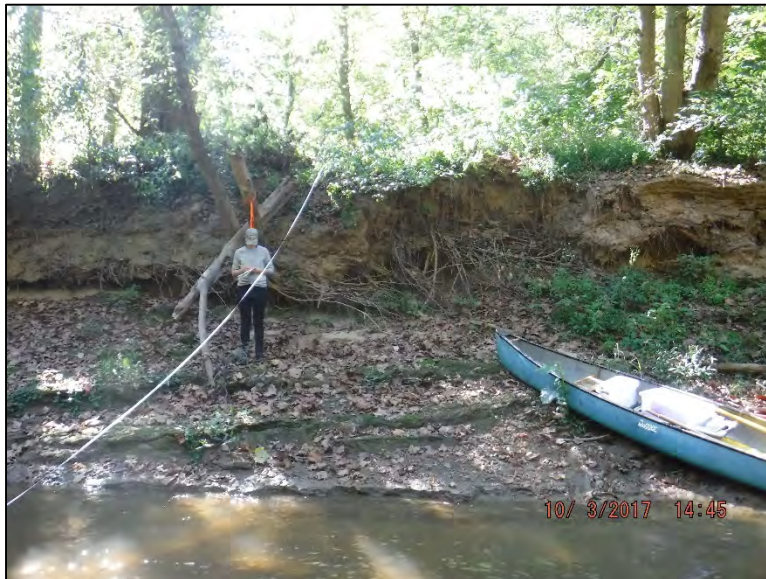
Photo 3-3

Description: View looking left from the middle of Cross Section 3

Vegetation: 40% herbaceous plants, few trees

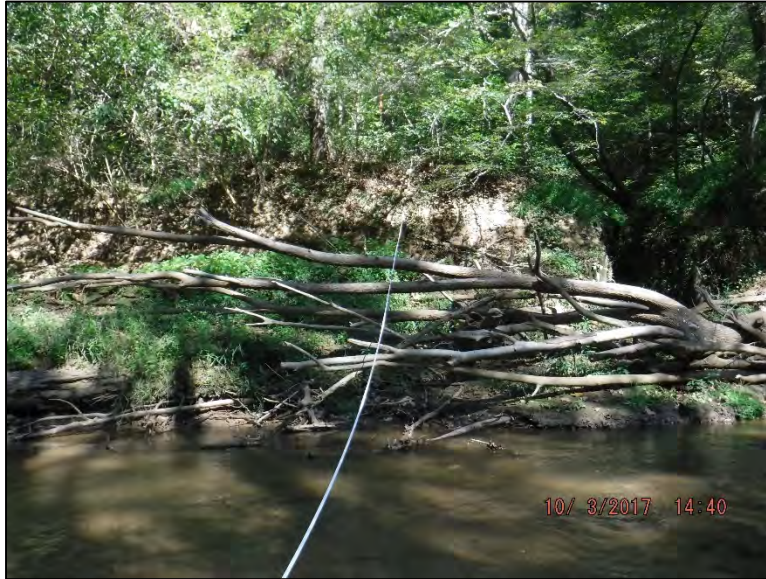
Photo 3-4

Description: View looking right from the middle of Cross Section 3

Vegetation: 80% herbaceous cover and a few trees at top of bank

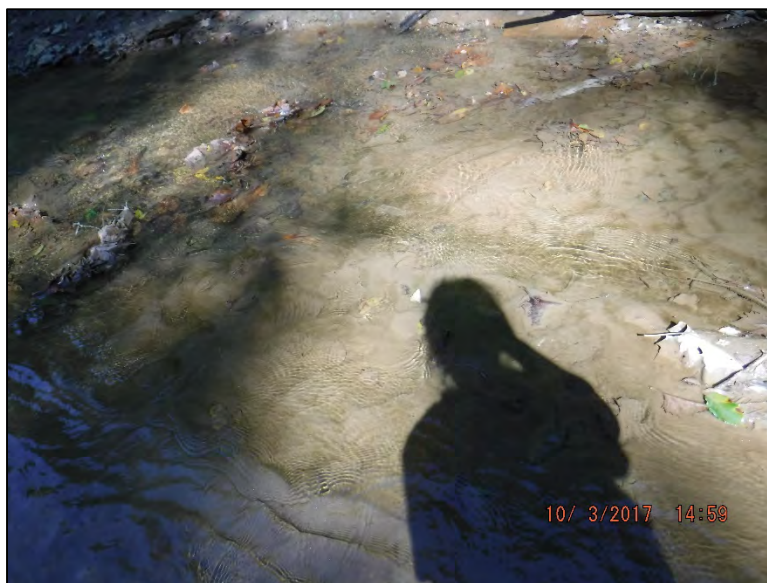
Photo 3-7

Description: Bed material at Cross Section 3 was almost entirely silt

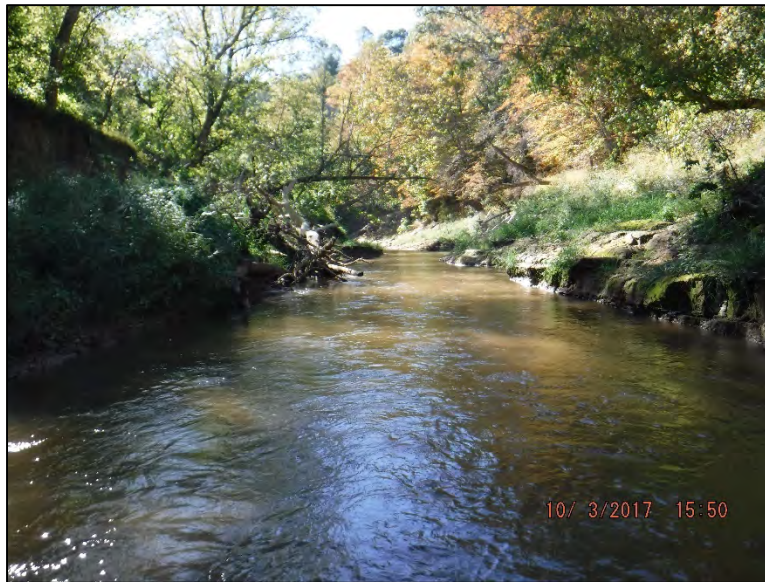
Photo 4-1

Description: View looking upstream from the center of Cross Section 4  
Woody Debris: 10

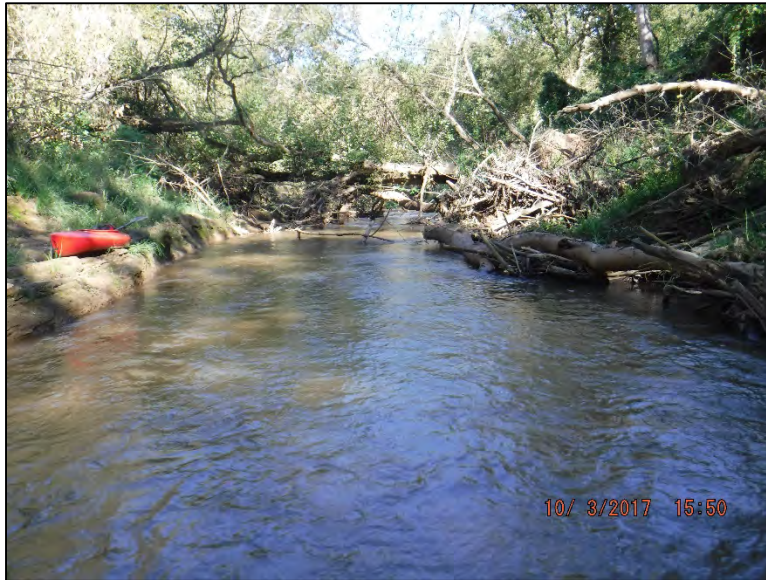
Photo 4-2

Description: View looking downstream from the middle of Cross Section 4  
Woody Debris: 60

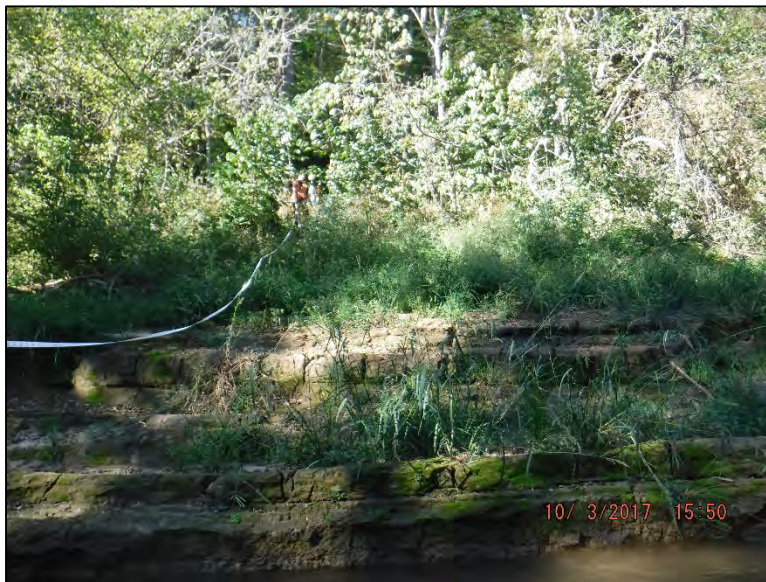
Photo 4-3

Description: View looking left from the middle of Cross Section 4  
Vegetation: 90% herbaceous cover and a few trees at top of bank

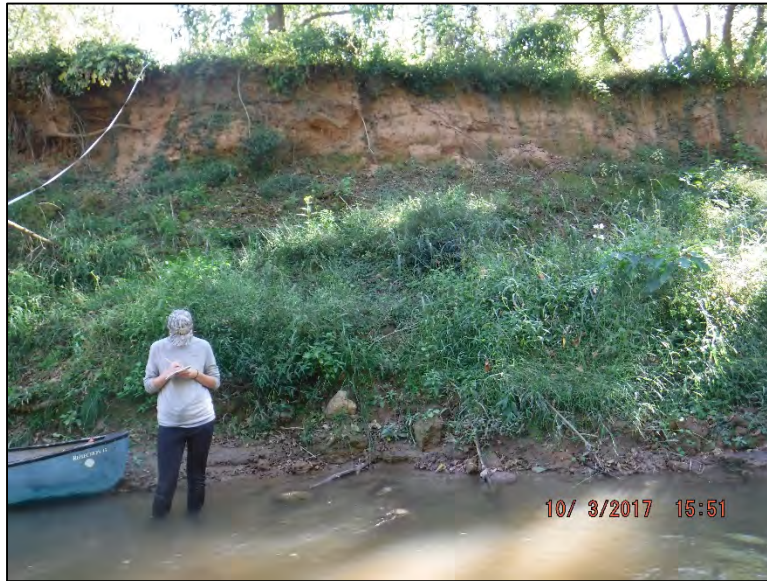
Photo 4-4

Description: View looking right from the middle of Cross Section 4

Vegetation: 80% herbaceous on lower terrace, small shrubs and a few trees at top of bank

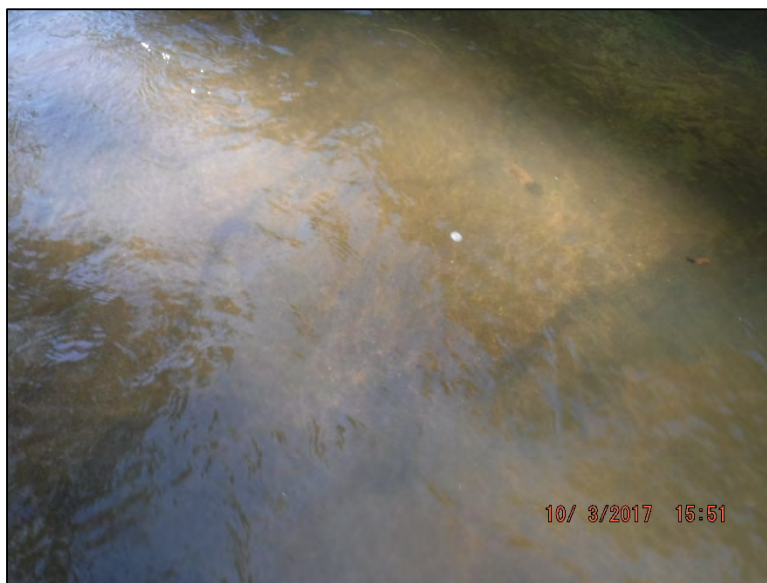
Photo 4-7

Description: Bed material at Cross Section 4 was almost entirely sand/silt

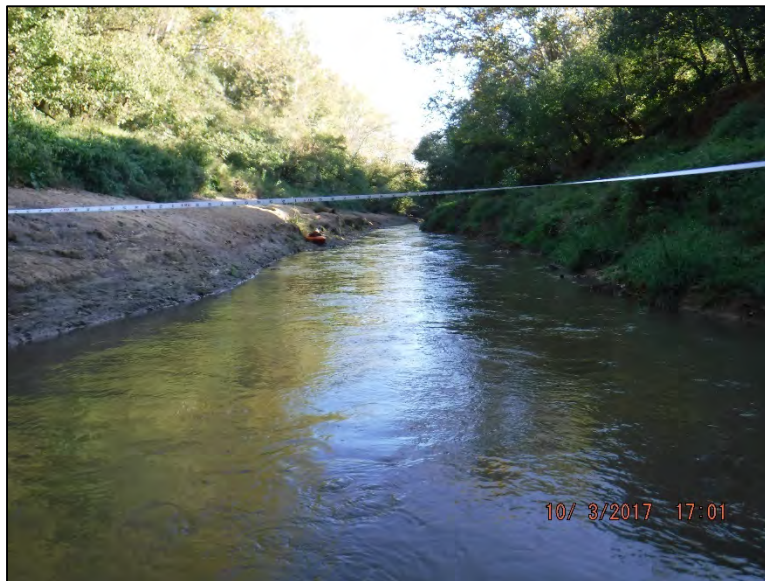
Photo 5-1

Description: View looking upstream from the center of Cross Section 5

Woody Debris: 2

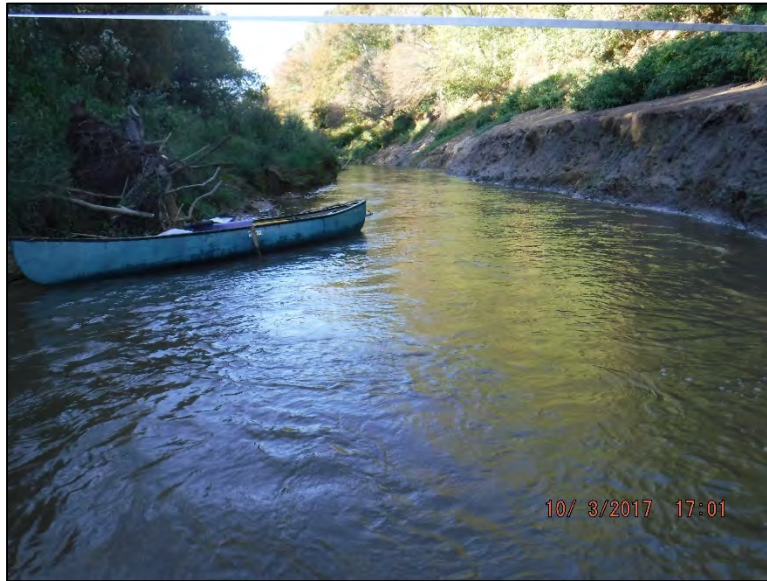
Photo 5-2

Description: View looking downstream from the middle of Cross Section 5

Woody Debris: 3

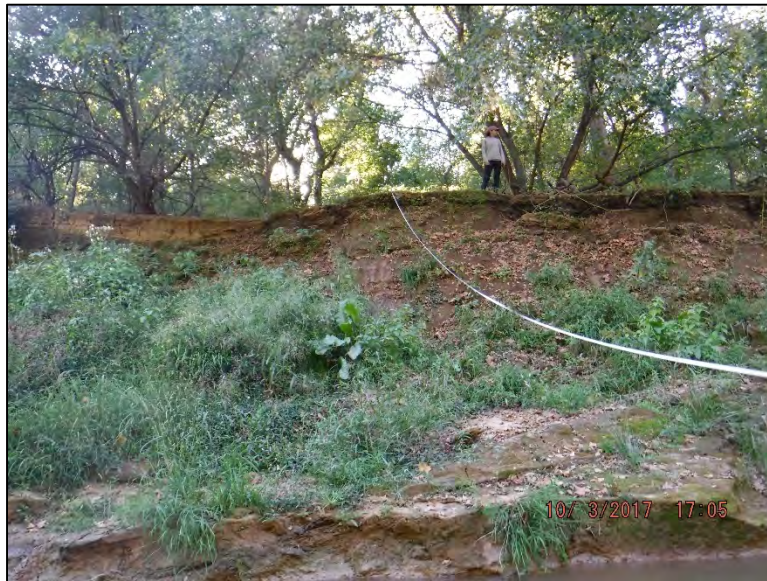
Photo 5-3

Description: View looking left from the middle of Cross Section 5

Vegetation: Small trees at bankfull, 80% herbaceous cover below top of bank

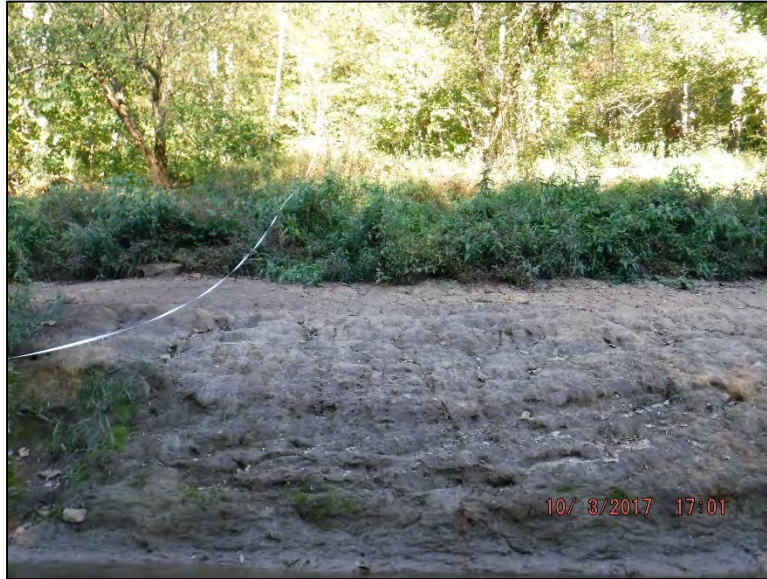
Photo 5-4

Description: View looking right from the middle of Cross Section 5

Vegetation: Small trees and grass at bankfull, no vegetation below top of bank

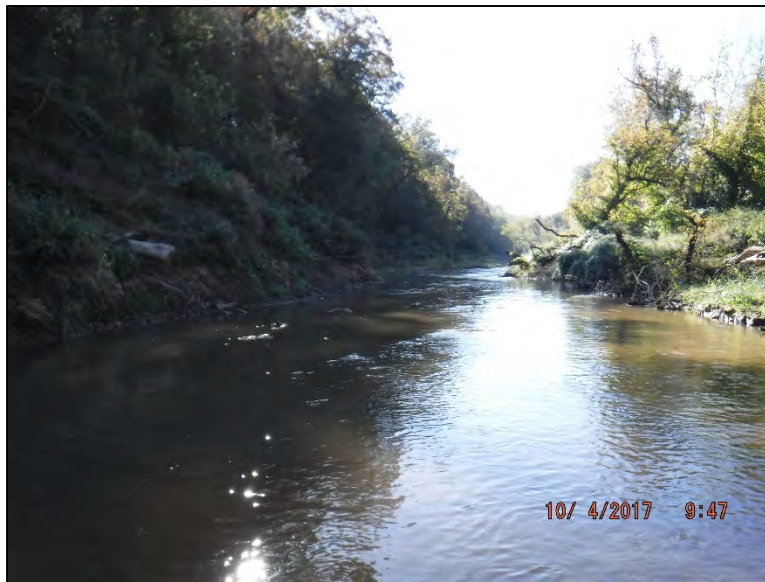
Description: View looking upstream from the center of Cross Section 6  
Woody Debris: 4

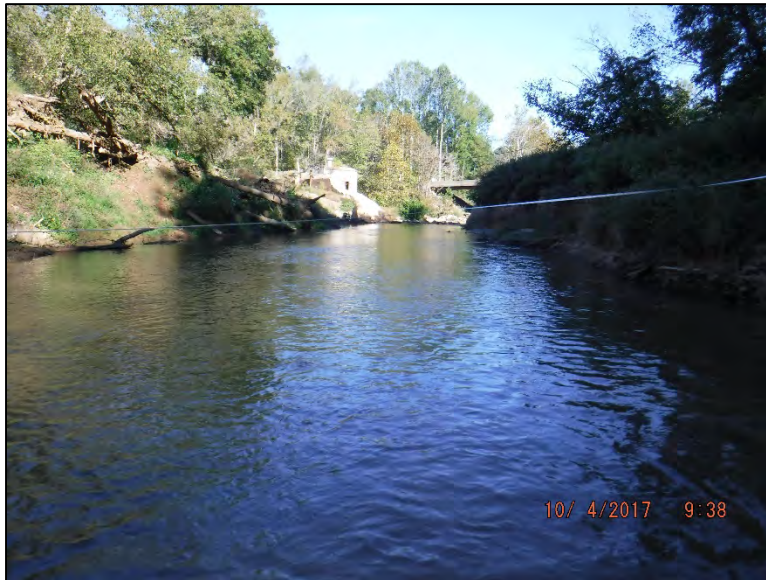
Photo 6-2

Description: View looking downstream from the middle of Cross Section 6  
Woody Debris: 15

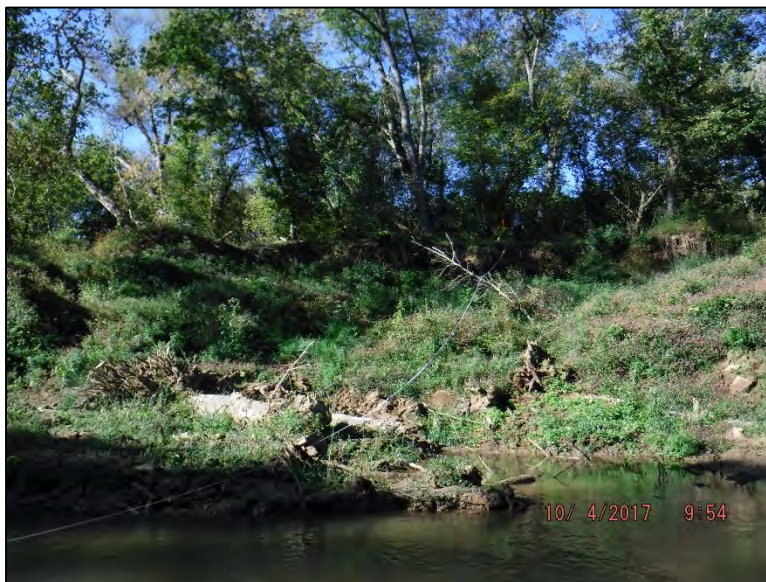
Photo 6-3

Description: View looking left from the middle of Cross Section 6  
Vegetation: 90% herbaceous cover, large trees and shrubs at top of bank

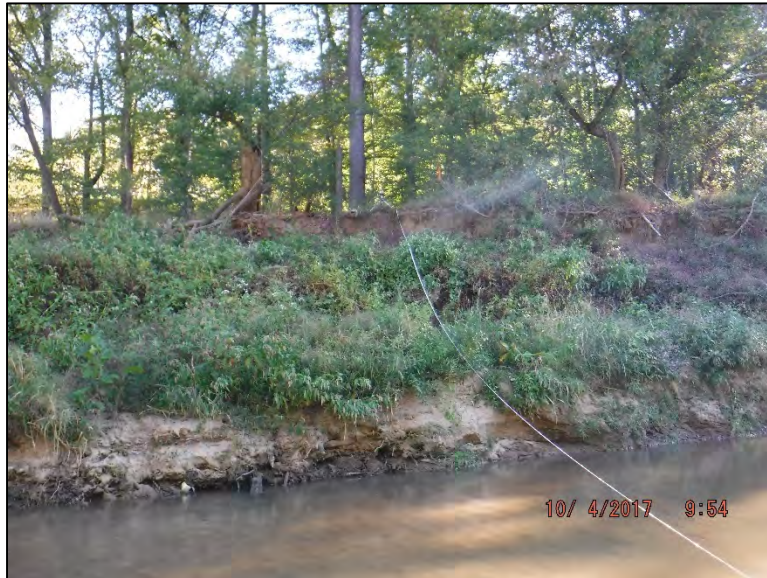
Photo 6-4

Description: View looking right from the middle of Cross Section 6  
Vegetation: 90% herbaceous cover, large trees and shrubs at top of bank

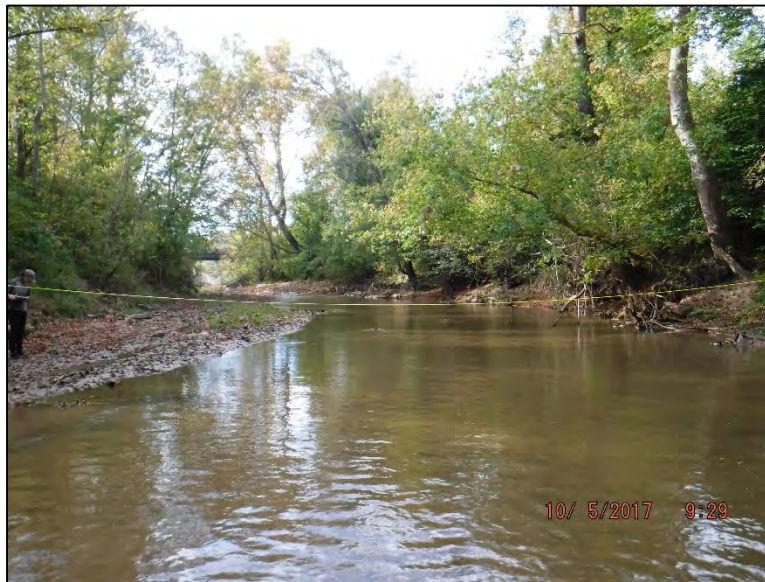
Photo 7-1

Description: View looking upstream from the middle of Cross Section 7  
Woody Debris: 10

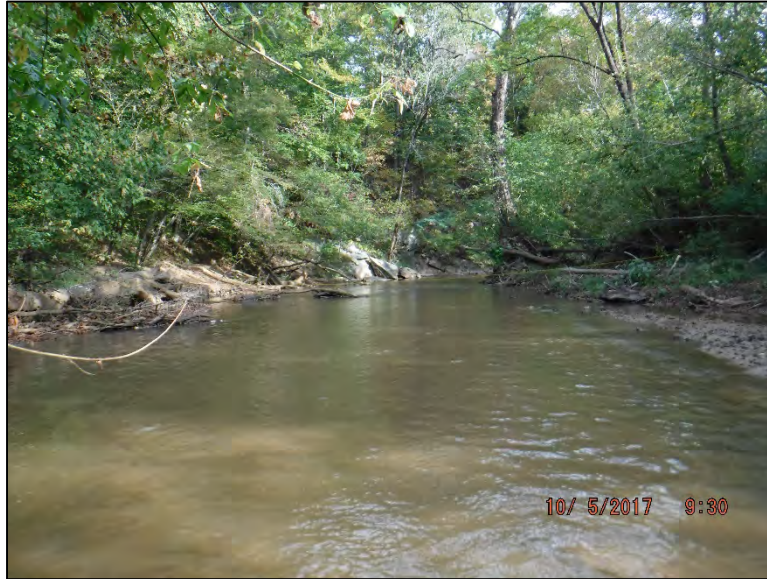
Photo 7-2

Description: View looking downstream from the middle of Cross Section 7

Woody Debris: 7

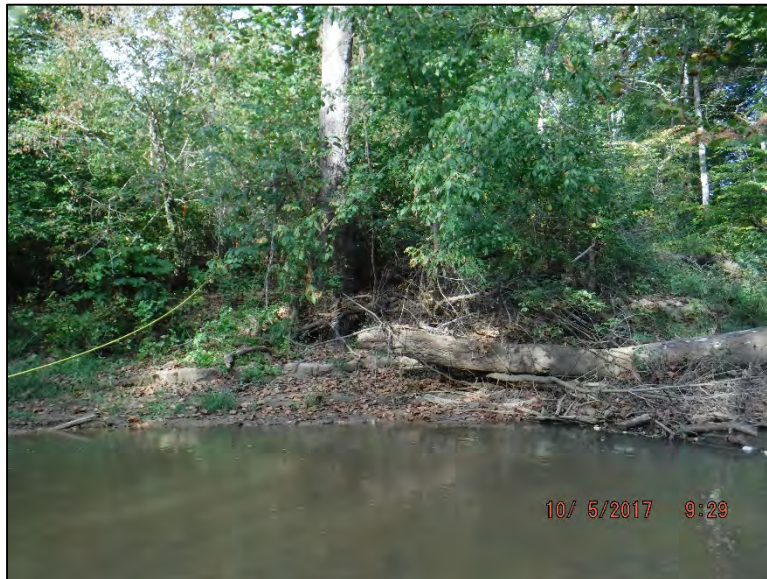
Photo 7-3

Description: View looking left from the middle of Cross Section 7

Vegetation: 30% herbaceous cover, few trees

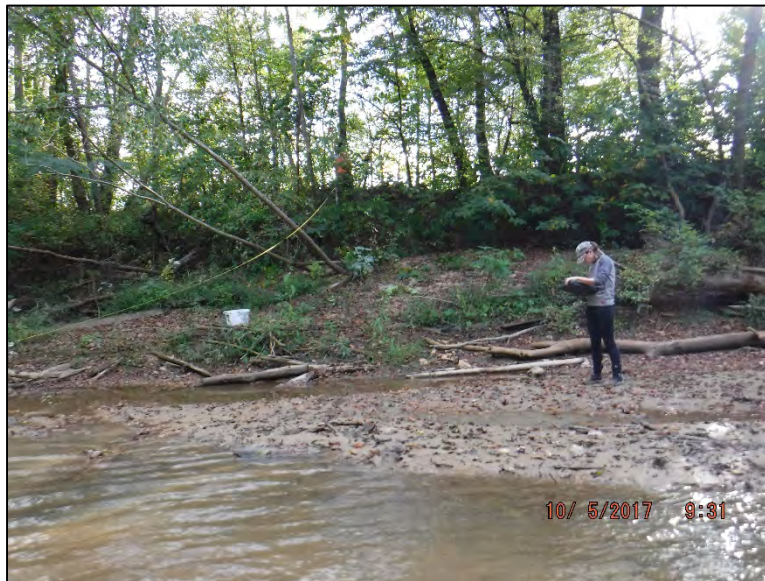
Photo 7-4

Description: View looking right from the middle of Cross Section 7

Vegetation: 40% herbaceous plants, trees at bankfull
