Pigg River Dam Removal Restoration - Monitoring
Rocky Mount, Virginia

Year 1 - XS 2

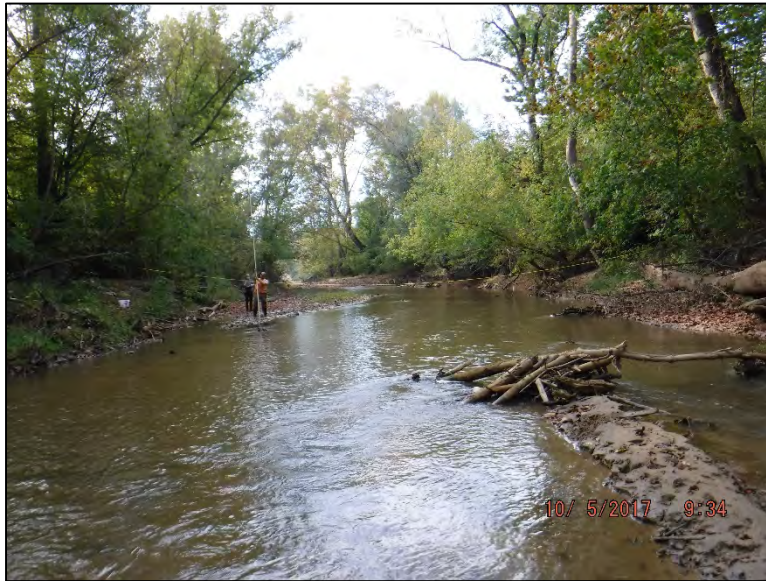
Photo 7-6

Description: View looking upstream at Cross Section 7 from a downstream position

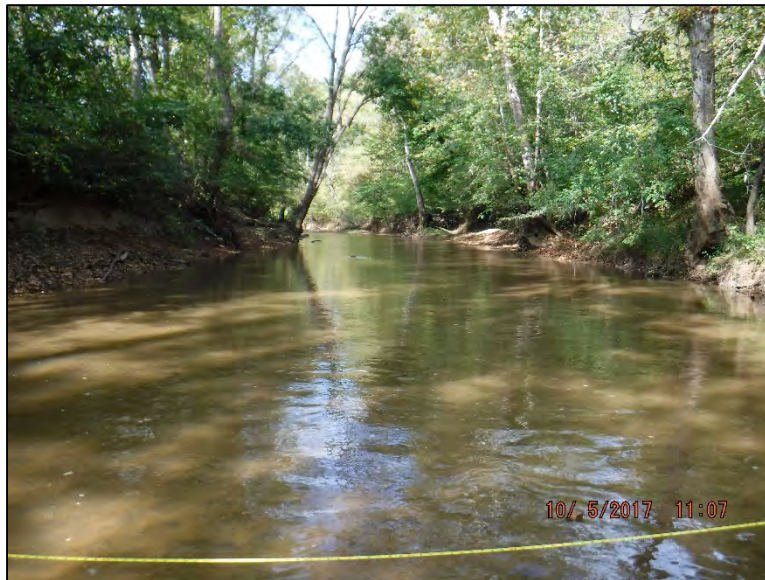
Photo 8-1

Description: View looking upstream from the middle of Cross Section 8

Woody Debris: 4

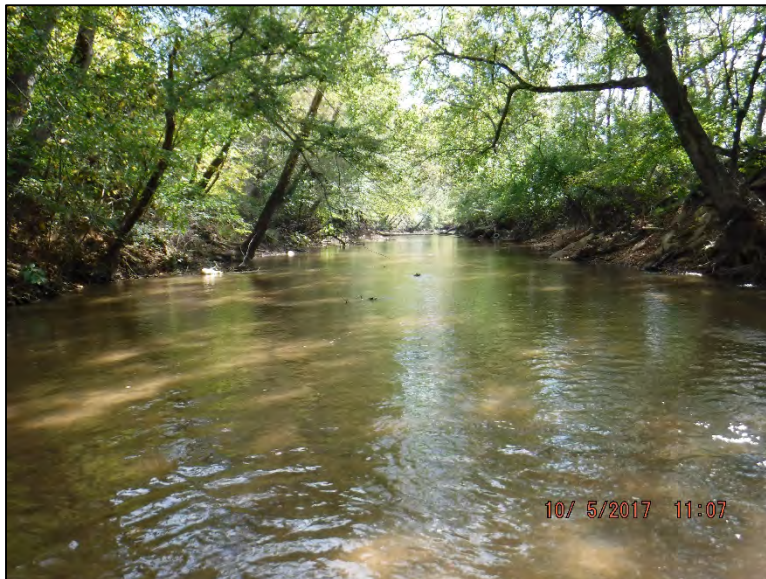
Photo 8-2

Description: View looking downstream from the middle of Cross Section 8
Woody Debris: 3

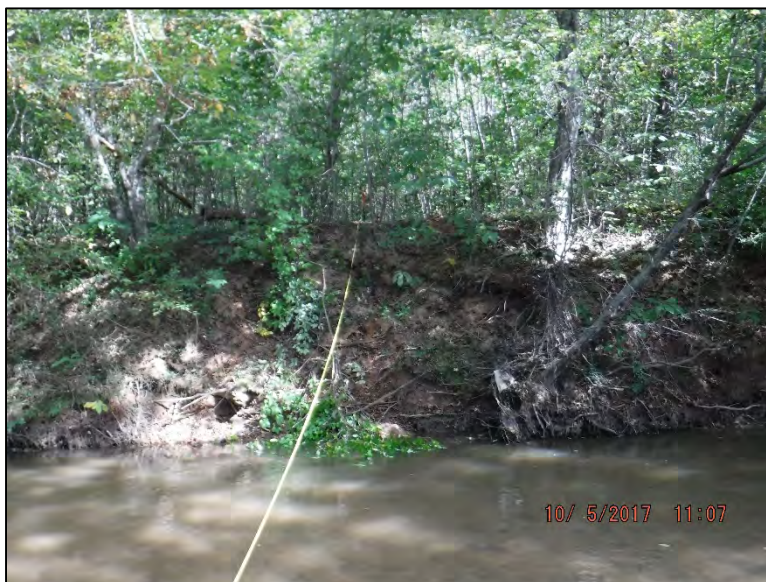
Photo 8-3

Description: View looking left from the middle of Cross Section 8
Vegetation: 30% herbaceous cover, saplings, small trees

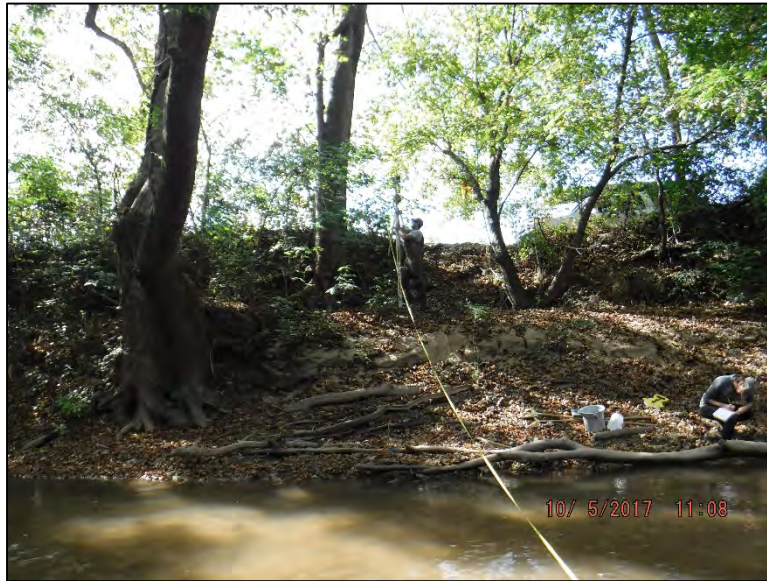
Photo 8-4

Description: View looking right from the middle of Cross Section 8

Vegetation: 10% herbaceous plants, trees

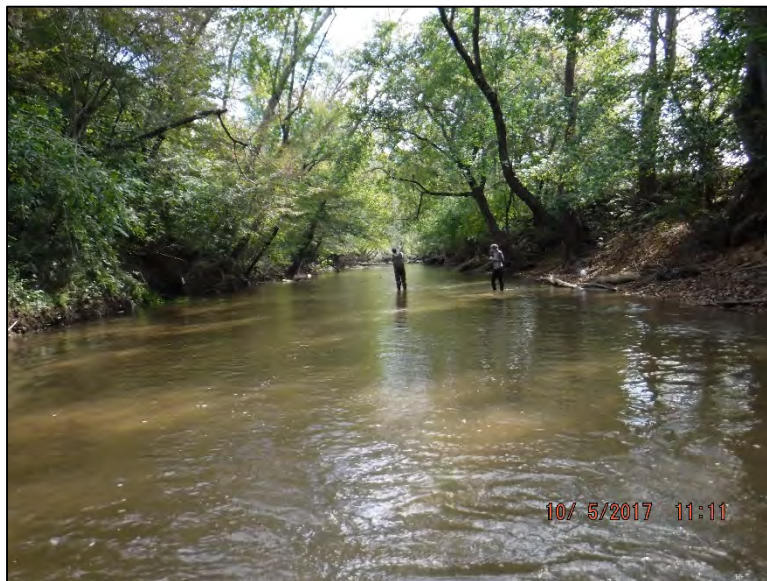
Photo 8-5

Description: View looking downstream at Cross Section 8 from an upstream position

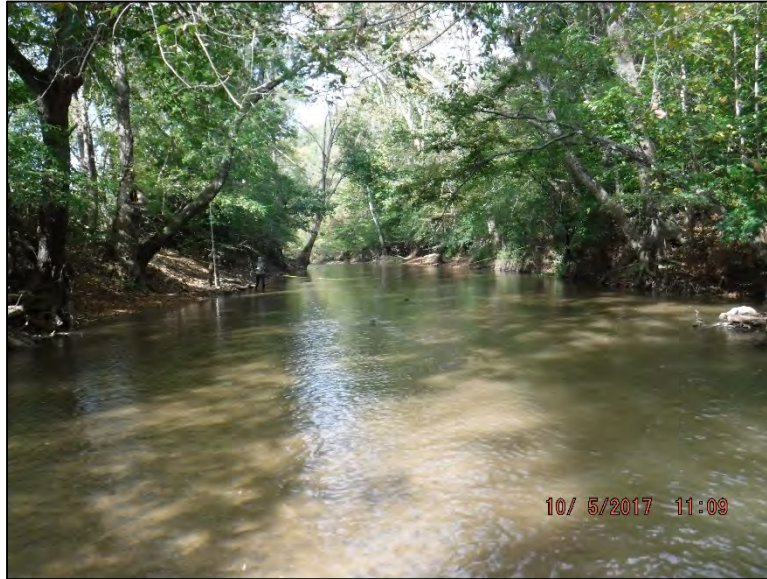
Photo 8-6

Description: View looking upstream at Cross Section 8 from a downstream position

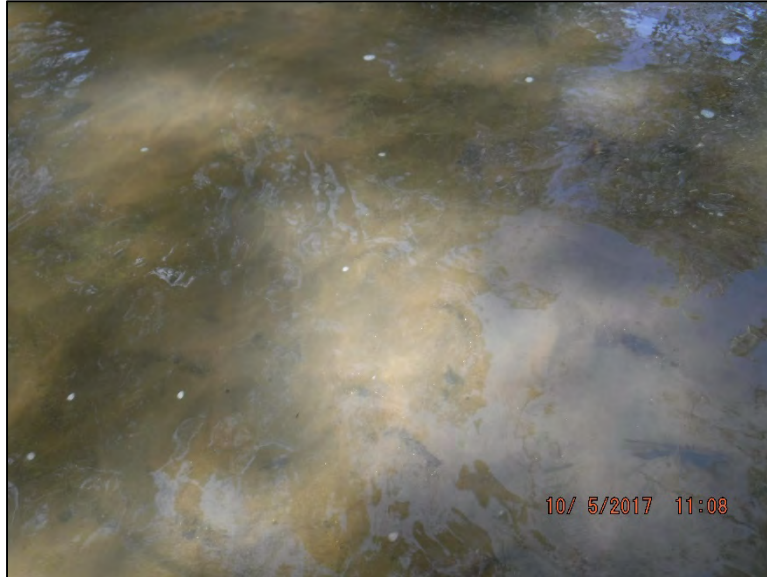
Photo 8-7

Description: Bed material at Cross Section 8 was almost entirely silt

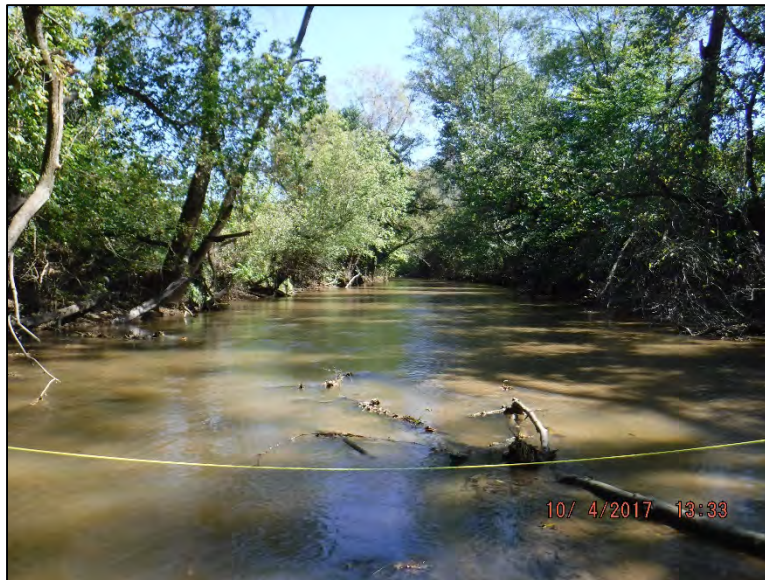
Photo 9-1

Description: View looking upstream from the middle of Cross Section 9
Woody Debris: 4

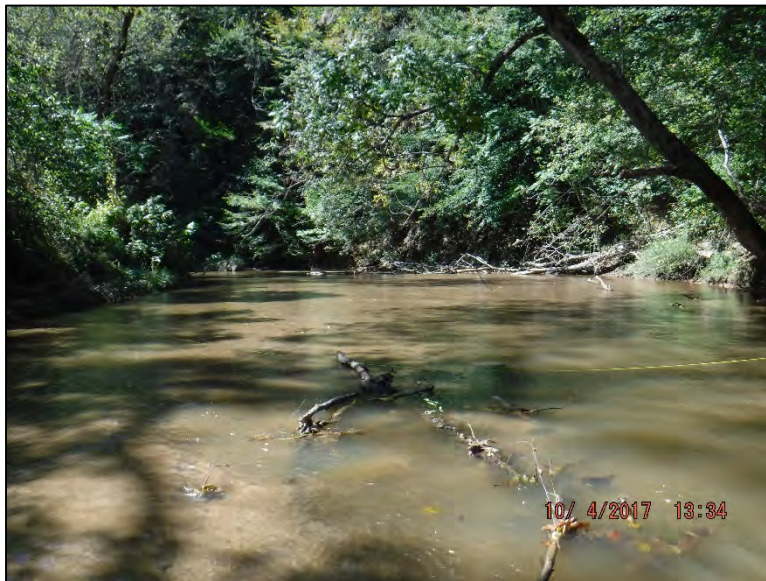
Photo 9-2

Description: View looking downstream from the middle of Cross Section 9

Woody Debris: 5

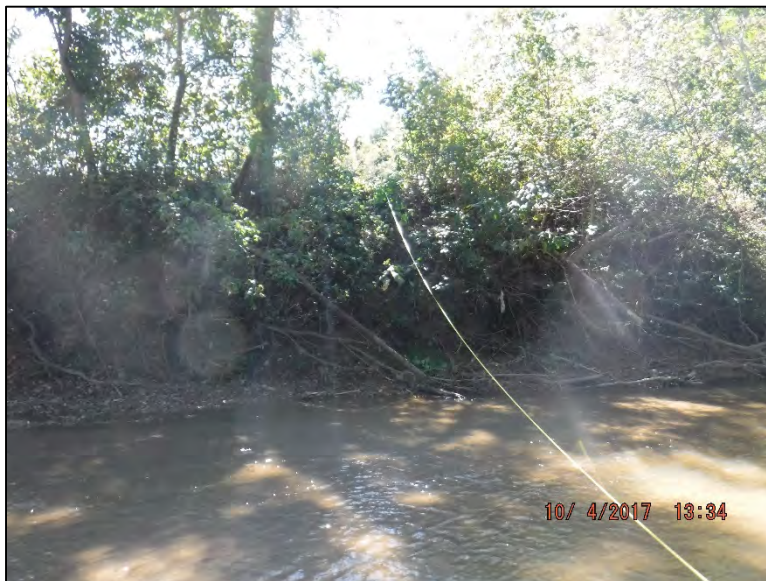
Photo 9-3

Description: View looking left from the middle of Cross Section 9

Vegetation: 40% herbaceous cover with small trees on top of bank

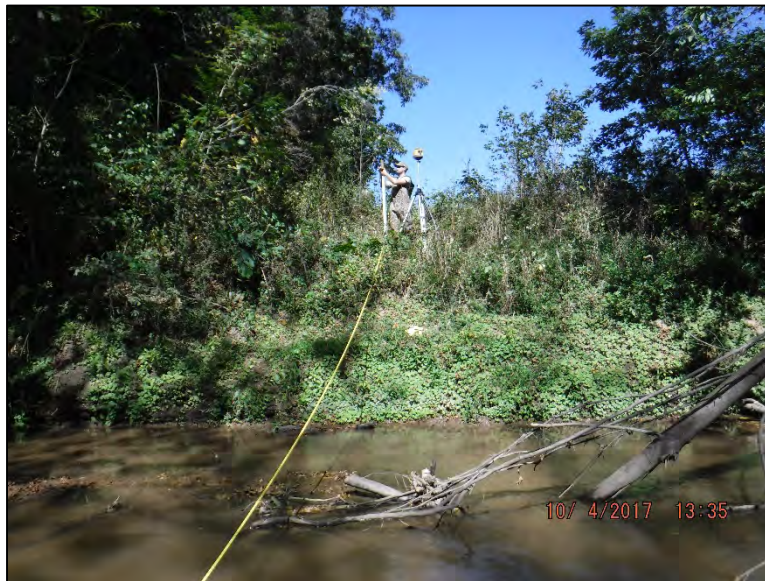
Photo 9-4

Description: View looking right from the middle of Cross Section 9

Vegetation: 90% herbaceous cover on bank

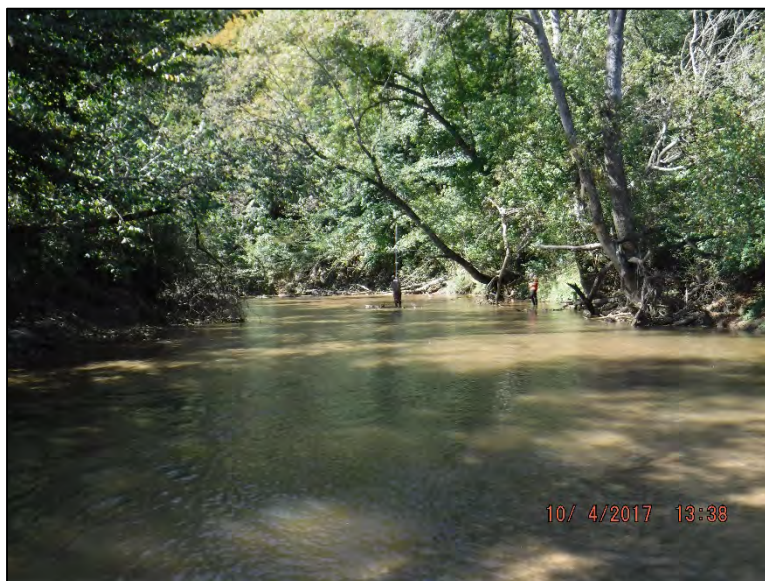
Photo 9-5

Description: View looking downstream at Cross Section 9 from an upstream position

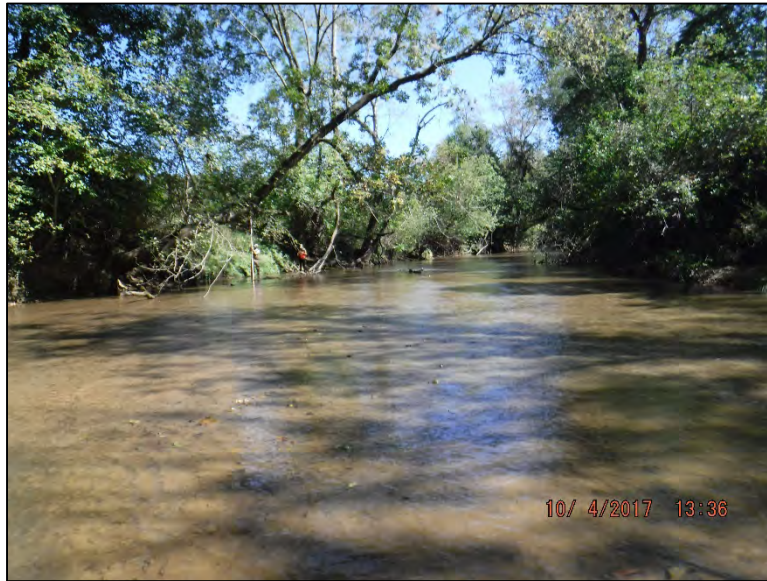
Photo 9-6

Description: View looking upstream at Cross Section 9 from a downstream position

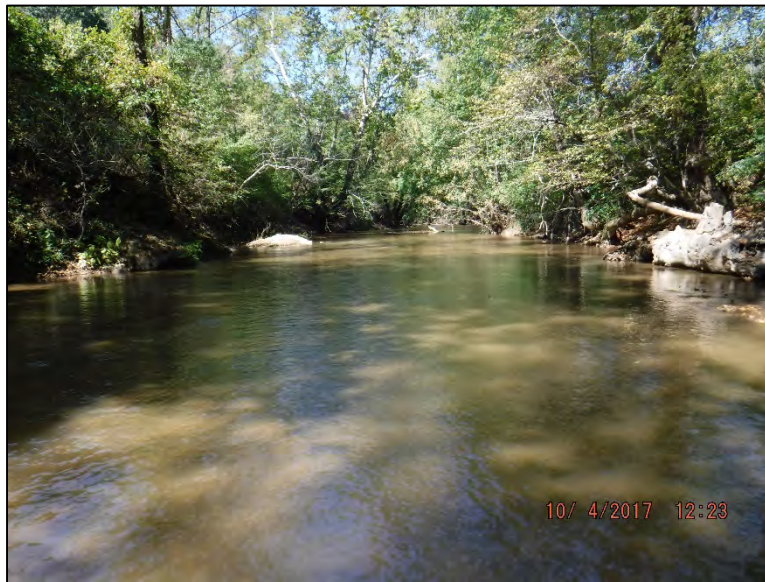
Photo 10-1

Description: View looking upstream from the middle of Cross Section 10

Woody Debris: 2

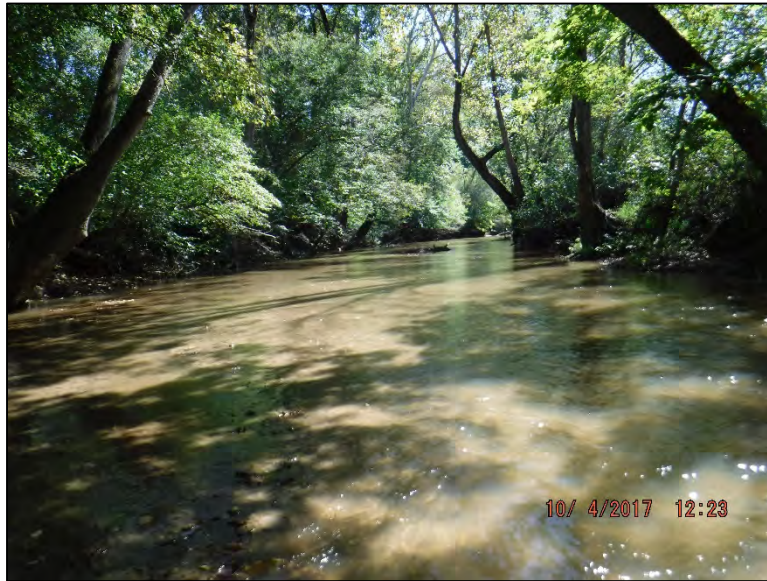
Photo 10-2

Description: View looking downstream from the middle of Cross Section 10

Woody Debris: 4

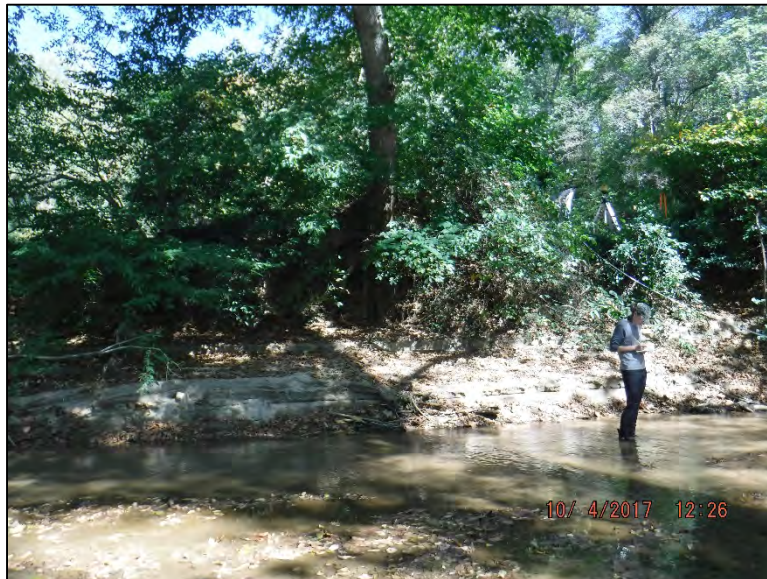
Photo 10-3

Description: View looking left from the middle of Cross Section 10

Vegetation: 30% herbaceous cover, trees

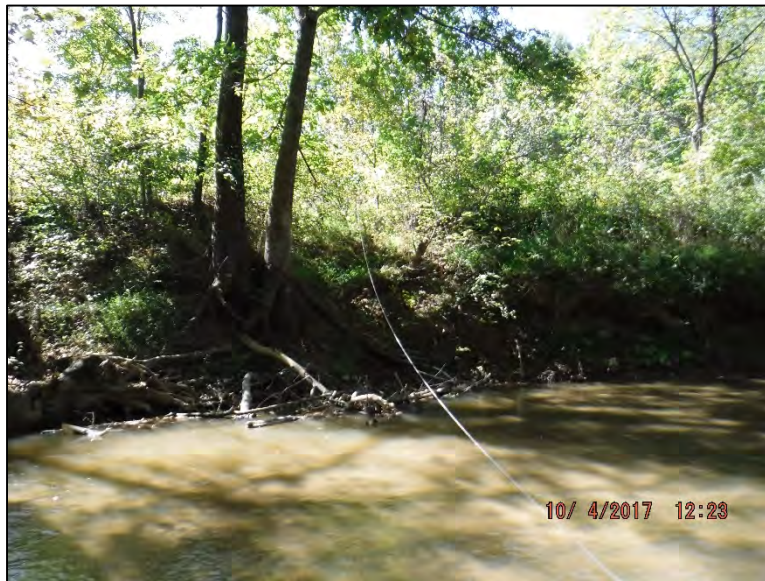
Photo 10-4

Description: View looking right from the middle of Cross Section 10

Vegetation: 60% herbaceous cover, some trees higher on bank

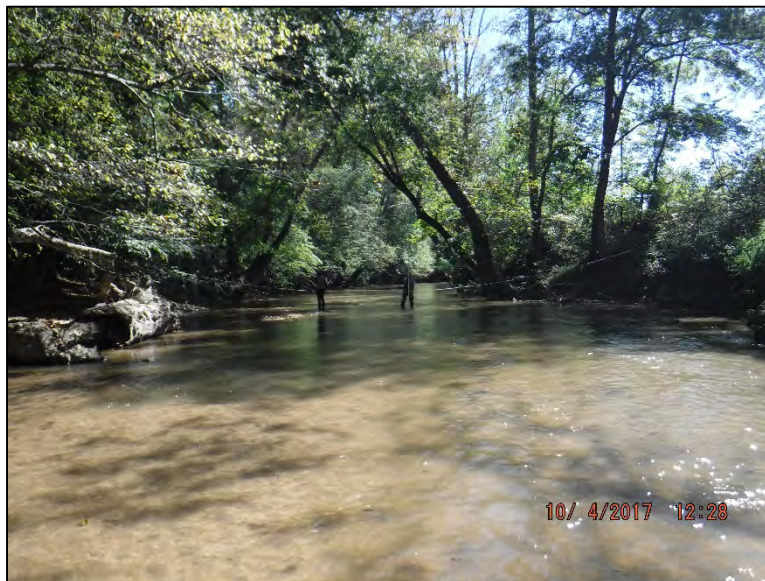
Photo 10-5

Description: View looking downstream at Cross Section 10 from an upstream position

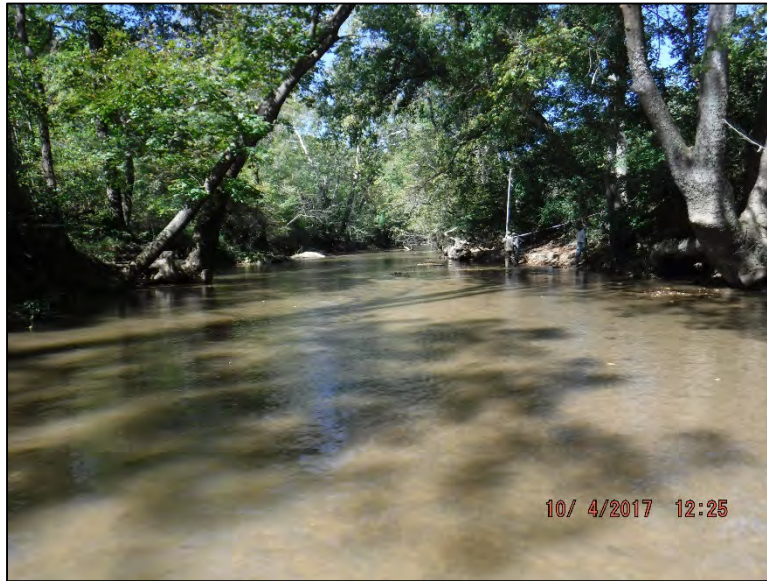
Photo 10-6

Description: View looking upstream at Cross Section 10 from a downstream position

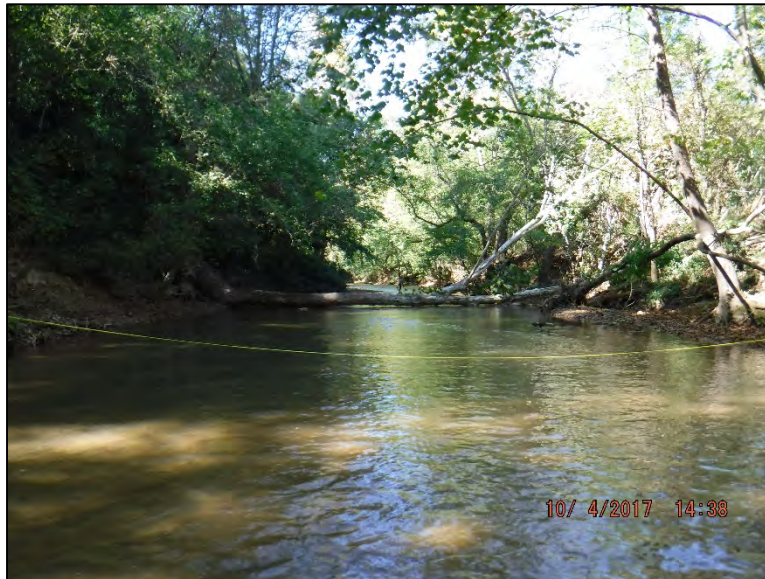
Photo 11-1

Description: View looking upstream from the middle of Cross Section 11

Woody Debris: 2

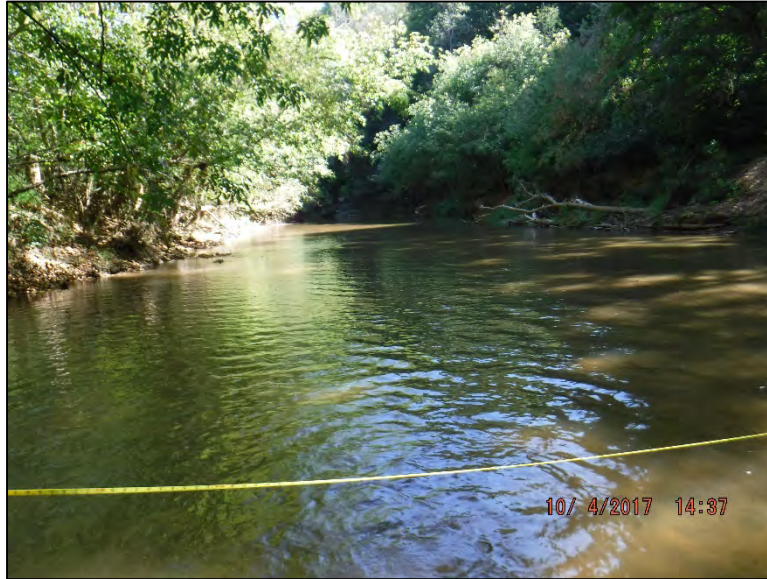
Photo 11-2

Description: View looking downstream from the middle of Cross Section 11

Woody Debris: 3

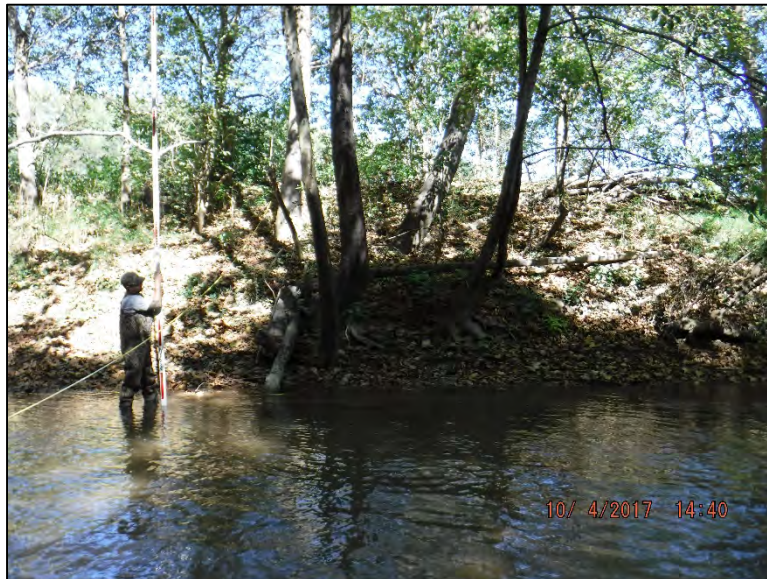
Photo 11-3

Description: View looking left from the middle of Cross Section 11

Vegetation: 40% herbaceous cover, trees

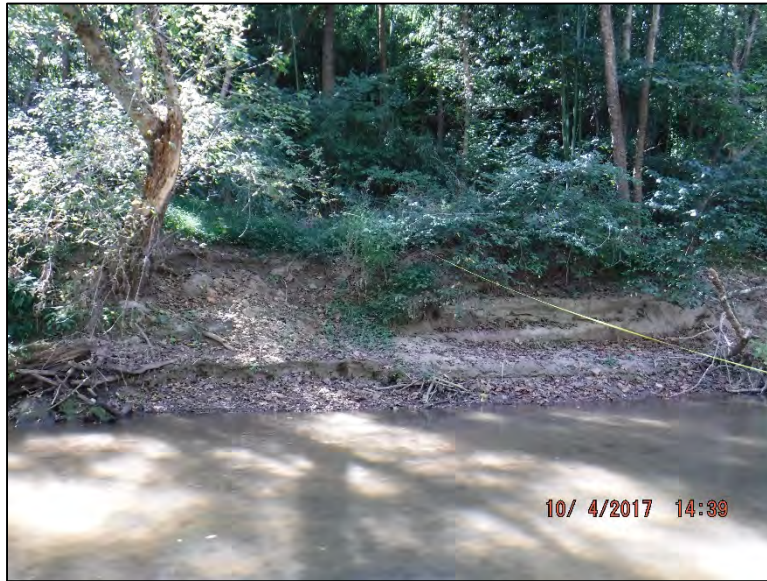
Photo 11-4

Description: View looking right from the middle of Cross Section 11

Vegetation: 60% herbaceous cover and small trees going up slope, bamboo/forest at bankfull

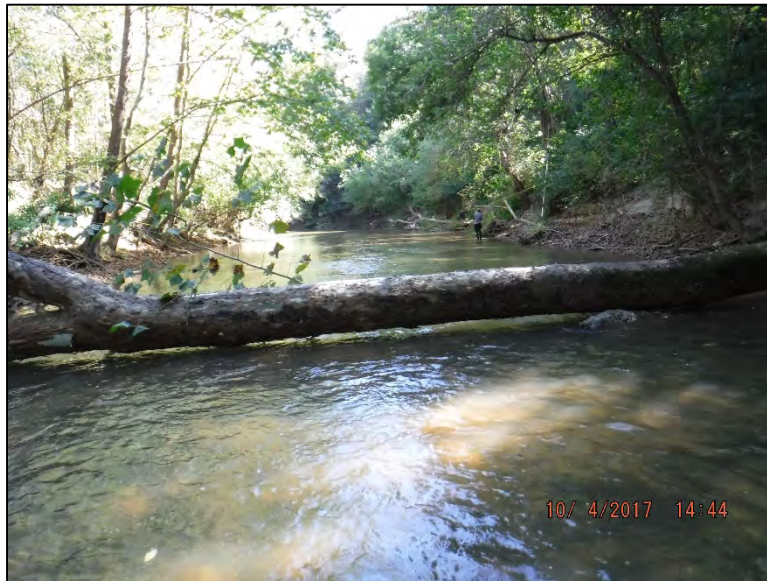
Photo 11-5

Description: View looking downstream at Cross Section 11 from an upstream position

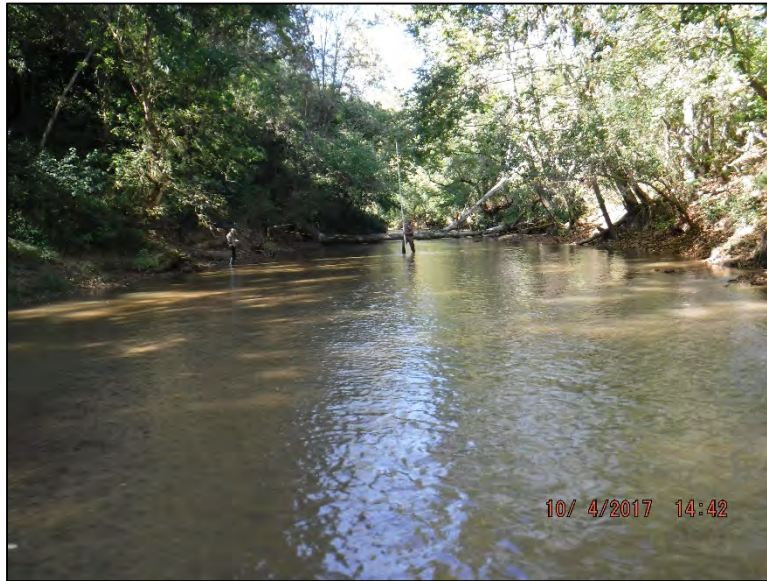
Photo 11-6

Description: View looking upstream at Cross Section 11 from a downstream position

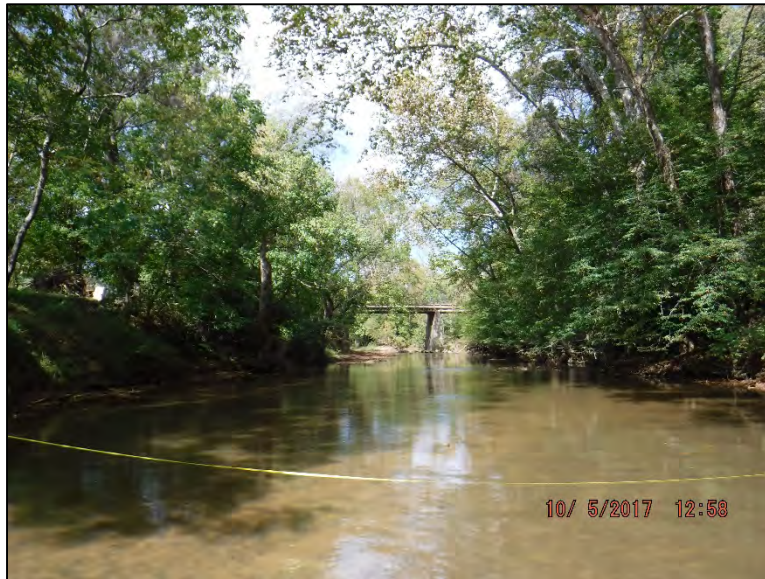
Photo 12-1

Description: View looking upstream from the middle of Cross Section 12

Woody Debris: 2

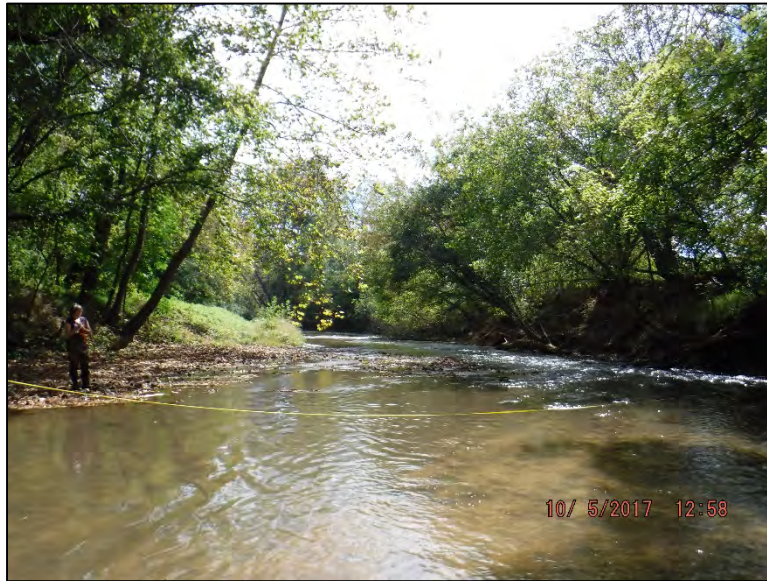
Photo 12-2

Description: View looking downstream from the middle of Cross Section 12

Woody Debris: 2

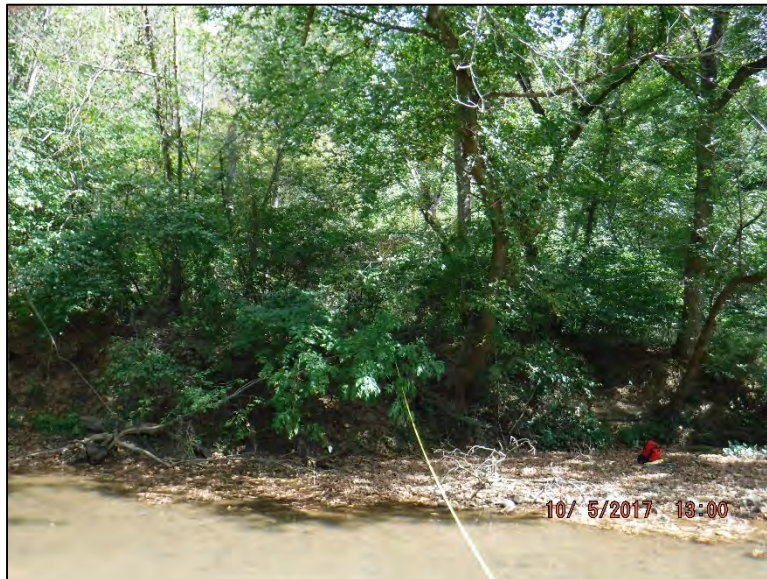
Photo 12-3

Description: View looking left from the middle of Cross Section 12

Vegetation: 80% herbaceous cover, trees

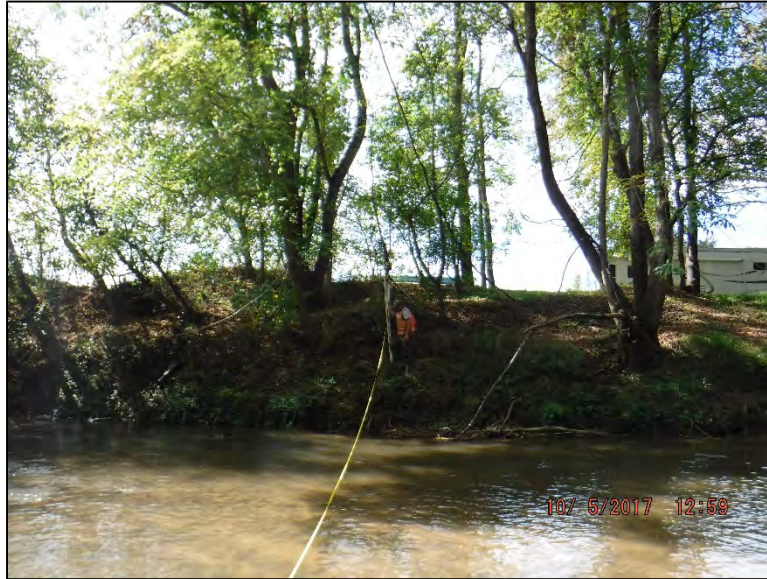
Photo 12-4

Description: View looking right from the middle of Cross Section 12

Vegetation: 60% herbaceous cover, trees at top of bank

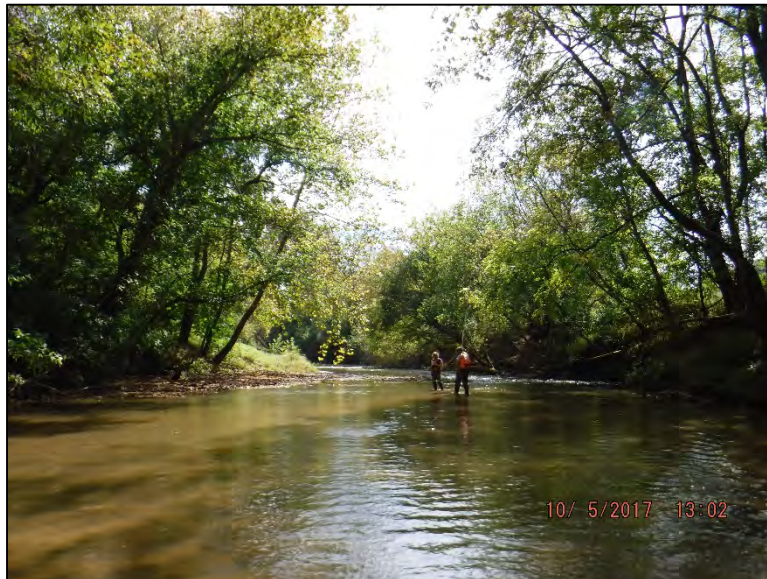
Photo 12-5

Description: View looking downstream at Cross Section 12 from an upstream position

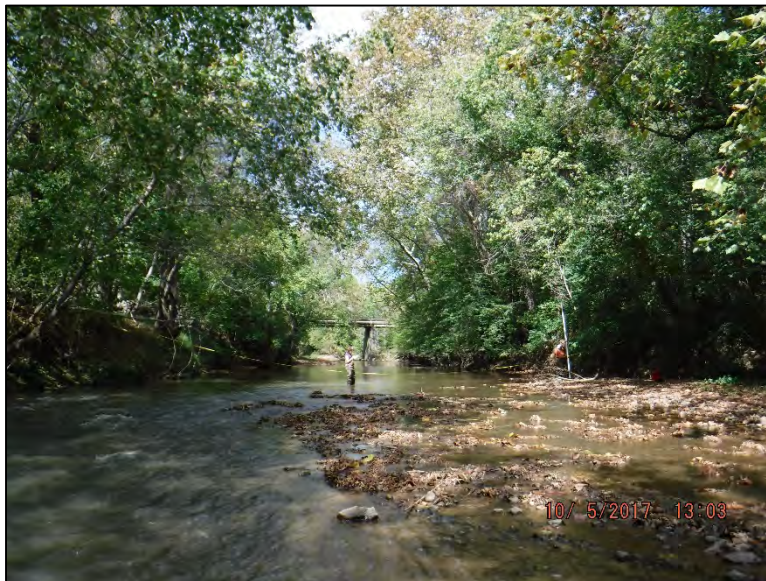
Photo 12-6

Description: View looking upstream at Cross Section 12 from a downstream position

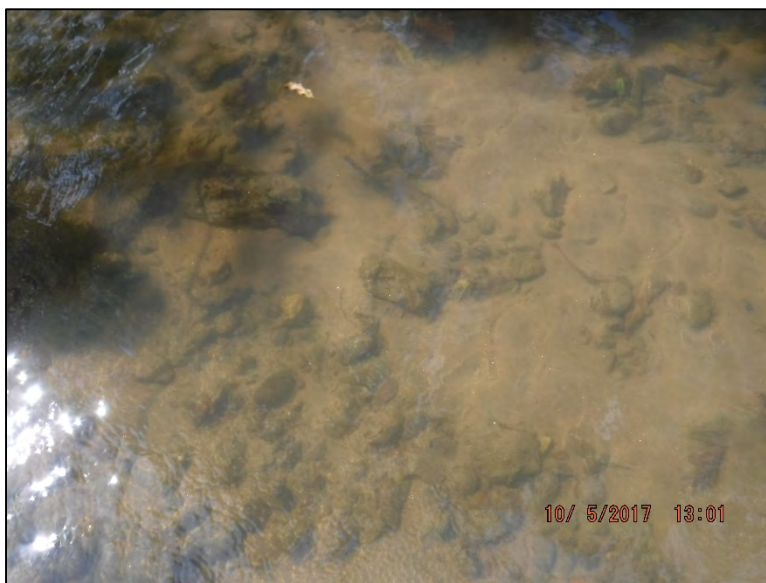
Photo 12-7

Description: Bed material at Cross Section 12 was sand and coarse gravel
