Pigg River Restoration at Power Dam

Year-2 Monitoring Report

As required by VDEQ Permit #15-1551 and USFWS Biological Opinion for the Pigg River Restoration at Power Dam Project.

DECEMBER 2018

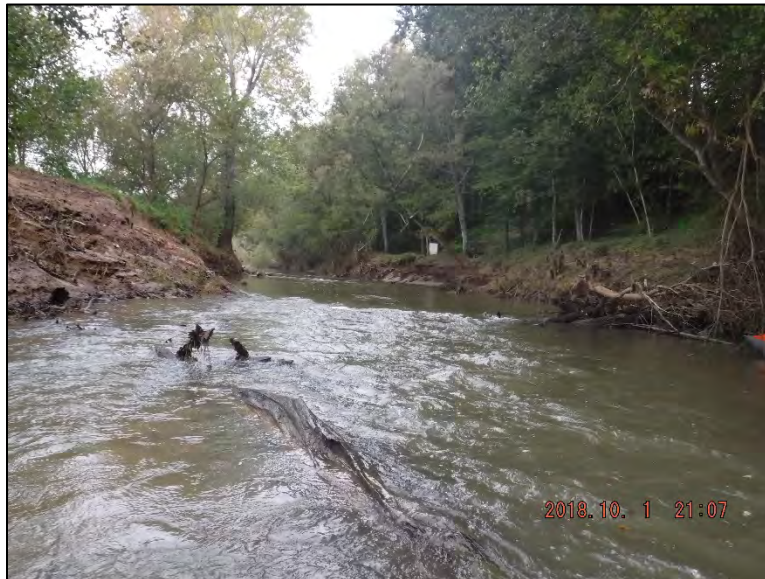
Photo 1-1

Description: View looking upstream from the middle of Cross Section 1

Woody Debris: 15

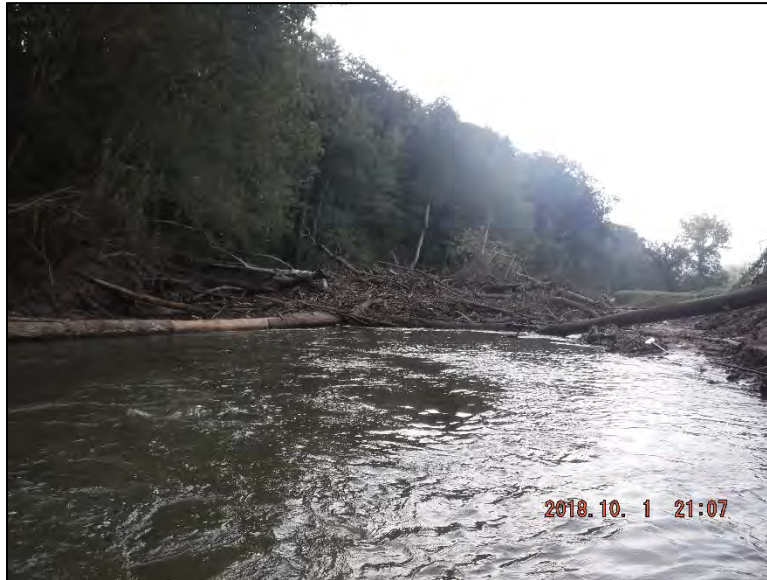
Photo 1-2

Description: View looking downstream from the middle of Cross Section 1
Woody Debris: >100

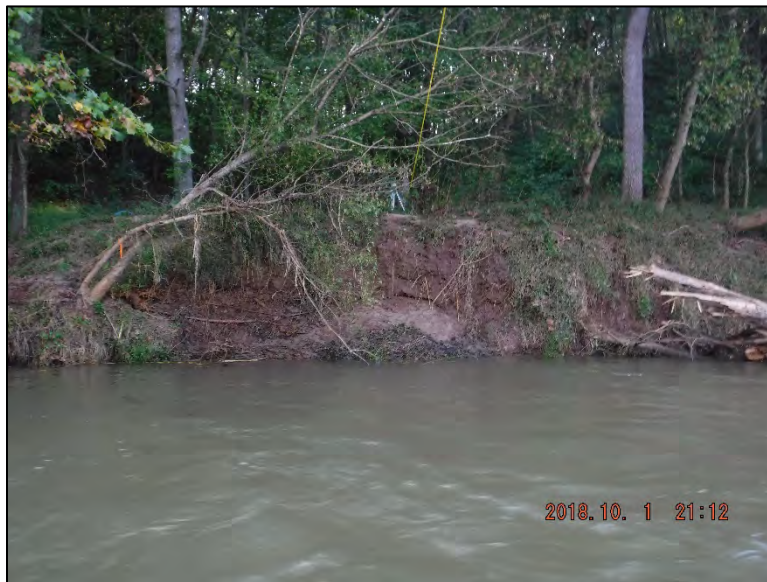
Photo 1-3

Description: View looking left from the middle of Cross Section 1
Vegetation: 30% herbaceous cover, few trees at top of bank

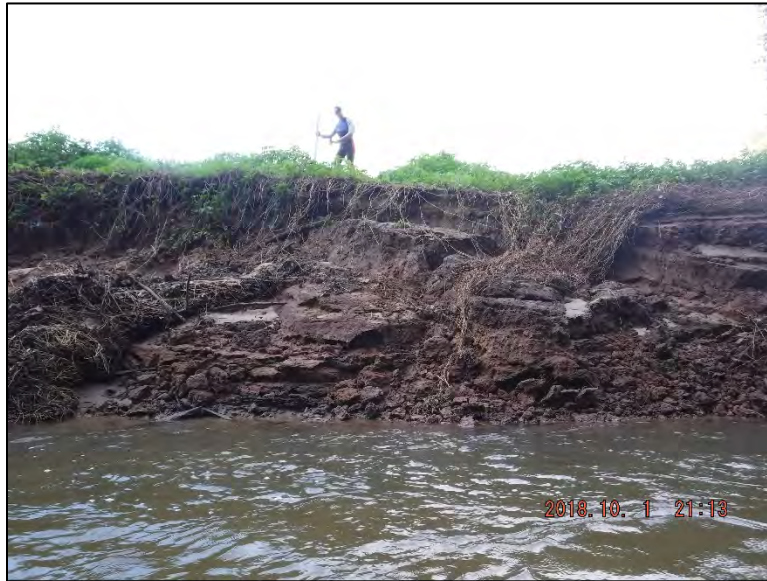
Photo 1-4

Description: View looking right from the middle of Cross Section 1

Vegetation: 10% herbaceous cover, no trees

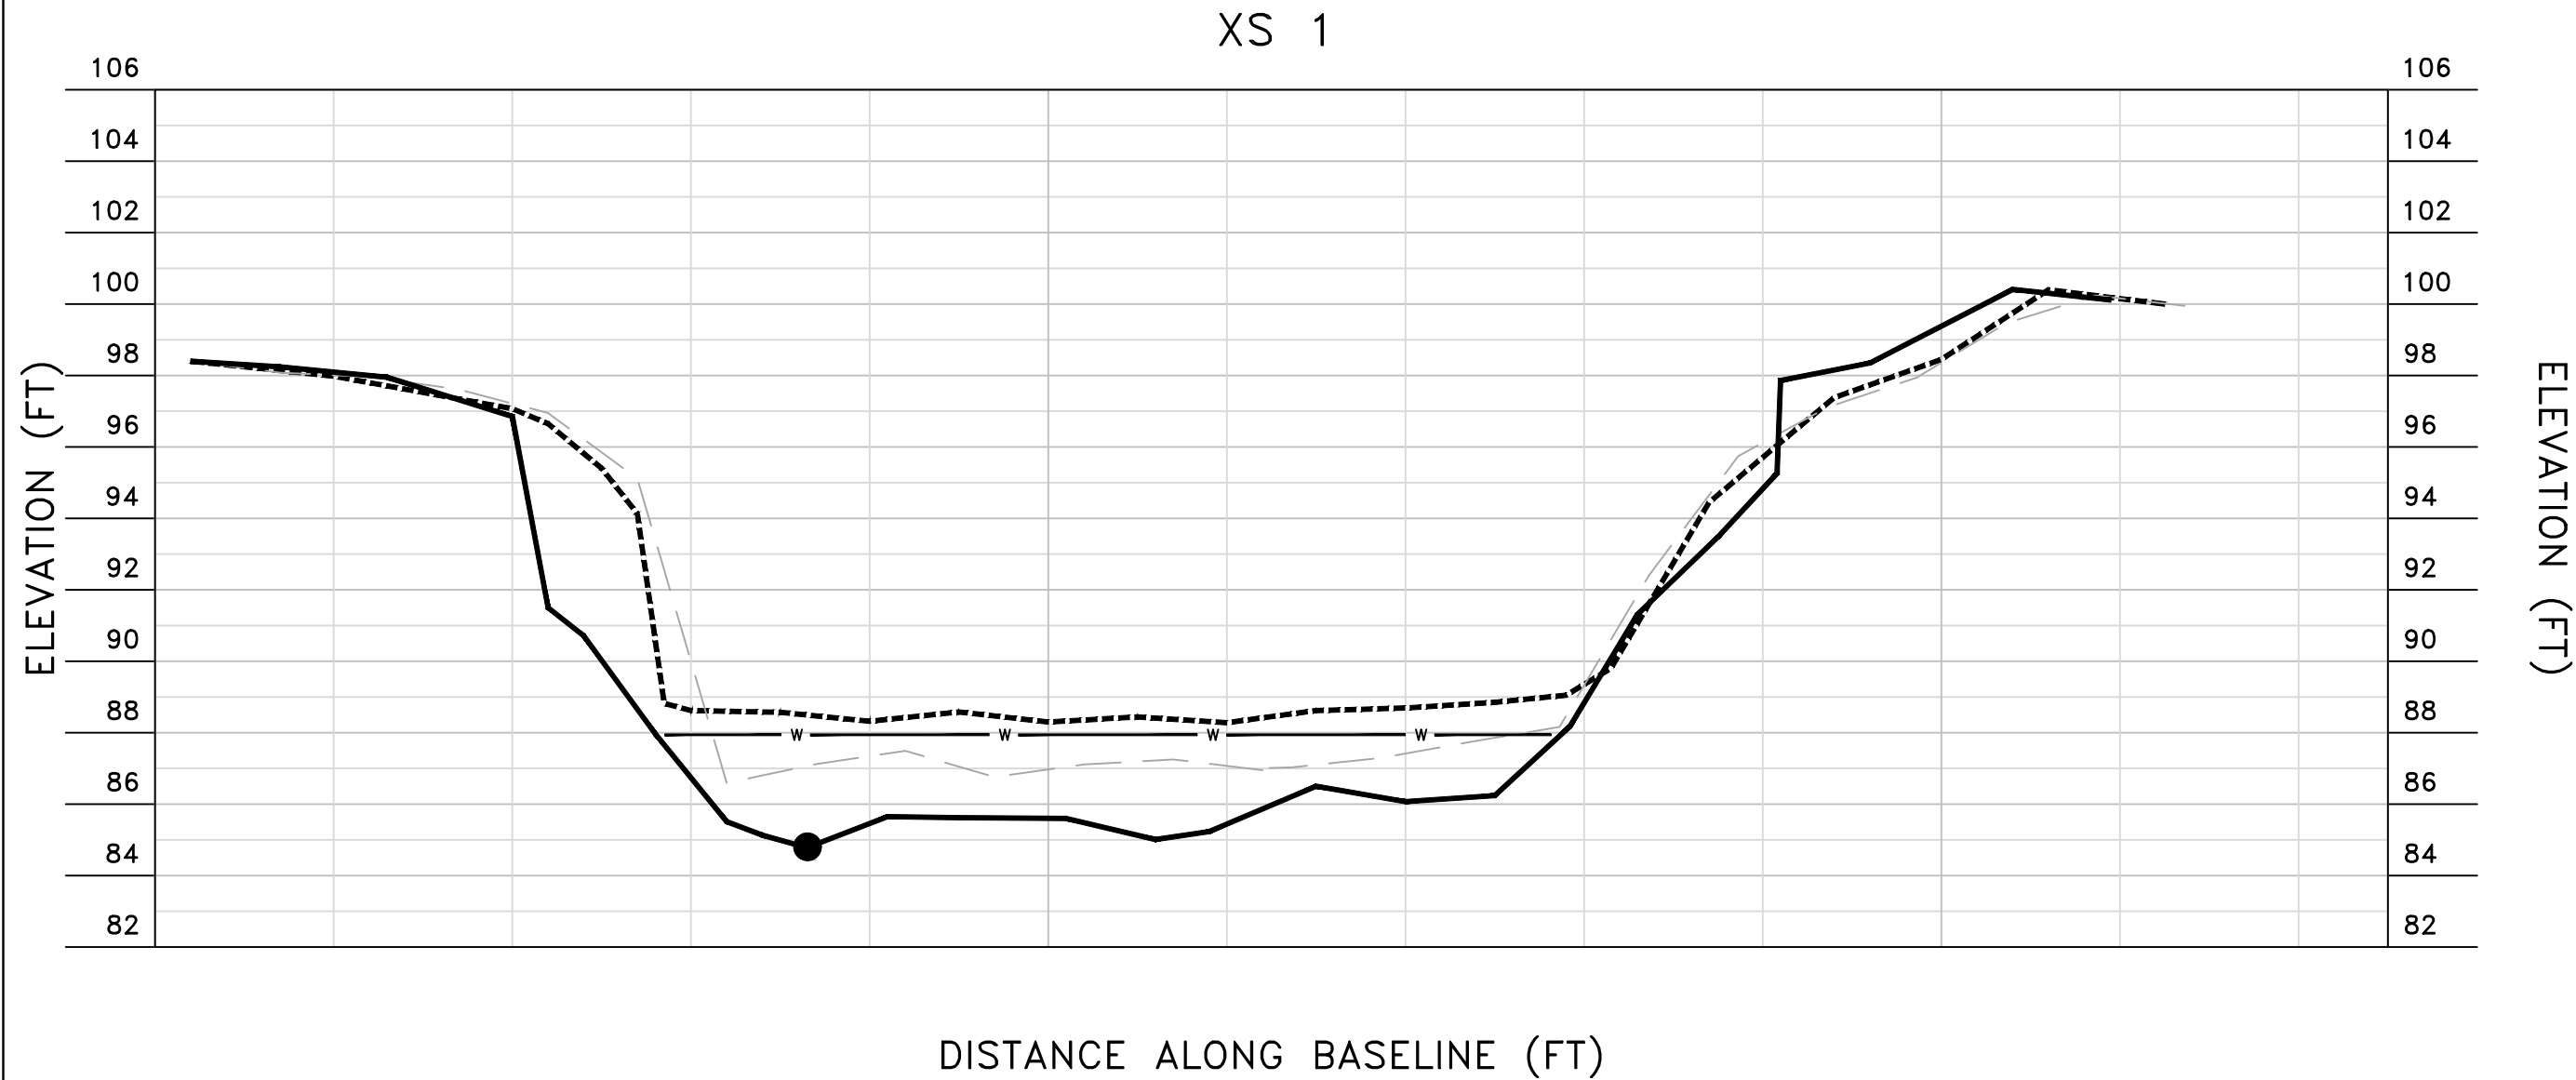
Year 2 - XS 1
Copyright © 2018

Year 2 monitoring cross section surveys indicate continued bed incision at Cross Section 1 (approximately 1-ft of drop in bed elevation since Year-1), likely driven by the frequency and intensity of storm events experienced throughout the year. Cross Section 2 had almost no change from the previous year, downcutting increased in Cross Sections 3-4 ranging from 2-ft to 3-ft at Section 4. Changes at Sections 5 and 6 were less dramatic since significant evolution occurred immediately following construction and these sections now approach the invert elevation of the dam remains. Upstream of the removed dam, there was a significant loss of bank vegetation and signs of consistent bank failure, again largely attributable to the frequency and intensity of high water events in 2018. Tension cracking and mass failure is visible at cross sections where steep banks still exist. Downstream of the removed dam the banks had sediment deposits, with these deposits becoming less pronounced with greater distance from the dam. End pins at various cross sections downstream of the dam saw deposition of approximately 0.1 ft, confirming sediment transport in overbank events since Year 1 monitoring.

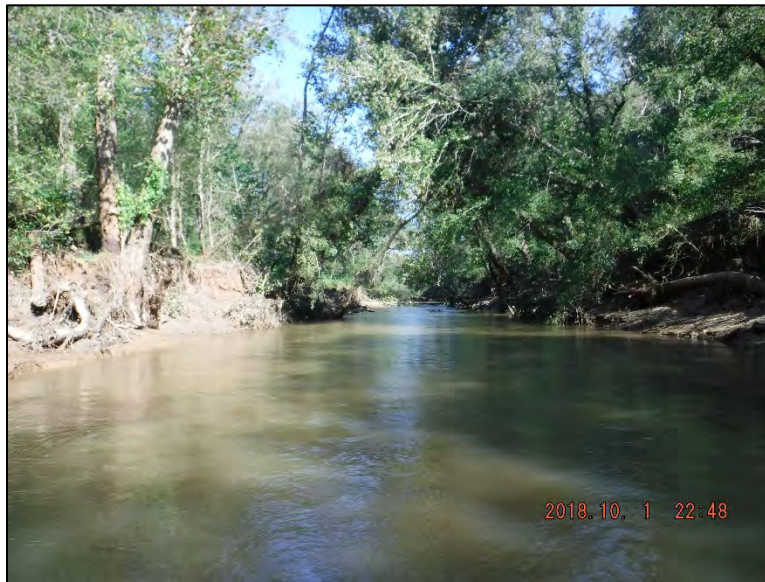
Photo 2-1

Description: View looking upstream from the center of Cross Section 2

Woody Debris: 10

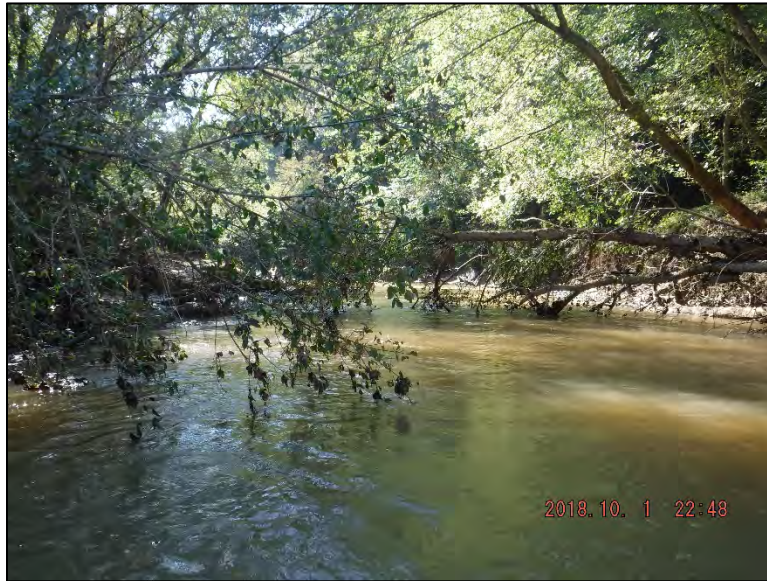
Photo 2-2

Description: View looking downstream from the middle of Cross Section 2

Woody Debris: 10

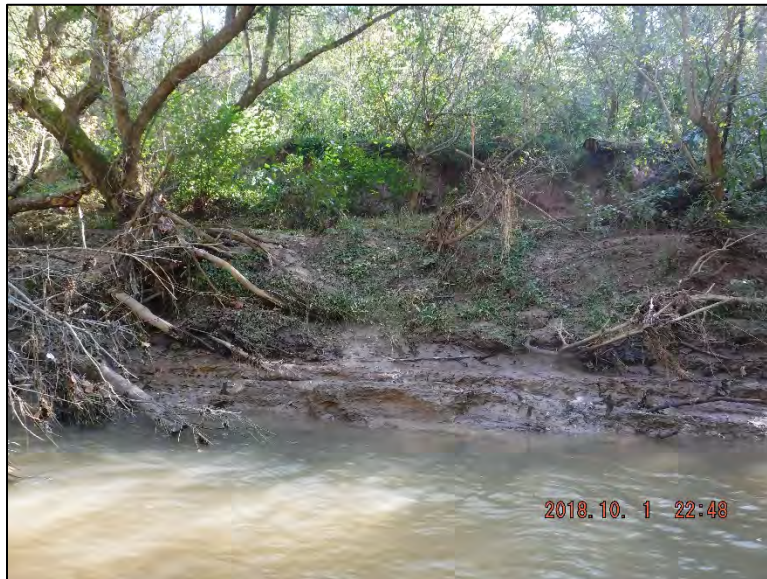
Photo 2-3

Description: View looking left from the middle of Cross Section 2

Vegetation: 40% herbaceous cover, few trees, woody debris

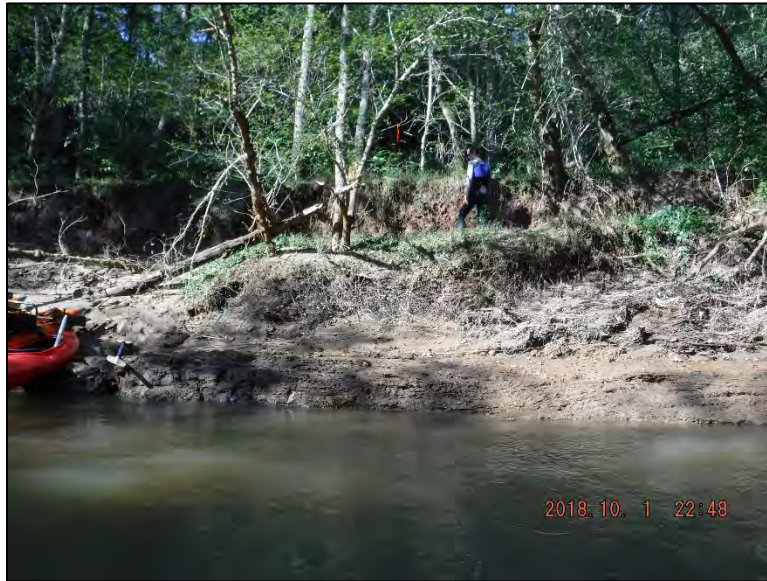
Photo 2-4

Description: View looking right from the middle of Cross Section 2

Vegetation: 20% herbaceous cover, few trees, woody debris

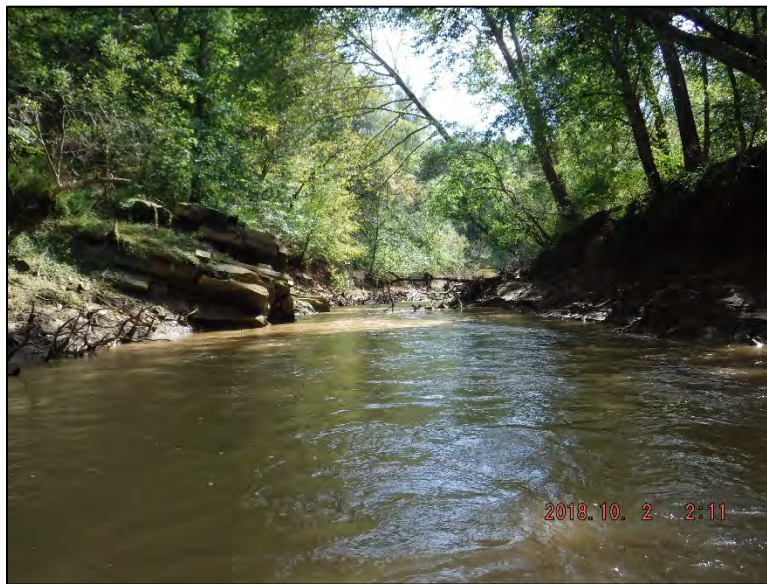
Photo 3-1

Description: View looking upstream from the center of Cross Section 3

Woody Debris: 3

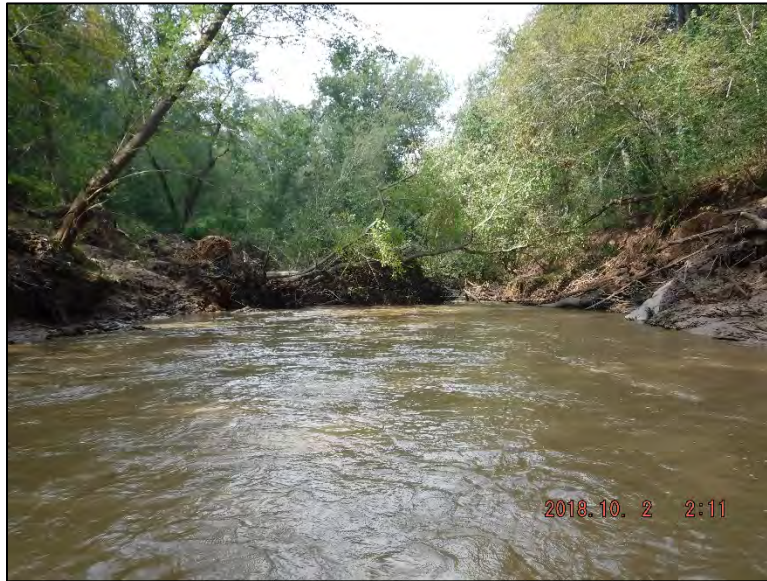
Photo 3-2

Description: View looking downstream from the middle of Cross Section 3

Woody Debris: 50

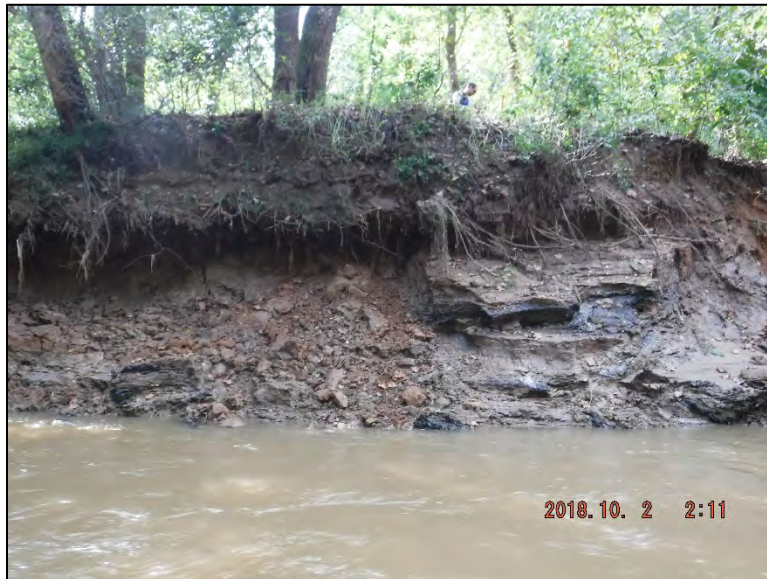
Photo 3-3

Description: View looking left from the middle of Cross Section 3

Vegetation: 10% herbaceous plants, few trees on top of bank

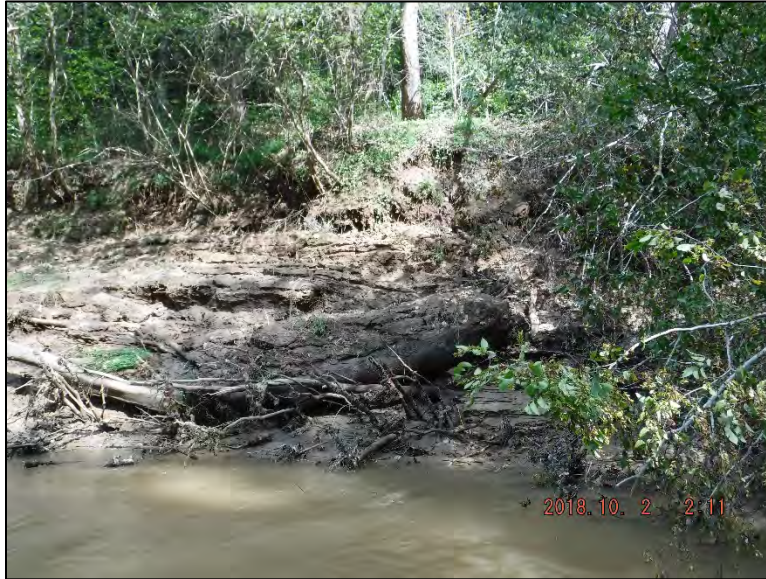
Photo 3-4

Description: View looking right from the middle of Cross Section 3

Vegetation: 10% herbaceous cover, a few trees at top of bank, and woody debris

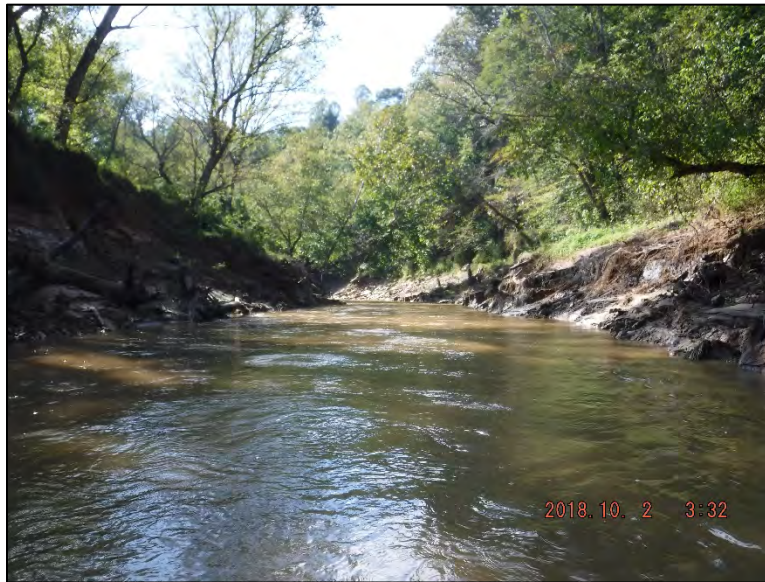
Photo 4-1

Description: View looking upstream from the center of Cross Section 4

Woody Debris: 3

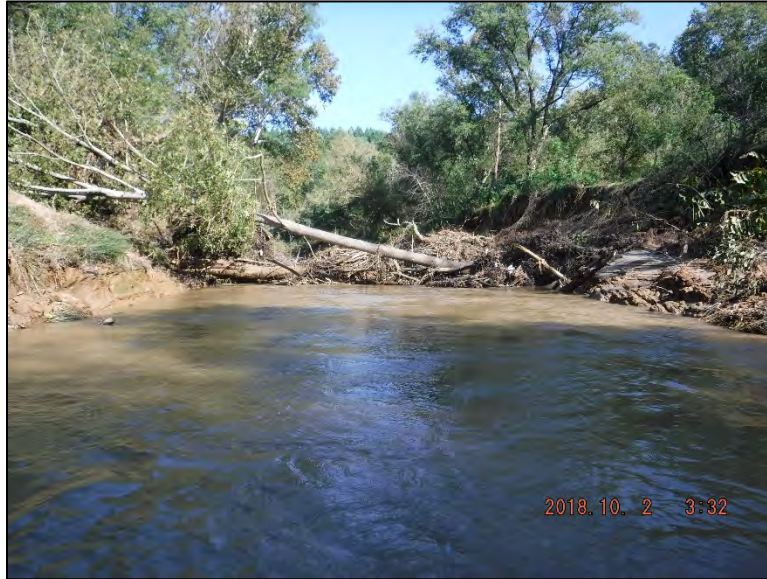
Photo 4-2

Description: View looking downstream from the middle of Cross Section 4

Woody Debris: 50

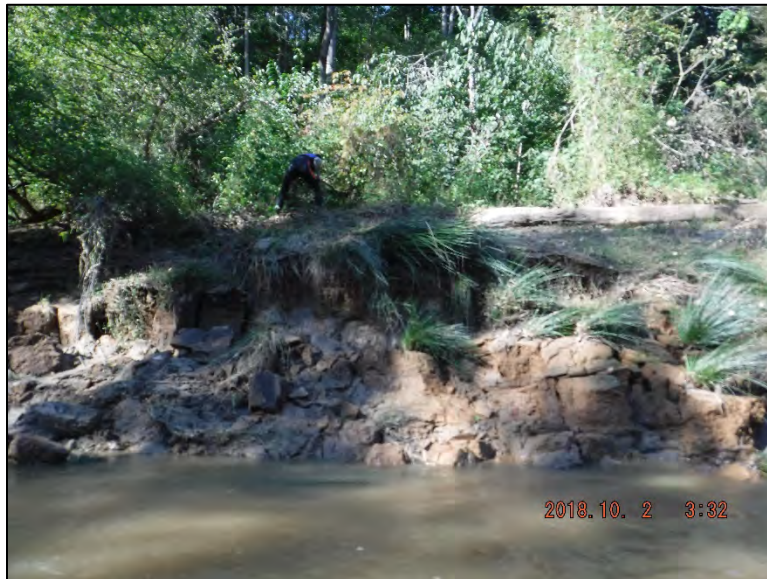
Photo 4-3

Description: View looking left from the middle of Cross Section 4

Vegetation: 40% herbaceous cover with some shrubs on the top of the bank

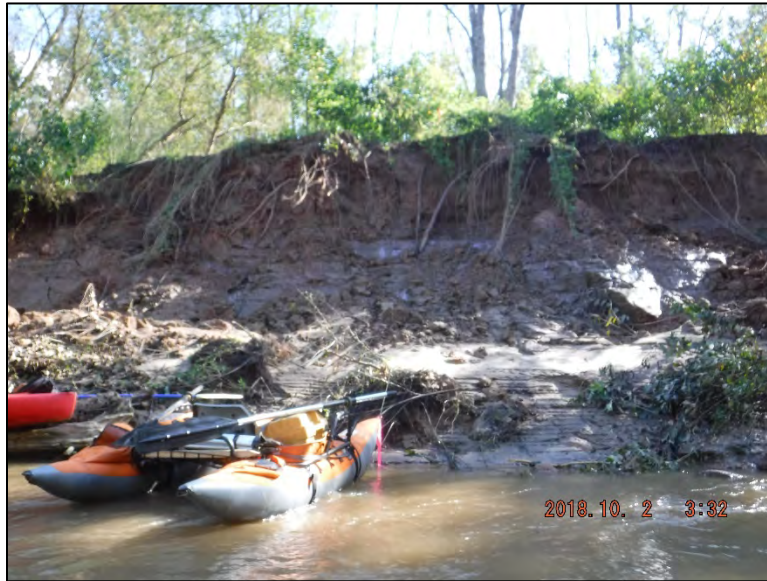
Photo 4-4

Description: View looking right from the middle of Cross Section 4

Vegetation: 5% herbaceous cover, small shrubs and a few trees at top of bank

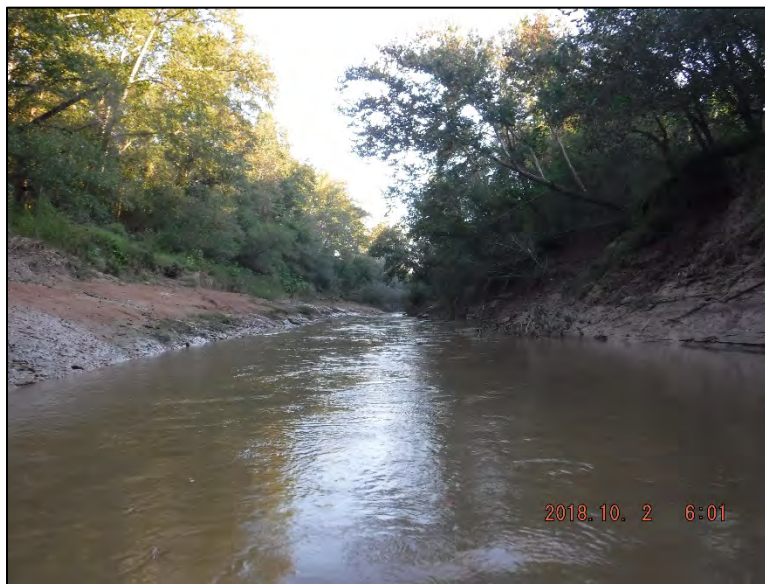
Photo 5-1

Description: View looking upstream from the center of Cross Section 5

Woody Debris: 1

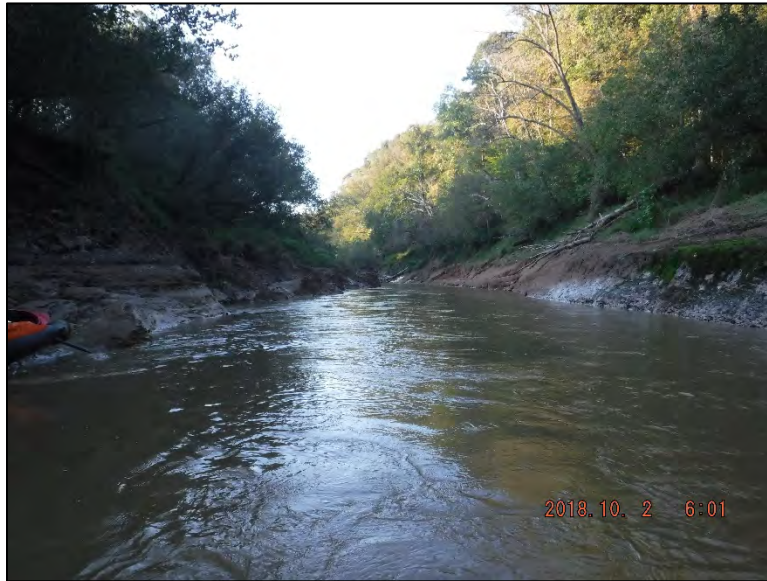
Photo 5-2

Description: View looking downstream from the middle of Cross Section 5

Woody Debris: 2

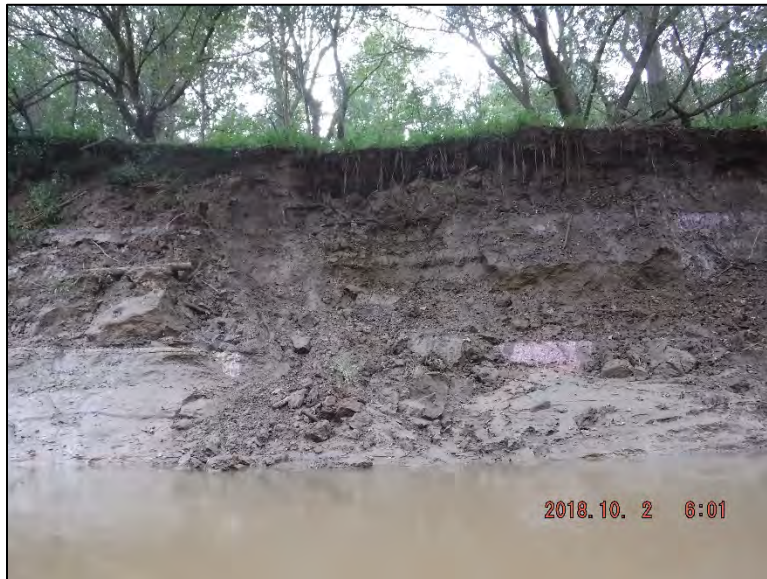
Photo 5-3

Description: View looking left from the middle of Cross Section 5

Vegetation: 2% herbaceous cover

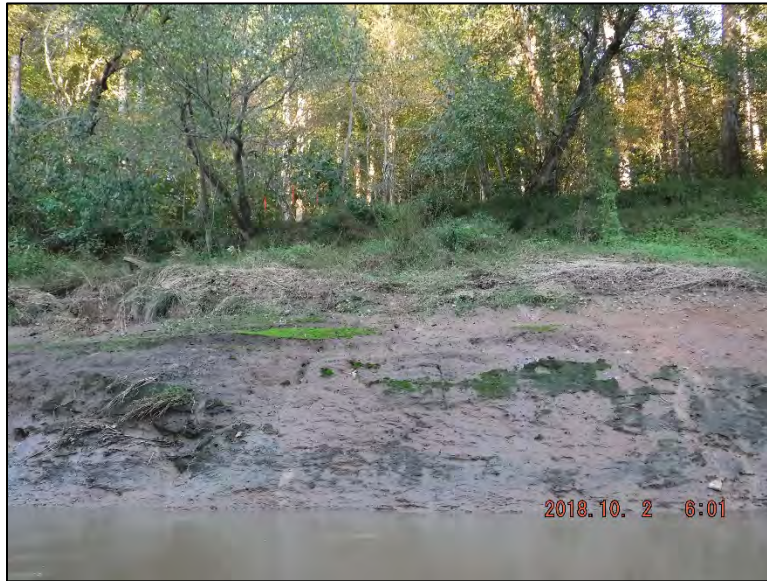
Photo 5-4

Description: View looking right from the middle of Cross Section 5

Vegetation: 25% herbaceous cover (mainly upper bank)

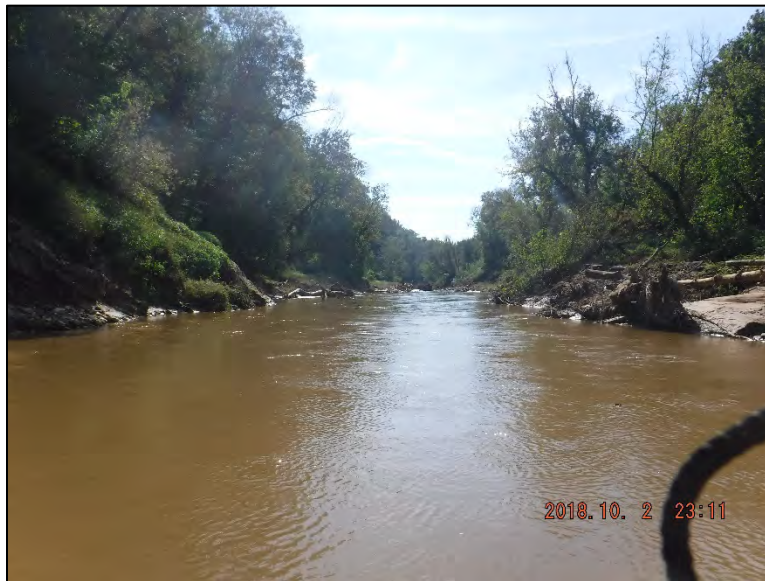
Photo 6-1

Description: View looking upstream from the center of Cross Section 6
Woody Debris: 5

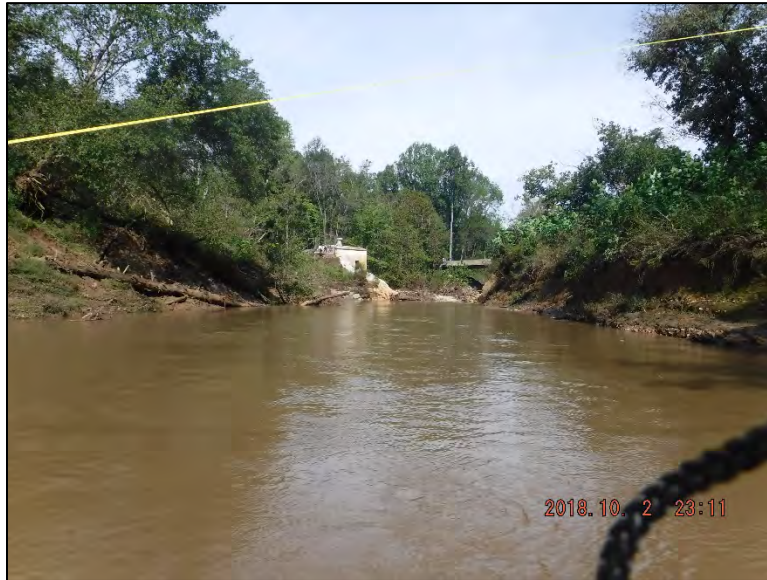
Photo 6-2

Description: View looking downstream from the middle of Cross Section 6

Woody Debris: 6

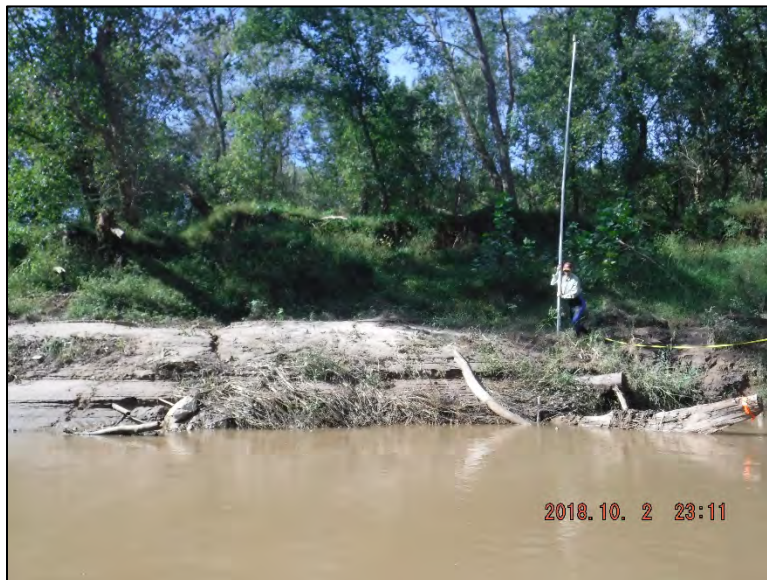
Photo 6-3

Vegetation: 75% herbaceous cover, large trees and shrubs at top of bank

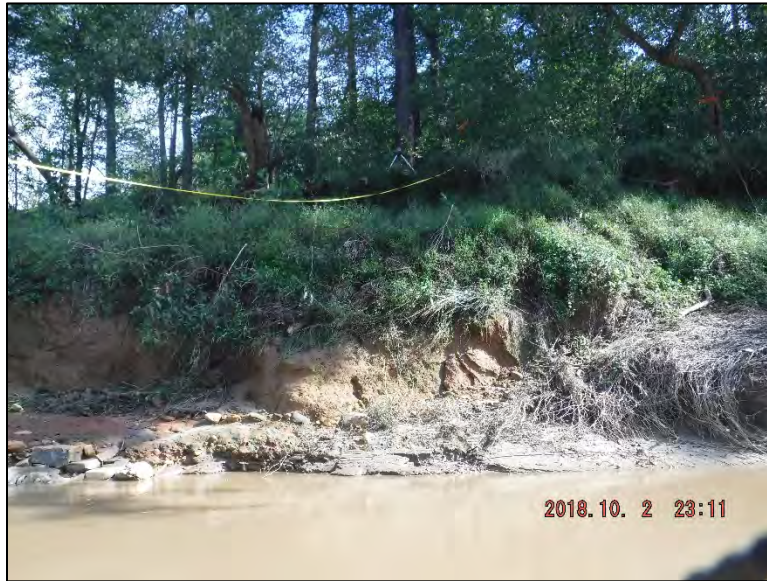
Photo 6-4

Vegetation: 75% herbaceous cover, large trees and shrubs at top of bank
