Pigg River Restoration at Power Dam

Year 3 Monitoring Report

DECEMBER 2019

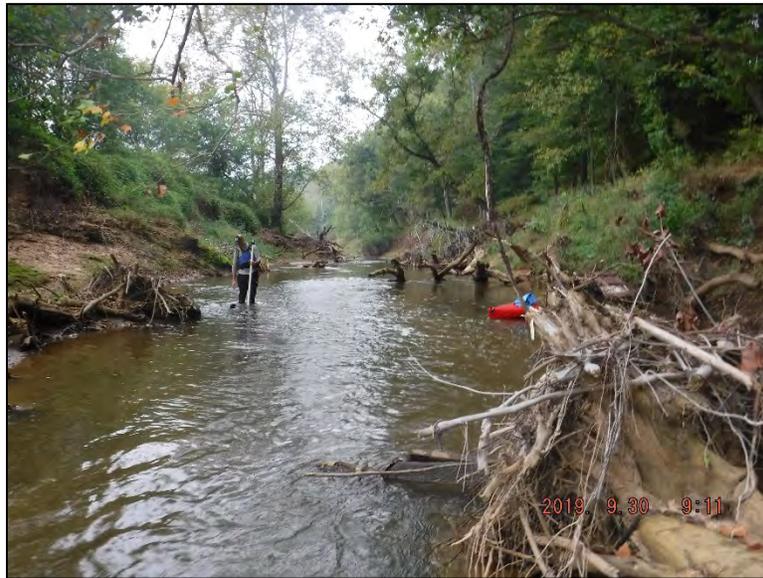
Photo 1-1

Woody Debris: 15

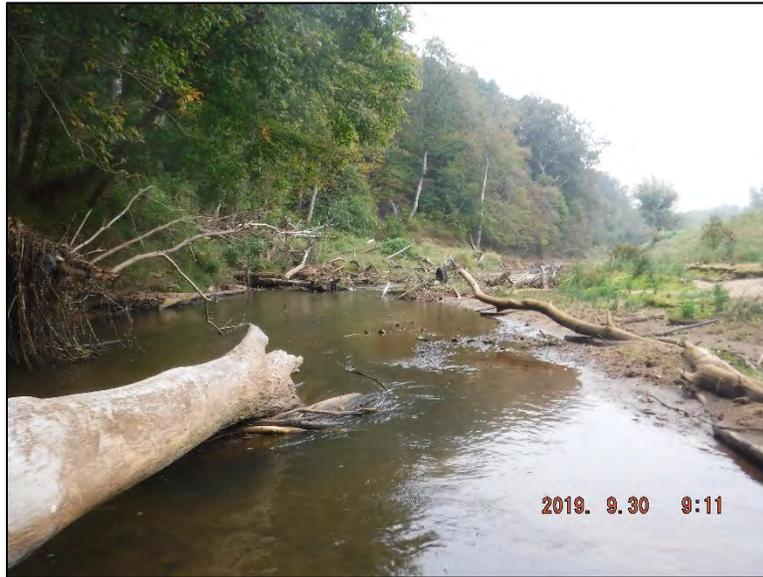
Photo 1-2

Woody Debris: 30

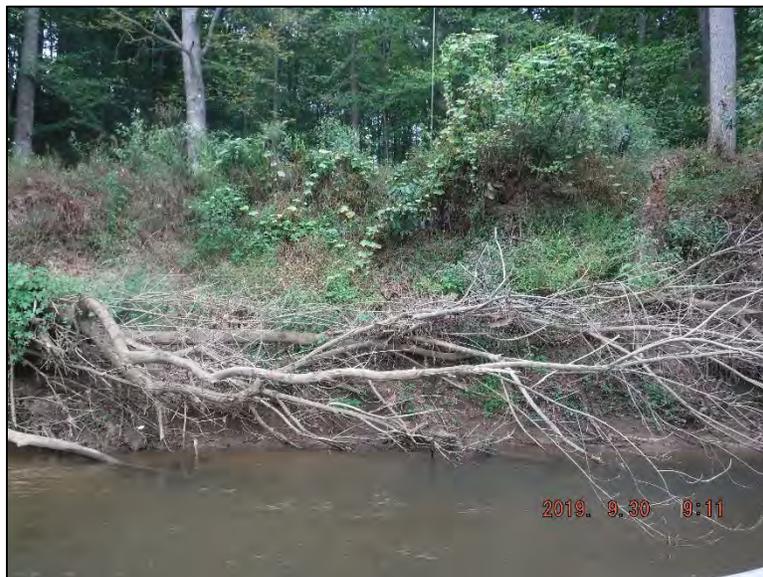
Photo 1-3

Vegetation: 60% herbaceous cover, few trees at top of bank, large woody debris present

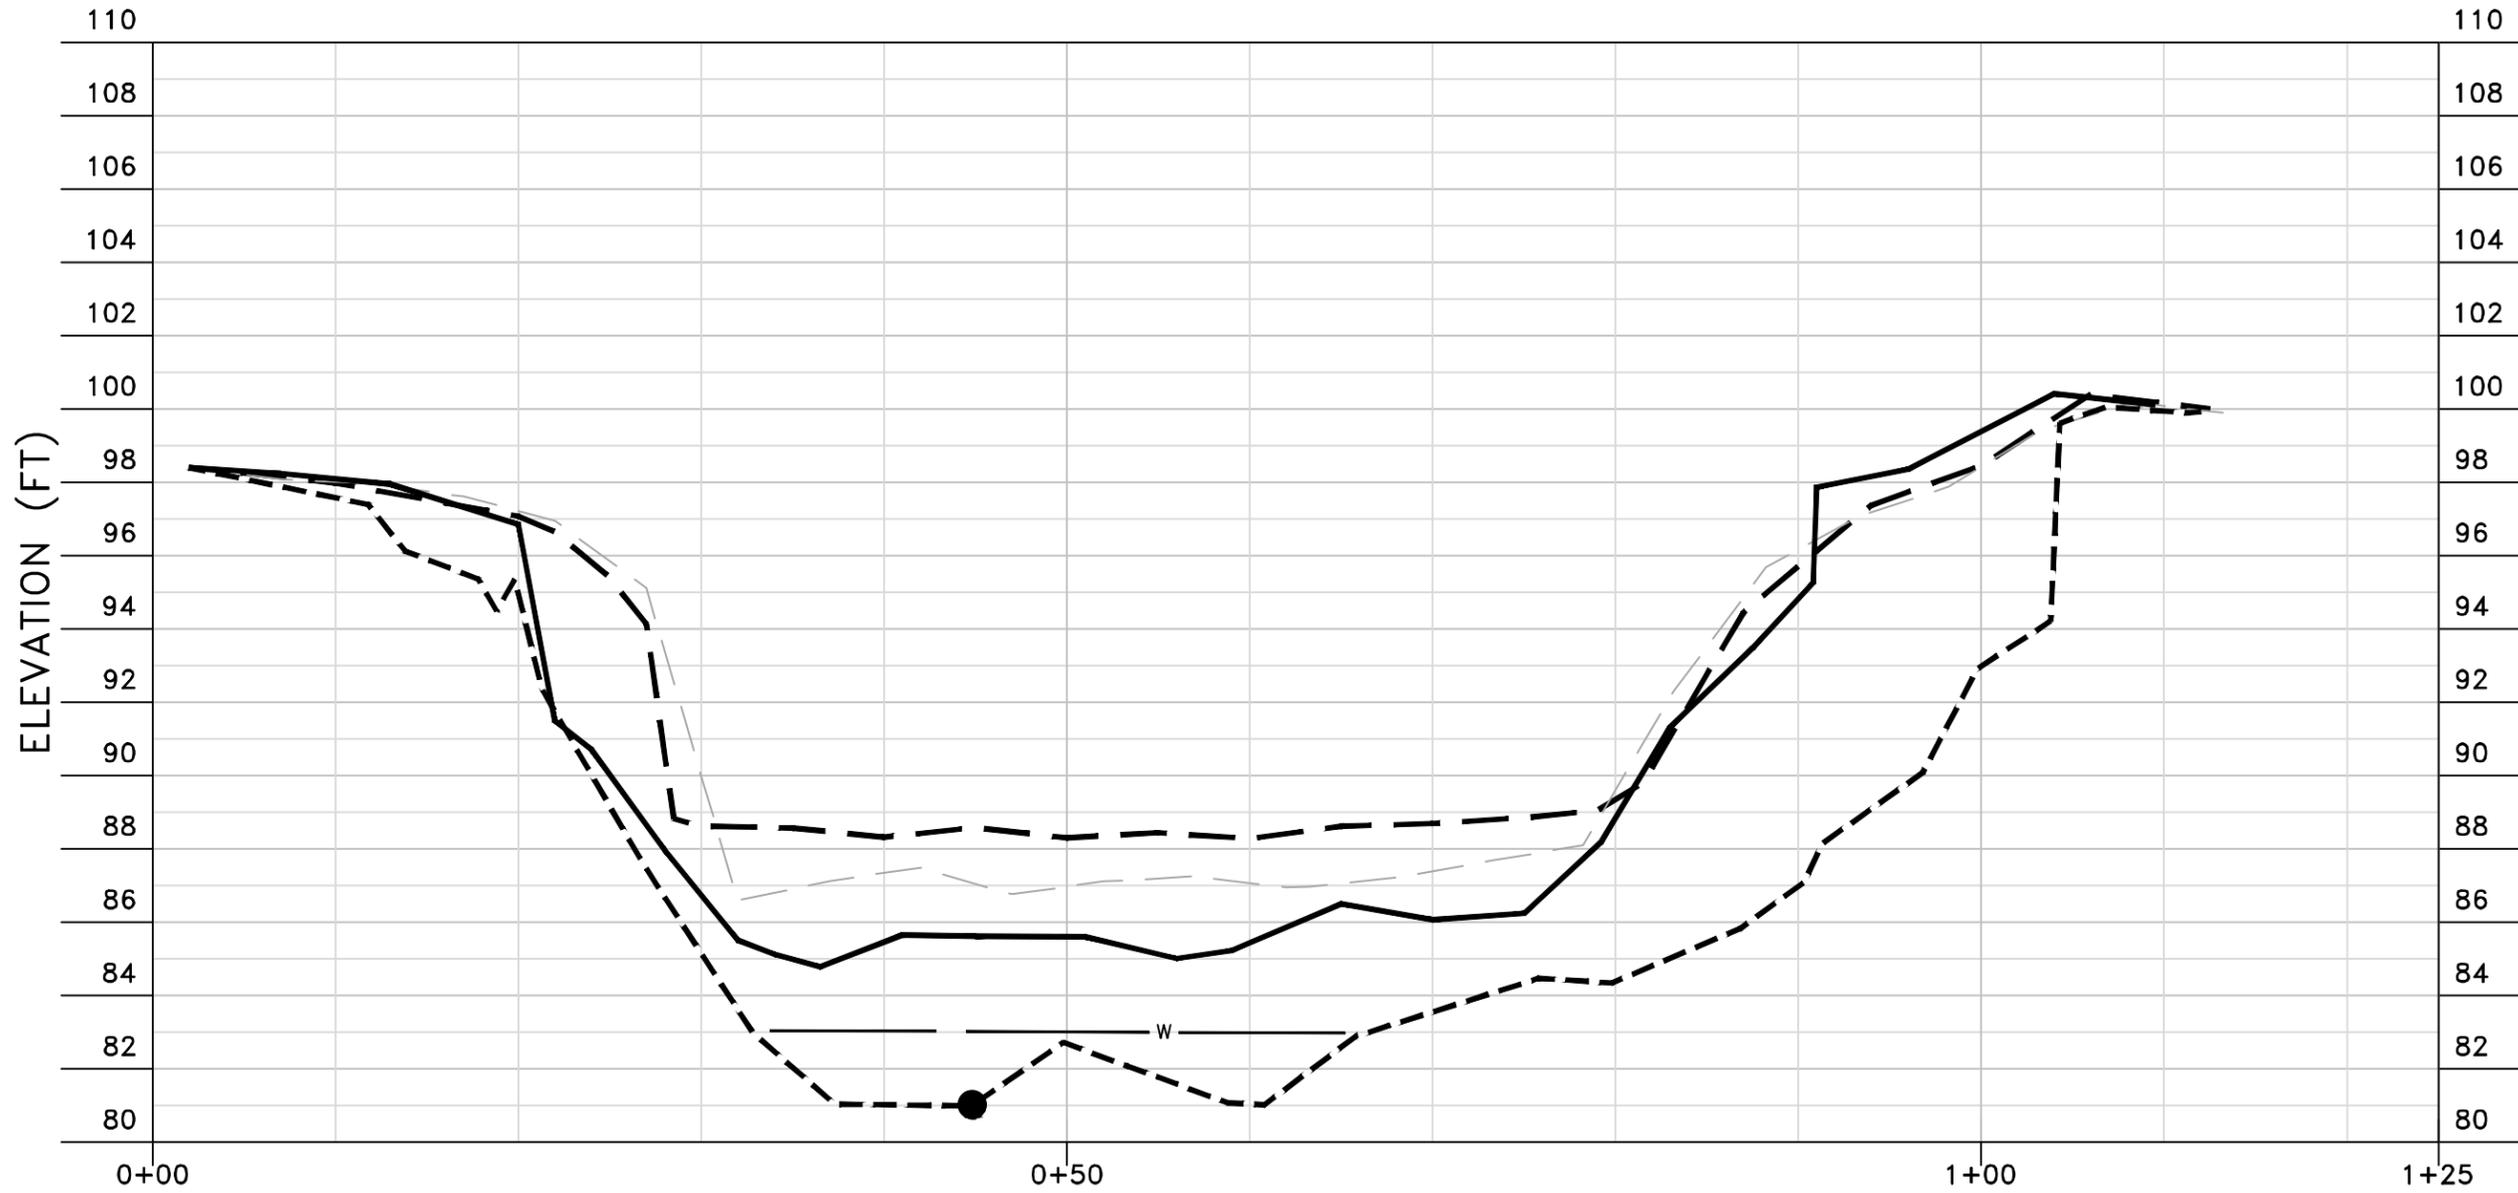
Copyright © 2019
Year 3 - XS 1

Year 3 monitoring cross section surveys indicate continued bed incision at Cross Section 1 and 2 (approximately 1.5-ft of drop in Cross Section 1 and 2.5-ft in Cross Section 2 in bed elevations since Year 2), likely driven by the storm events experienced throughout the year. Cross Section 3 saw such a dramatic bank failure neither end pin could be found. Resurvey at Cross Section 3 was precluded by a large debris jam. Basic field measurements were taken and indicate minimal further incision (bed rock outcroppings are now exposed), but channel widening of over 30 feet. Cross Sections 4 saw little change in bed incision but continued bank failure, especially on the left bank. Changes at Sections 5 and 6 were less dramatic since significant evolution occurred immediately following construction and these sections now approach the invert elevation of the dam remains. Upstream of the removed dam, there was a significant loss of bank vegetation and signs of consistent bank failure, even though rain events were less frequent than the previous year, based off precipitation data from NOAA dating from January to September for 2018 and 2019. 2018 showed a total of 55.78 inches and 2019 showed a total of 38.13 inches. Tension cracking and mass failure is visible at cross sections where steep banks still exist. Downstream of the removed dam the banks had sediment deposits, with these deposits burying most of the end pins on both banks. End pins at various cross sections downstream of the dam saw deposition ranging from 2 inches to 10 inches, confirming sediment transport in overbank events since Year 2 monitoring.

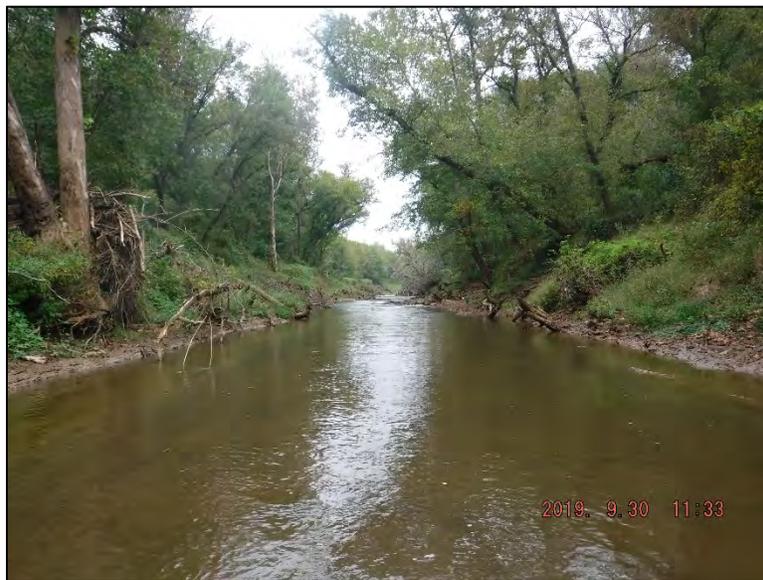
Photo 2-1

Woody Debris: 25

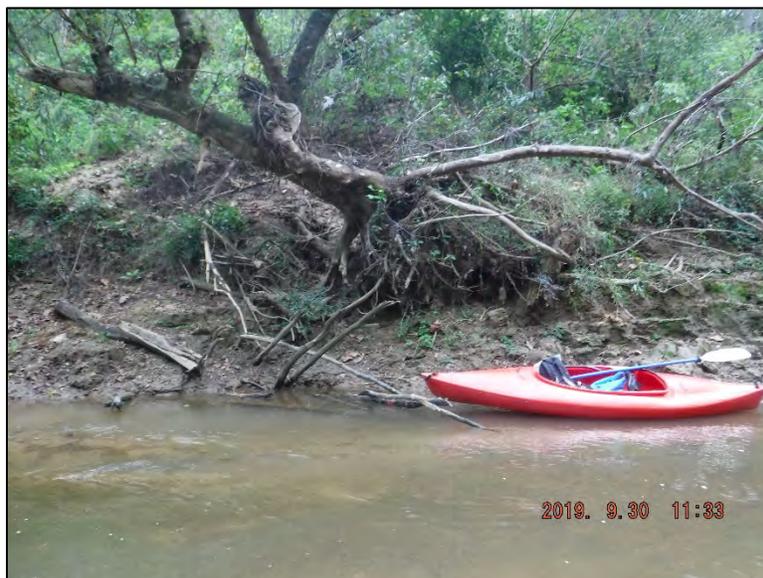
Photo 2-3

Description: View looking left from the middle of Cross Section 2
Vegetation: 40% herbaceous cover, few trees, woody debris

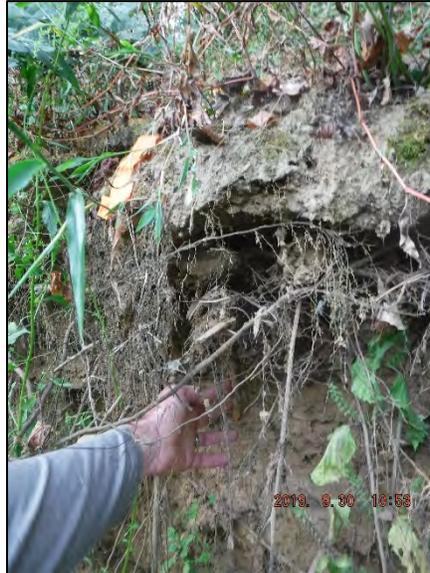
Photo 2-7

Description: Photo of the end pin right on the edge of bank erosion before it was moved.

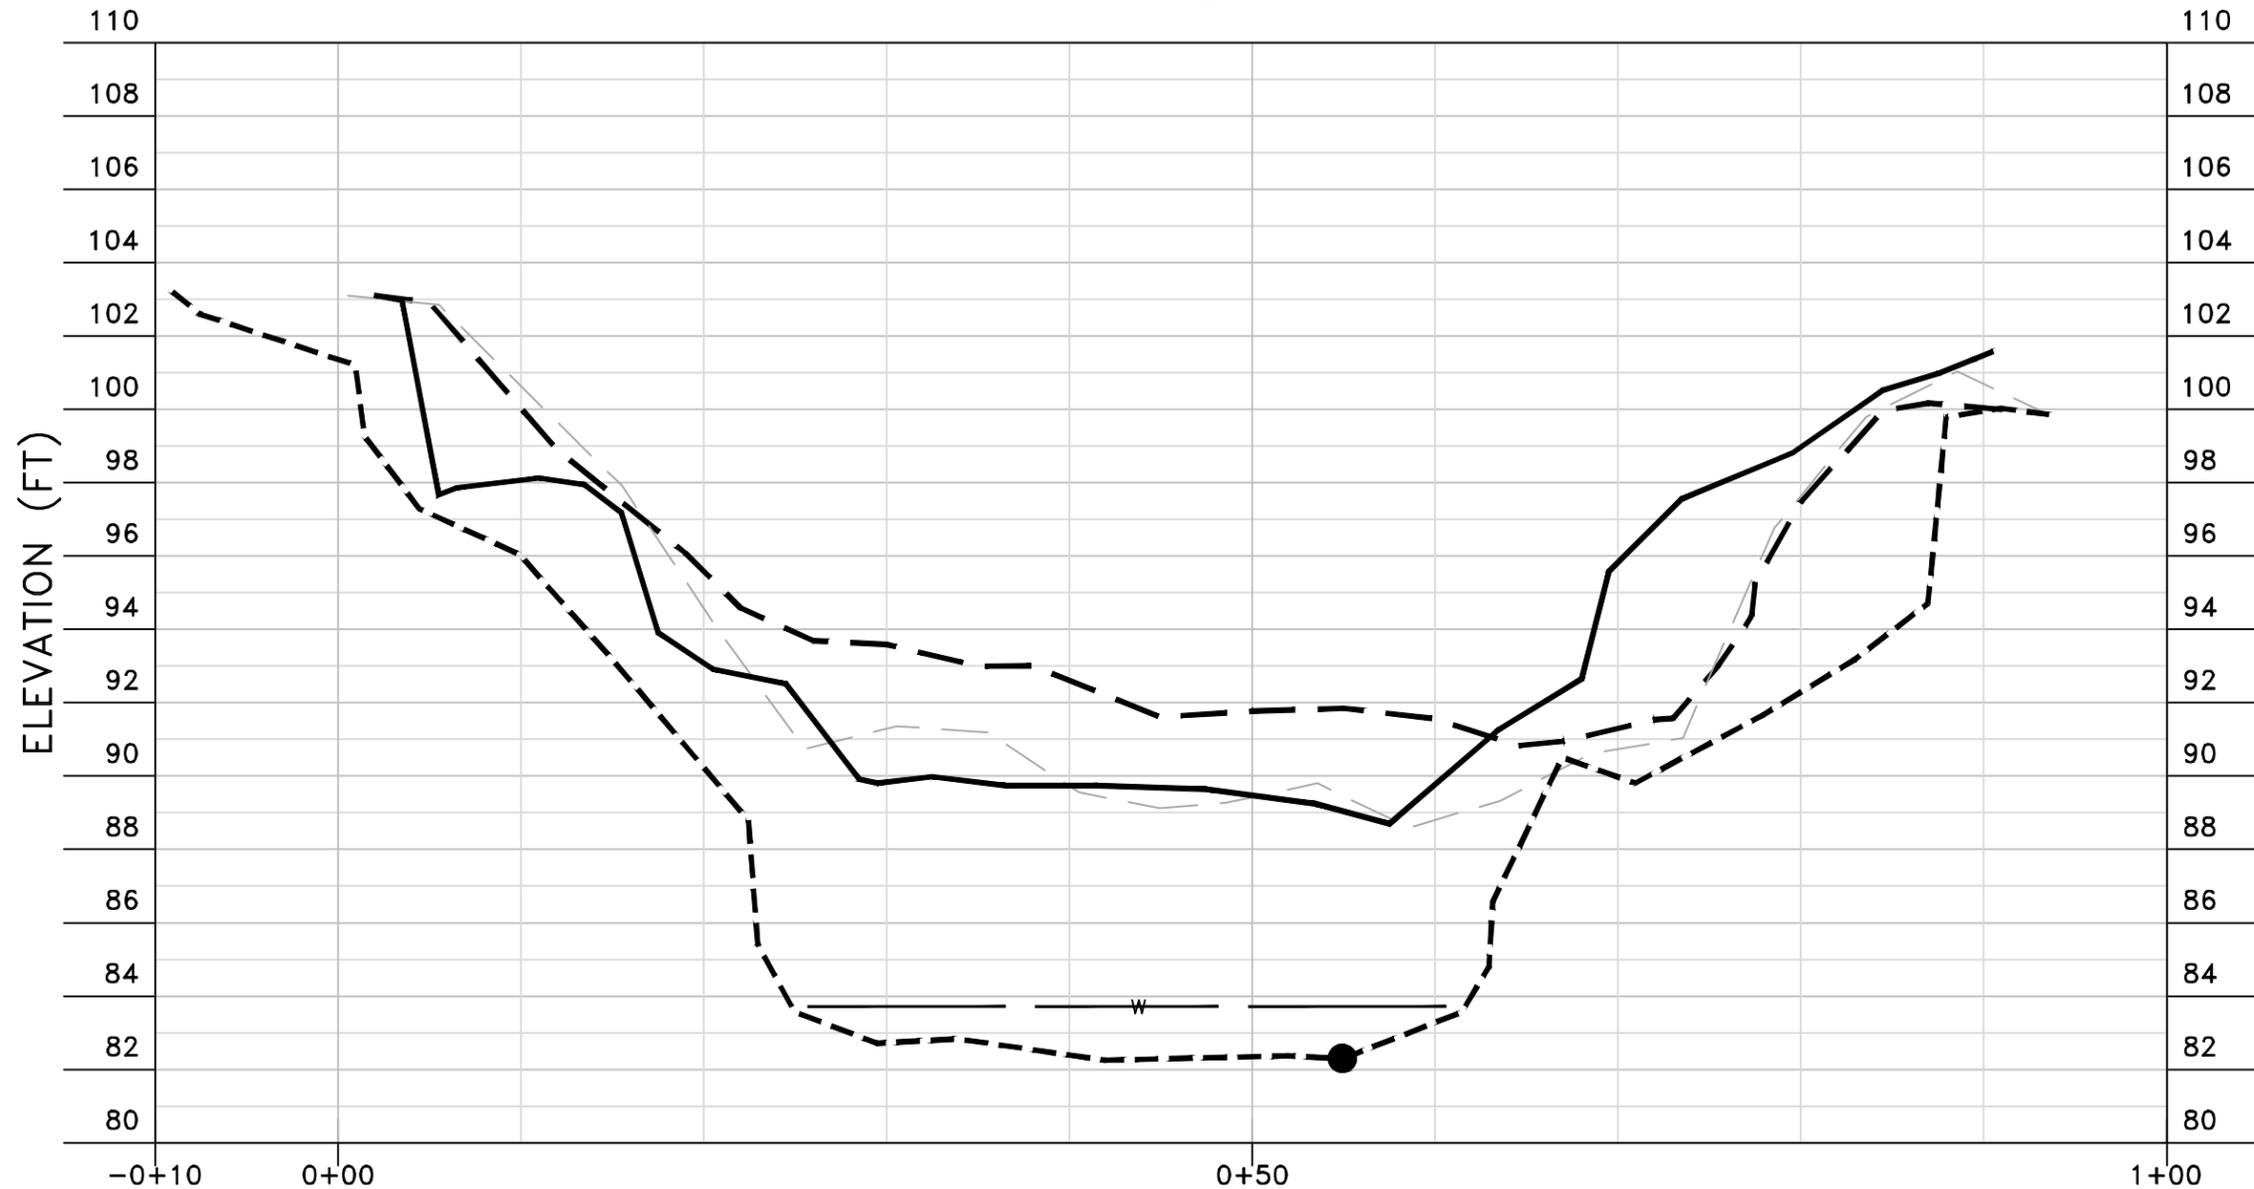
Year 3 - XS 2
Copyright © 2019

The instrument setup for this Cross Section was measured from left bank (HI = 4.93 ft.). The Cross Section plot and thalweg profile are shown below. No pebble count was taken at this location due the uniform fine-grained (sandy) nature of bed sediments but 10% of bed contained 3-10mm gravel. The left bank end pin was not found and was assumed to be washed away. The right bank pin was moved six feet back (the pin was moved after measurements were taken), due to it being right on the edge of the eroding bank. Year 3 showed increased bed incision and bank failure.

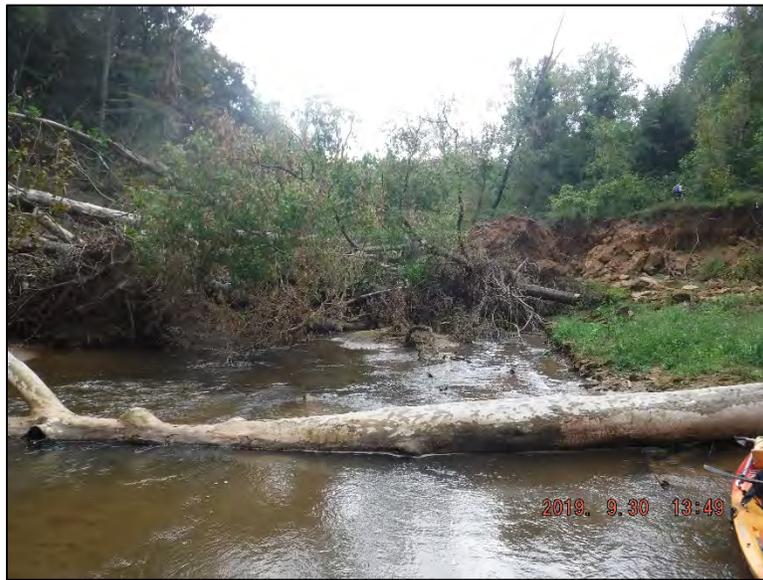
Photo 3-1

Woody Debris: >100

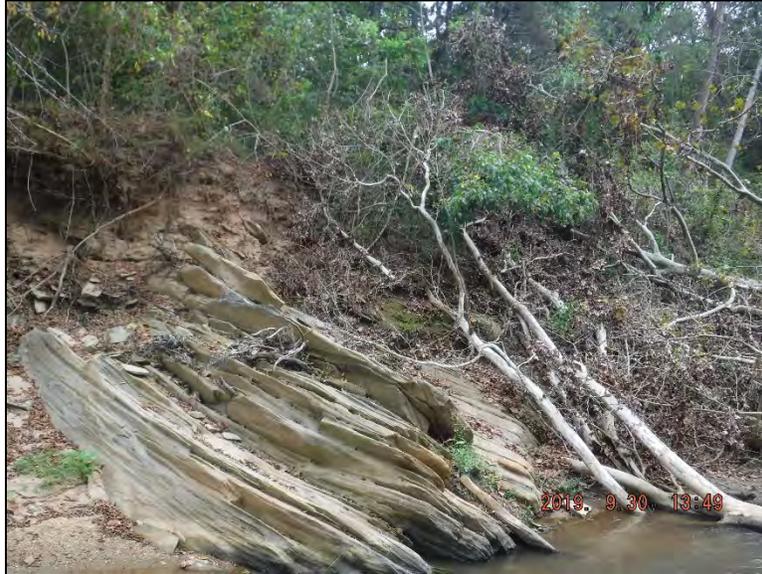
Photo 3-4

Vegetation: 10% herbaceous cover, a few trees at top of bank, exposed bedrock and woody debris

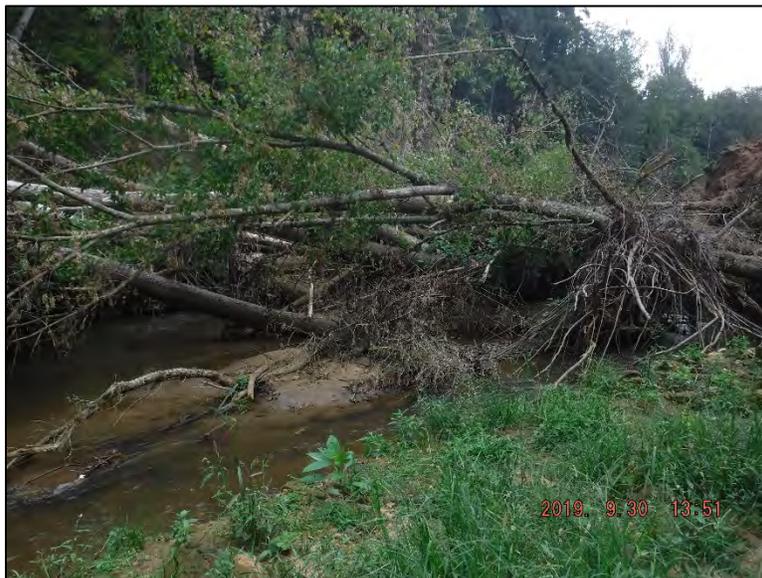
Photo 3-5

Description: View looking from left bank at the large debris pile at Cross Section #3
