SCIENCE IN SERVICE OF WILDLIFE AND WILDLANDS

## MEMORANDUM

RE: Jordan River Bird Refuge RSRA Training Event & Stream Condition Results

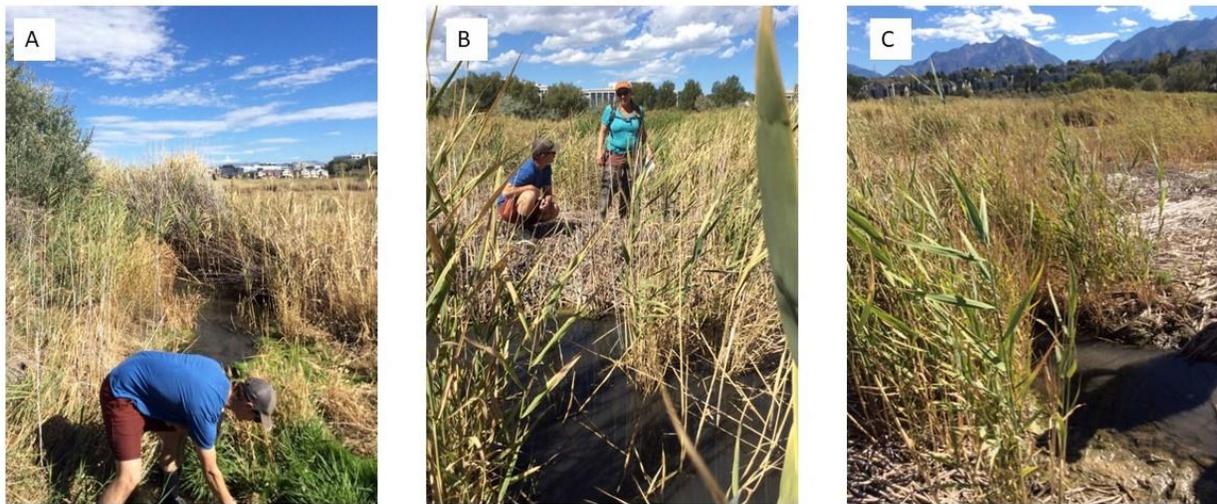
The RSRA survey results for Willow Creek (9/20/2022) are summarized in Table 1. Briefly, the overall score for Willow Creek was 3.0. Two indicators (Cobble embeddedness and diversity of aquatic invertebrates) were not measured because the stream channel was dominated by silt, and there were no cobbles present to measure or observe invertebrates. The water quality score was 4.5 out of 5 because the channel was heavily shaded and there was little to no filamentous algae present. Notably, the channel was shaded by invasive *Phragmites australis* (i.e. Phragmites or Common Reed). The hydro-geomorphology score was 3.6 out of 5, and the lowest indicators within this category were floodplain connection (the channel was incised relative to the floodplain) and hydraulic habitat diversity. The Fish & aquatic habitat score was 2.25 out of 5 due to an absence of riffle-pool distributions, low under-bank cover, and lack of large woody debris. The riparian vegetation score was 2.85, owing to low or no different life stages of native shrubs and trees, and a high percentage of non-native herbaceous plant cover (Phragmites). Finally, the Terrestrial Wildlife Habitat score was 2 out of 5 due to absence of shrubs, mid-canopy, and upper canopy woody vegetation.

It is worth noting that this scoring system is set relative to a multi-level riparian forest canopy, similar to what would be expected along the Jordan River. The Jordan River Bird Refuge site is currently a wet meadow stream complex dominated by invasive Phragmites and does have some beaver activity. This site likely historically represented a mix of wet meadow and cottonwood- willow forest patches. While the scoring in Table 1 represents the idealized Riparian Forest, the individual components provide useful information about the status of the stream-riparian area regardless. Site photos for representative points at Willow Creek demonstrate the relative lack of woody vegetation and domination of the herbaceous layer by Phragmites (Figures 1-2). Survey participants did observe a patch of Alkalai Bulrush (*Bolboschoenus maritimus*), not pictured.

Figure 1. (Above) Photos of the three representative sites for the 9/20/2022 RSRA survey of Willow Creek.

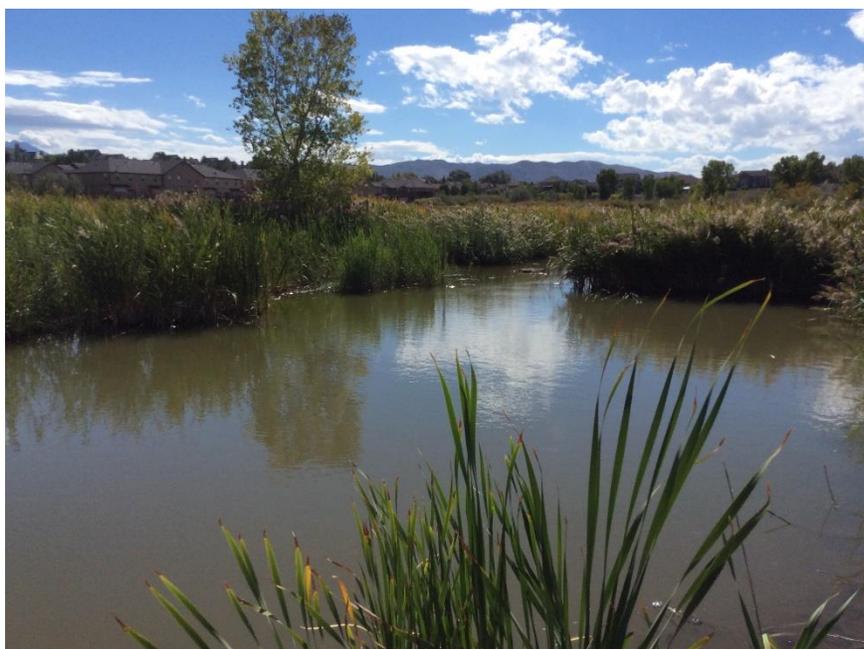
Figure 2. Photo of the bottom of the Willow Creek transect, looking southward across a large beaver complex dominating flow of Willow Creek.

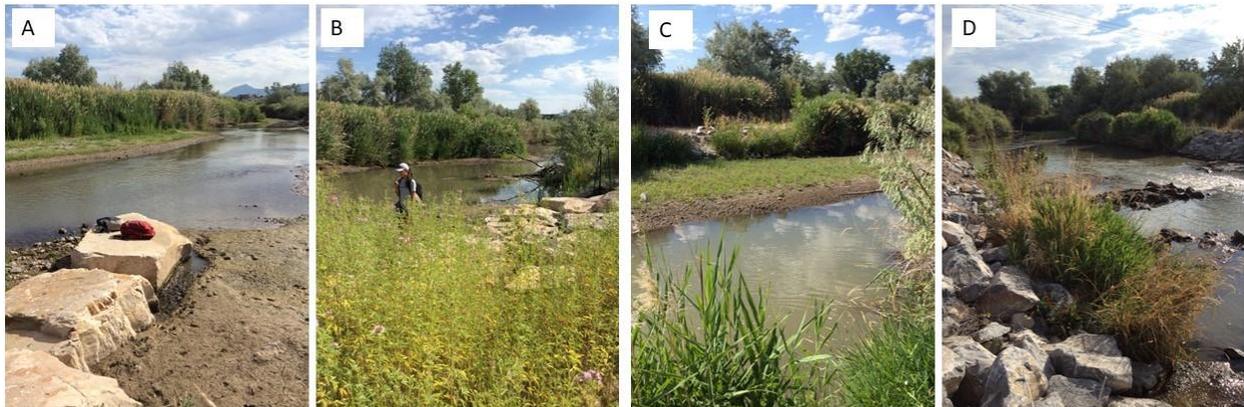
The partial Big Bend survey was conducted on July 8, 2021. Results are summarized in Table 2, and site photos are shown in Figure 3. As seen in the table, several indicators are missing, but each of the 5 categories are represented by existing measurements to some degree. The water quality indicator score had low points due to the lack of channel shading (2 out of 5 pts). The Hydro-geomorphology score was 3.25 with a notable lack of beaver activity and extremely incised banks. The Fish & Aquatic Habitat score was 3.5, averaged from two indicators (cobble embeddedness and aquatic invertebrate diversity). The Riparian Vegetation score (2.5 out of 5) lost points due to the dominance of non-native herbaceous and woody vegetation. The Terrestrial Vegetation score was 2.75 with points lost for low density of upper canopy trees. Over time, restoration activities including structural additions to the channel and re-vegetating the riparian zone will likely improve the overall habitat and RSRA score of this site.

Figure 3. Photos of representative sites 1,2, and 3 (A, B, C respectively) as well as the upstream extent of the survey reach (D). Panel D provides perspective on the degree of channel entrenchment relative to the historic floodplain. Riprap stabilizing the bank is part of ongoing restoration activities. Russian Olive and large patches of *Phragmites* dominate the riparian plant community, although some cottonwood, willow and native herbaceous plants are present as well.
