Baseline Documentation Report

LORDSTOWN ENERGY CENTER PROPERTY

The Village of Lordstown, Trumbull County, Ohio

Report Prepared By: George Warnock Date of Site Visit: January 30, 2016

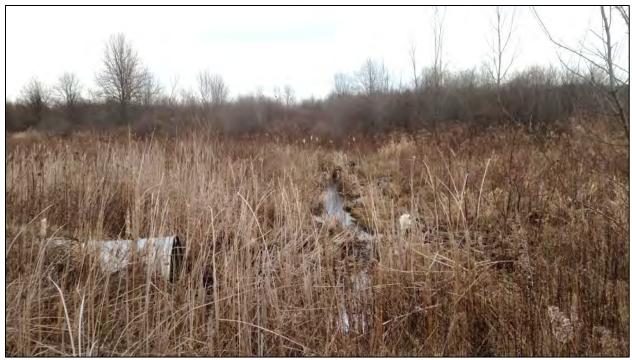
4. Looking northeast along a north flowing drainage ditch near the southwestern corner of the western portion of the Protected Property. Note the culvert on the left side of the photo coming from the adjacent property to the west.

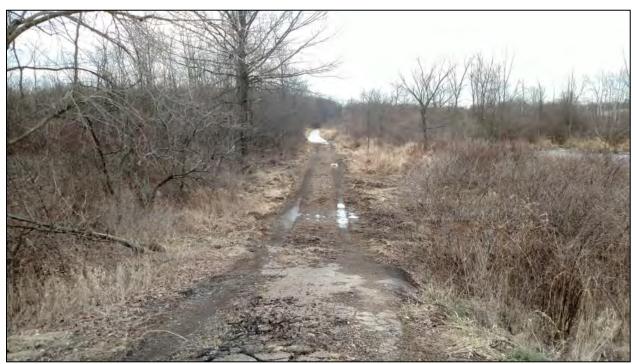
Approximately 0.6 acres of the Protected Property contain an oil/gas access road and two clearings; one for an oil/gas tank battery and one for an oil/gas well head (See Appendix C: Existing Conditions Map). On the western portion of the Protected Property, the oil/gas access road starts at the western boundary in the parking lot for Magna Seating Systems at 1702 Henn Pkwy, Warren, OH 44481 and travels east to the oil/gas tank battery clearing. On the eastern portion of the Protected Property the oil/gas access road starts along the western boundary to the east of the oil/gas tank battery and travels generally east southeast and ends at the oil/gas well head clearing (Photo Points 33 & 34). Most of the oil/gas access road is in fair condition, through a part of the access road on the western portion of the Protected Property was recently spread with gravel (Photo Point 7).

7. Looking east along an oil/gas access road from the western boundary on the western portion of the Protected Property. Note the recently spread gravel on the access road in the center of the photo.

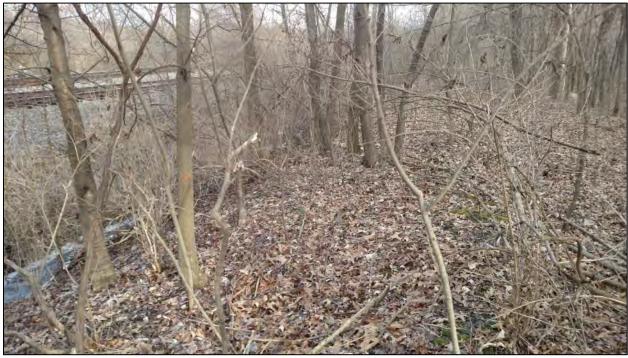
11. Looking east northeast along the berm along the northern boundary of the western portion of the Protected Property. Note the drainage ditch separating the berm from the railroad siding for the Norfolk and Southern Railroad which runs along the northern boundary.

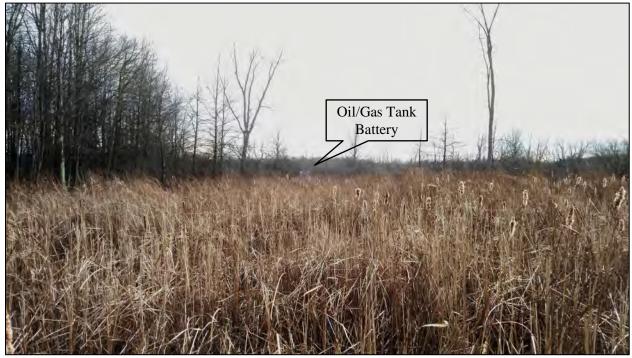
- An oil/gas storage tank battery was observed during the property visit and is located along the eastern boundary of the western portion of the Protected Property (Photo Point 13). An oil/gas access road leads east from the adjacent property to the west and provides access to the oil/gas storage tank battery (Photo Point 7).
- An oil/gas well head was observed during the property visit and is located in the southcentral part of the eastern portion of the Protected Property (Photo Point 33). An oil/gas access road leads east from

13. Looking south at the cattail wetland in the central part of the western portion of the Protected Property. Note the light blue oil/gas tank battery in the center of the photo.

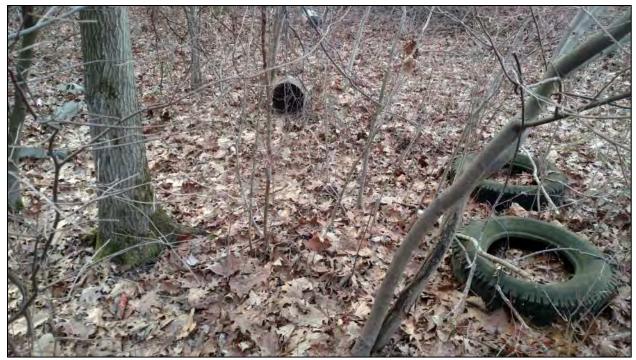
• Several piles of old junk items including tires, car parts, bottles, and cans were found along the northern property boundary and south of the Norfolk and Southern Railroad tracks (Photo Point 16).

16. Looking west at a trash pile along the northern boundary from the northeastern corner of the western portion of the Protected Property. Note the trash consists of tires, car parts, bottles and cans.

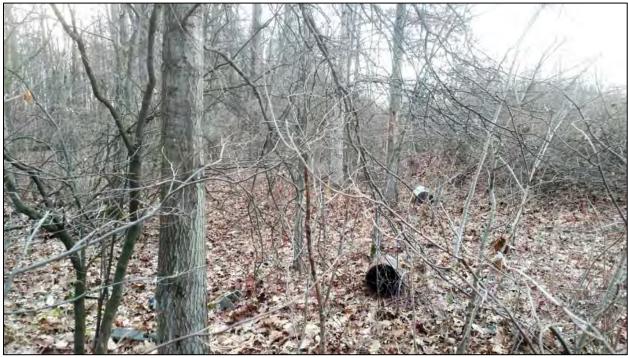
17. Looking west along the northern boundary from the northeastern corner of the western portion of the Protected Property. Note the pile of trash consisting of tires, car parts, bottles and cans.

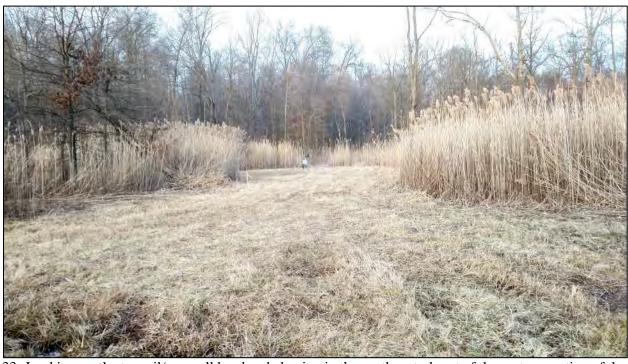
33. Looking north at an oil/gas well head and clearing in the southcentral part of the eastern portion of the Protected Property. Note the phragmites surrounding the oil/gas well head clearing.

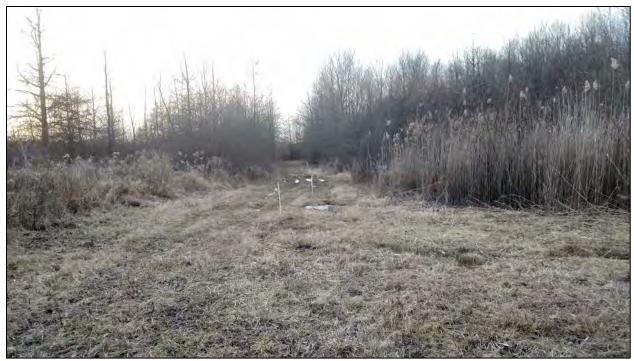
34. Looking west northwest along an oil/gas access road in the southcentral part of the eastern portion of the Protected Property. Note the phragmites.
