EMERGENCY RESTORATION PLAN AND ENVIRONMENTAL ASSESSMENT

**Pago Pago Harbor
American Samoa**

September 1, 1999

Prepared By:
The Government of American Samoa,
The U.S. Department of the Interior, and
The National Oceanic and Atmospheric Administration

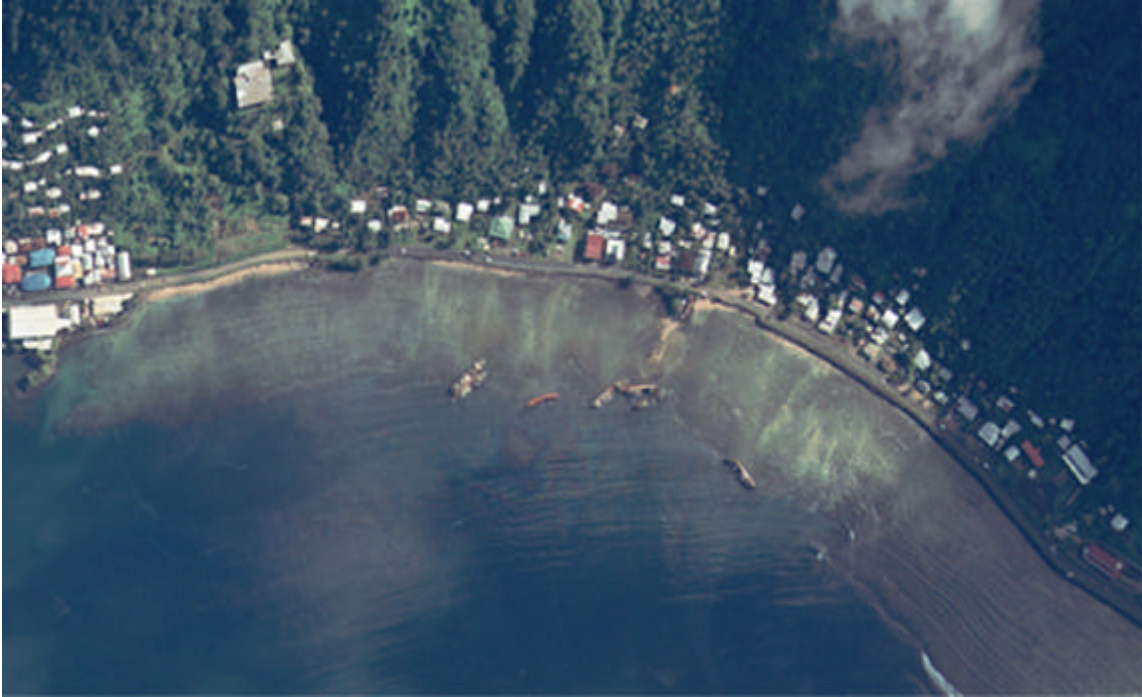
The locations and general condition of the grounded vessels within Pago Pago Harbor are shown in Exhibits 2, 3, 4, 5 and 6. Exhibits 3 and 4 are images from aerial photographs taken in 1994. Exhibit 3 shows the seven vessels grounded in the inner harbor, near the village of Leloalua. Although the photograph indicates that all seven vessels are stranded on the reef flat, field observations confirm that vessel 3 (the reddish brown vessel third from the left) has broken up and/or edged off the reef flat into deeper water since this photograph was taken.⁴ Exhibit 4 shows the two vessels stranded in the outer harbor, approximately one-mile southeast of the seven inner harbor vessels.

EXHIBIT 3. Aerial Photograph of Seven Inner Harbor Vessels (taken in 1994). The seven vessel total includes two resting against each other at the left end of the vessel distribution (vessels 1 and 2), the reddish/brown vessel (vessel 3) which has since broken up/sunk, three vessels clustered near the end of the Leloaaloa causeway (vessels 4, 5, 6) and vessel 7 (sitting almost parallel to the shoreline)

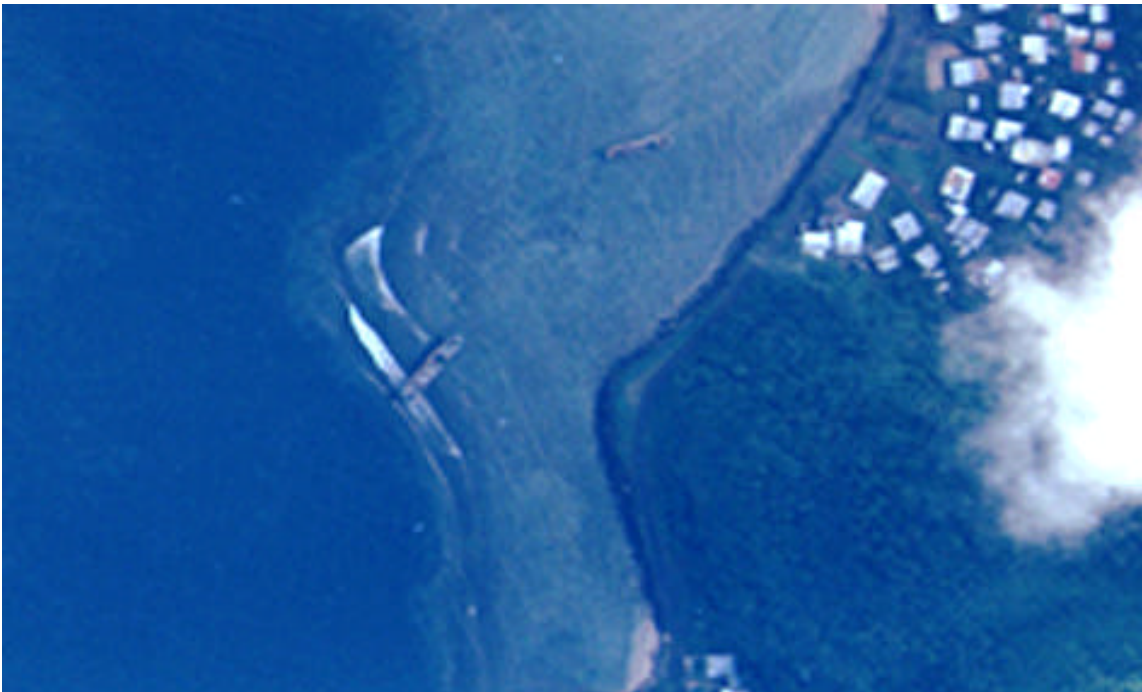
EXHIBIT 4. Aerial Photograph of Two Outer Harbor Vessels (taken in 1994). Vessel 8 is sitting near the middle of the reef flat. The village to the immediate right of this vessel is Aua. Vessel 9 is sitting on the reef crest, near the breaking waves.

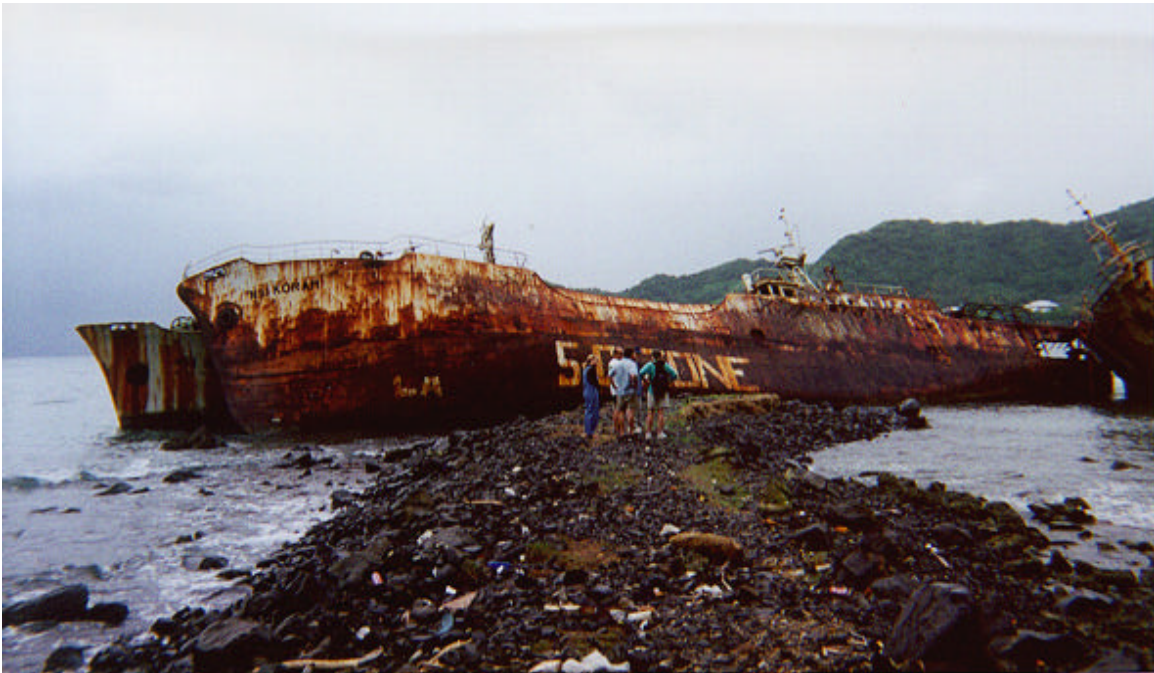
Exhibits 5 and 6 are June 1999, photographs taken of the cluster of vessels stranded near the causeway at Leloalua (Exhibit 5) and Aua (Exhibit 6). These images show the size and current condition of the stranded vessels. Overall, the nine vessels range between 125 and 160 feet in length and 25 to 30 feet in width. The two outer harbor vessels are in the best condition, although they have experienced substantial deterioration since grounding in 1991.

EXHIBIT 5. Vessels 4, 5 and 6 (at Leloaloe Causeway) (taken in 1994). The middle of the three vessels (vessel number 5) is featured prominently in the center of the photograph. A portion of vessel number 4 is visible at the right edge of the photograph. The bow of vessel number 6 is visible at the left edge of the photograph.

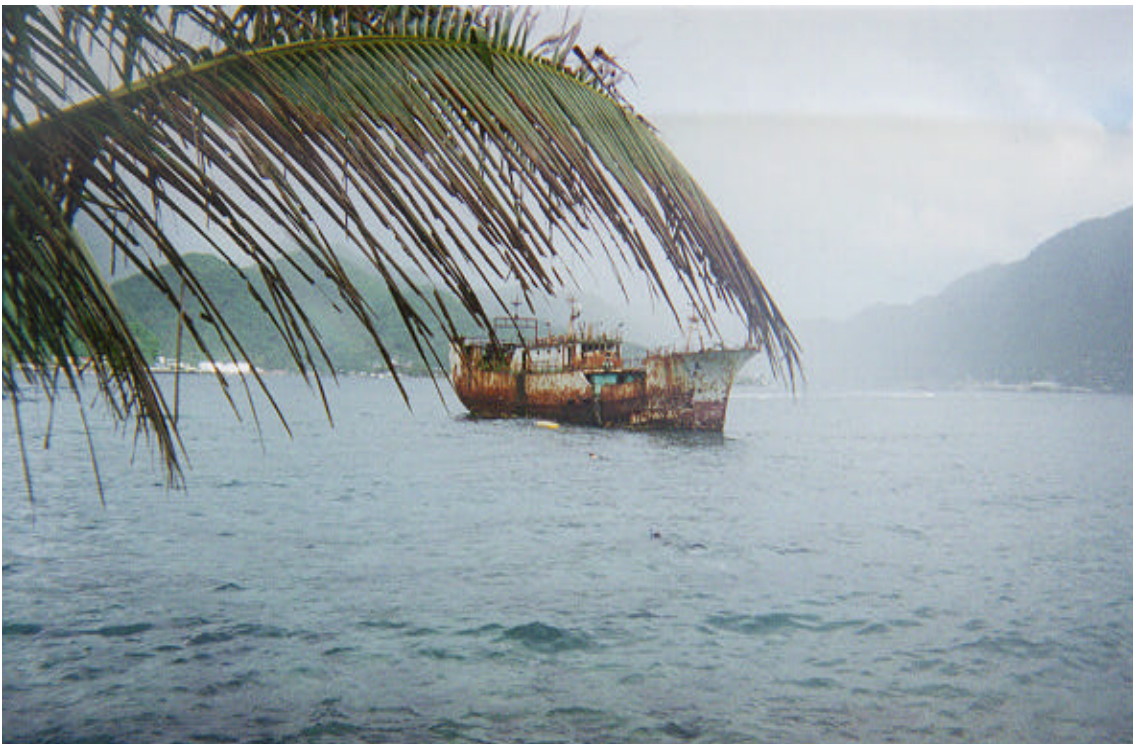
EXHIBIT 6. Vessel 8 (taken in June 1999), from the shoreline in Aua.
