Cullinan Ranch Restoration Project

Monitoring Report 2019

April 22, 2020

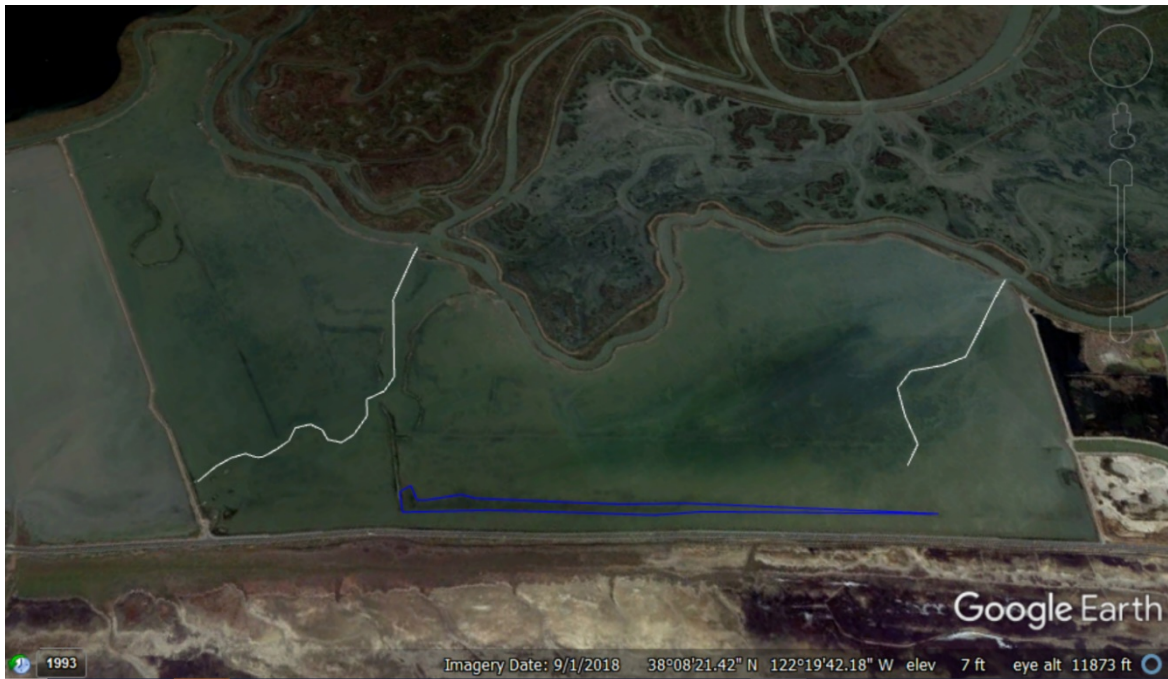
Review of aerial imagery from Google Earth 2014–2018 (Attachment I) shows that tidal wetland plant cover is still only approximately 1% of the restored site. There is no readily available or free aerial imagery for 2019, however ground based observations of habitat evolution were consistent with 2018. Tidal wetland vegetation is colonizing the lowered levees along Dutchman Slough, several mounds and small islands, and the transition ramp along Highway 37, but not yet within most of the main acreage of the interior of the site. Since tidal wetland plant cover is less than the 20% threshold, vegetation assessment has not yet begun.

Figure 3. Aerial imagery shows a band of vegetation (blue polygon) beginning to establish approximately 80 meters north of State Route 37 and historic/evolving channel networks (white lines).

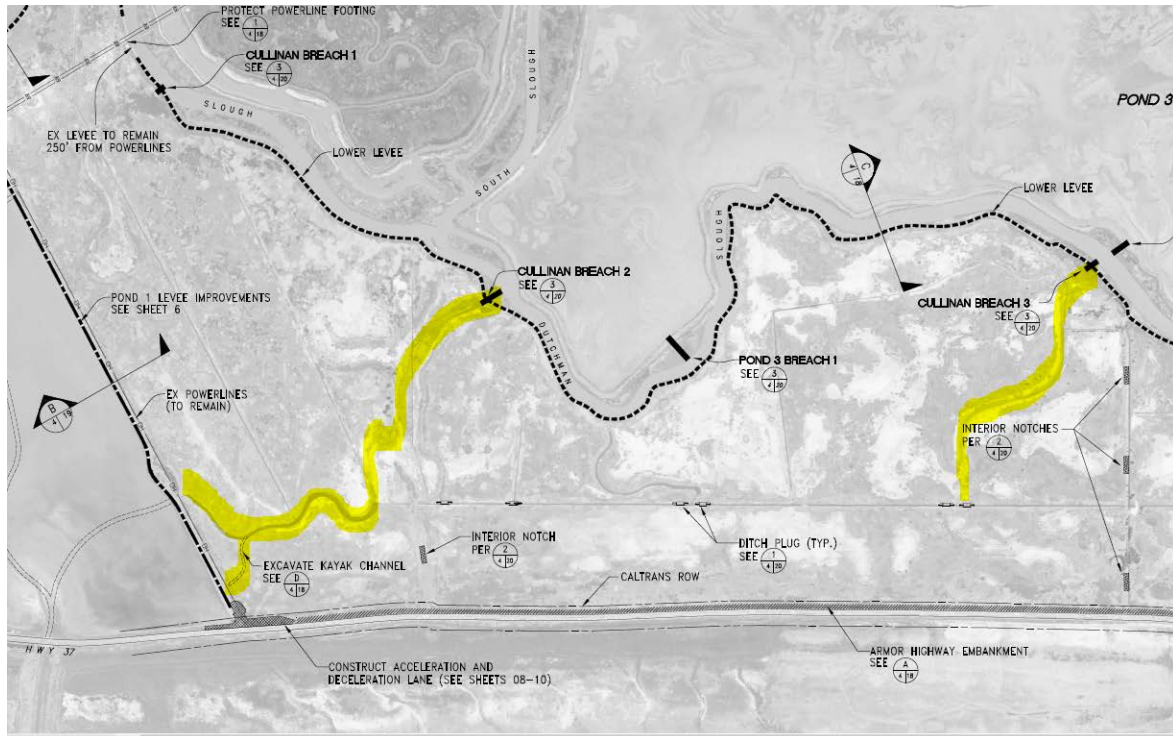
Aerial imagery and erosion pins were used to monitor development of tidal channels at the site. Review of aerial imagery (Attachment I) indicates that channel networks are not yet detectable for most of the interior of the site because it is inundated at both high and low tides; however, the historic channel that was excavated to connect to the kayak launch is visible (Figure 4).

Figure 4. Project design showing remnant historic channels and excavated tie in for kayak launch, re-connected to Dutchman Slough.

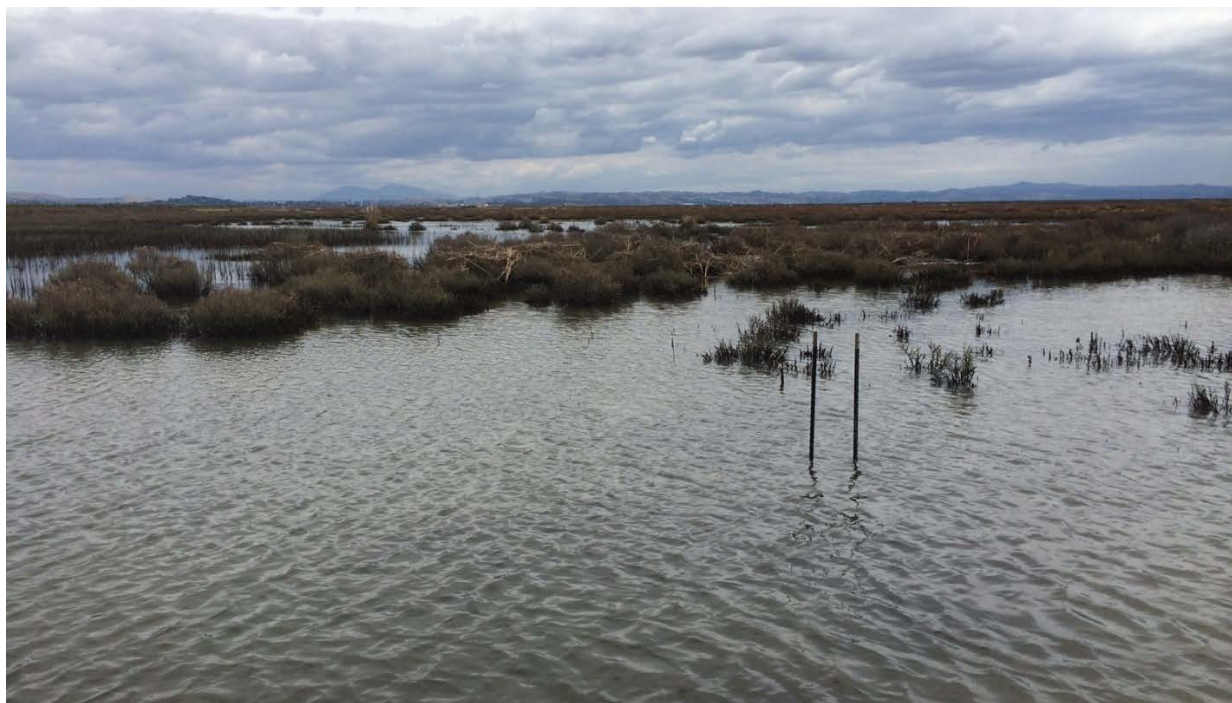
Figure 7. Sedimentation plate marked by T-posts, shown in the right-hand side of the photograph.
