# Potential Restoration Projects for Natural Resources Impacted by the Morris J. Berman Oil Spill San Juan National Historic Site and Nearby Areas along the North Coast of Puerto Rico: Project Summaries

April 2006

*Prepared by:*  
TETRA TECH, INC.  
P.O. Box 79192  
Carolina, PR 00979

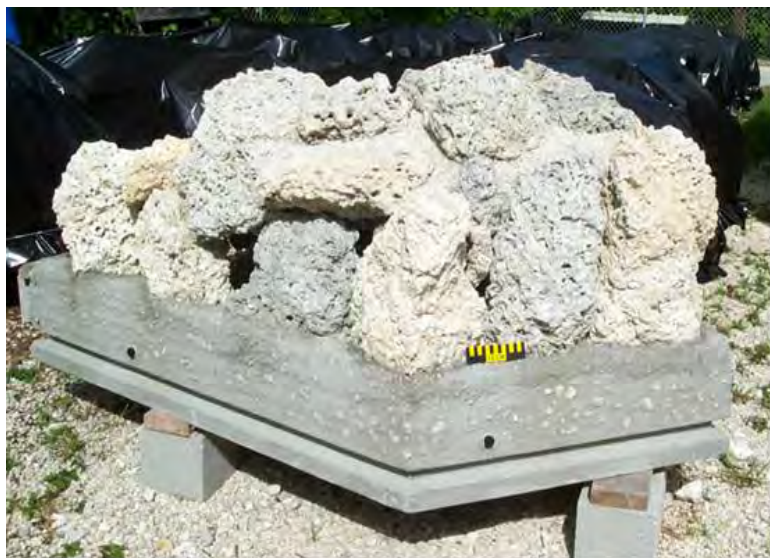
**Figure 2-2. Side View of Low-Profile Reef Module from Florida Keys National Marine Sanctuary**

Figure 2-2 illustrates one type of artificial reef module that mimics a natural reef. The module, which is provided for illustrative purposes only, was constructed to repair a reef injury in the Florida Keys National Marine Sanctuary and was designed for both aesthetics and habitat function.

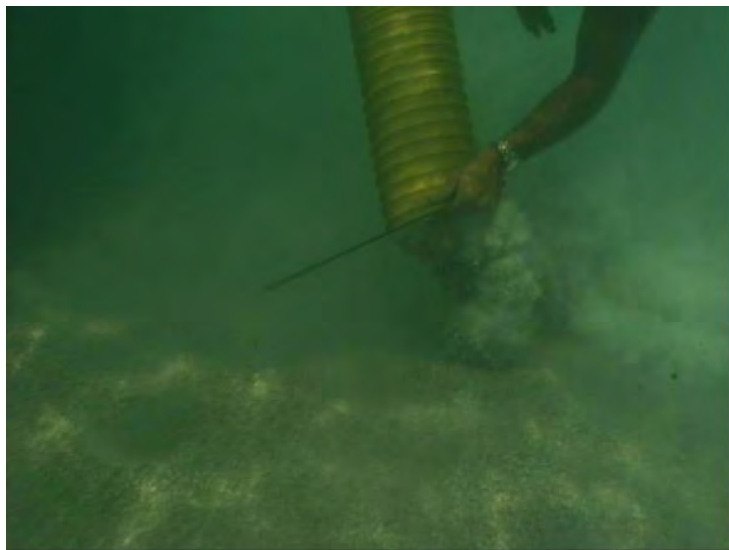
**Figure 2-3. Fill Being Deposited in a Blowhole using a Large-Diameter Flexible Hose**

According to a Preliminary Restoration Plan prepared by U.S. Army Corps of Engineers in March of 2003, an area totaling approximately 32 acres would be filled from a maximum depth of 35 feet to a maximum depth of 15 feet. This reduced depth would facilitate increased water flow and flushing, increased light reaching the seafloor and increased dissolved oxygen levels, as well as other benefits. Figure 2-3 illustrates one technique for managing the sediment filling process on similar depressions that resulted from vessel groundings called 'blowholes.' Once these dredge holes or blowholes are filled to grade and leveled, natural seagrass recovery and plant succession can be allowed to proceed unassisted. Figure 2-4 provides an example of what a blowhole looks like after sediment fill is placed.

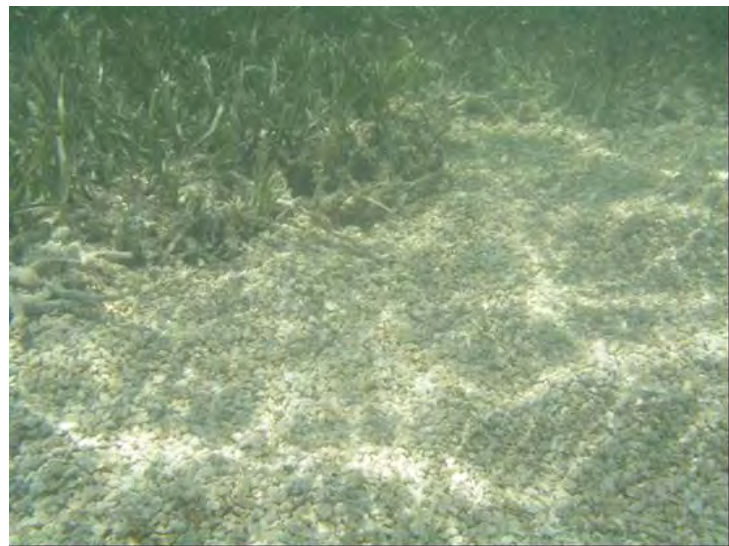
**Figure 2-4. Example of Fill in a Blowhole that Is Level and Up to the Surrounding Grade**

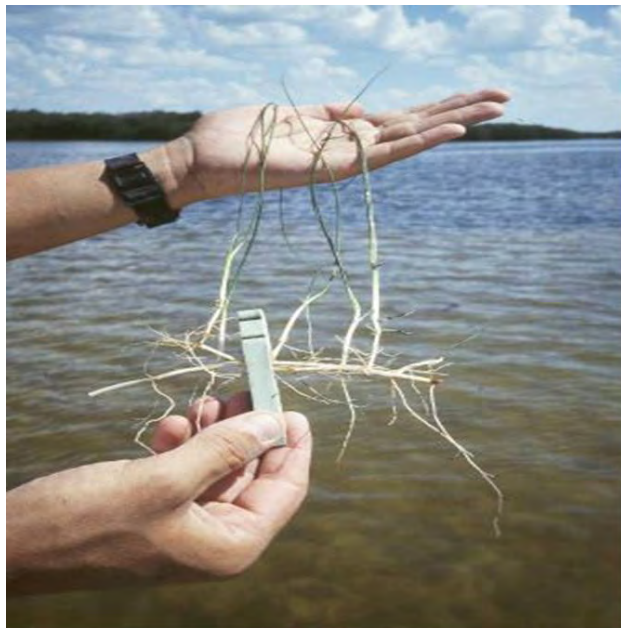
**Figure 2-5. Example of a *Syringodium filiforme* (Manatee grass) Planting Unit**

An additional option exists to promote a more rapid recovery by planting bundled units of fast growing seagrass species (i.e., *Halodule wrightii* or *Syringodium filiforme*) within the filled area. Success will be favored in areas not currently experiencing loss of seagrass cover and of relatively low levels of wave and current energy. Figure 2-5 illustrates a seagrass planting unit that is going to be transplanted onto the surface of a sediment-filled hole to jumpstart the propagation of seagrass.

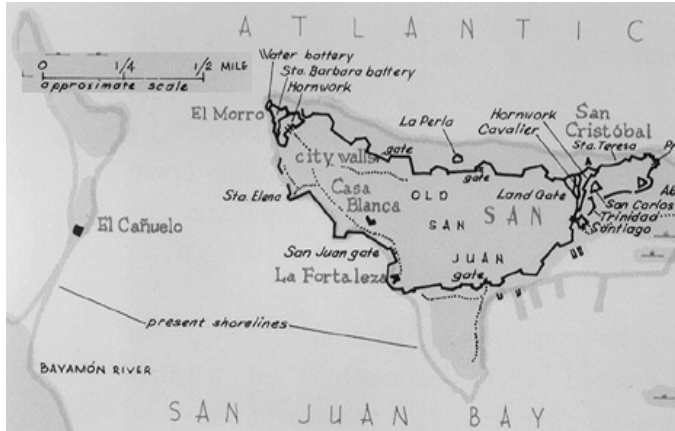
**Figure 4-1. Layout of Features at San Juan National Historic Site and Old San Juan**

The Trustees are proposing three projects for San Juan National Historic Site (Figures 4-1 and 4-2) related to compensation for lost visitor use caused by the spill. The three proposed alternatives are, in priority order, improving and extending the Coastal Promenade, restoring the El Morro Water Battery (also known as the Floating Battery), and cleaning and stabilizing the exterior wall of El Morro. Figure 4-3 shows the Coastal Promenade (Phase I) as well as the El Morro Water Battery and the exterior wall areas that are to be improved under the proposed alternatives. A Beach Erosion Mitigation project (construction of breakwaters to protect Fort El Canuelo), a fourth project defined in the Damage Assessment Restoration Plan, is now considered unnecessary (based on a U.S. Army Corps of Engineers' analysis) because shoreline erosion has slowed and is no longer a serious threat.

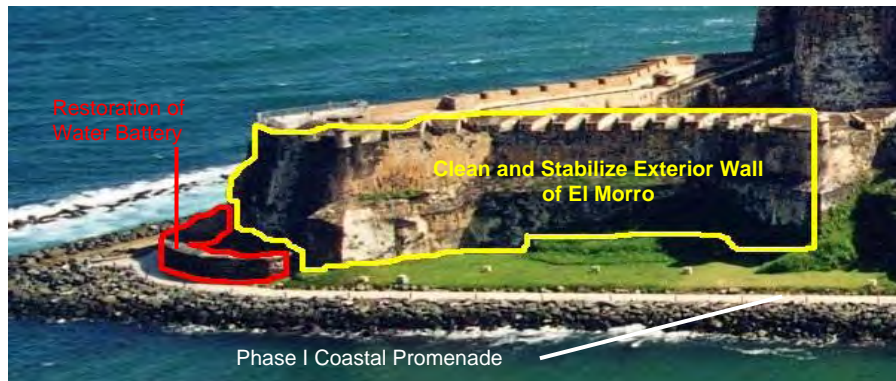
**Figure 4-3. Phase I Coastal Promenade, Water Battery, and Wall Area Proposed for Improvement**

The Coastal Promenade Project, originally defined during the damage assessment, consists of two phases. Phase I, constructing the promenade from the San Juan Gate to the Water Battery (see Figures 4-2, 4-3) has been completed. Phase II, which involves improvements to and extension of the existing Promenade is now being proposed as the first priority project for the Berman restoration. It consists of the seven options described below (see Figures 4-3, 4-4):

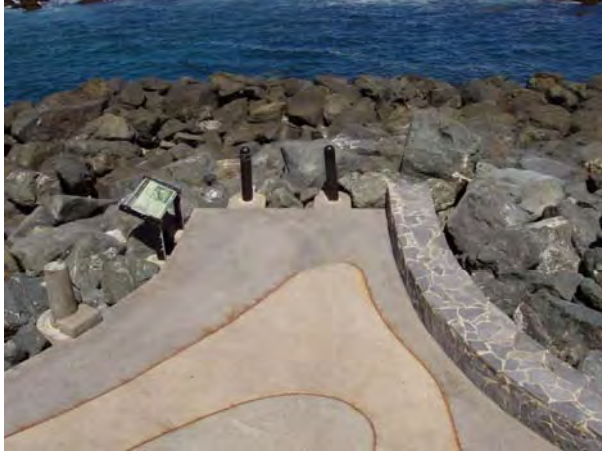
**Figure 4-5. Close-up of Existing Stone Seat Wall and Bollards at the “Floating Battery”**

Option 2 would extend the Promenade at the Water Battery in a circular manner and center the overlook on the existing stone seat wall (Figure 4-5). Other features include concrete bollards, low-level walkway lights, rip-rap, a drinking fountain, and interpretive signage.
