# Biological and Physical Characteristics of the Nearshore Environment of the Bunker Point Restoration Area and the Palos Verdes Peninsula II

NOAA Restoration Center/Montrose Settlement Restoration Program  
2012

Vantuna Research Group  
Moore Laboratory of Zoology  
Occidental College  
1600 Campus Road  
Los Angeles, CA 90041

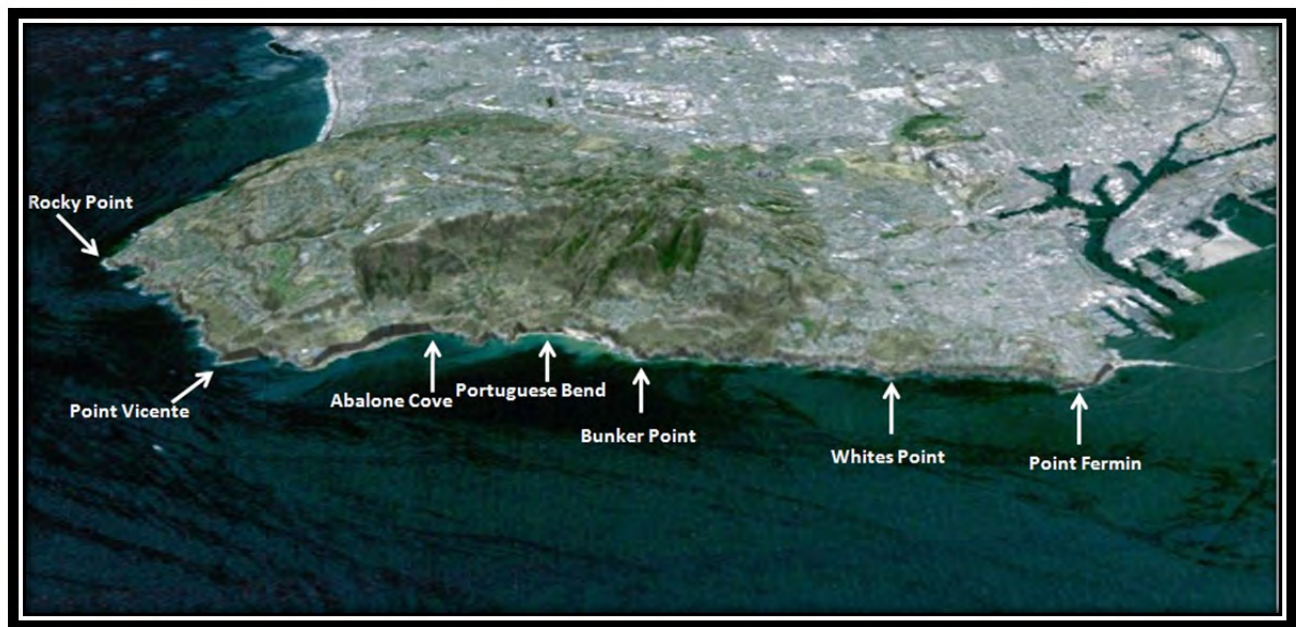
**Figure 1.** Satellite image of the Palos Verdes Peninsula (image adapted from NASA/JPL).

For a variety of reasons, the nearshore environment of the Palos Verdes Peninsula (Figure 1) has been intensively studied for decades. In particular the nearshore reefs of this headland have garnered attention due to a variety of anthropogenic activities (e.g., commercial and recreational fishing, establishment of marine protected areas, giant kelp beds lost to pollution, landslides). Historically the greatest deleterious impact to the reefs at Palos Verdes was the loss of its kelp beds due to pollution from the Joint Water Pollution Control Plant's Whites Point outfall. By 1960 due to untreated sewage, the only kelp left on the peninsula was at Abalone Cove and in Portuguese Bend (North 1964). To exacerbate the situation, road construction on Palos Verdes Drive triggered the Portuguese Bend Landslide in 1956. From 1956 to 1999, approximately 5.7 to 9.4 million metric tons of sediment slid onto the inner shelf (Kayen 2002). By 1999, the landslide was dewatered, slowed appreciably and now only releases sediment due to wave action. Nonetheless the biological damage has been extreme, highlighted by the loss of the Portuguese Bend Kelp Bed leaving only the Abalone Cove Kelp Bed by 1974. Due to the infrastructure improvements of the Whites Point Outfall (i.e. expansion offshore and switch to secondary treatment) and the Wheeler North kelp restoration efforts of the early 1970's, giant kelp returned to the peninsula (Figure 2) and remains present today (Figure 3).

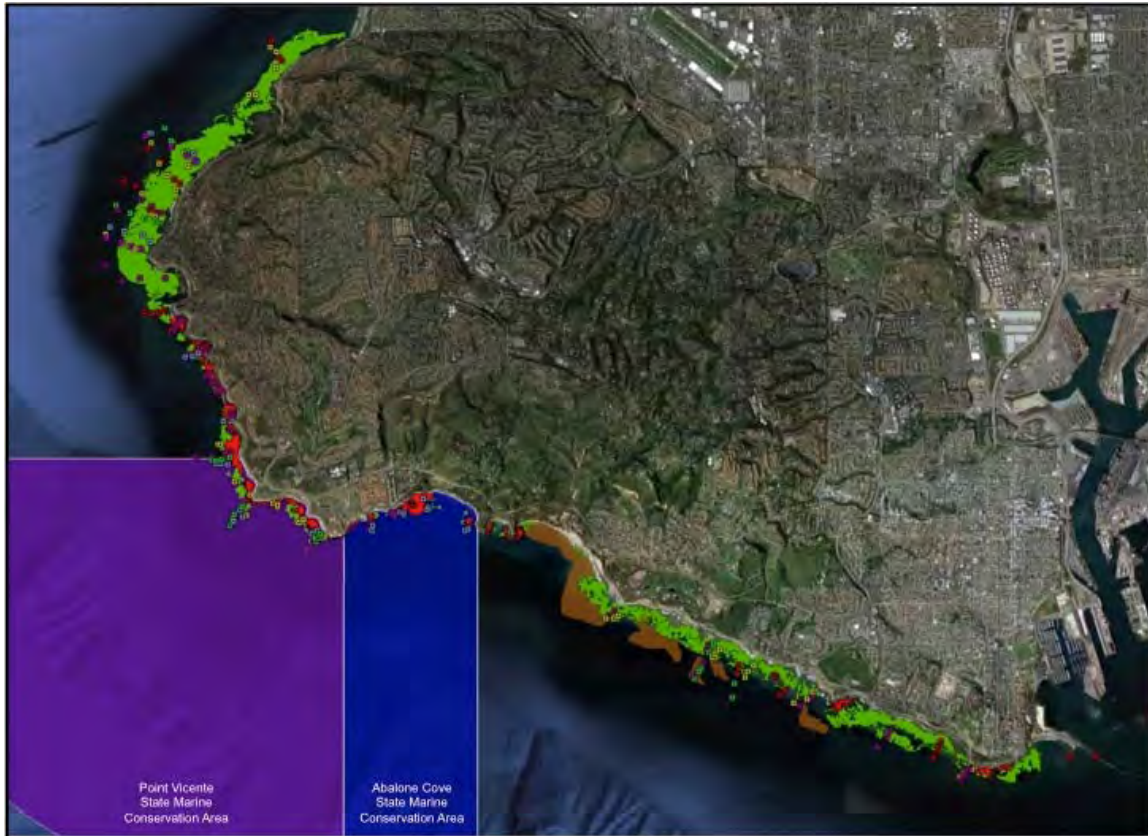
**Figure 3.** Palos Verdes Peninsula. Kelp canopy (green) in 2008 (Source: MBC Applied Environmental Sciences), urchin barrens (red), buried reef (brown), and sites of dive transects conducted by the VRG.

Areas of low-relief buried reef in the Bunker Point Restoration Area (see brown polygons in Figure 3) that can be restored through the addition of high relief quarry rock are located in depths of 13-20 m. Biomass densities of legal sized kelp bass and California sheephead (> 30 cm TL each) at nearby low-relief reefs (3 Palms East, Point Fermin, Whites Point, and Bunker Point) were compared to biomass densities at surrounding reefs with higher relief features at those same depths (Cairns and KOU Rock). Data were  $\log_{10}(x+1)$  transformed to meet assumptions of normality and analyzed using a Welch Two-Sample t-test. Legal sized kelp bass (mean high relief = 2033 g/100 m<sup>2</sup>, mean low relief = 457 g/100 m<sup>2</sup>;  $t = 2.75$ ,  $df = 7.18$ ,  $p = 0.028$ ) and California sheephead biomass (mean high relief = 4073 g/100 m<sup>2</sup>, mean low relief = 406 g/100 m<sup>2</sup>;  $t = 3.66$ ,  $df = 3.97$ ,  $p = 0.022$ ) were both significantly higher at the reefs with high relief features (Figure 41), illustrating the potential for highly increased availability of targeted species and productivity at restored reefs.

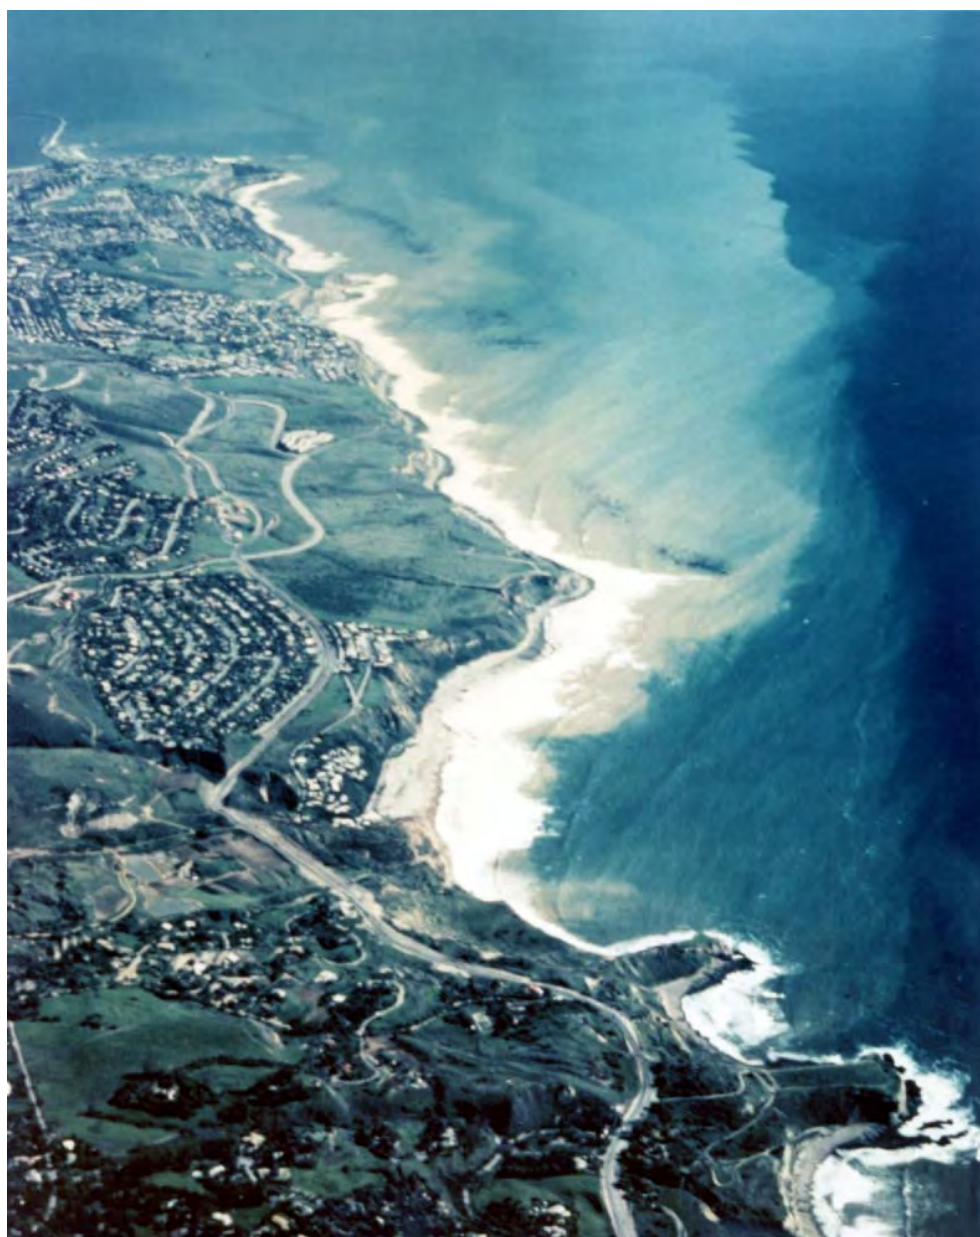
**Figure 4.** Turbidity plume from the Portuguese Bend landslide.

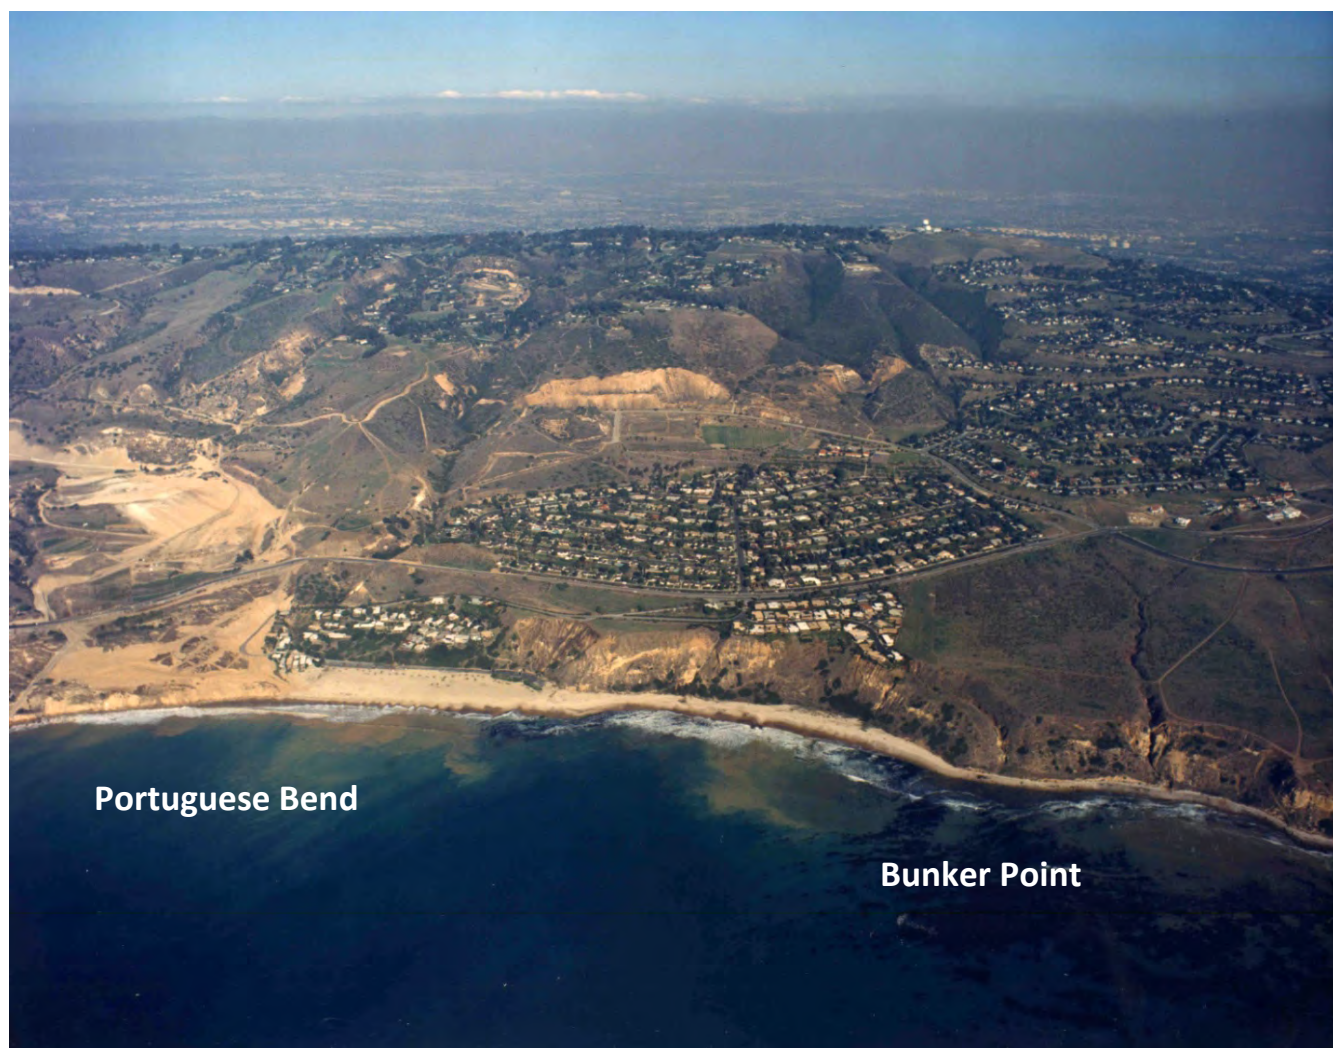
**Figure 5.** Portuguese Bend and Bunker Point prior to the construction of the Trump National Golf Course, December 17, 1986. Turbidity plumes originating in Portuguese Bend can be observed.

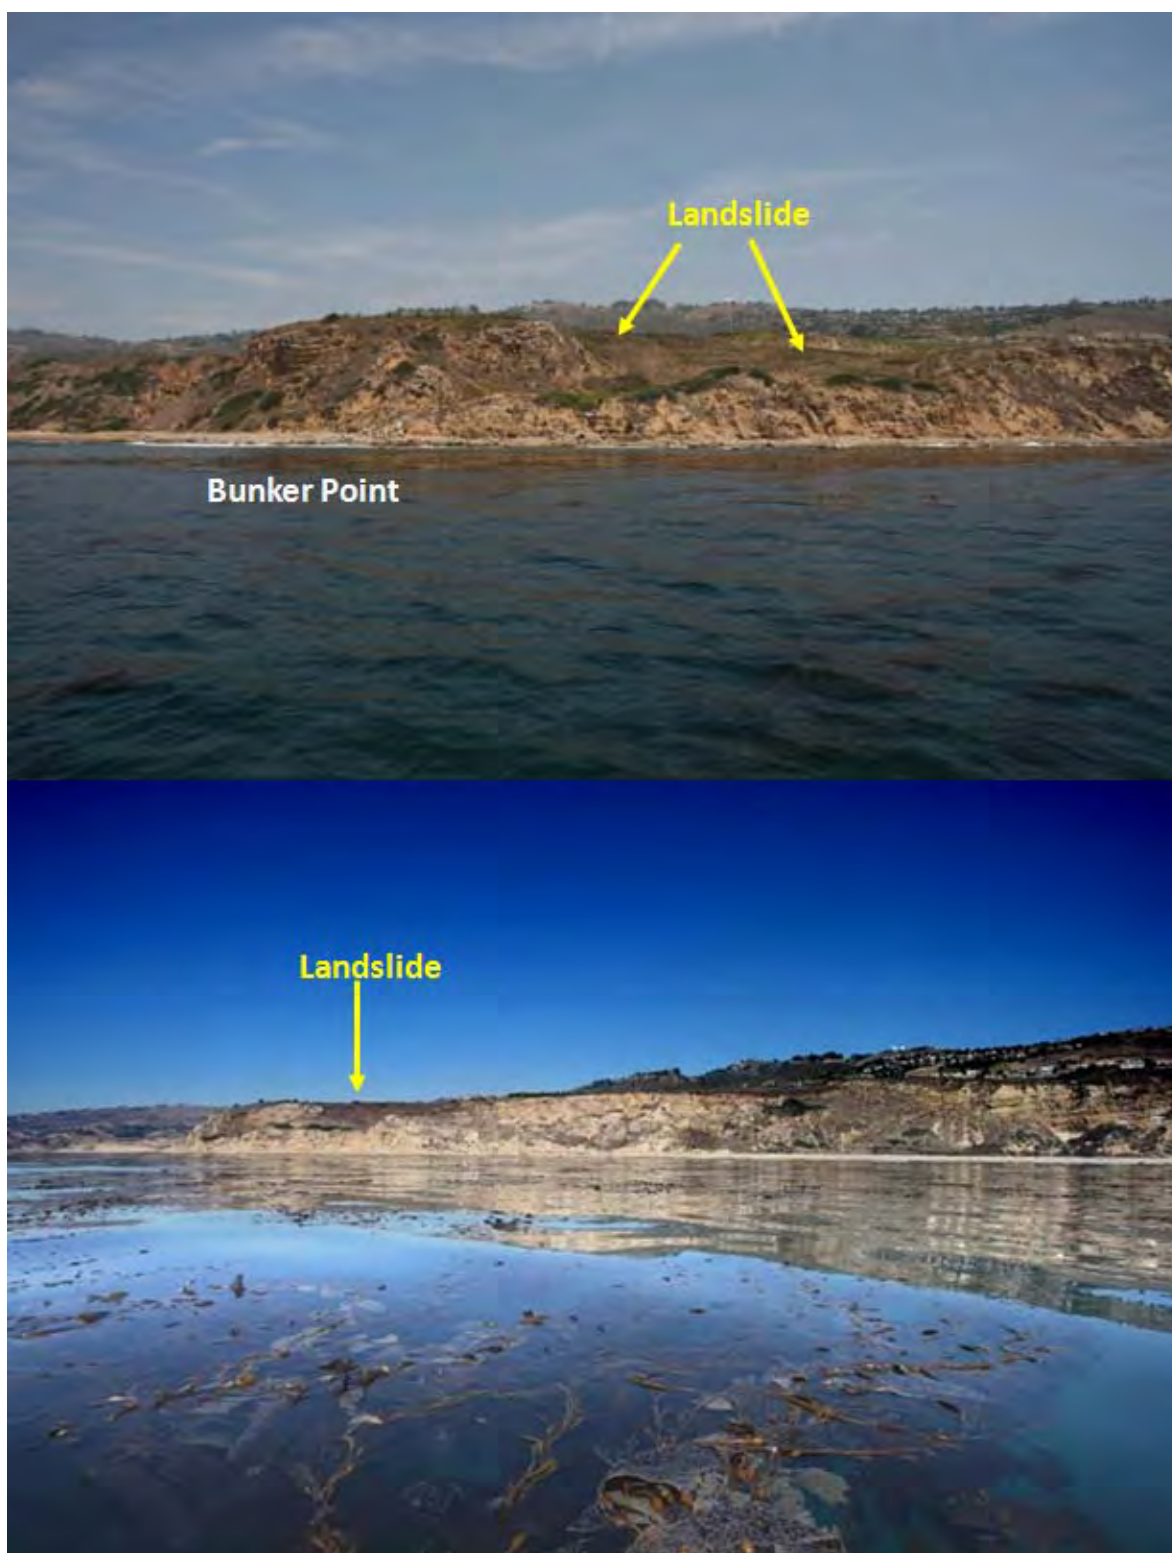
**Figure 6.** Bunker Point and location of Trump National Golf Course landslide (photo credits: upper picture D. Pondella, Lower picture D. Witting, NOAA).

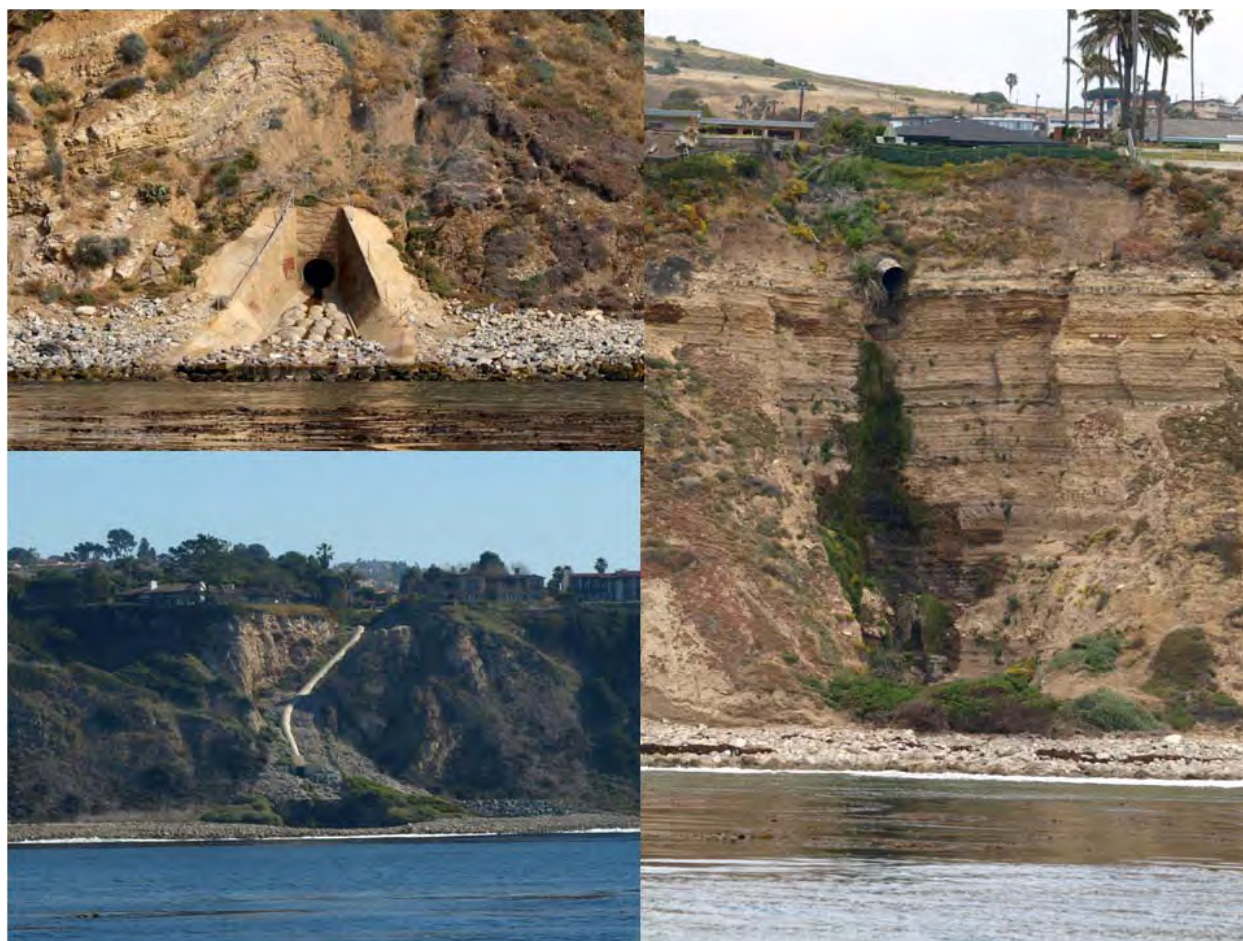
**Figure 7.** Examples of large storm drains on the Palos Verdes Peninsula. Clockwise from top left: Abalone Cove, 3 Palms (between Bunker Point and Whites Point), and Rocky Point (photo credits, J. Williams).

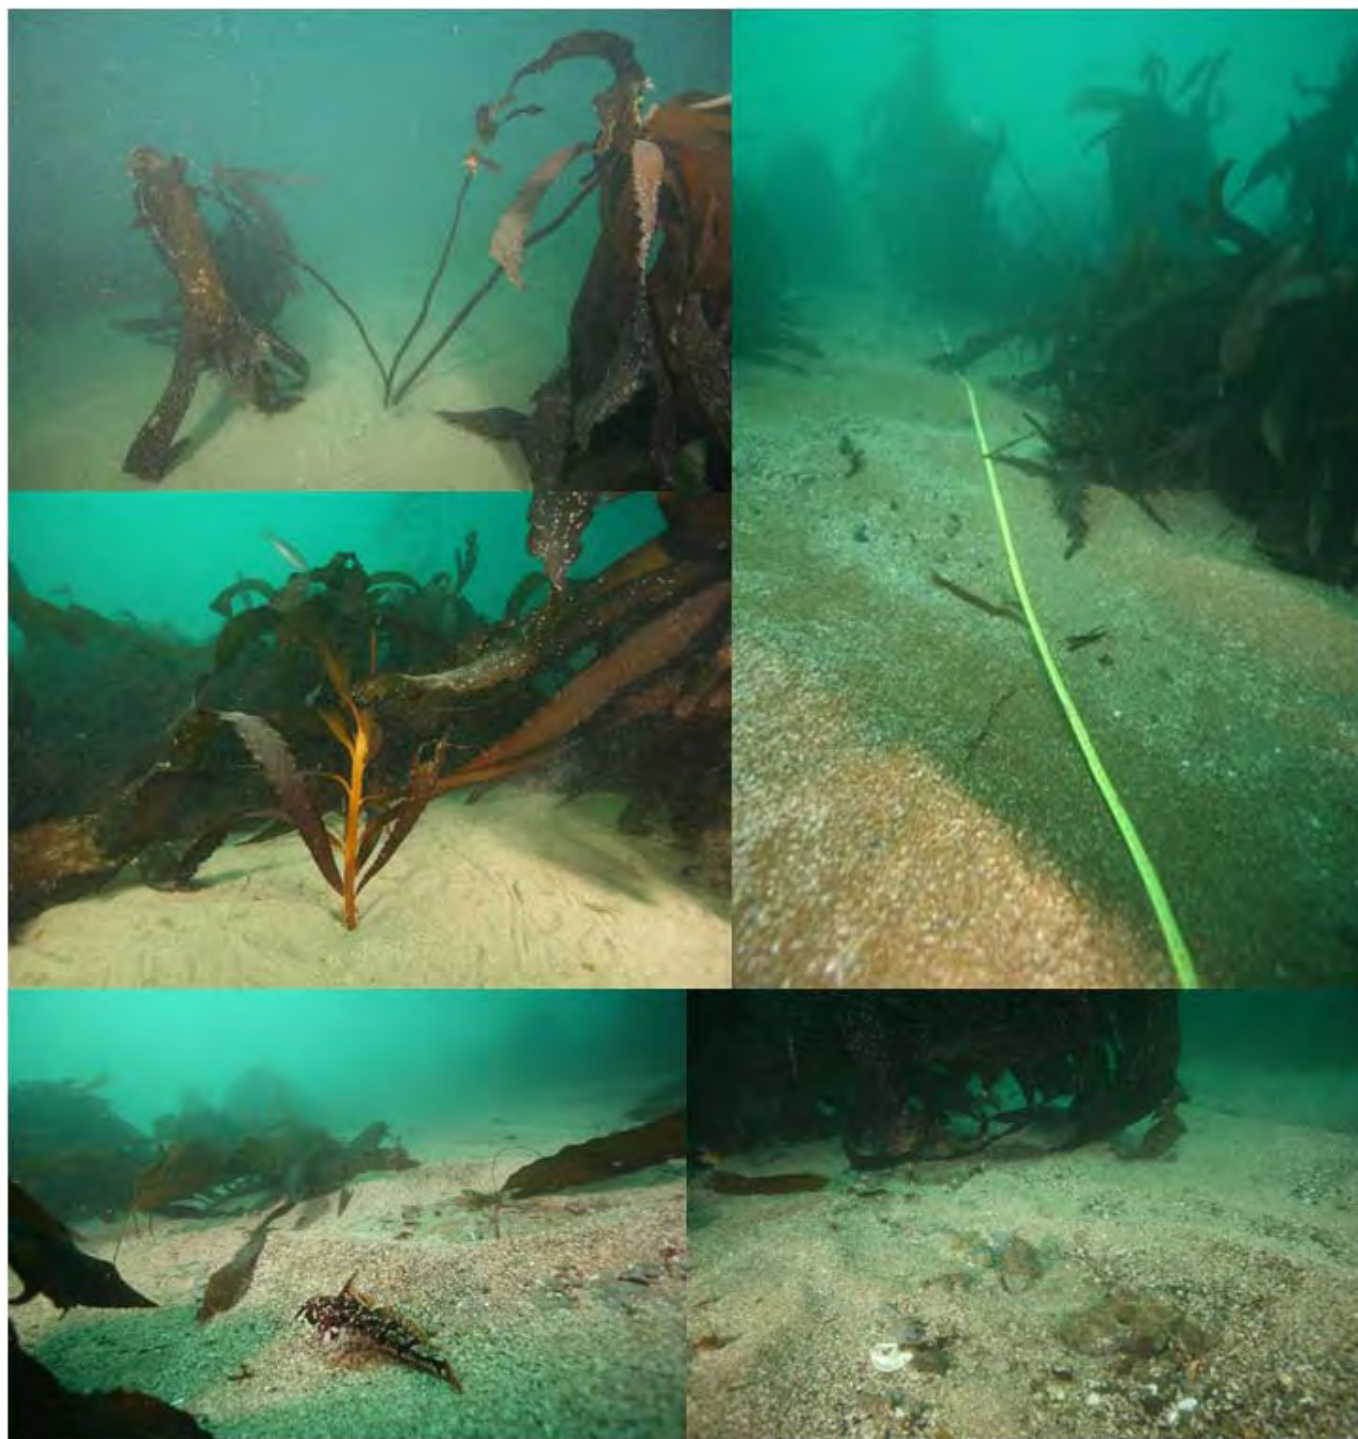
**Figure 8.** Buried *Pterygophora* reefs at Bunker Point, October 22, 2008 (Photos credits: D. Witting, NOAA).

The nearshore reefs (<30 m) of the peninsula have been intensively surveyed in the past for the Santa Monica Bay Restoration Commission (Pondella 2009), and finer-scale sampling has continued recently for this project. During these rocky reef surveys, buried reefs at Bunker Point with *Pterygophora* growing out of the sediment were observed on November 15, 2007, October 22, 2008, and April 20, 2010 (Figure 8). Considering that reef burial was not observed during the extensive surveys of this region in the 1990s (Stephens 1996), this burial likely occurred in the last decade. The reef's proximity to the Trump National Golf Course landslide suggests it has likely been buried since 1999. This reef at Bunker Point remained buried through the spring of 2010. In addition, we observed buried *Pterygophora* on reefs near Whites Point throughout this study (Figure 9).

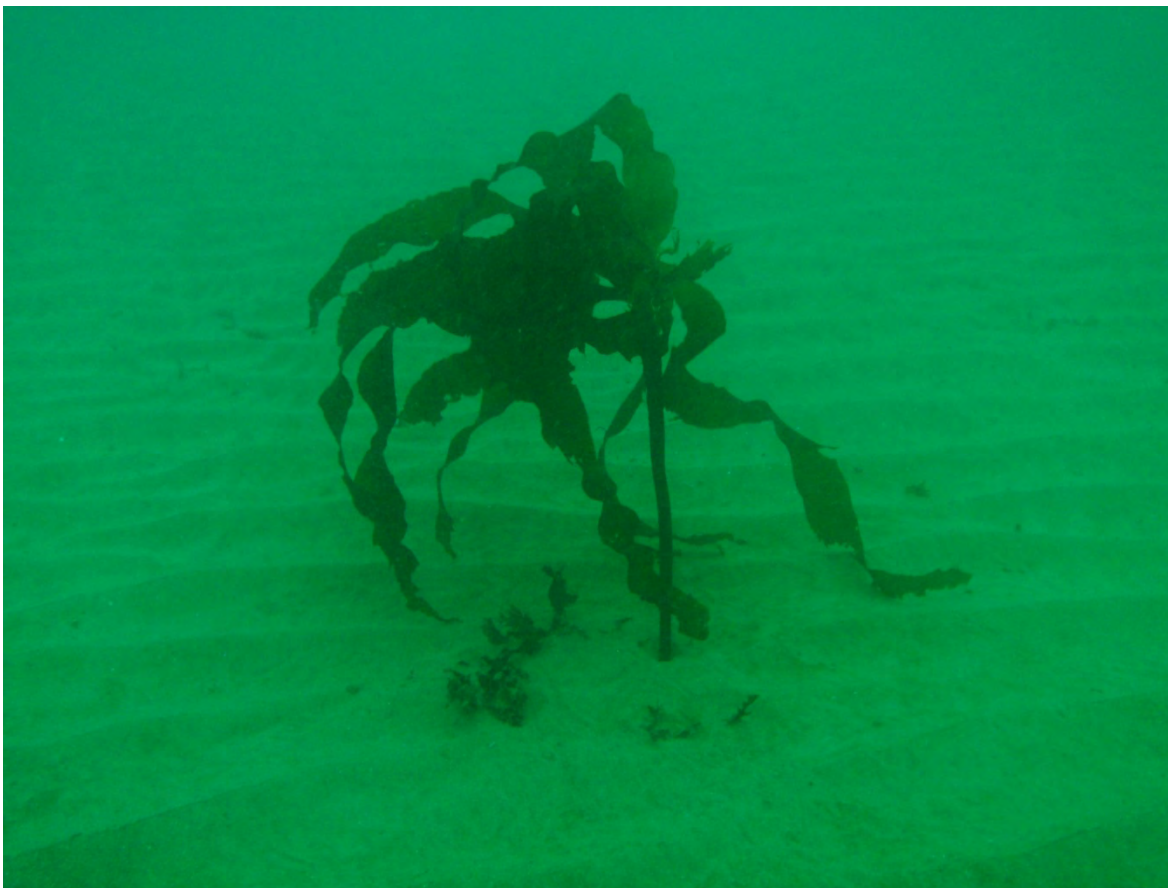
**Figure 9.** Buried *Pterygophora* reef at Whites Point, June 3, 2009 (Photo credit J. Williams).

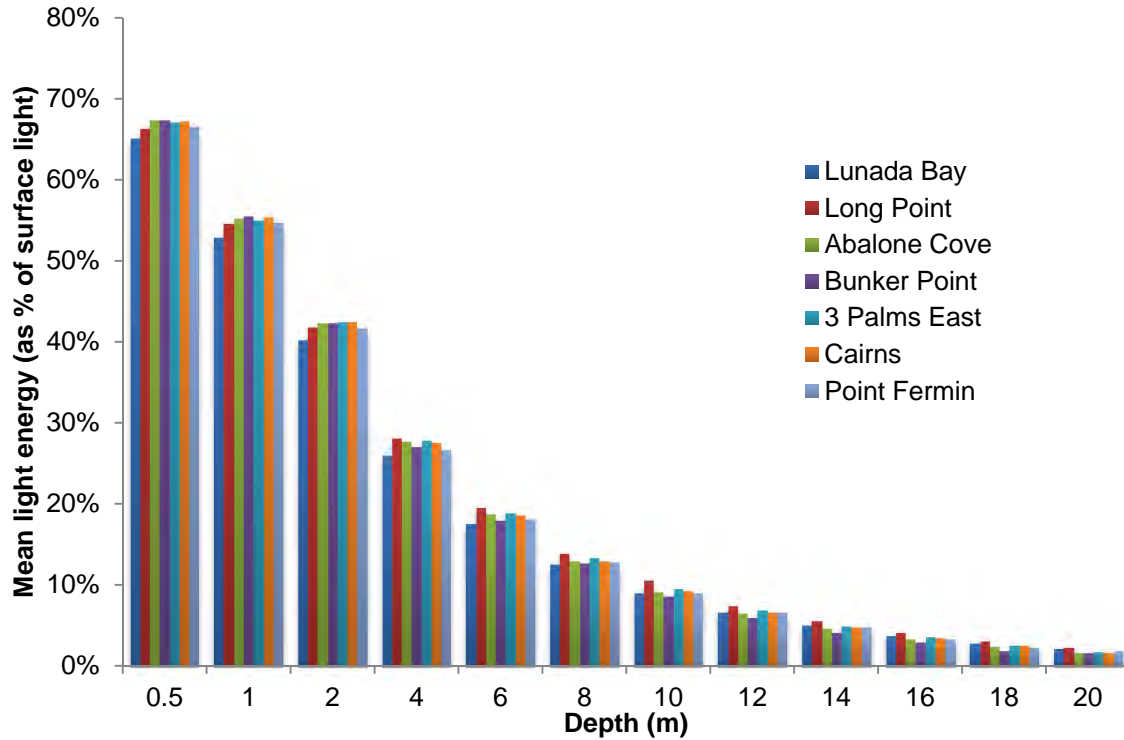
Figure 11. Mean light attenuation at seven sites along the Palos Verdes Peninsula.

To analyze the effect of turbidity along the peninsula and its potential to limit algal growth at depth, we examined a survey of the water column profile of light energy [measured as photosynthetically active radiation (PAR)] that was conducted monthly from 1982-2009 at seven nearshore sites along the Palos Verdes Peninsula (Figure 10). This survey is part of the Joint Water Pollution Control Plant (JWPCP) NPDES monitoring program. Readings are taken at 0.5m, 1 m and then at 2 m intervals below the surface until contact with the bottom or 20 m depth, whichever comes first. The light energy value measured at each depth (quanta/sec/cm<sup>2</sup>) is divided by the surface light energy measurement (also quanta/sec/cm<sup>2</sup>) to obtain a percentage of the surface light energy that passes through the water column to each depth. That percentage was then averaged over every sampling period from April 1982 to December 2009 to obtain a mean percentage of surface light energy captured at each depth (Figure 11). By plotting the difference between the percentage at each site/depth and the average percentage of all sites at each depth, discernable patterns begin to appear (Figure 12). Patterns at the Lunada Bay (Palos Verdes Point) and Long Point stations show far below average light energy transmittance near the surface compared to other sites, but far greater transmittance further down in the water column, suggesting that the thick kelp canopy, rather than turbidity, impacts light penetration at those sites. Additionally, these data may suggest that turbidity at those sites is generally low when compared to thinner-canopied sites to the east, such as Abalone Cove and Cairns. Given the small differences in the percentages by site, it appears that there is sufficient light penetration at all stations to sustain macroalgae.

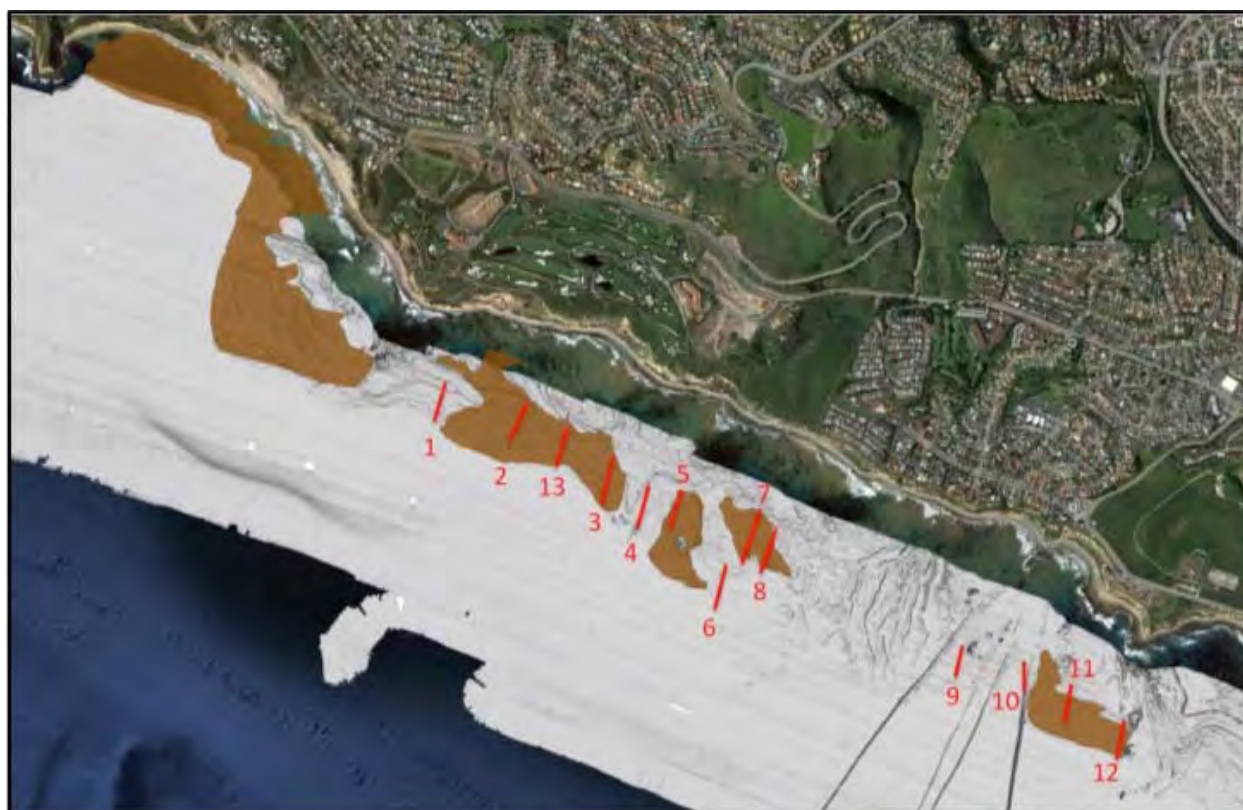
**Figure 14.** Mapped reef habitat, sediment survey transects (red numbered lines), and areas with buried rocky reef (brown polygons).

To determine the sediment depth over the rock throughout this area, we conducted scuba surveys at twelve locations (Figure 14). These surveys were conducted perpendicular to the coastline starting at the 20 m isobath, and divers would measure the sediment depth at 10 m intervals until completely uncovered and unbroken reef habitat was found. The initial sediment characterization was conducted in Spring 2009 and a second survey was conducted in Spring 2010. A third survey was conducted in Spring 2011 to fill in spatial gaps, determine fidelity of buried reefs, and concentrate surveys on possible restoration sites. Sites that were primarily rock were excluded from the second and third surveys. With the exception of stations 11 and 12, all surveys were conducted over mapped rocky reef habitat. Between each of these study periods we had long winters of cold El Niño storms associated with heavy rains. This set up a natural experiment of the effects of heavy swell and rain on the study site.

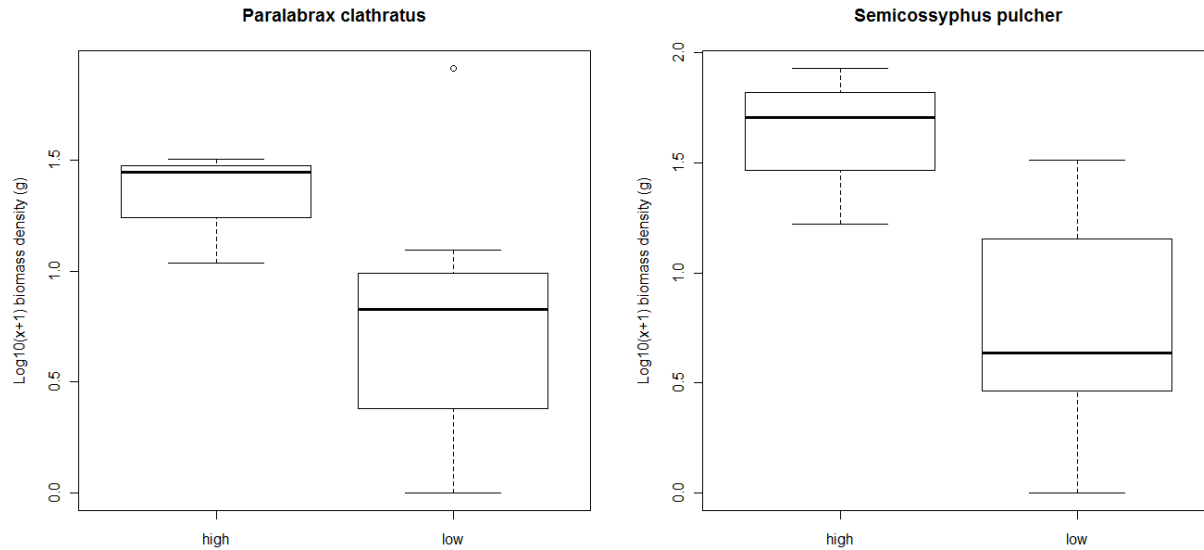
**Figure 41.** Biomass (grams per 100 m<sup>2</sup>) of legal size (> 30 cm) kelp bass (*Paralabrax clathratus*; mean high relief = 2033 g/100 m<sup>2</sup>, mean low relief = 457 g/100 m<sup>2</sup>;  $t = 2.75$ ,  $df = 7.18$ ,  $p = 0.028$ ) and California sheephead (*Semicossyphus pulcher*; mean high relief = 4073 g/100 m<sup>2</sup>, mean low relief = 406 g/100 m<sup>2</sup>;  $t = 3.66$ ,  $df = 3.97$ ,  $p = 0.022$ ) at high relief and low relief sites in the 15-25 m depth zones on the Palos Verdes Peninsula.

These analyses show that the reefs within the Bunker Point Restoration Area can potentially hold a tremendous amount of value. Unburied sections of the reefs (typically the shallower areas, < 10 m) have enough biomass of fisheries species to make the reefs among the most productive areas (with respect to those species) at Palos Verdes Peninsula, despite the lack of suitable habitat in the deeper, buried regions. Should high relief features that can act as pinnacle reefs (like KOU Rock) be placed on top of buried areas, biomass densities of catchable kelp bass and California sheephead can potentially increase by as much as 290% and 900%, respectively, at those depths (Figure 41).
