FINAL REPORT
RESTORATION ACTIONS
WITHIN THE
SAN LUIS OBISPO CREEK WATERSHED
PREPARED FOR THE AVILA BEACH TRUSTEE COUNCIL
with Funds from the Avila 1992 Unocal Oil Spill Settlement
San Luis Obispo County, California
MARCH 2008

THE
LAND CONSERVANCY
of SAN LUIS OBISPO COUNTY
743 Pacific Street
San Luis Obispo
California 93401
(805) 544-9096
www.LCSLO.org

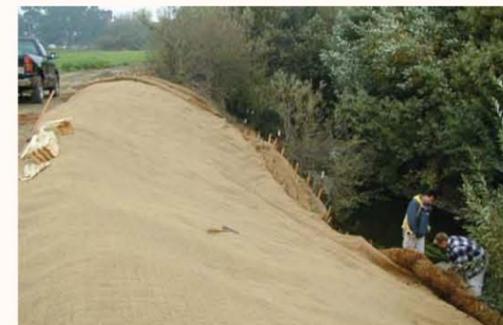
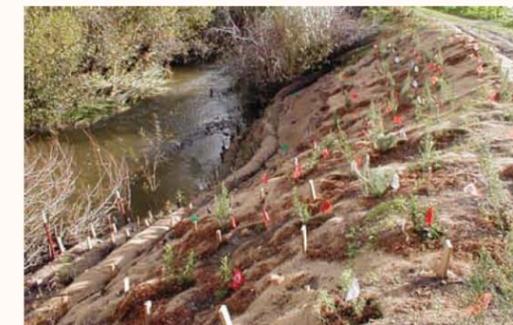
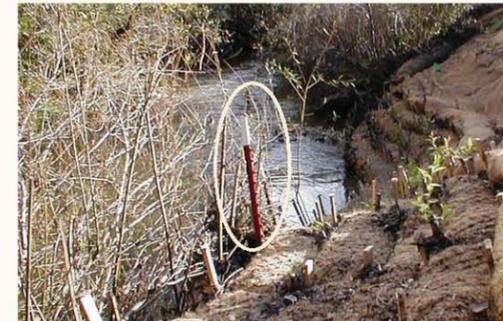
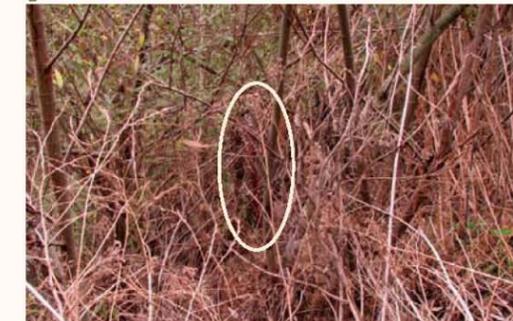
REPLANTING A STREAM BANK

1. San Luis Obispo Creek, near South Higuera Street and the Octagon Barn.
2. Mats woven from an organic coconut fiber called *coir* protect the bank from erosion caused by rushing water. The mats take a few years to decompose completely, allowing young plants time to grow and take over the job of holding soil in place.
3. Holes are made in the mat and native vegetation is planted.
4. Biologs are flexible rolls of coir mat covered with coir netting. The biologs are placed at the base of the slope to stabilize the bank.
5. Compare this photo with number 4 to the left. The red stake that was placed to stabilize the biologs is still there, but mostly hidden by 4 - 6" diameter willows.

To repair the eroded stream bank, the bank was first re-sloped with a backhoe to an angle gentle enough for vegetation to be established. Precautions were taken during the grading to make sure none of the soil entered the stream.

Once the bank was properly shaped, the toe of the slope required protection so the stream would not undercut the new sloped bank. For this step, a natural slope protection method was used.

Rather than using large boulders, fiber rolls made from shredded coconut husks (biologs) were used in tandem with live willow planting.

These materials help build the strength of the bank naturally while providing habitat cover for fish and birds. The upper portions of the sloped bank were planted with other native plants and covered with an erosion control net. Several seasons later, the restored bank is naturally restored... and even hard to find.

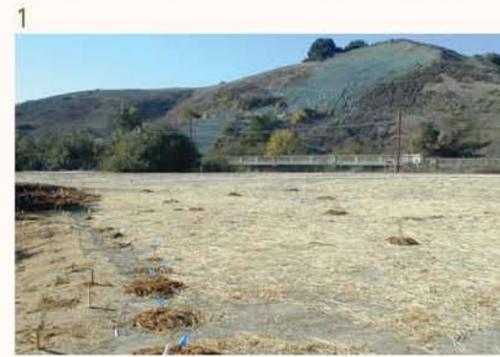
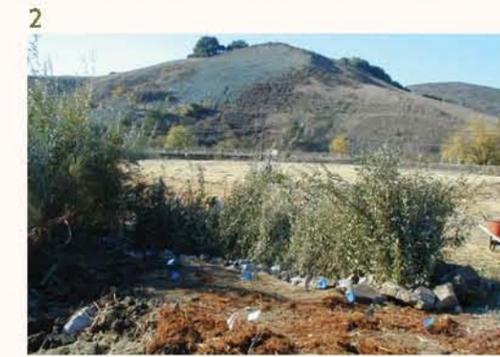
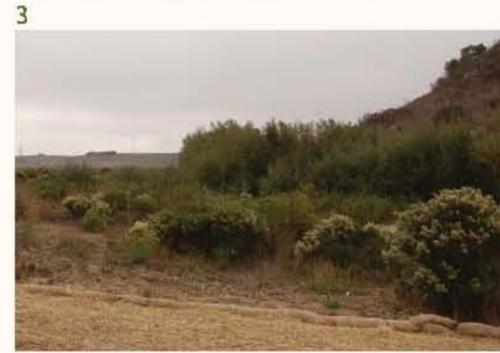
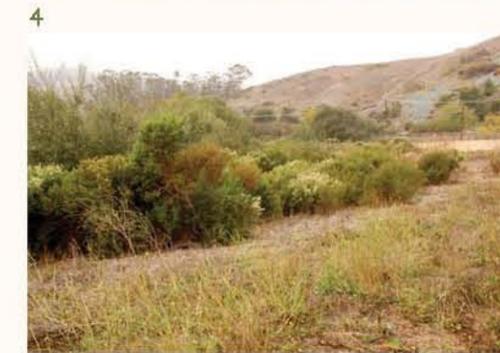
REVEGETATING A FLOODPLAIN

The South Higuera Street bridge can be seen in the background of the photos above. (1, 2) Before the project, the streambank was eroded and vegetation was sparse. Parts of the bank were re-sloped to hold vegetation, using netting and biologs. The plantings are now thriving on this site. (3, 4)

Before the project, the stream banks were eroded and were supporting little vegetation. Parts of the bank were re-sloped to hold vegetation, using netting and biologs. Grading undertaken through this grant included reduction of the floodplain elevation along a 500-foot section of the East Fork of San Luis Obispo

Following the grading, the banks and floodplain were replanted with a mixed palette of native plants. Approximately 400 feet of streambank was replanted. Some minor repairs were necessary following a winter flood, as was the installation of a live willow siltation baffle. The plantings thrived on this site and the area is already recruiting other native plants.

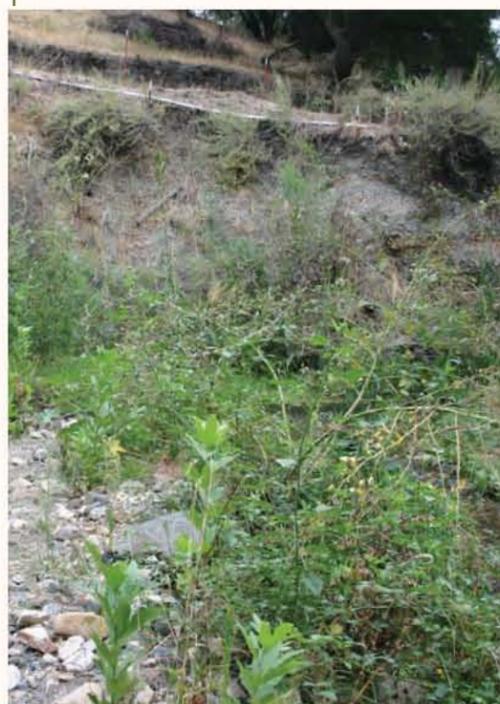
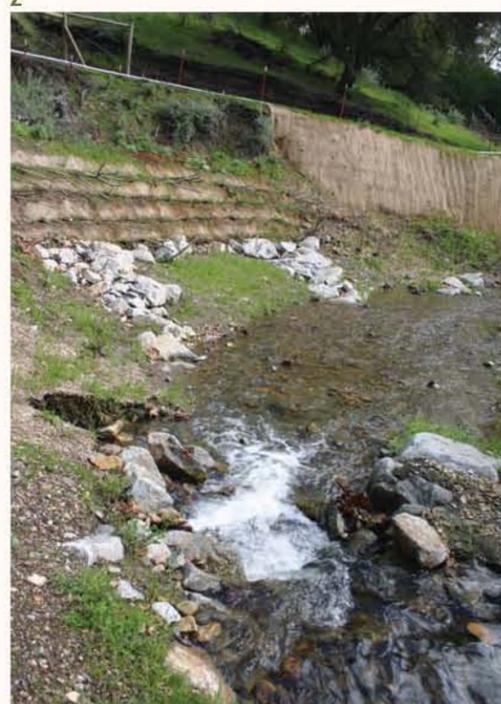
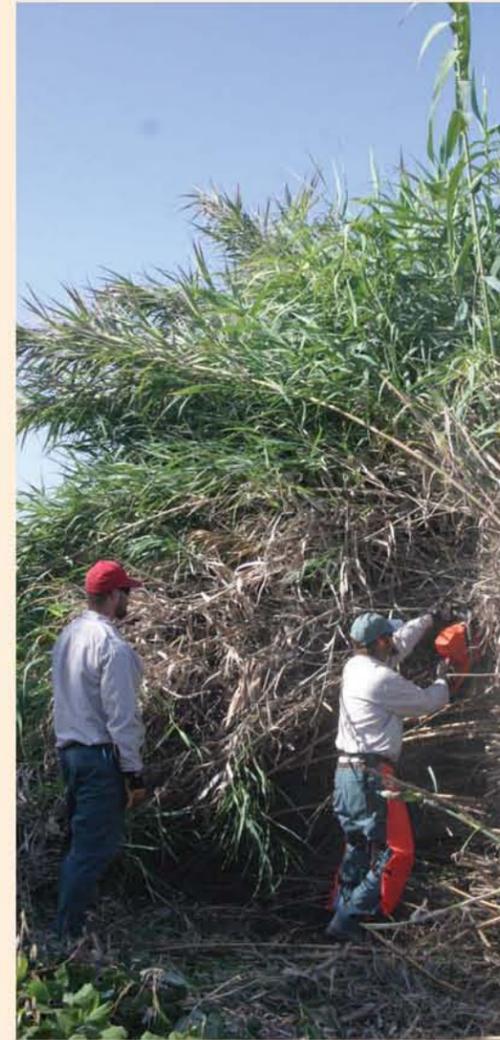
UPPER SAN LUIS OBISPO CREEK BANK STABILIZATION

1. The crumbling bank before the project began.

2. After, with rock vanes in place to help re-direct the flow away from the banks.

3. A bench was created to support the coir mats and live willow stakes.

4. The bank is replanted with native species.

5. The eroding bank was 18 feet tall and falling fast.

6. The creek was dammed and boulders were placed at the foot of the bank.

Settlement funds were used here to stabilize stream banks and improve steelhead habitat in the creek by repairing a 150-foot reach of the creek that had a tight S-curve. Along the curve, the stream bounced off each bank at extremely high velocities during rain events, causing intense erosion on each turn.

One of the banks was 18 feet tall and supported a historic stagecoach road. Every winter, soil from the bank fell into the creek, weakening the road and adding sediment to the stream. Vegetation struggled to grow on either bank, thus raising the temperature of the water and reducing areas for steelhead to hide from predators.

First, the stream was diverted through pipes to protect it from construction because the project required that heavy equipment enter the streambed. To protect the banks, low-profile rock structures were constructed along the toe of the vertical banks and live willow stakes were planted. Innovative structures named rock vanes were installed to re-direct the flow away from the banks and guide the creek through the site.

At the base of the 18-foot bank a bench was created that allowed us to build "soil wraps" of biodegradable erosion control blankets and live willow branches. This provides extra strength to the slope to allow for the willows to develop strong roots and subsequently grow larger and support the slope for the long term while providing shade for the creek. On top, the planted native shrubs and trees will one day grow up to provide even more shade on the creek. In total, 40 pounds of native seed were applied, over 750 willow stakes were placed, and 130 tons of rock was set to rebuild the banks.

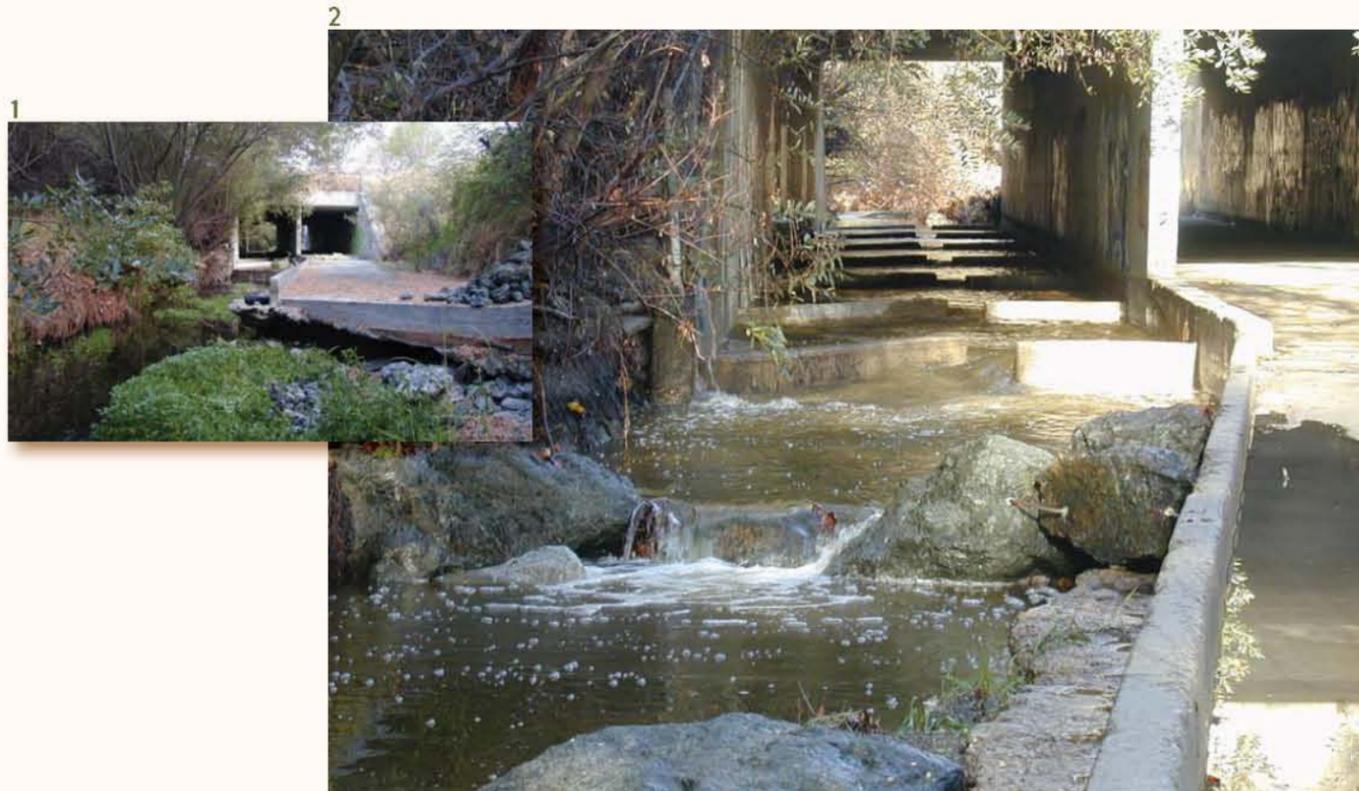
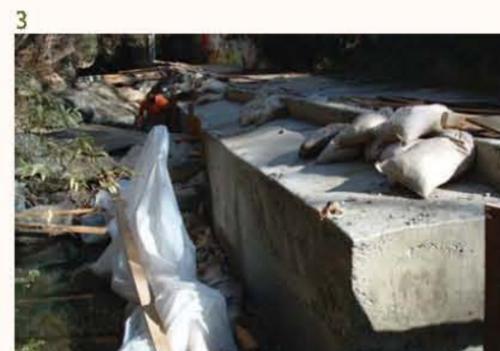
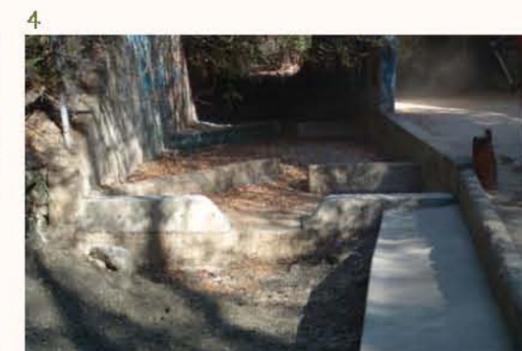
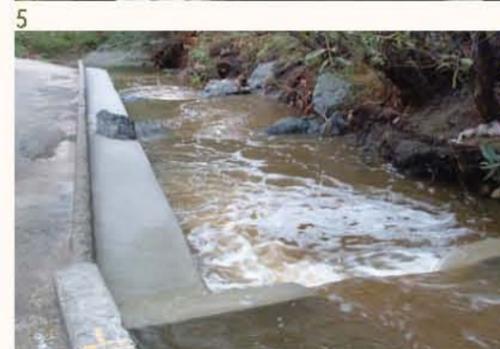
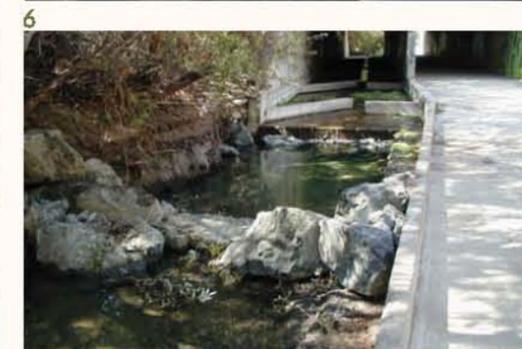
FIXING THE FISH PASSAGE

1. Before, the road was undercut and a steep drop created a barrier for fish.
2. The finished project allows juvenile steelhead to negotiate the creek.
3. The undercut road was filled in and shored up with boulders.
4. The barrier is reduced...
5. ...so water can flow and fish can pass.
6. Pools were created with boulders cemented in place.

This former fish migration barrier on Stenner Creek is located on the Cal Poly campus. The problem at this site was the vertical drop that fish had to negotiate. Juvenile fish in particular lack the jumping ability of adult fish.

In this case, the culvert under Highland Drive was already treated for fish passage using a concrete baffle system. While this system did work, the water depth during periods of low flow through the culvert spillway was still insufficient for some younger fish.

This project minimized the vertical jump by installing three boulder weirs that brought the stream elevation back up to the spillway elevation.

An additional concrete baffle at the end of the spillway was added to increase the water depth on the spillway and concentrate the low flow into a better migration channel.

The project was made more complex because this culvert has a road incorporated with it to move farm equipment under the overpass. The road had become undercut, so it was necessary to fill the undercut section to support the road and to make sure the stream flow did not travel under the road and around the passage project.

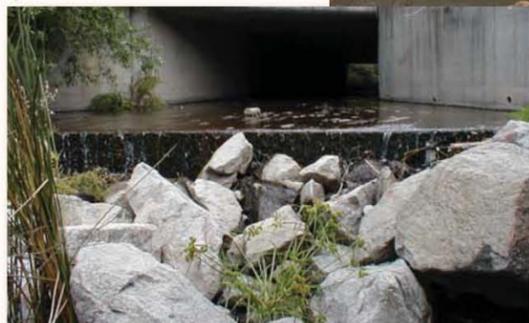
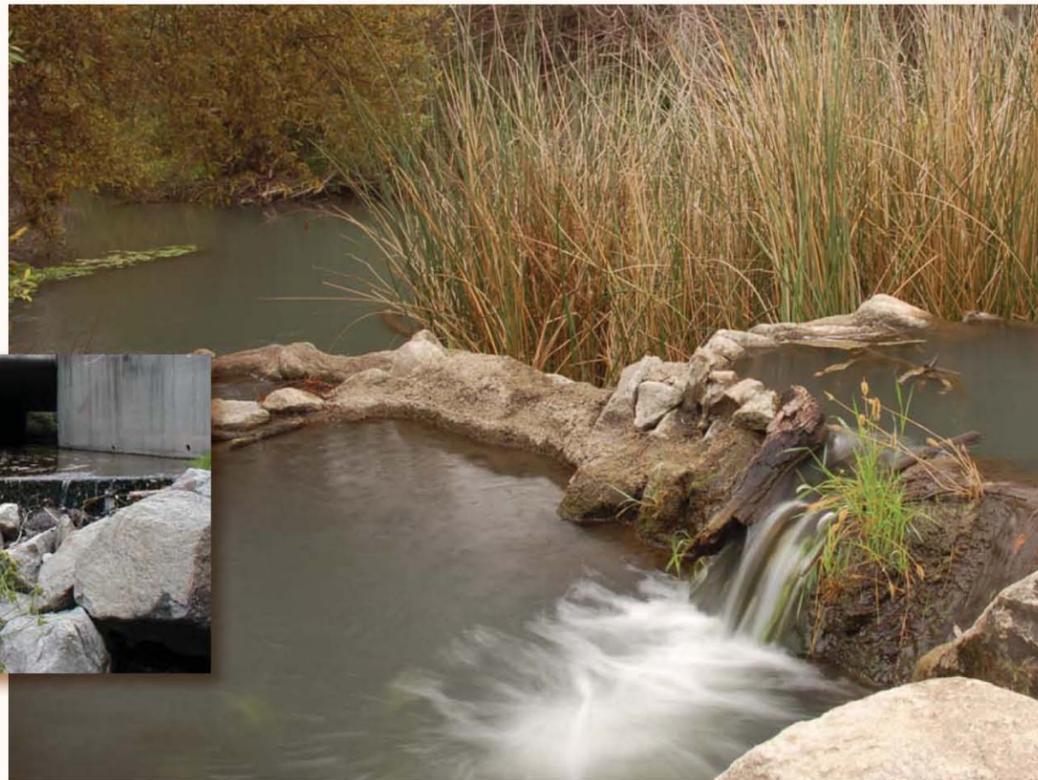
PREFUMO CREEK FISH PASSAGE

1. Flat concrete surface blocked fish passage.
2. New pools, after construction of baffles to slow the water and create depth sufficient for fish to swim through.

This fish barrier involved a 165-foot long concrete culvert that carries Prefumo Creek under Highway 101. The structure posed several challenges to migrating fish. First, the culvert outlet was over four feet higher than the stream below, creating a vertical jumping barrier. To complicate passage, boulders at the outlet did not allow for a pool to form, and pools are necessary for fish to generate jumping power.

These problems were addressed first by rearranging the rocks below the outfall to make pools, then grouting the rocks so the pools would hold water. This made for four small jumps instead of one high jump. The grouting also made for permanent pools that would create a path for migrating fish. The actual culvert was modified by adding a baffle system that slows down the water flow and creates sufficient depth for fish migration. The project subsequently provided successful fish passage.
