# Natural Resource Damage Assessment and Restoration Program

## *DuPont Newport Superfund Site, Delaware*

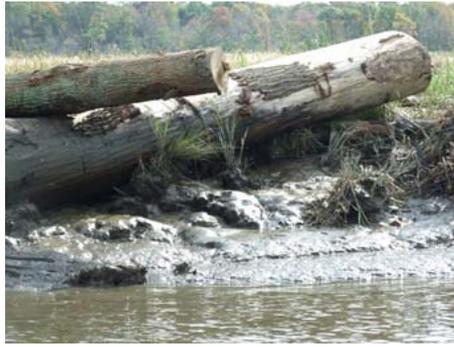
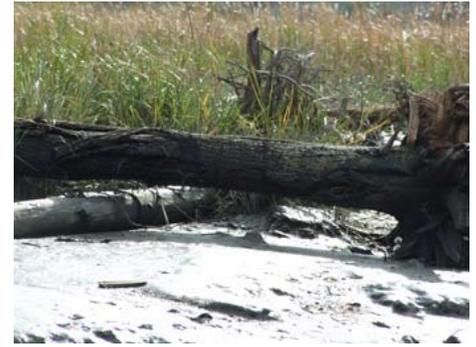
- Along the river, large diameter coarse woody debris (LWD) were used to provide immediate protection from boat wakes and trap organic and mineral sediment. Long-term protection will be provided by the re-establishment of vegetation. In addition to bank protection, the woody debris will enhance fish and wildlife habitat by providing roosting, nesting, refuge, and foraging opportunities

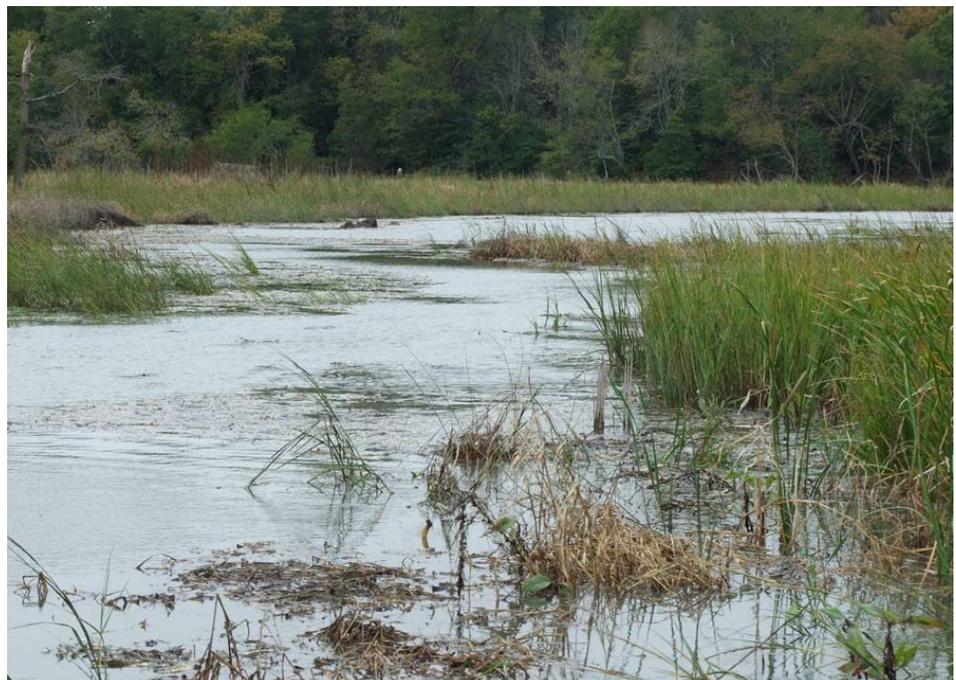
- The oxbow channel has filled in over 50 years because tidal exchange has been diminished. A portion of the oxbow channel was dredged to a depth below Mean Lower Low Water. Selected mudflats were dredged to create fish rearing areas. Based on photo records from 1938, these mudflats were once tidal pools. Spoil from the dredging was broadcast over the marsh in a thin layer ( $\leq 3$  inches).

*Completed channel at high tide.*
