Selected Spectral Imagery of the May 14, 1996 Pearl Harbor Oil Spill

A report submitted to:

TerraSystems, Inc.
2800 Woodlawn Drive, Suite 264
Honolulu, Hawaii 96822
(808) 539-3745
Attn: Dr. Jonathan Gradie

February 25, 1997

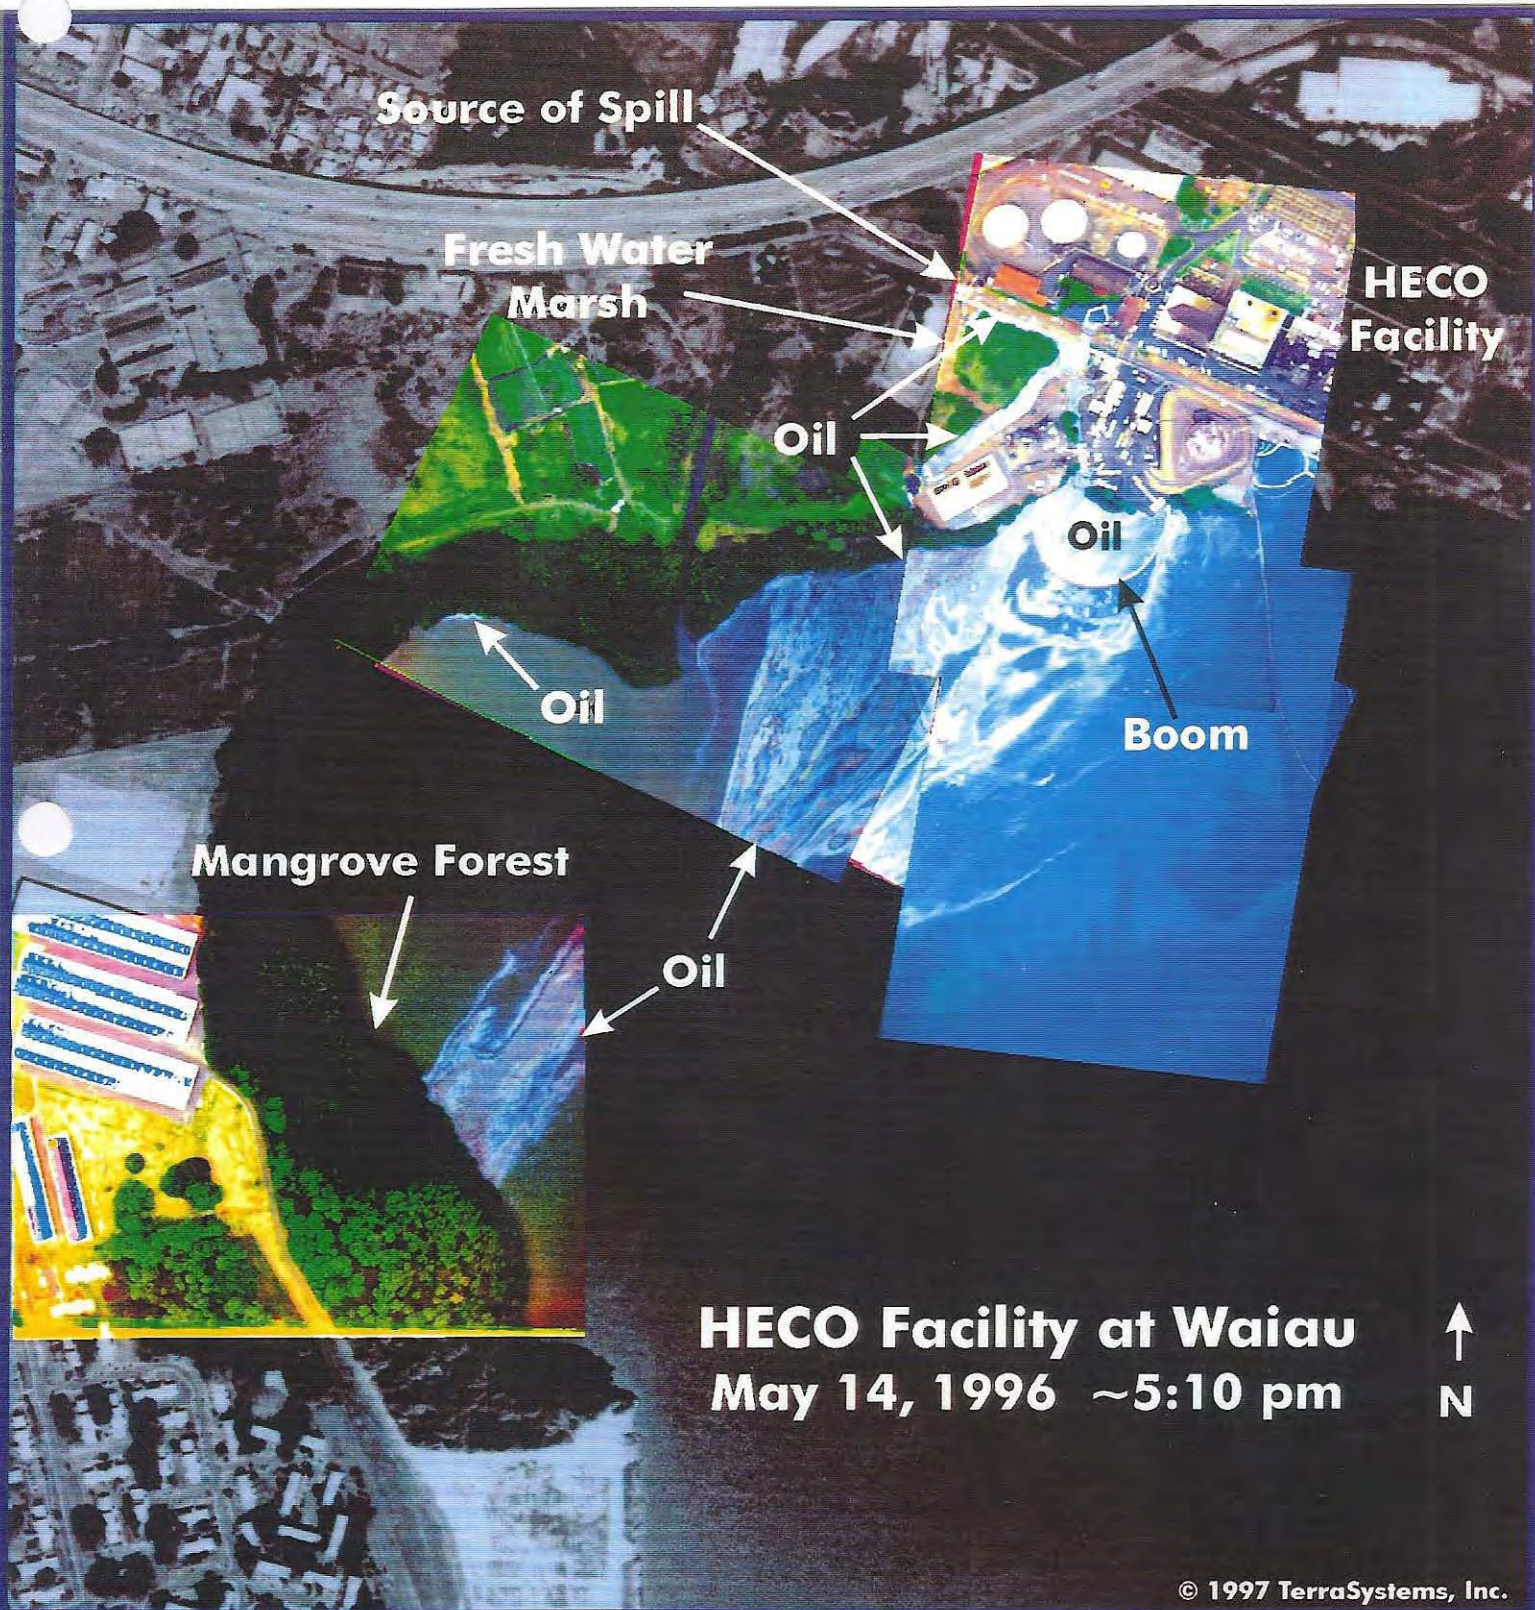
Arizona Memorial Visitor Center
May 14, 1996 5:16 p,m

Figure 4 shows the shoreline adjacent to the Arizona Memorial Visitor's center. Oil sheens can be seen attached to the shoreline, the U.S.S. Bowfin and the Naval Reservation docks. Oil has moved upstream past the oil boom protecting Halawa Stream.

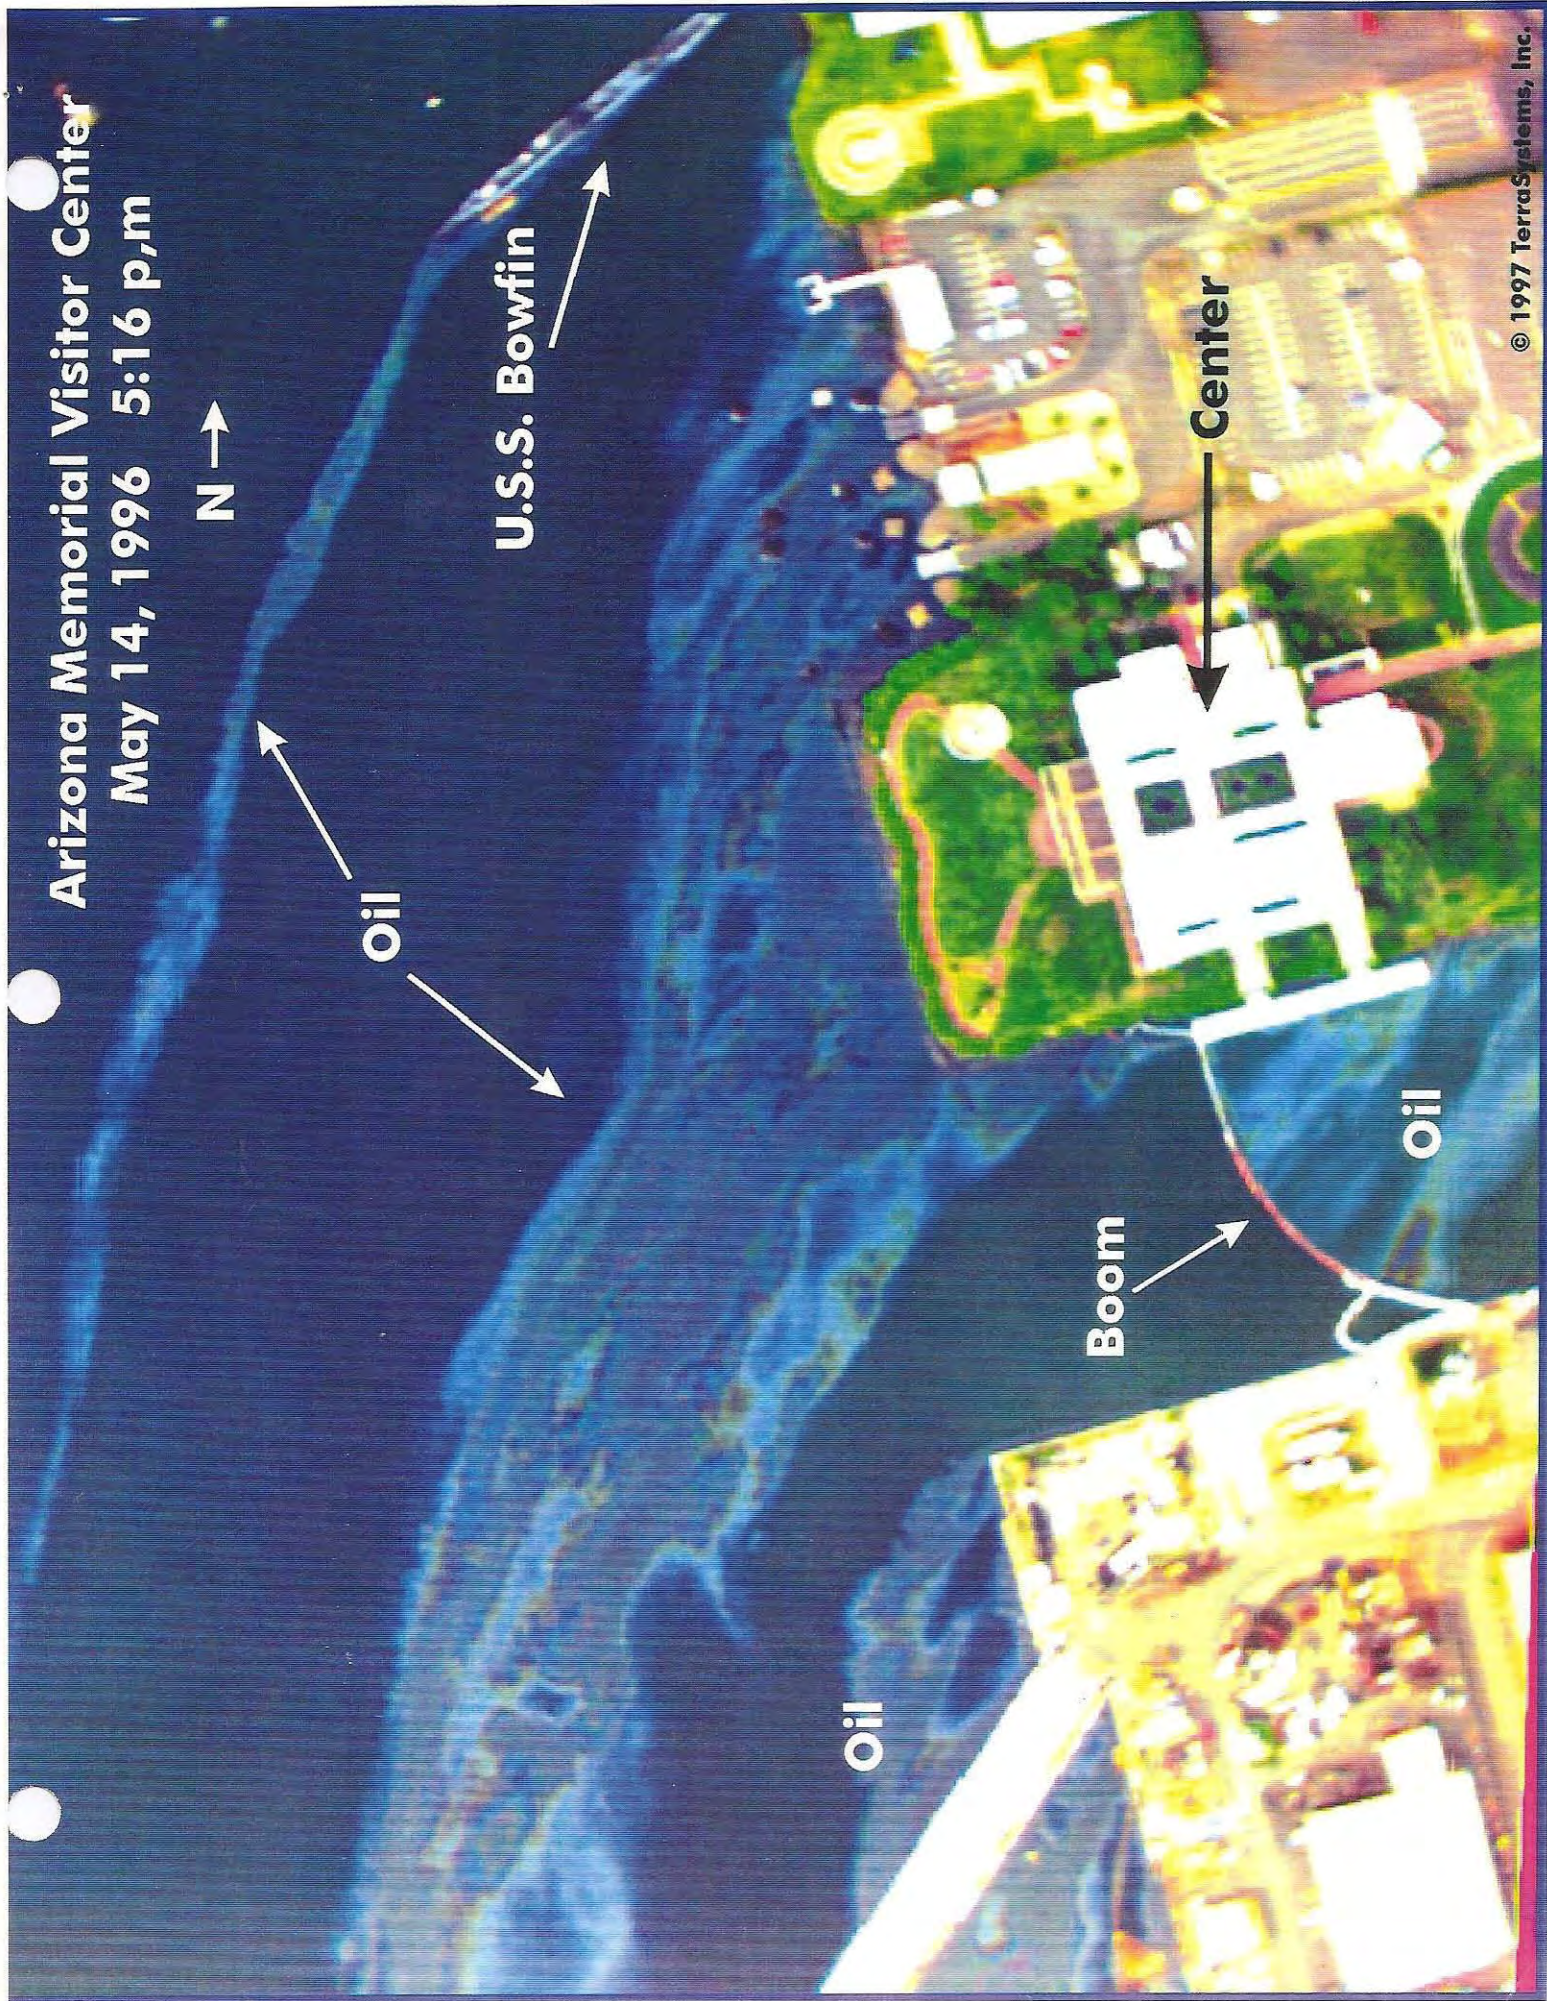
Arizona Memorial
May 14, 1996 5:20 pm

Figure 5 shows the Arizona Memorial and adjacent shoreline on Ford Island. Oil is seen on both sides of the booms set out to protect the memorial. Oil can be seen along the shores of Ford Island.

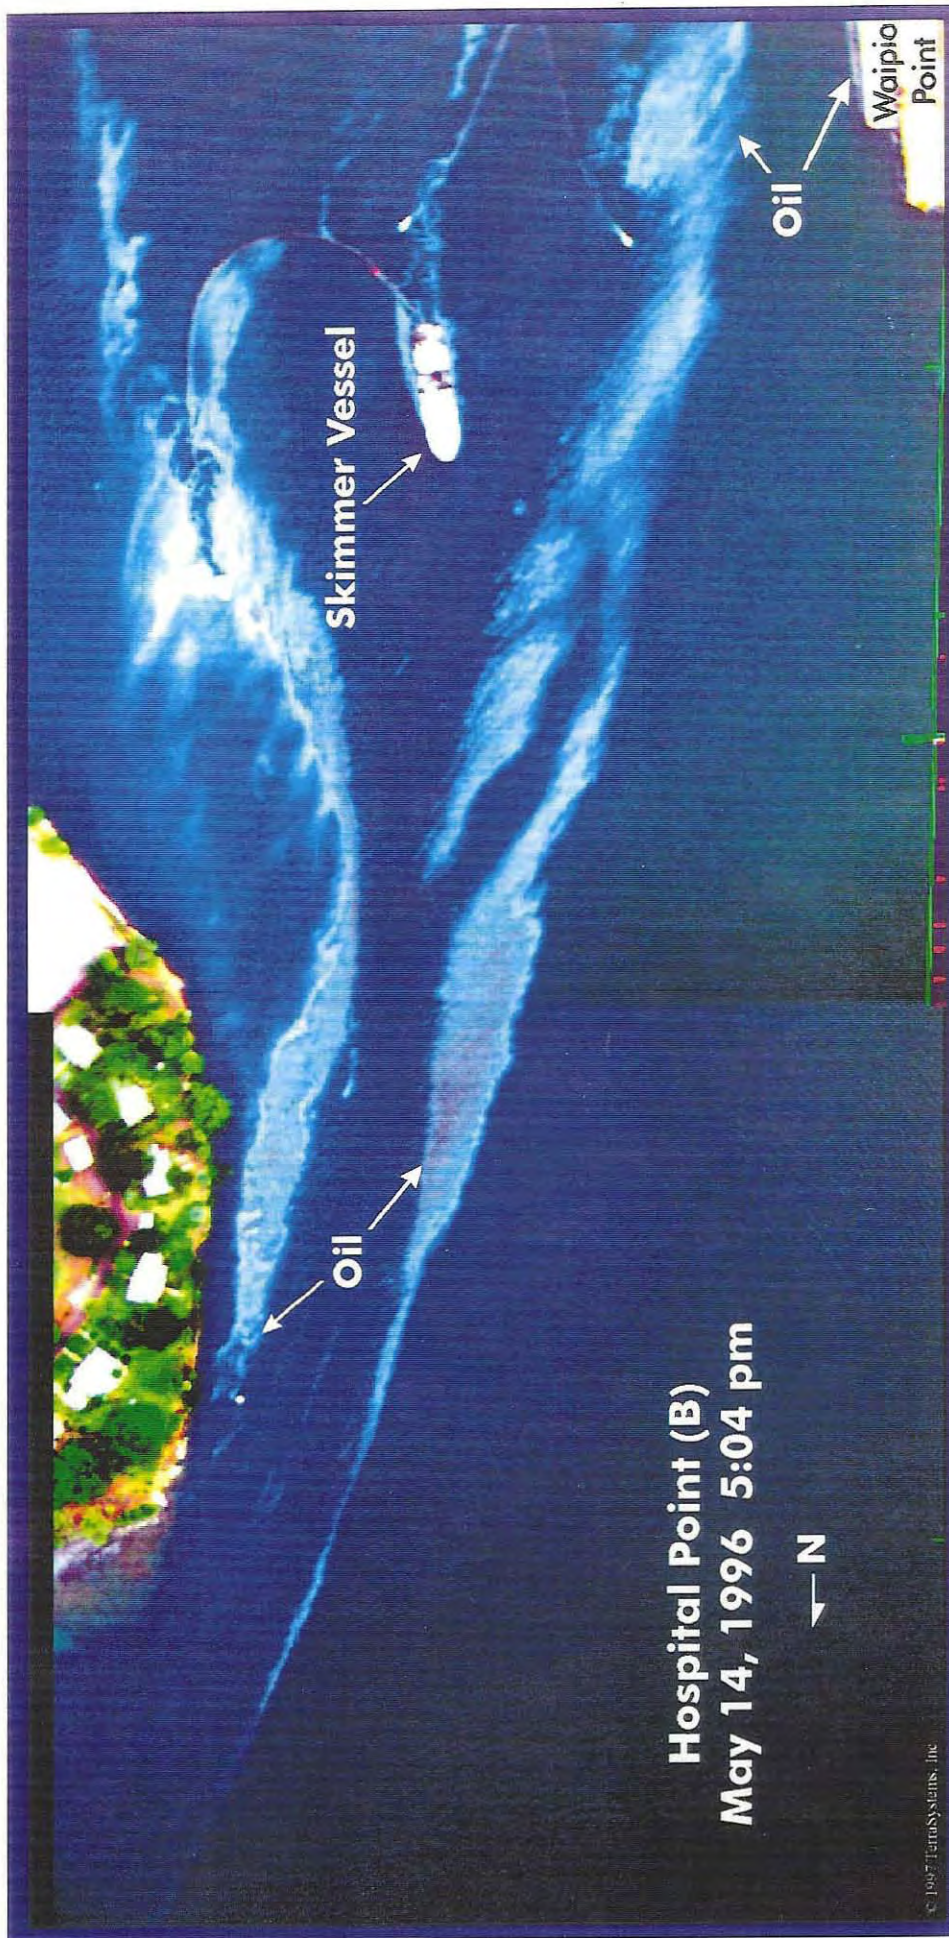
Hospital Point (B)
May 14, 1996 5:04 pm

Figure 3 (Hospital Point B) is a two image mosaic of the oil at Hospital Point in the channel at the entrance to Pearl Harbor. The skimmer vessel is seen collecting oil. Oil has impacted a region near Waipio Point. A light sheen can be followed all the way to the shore at Hospital Point.

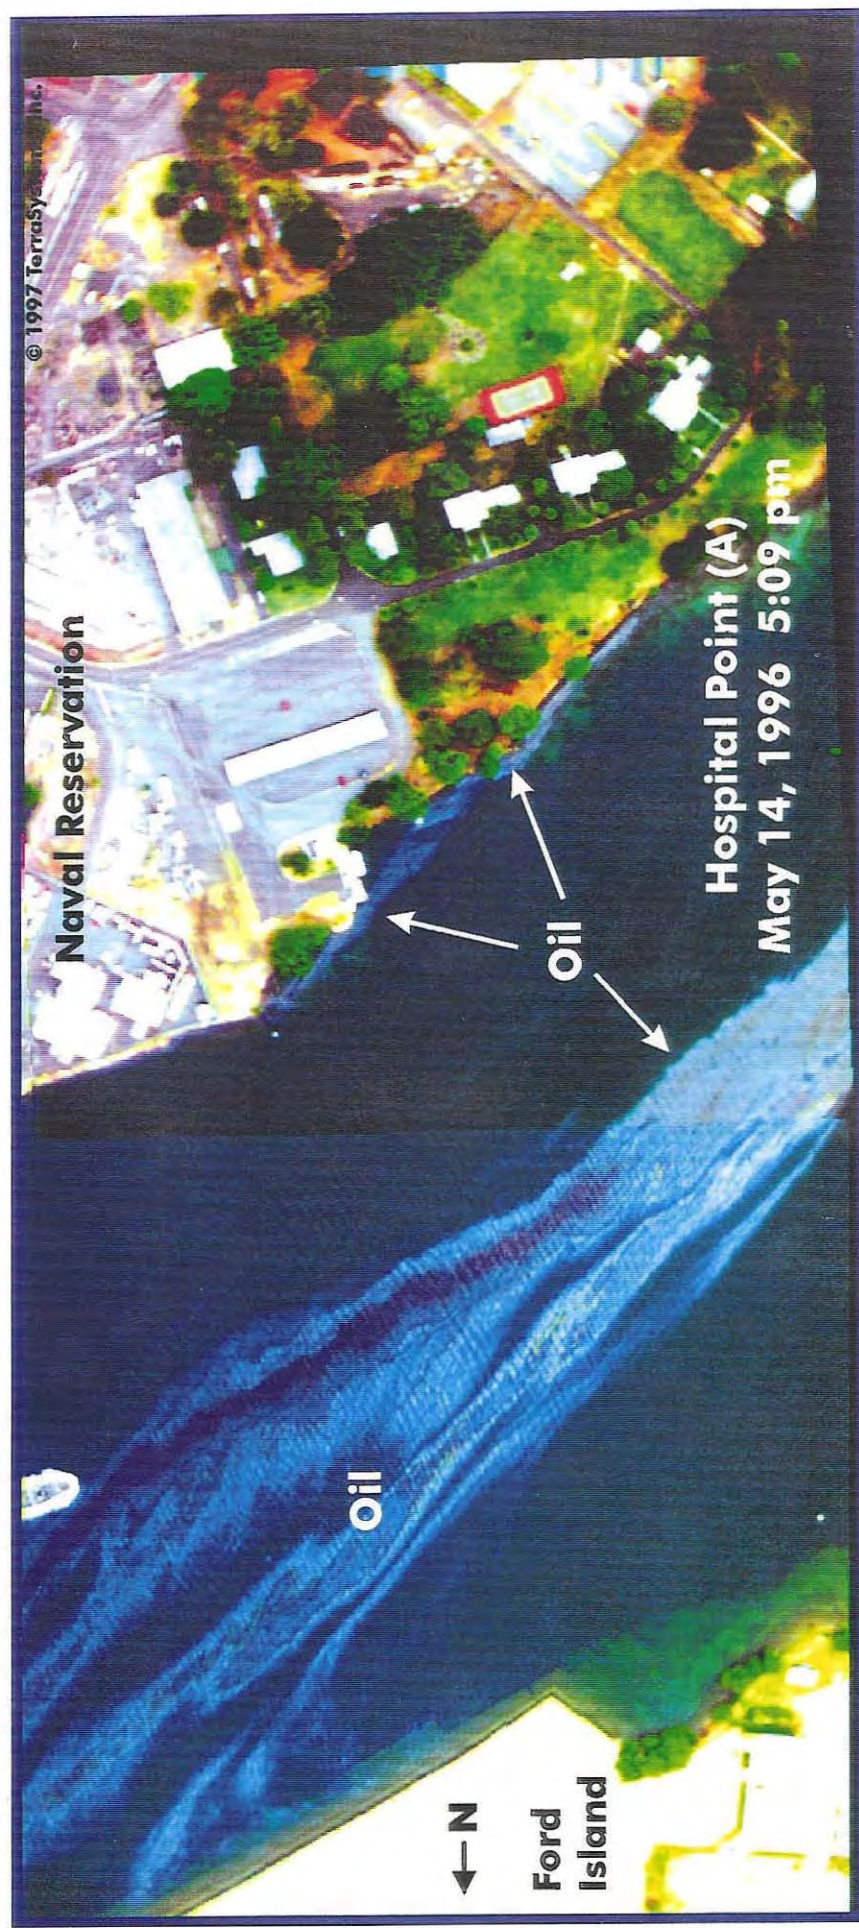
Hospital Point (A)
May 14, 1996 5:09 pm

Figure 2 (Hospital Point A) is a two image mosaic of the area just inside the harbor from Hospital Point. A large slick is seen between Ford Island and the Naval Reservation. A smaller slick is seen hitting the shoreline along Hospital Point.
