# **DRAFT RESTORATION PLAN and ENVIRONMENTAL ASSESSMENT**

## **DAN RIVER COAL ASH SPILL NATURAL RESOURCE DAMAGE ASSESSMENT AND RESTORATION**

**April 2019 DRAFT**

Dan River Natural Resource Trustee Council:

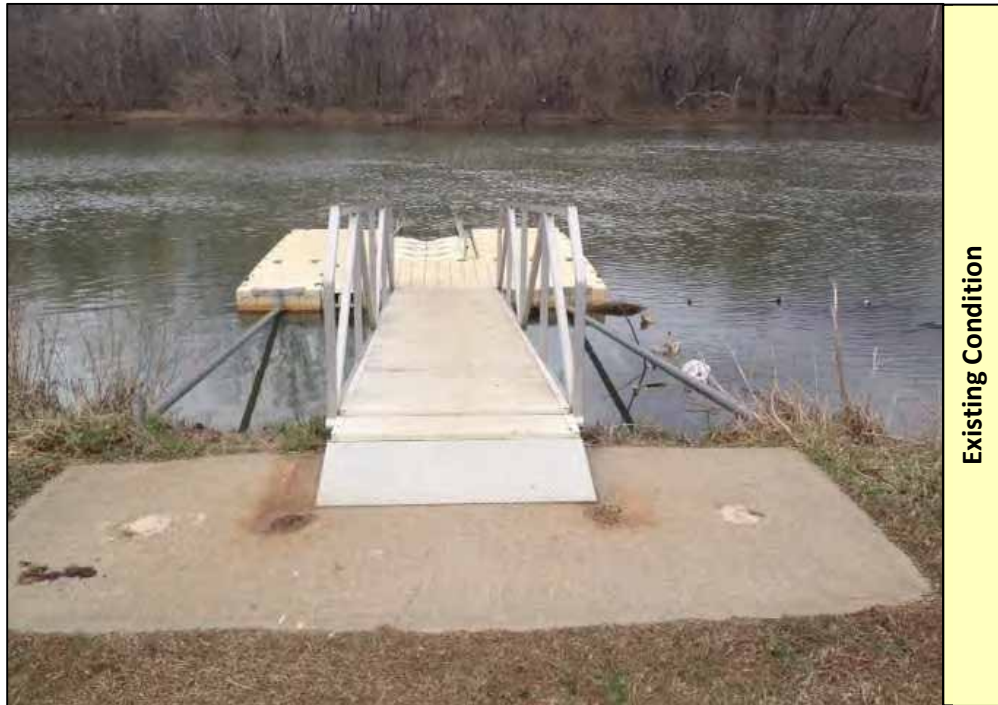
**Picture 1:** Existing floating dock and canoe launch. No enhancements planned.

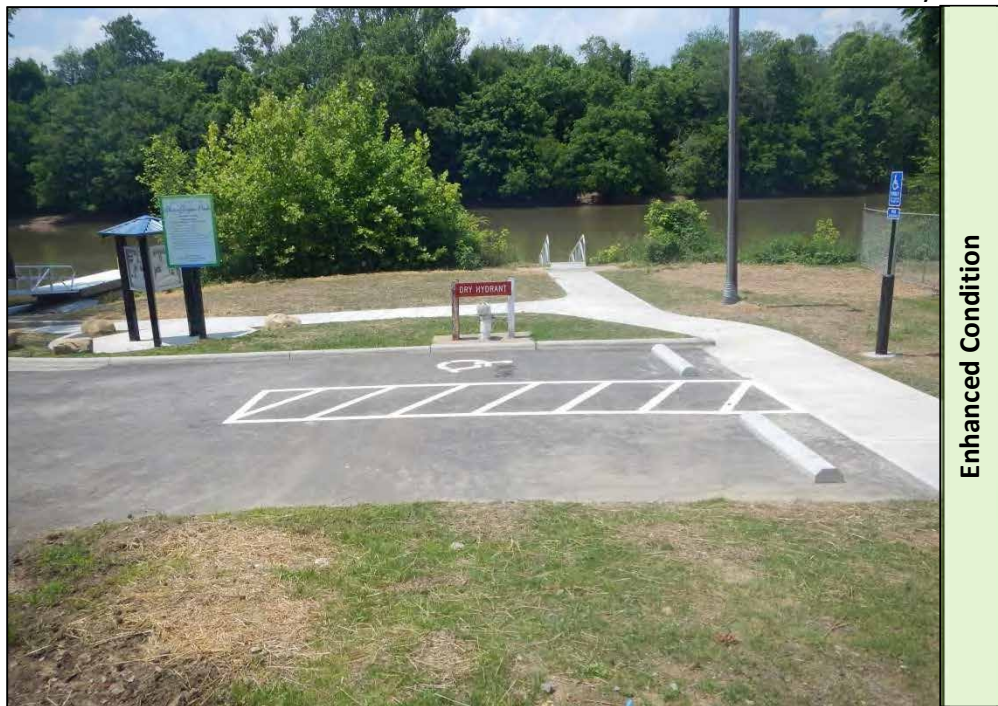
**Picture 2:** Added accessible parking and accessible sidewalk leading to the floating dock and canoe launch. Accessible sidewalk also leads to kiosk and courtesy dock.

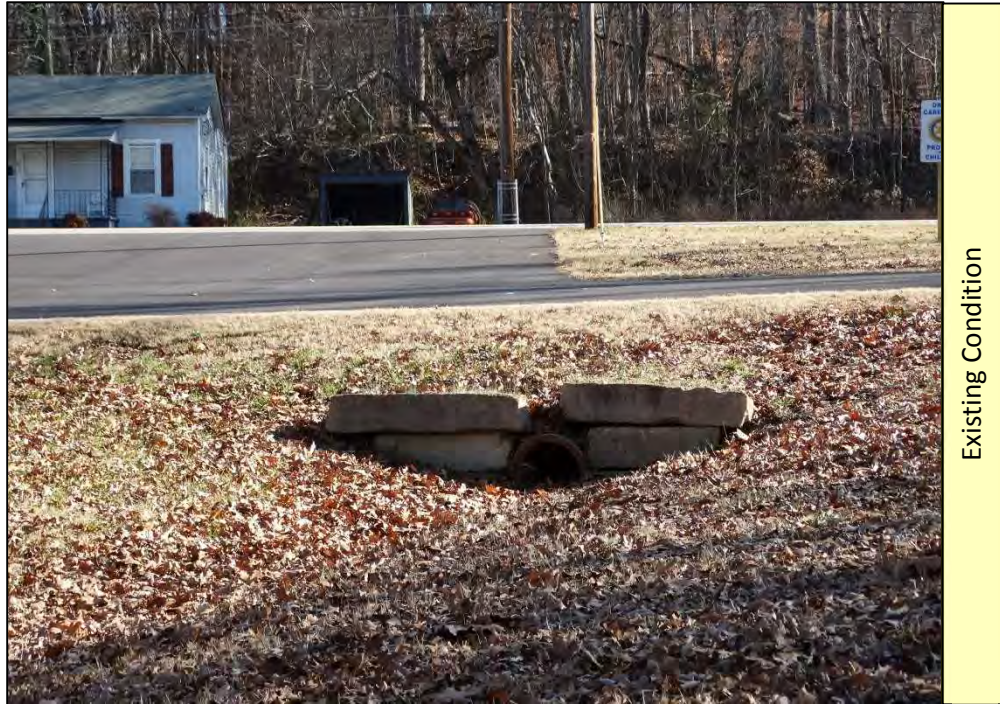
**Picture 7:** Existing culvert to receive new headwall.

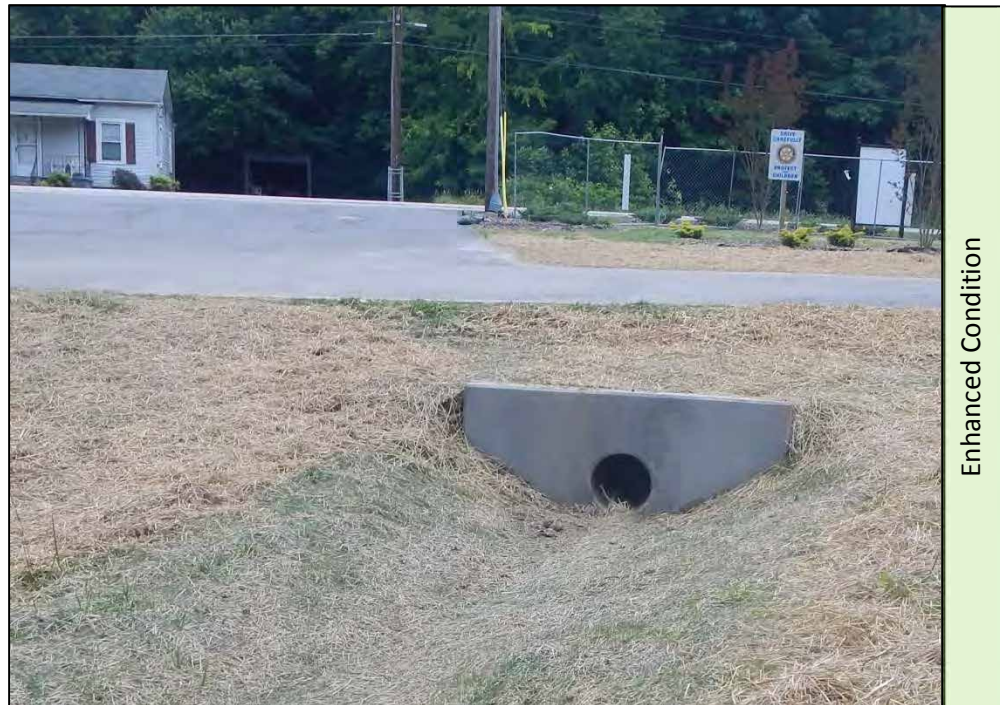
**Picture 8:** New headwall added to existing culvert.

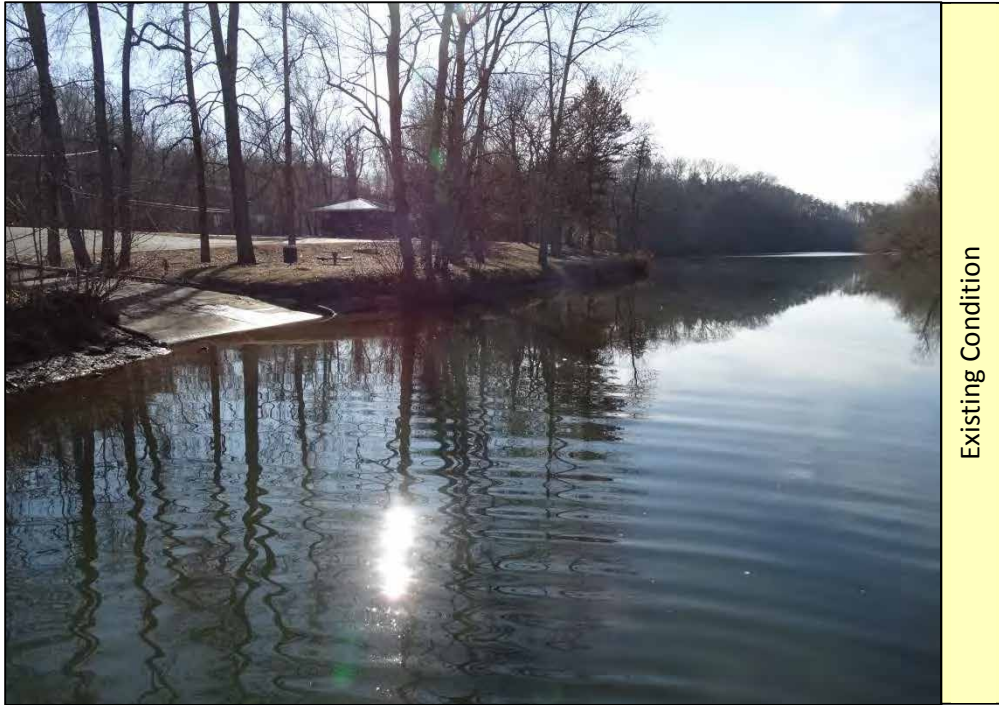
**Picture 11:** Additional view of existing boat ramp also showing area for proposed courtesy dock and fishing platform.

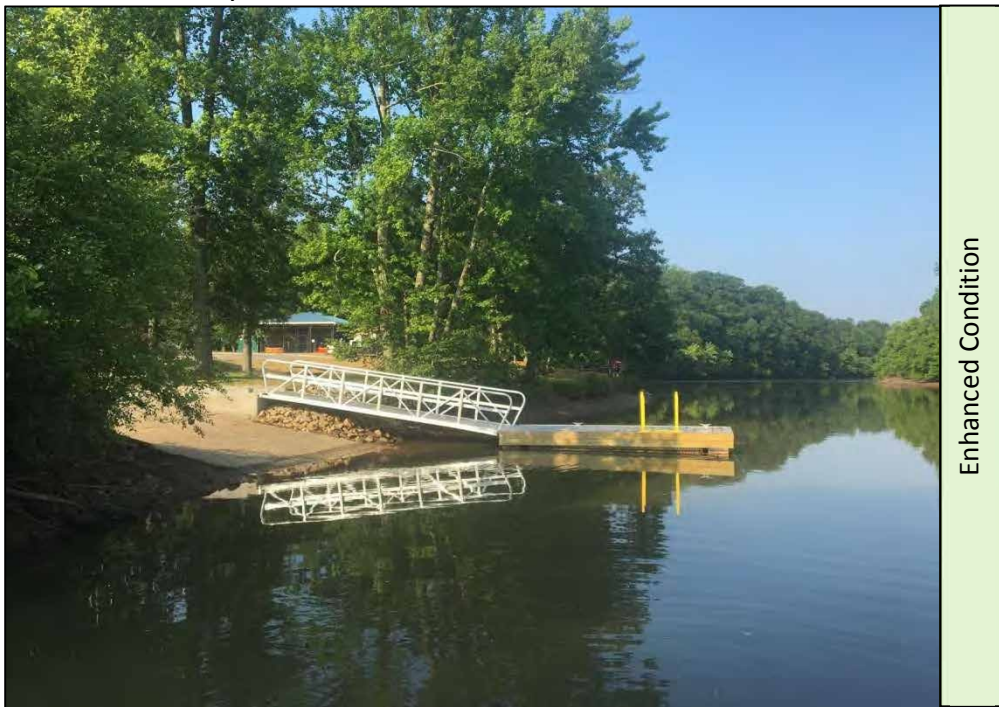
**Picture 12:** New courtesy dock.

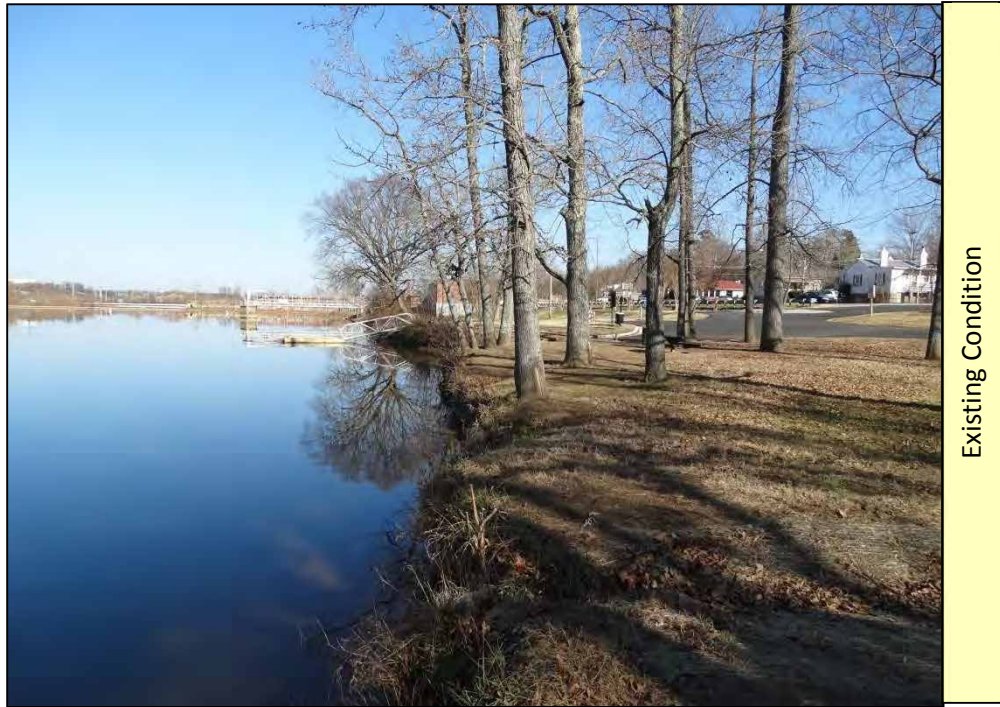
**Picture 13:** Area for proposed fishing platform and view of the existing floating dock and canoe launch.

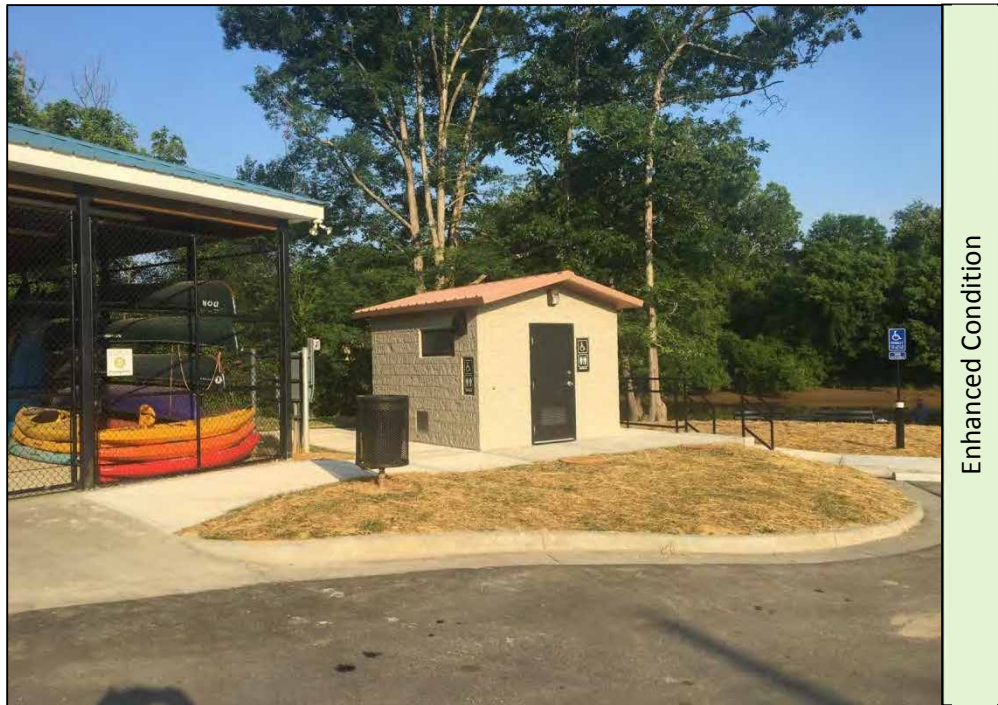
**Picture 18:** New restroom next to the existing storage building.

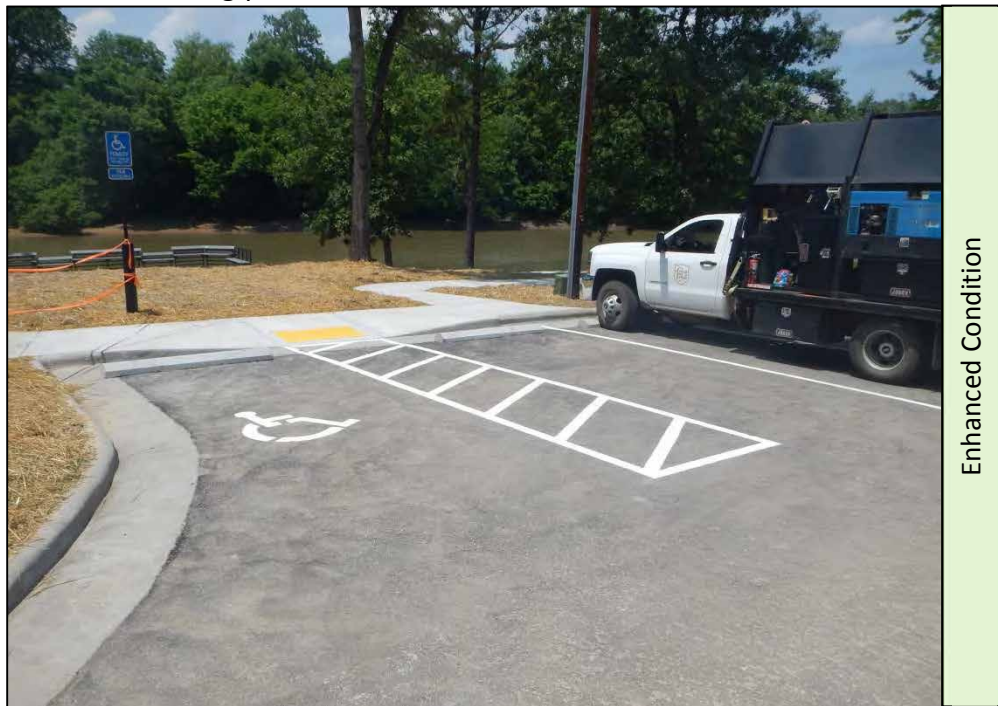
**Picture 22:** New accessible parking spaces with accessible sidewalk connecting to the restroom and fishing platform.

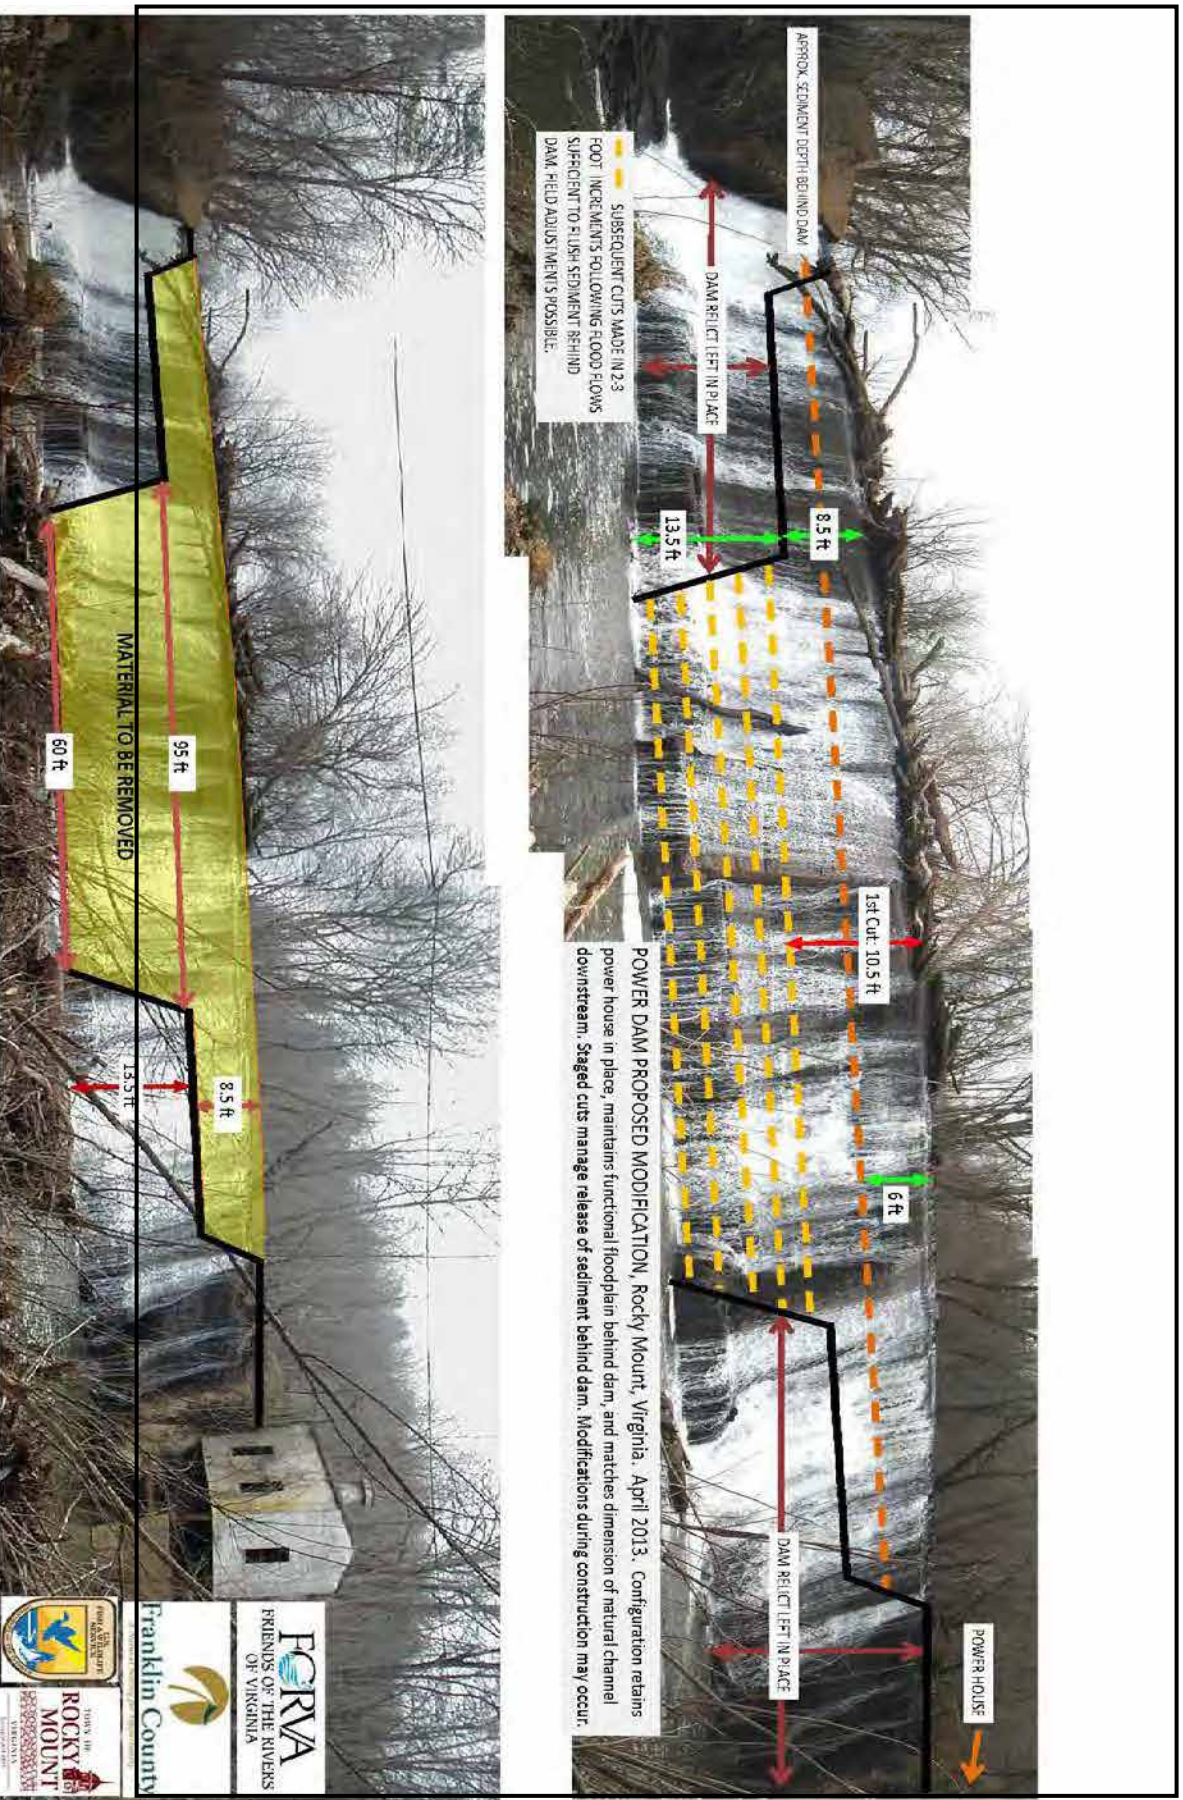
Figure 3. Proposed Sequential Notching and Final Notch Configuration Plan

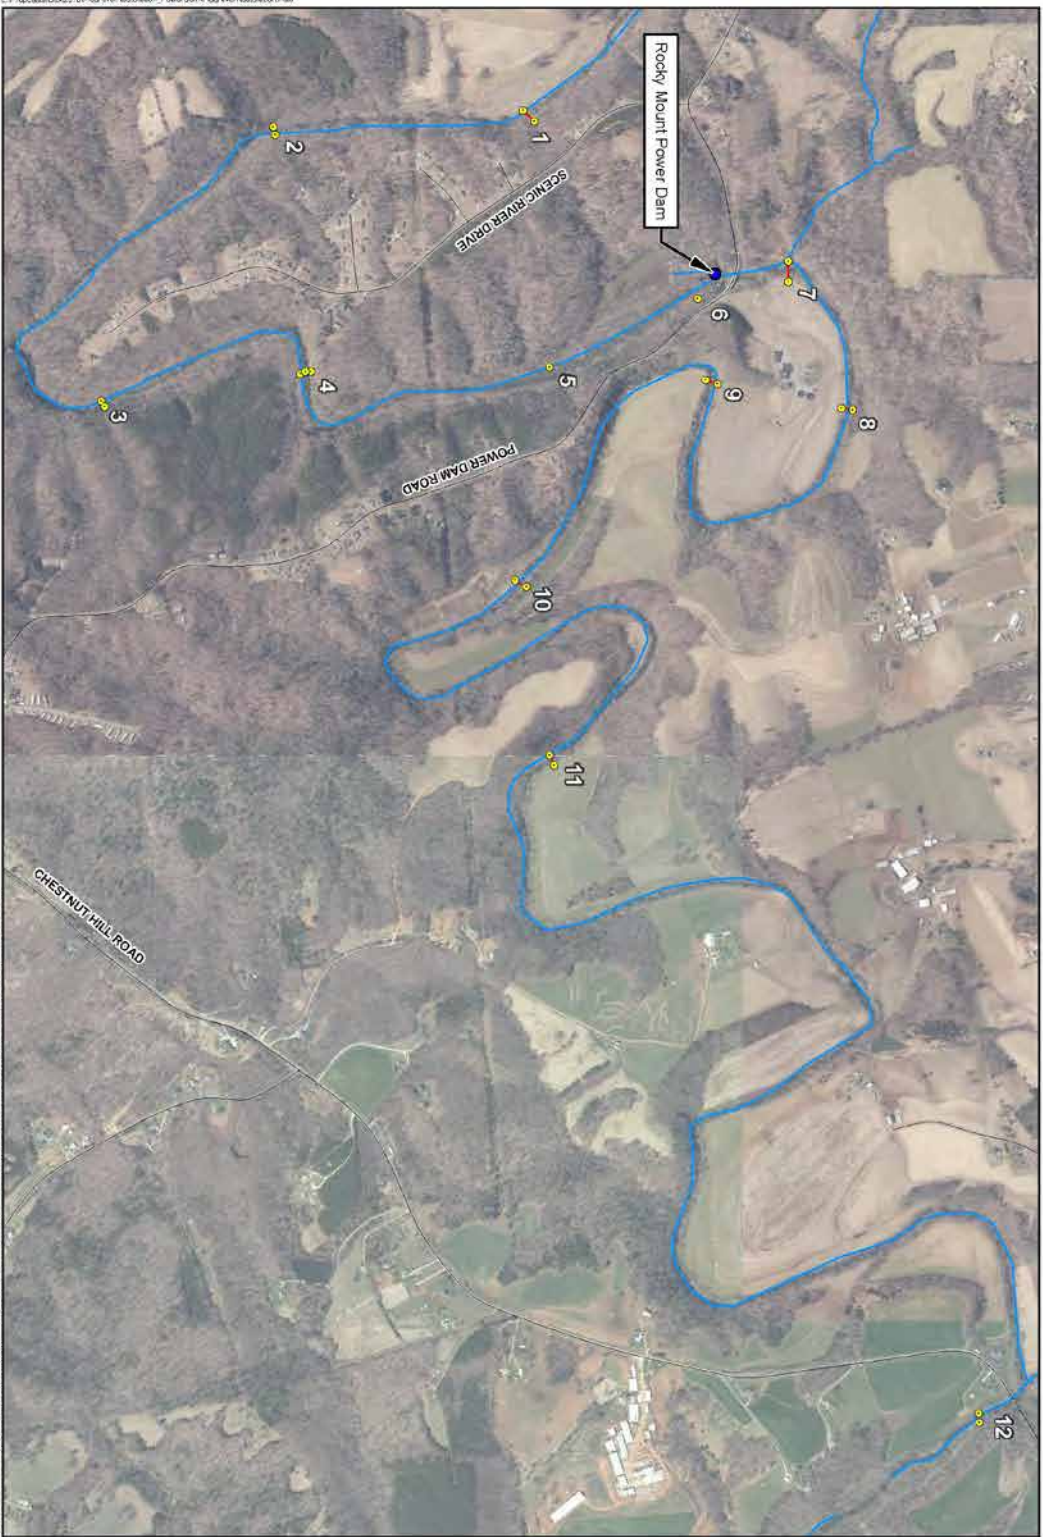
**Pigg River Restoration at  
Power Dam-Monitoring  
Permanent Monitoring Locations**  
Original Scale: 1"=1,000'

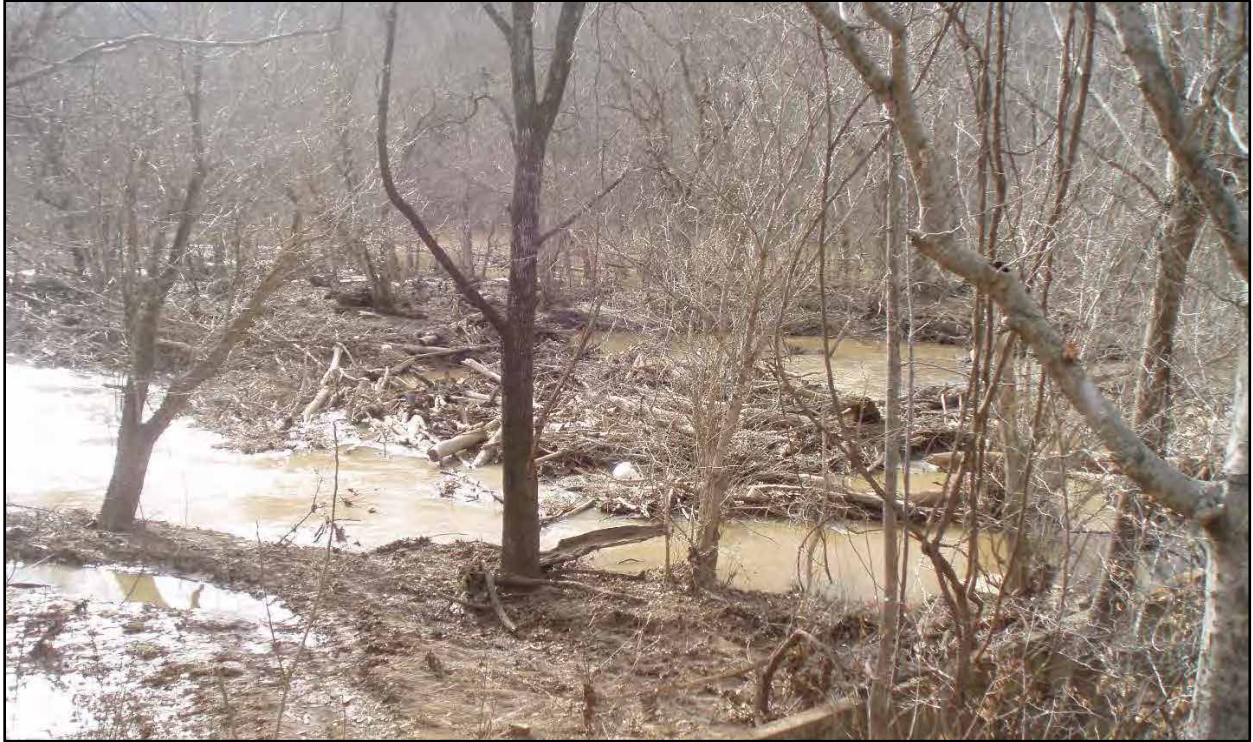
**3. Woody debris upstream of Power Dam blocking river channel pre-breach, causing adjacent flooding (1/26/06)**

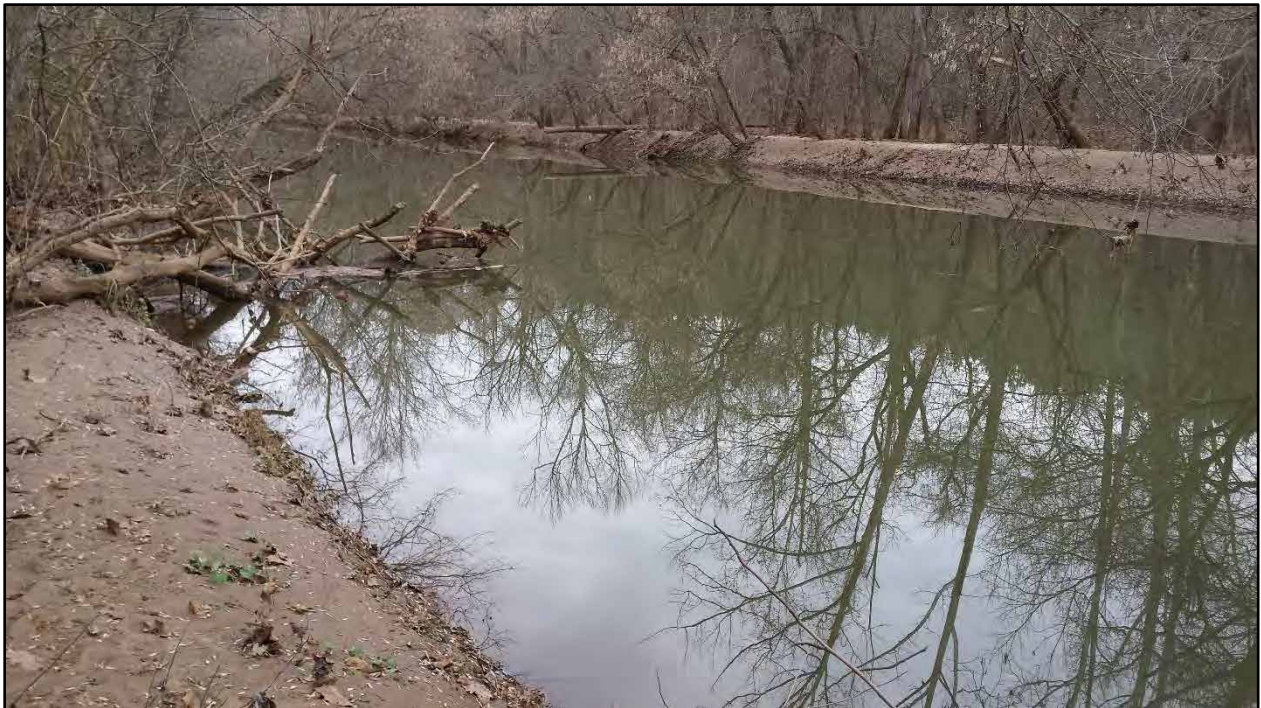
**4. Typical levee formations on both right and left banks upstream of Power Dam pre-breach (11/17/15)**

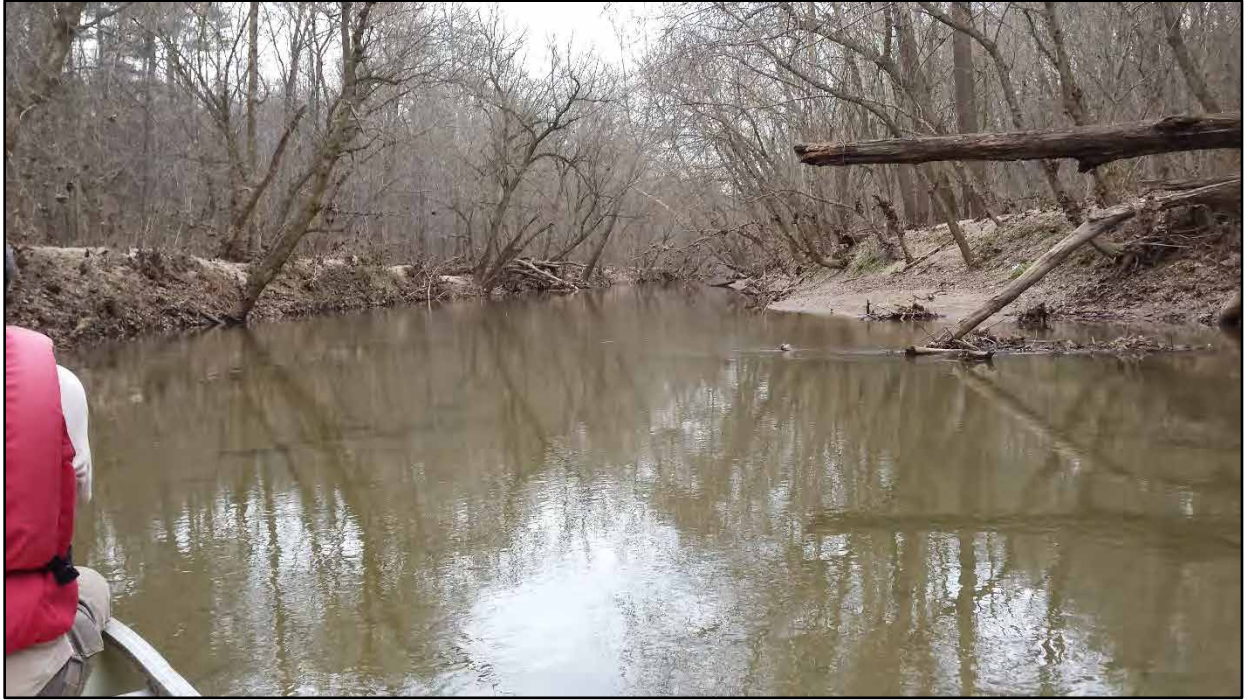
**5. Typical upstream river channel within pool with high levees and shallow, sediment filled channels (11/17/15)**

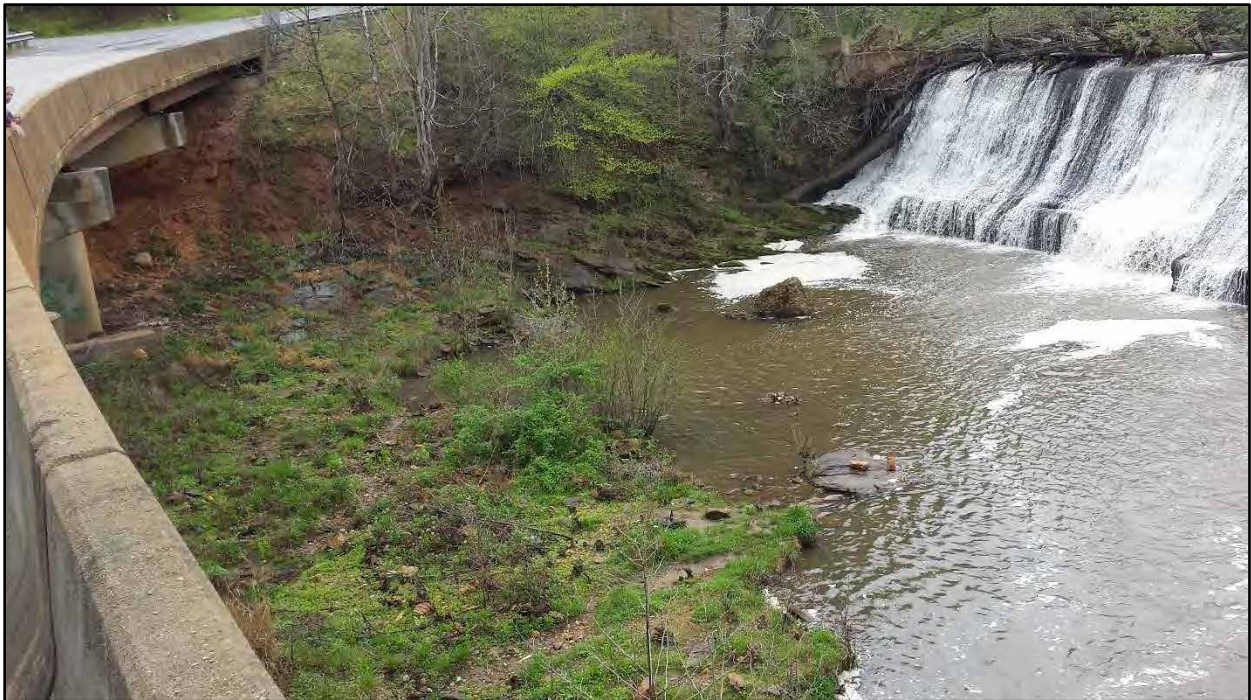
**6. Over-widened channel and scour hole on right bank below Power Dam, view east (4/16/15)**

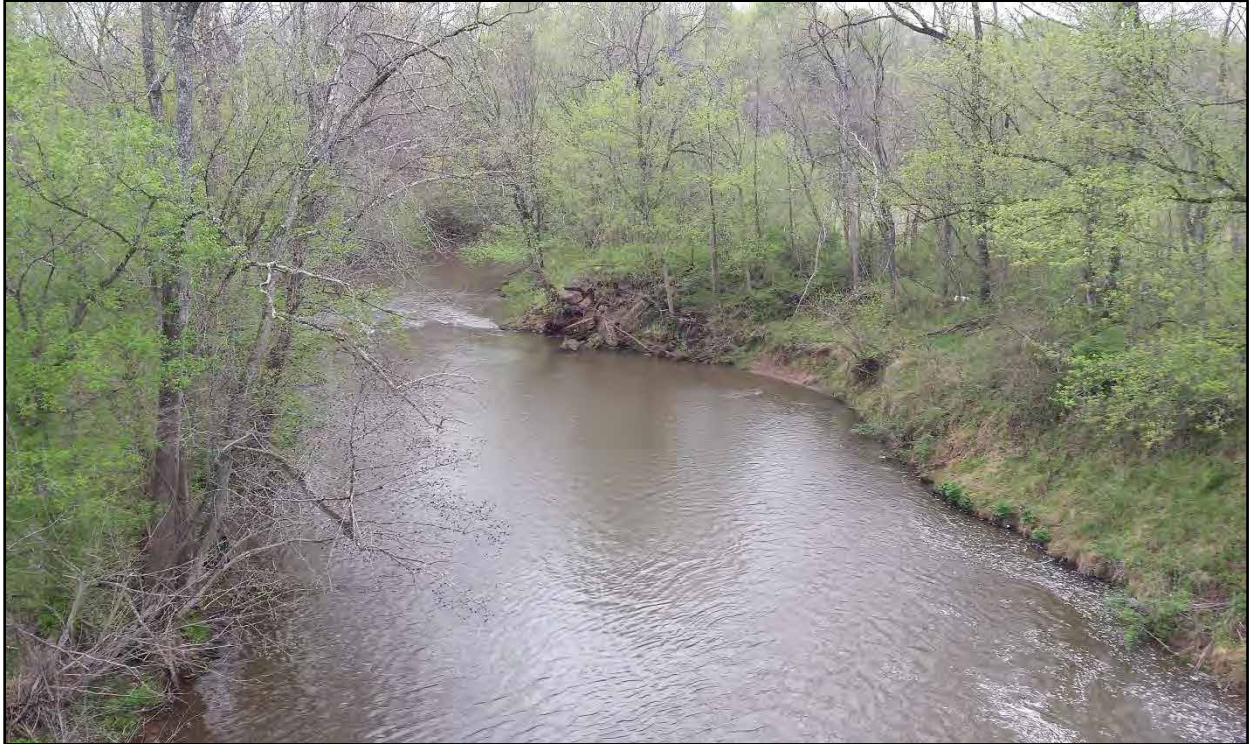
**7. View north, downstream of Power Dam depicting over-widened, sediment starved channel (4/16/15)**

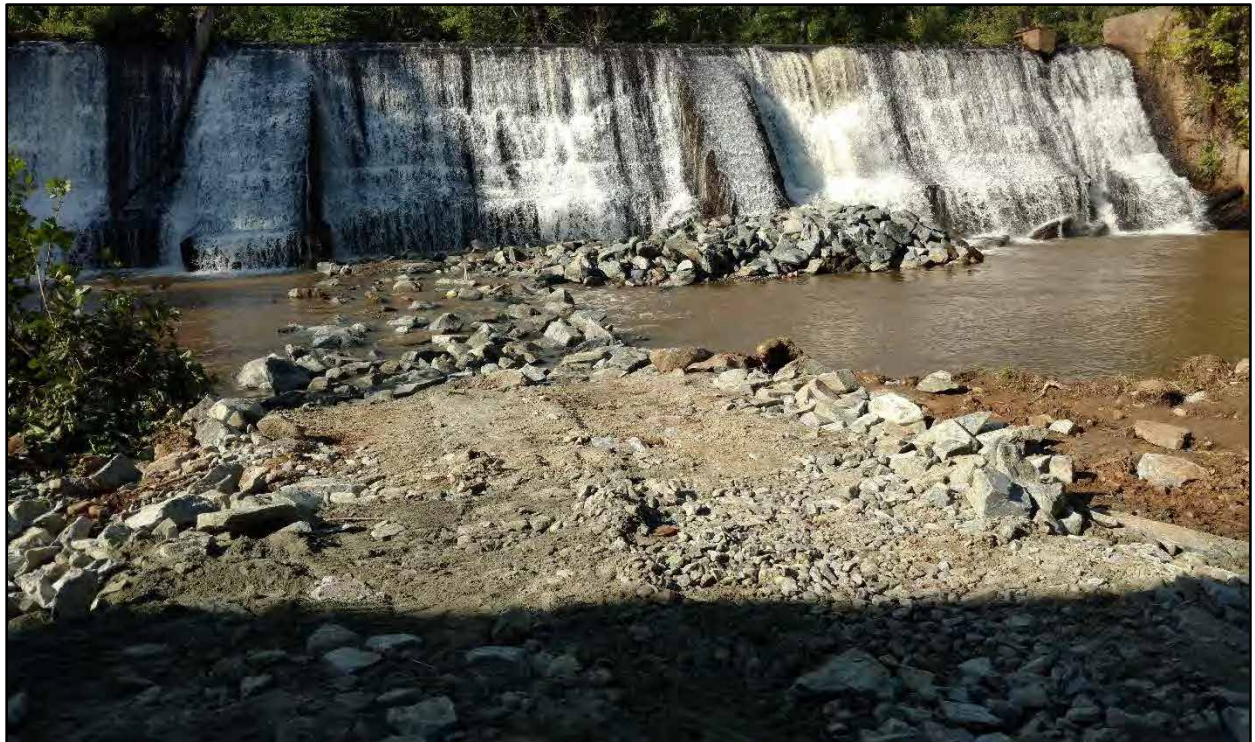
**10. Construction access causeway in place prior to removal, view north (8/25/16)**

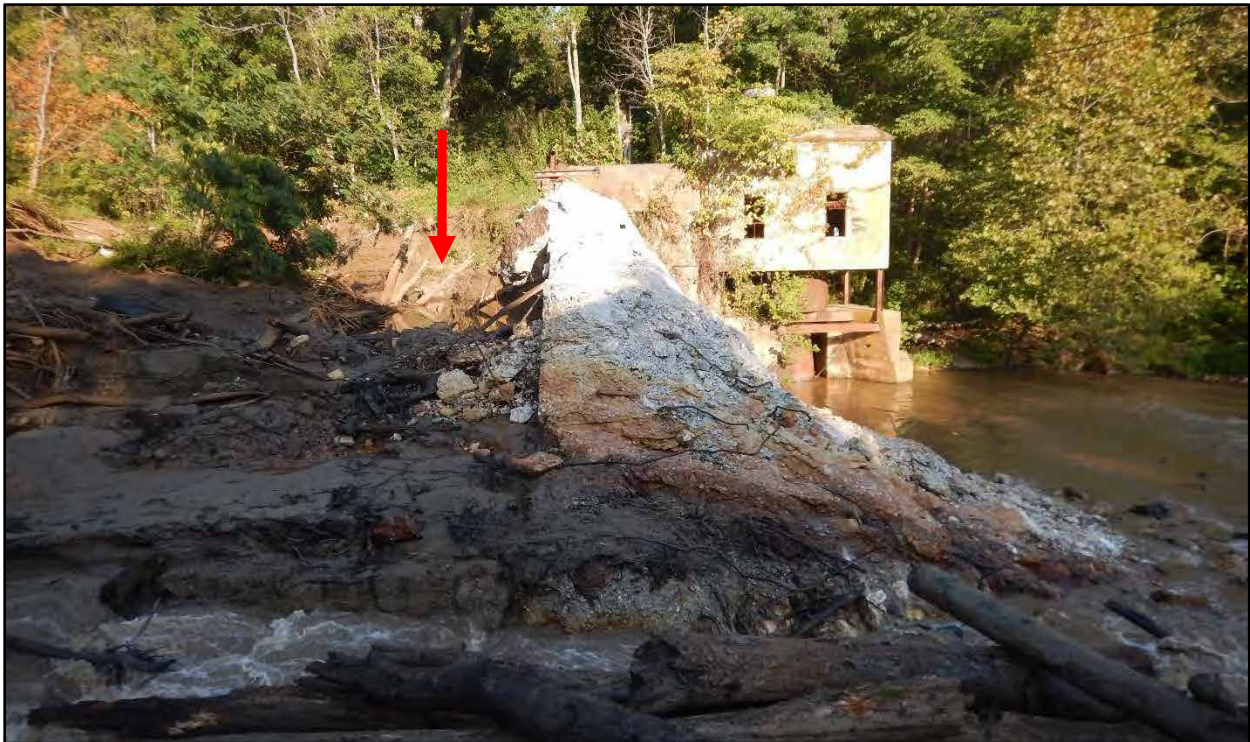
14. Exposure of existing scour hole (red arrow) above Power Dam, potentially leading to wetland headcut (9/7/16)

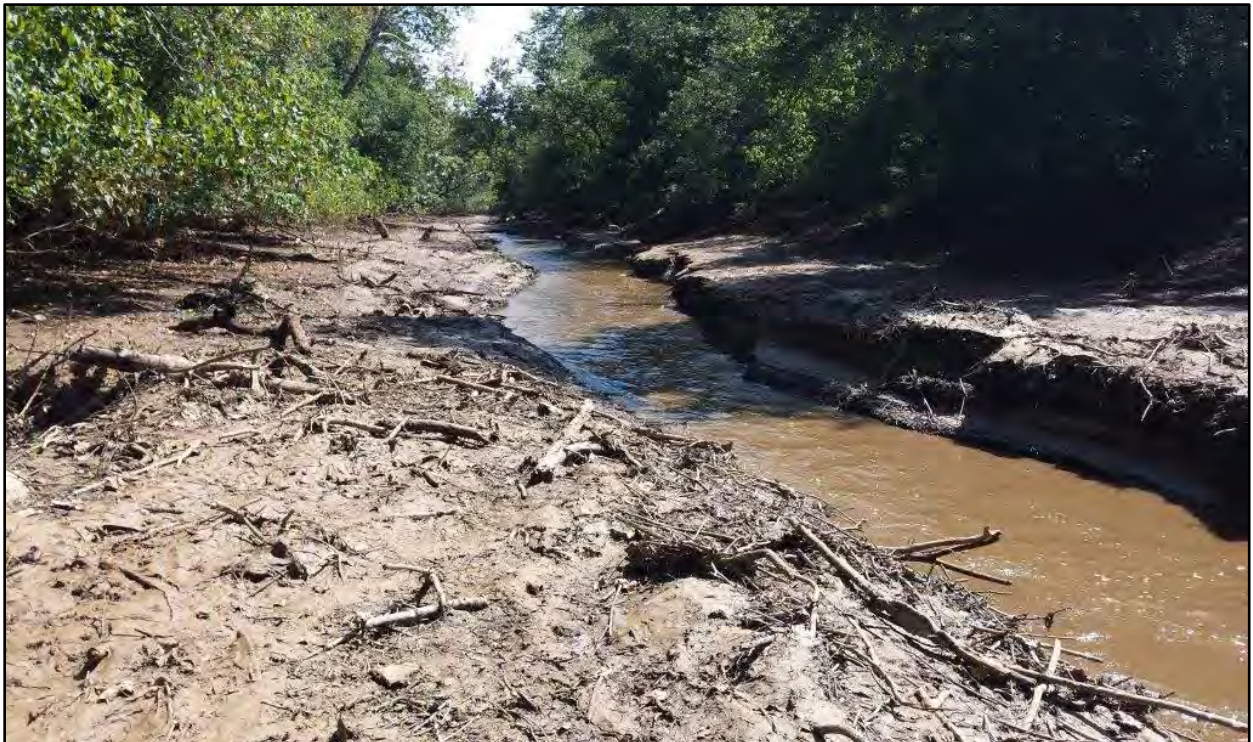
**18. River cutting channel through relict sediment immediately upstream of breach, view east (9/12/16) (credit FORVA)**

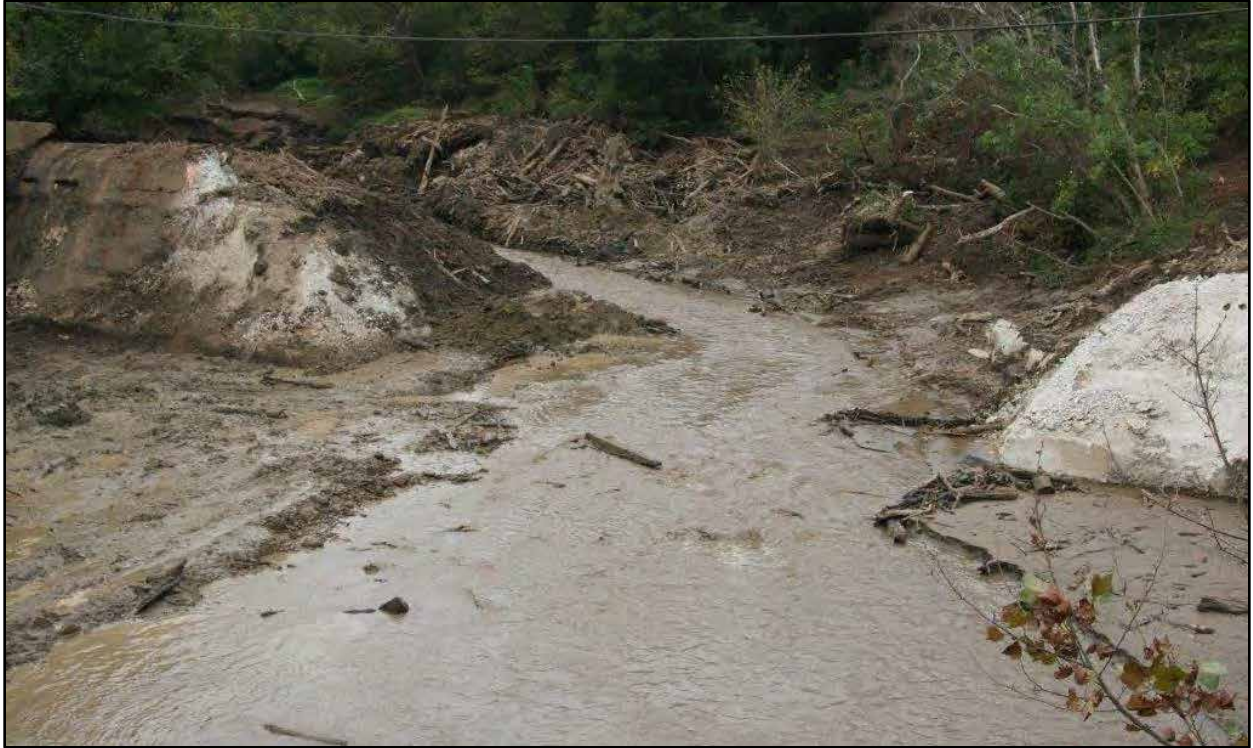
**23. Sixty-five foot width base flow channel completed through Power Dam (9/22/16) (credit FORVA)**

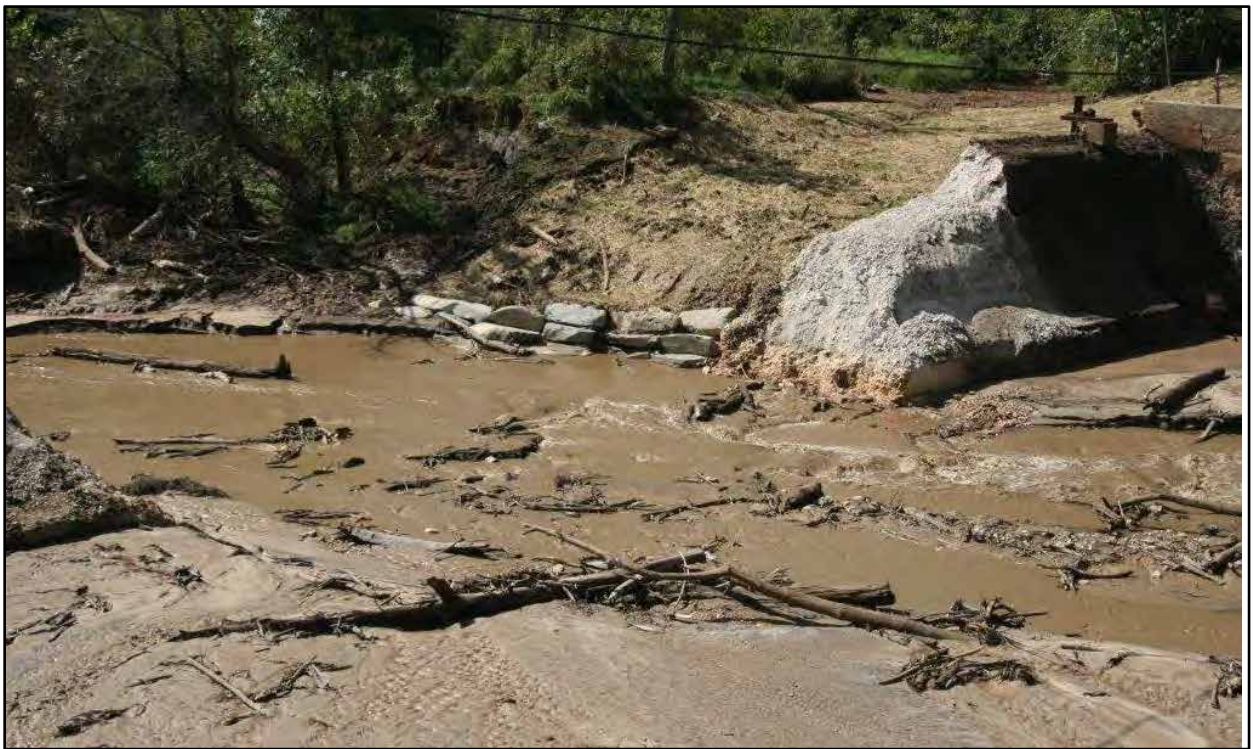
**24. View of left bank upstream of dam after stacked stone toe, backfilling, and matting stabilization (10/5/16)**

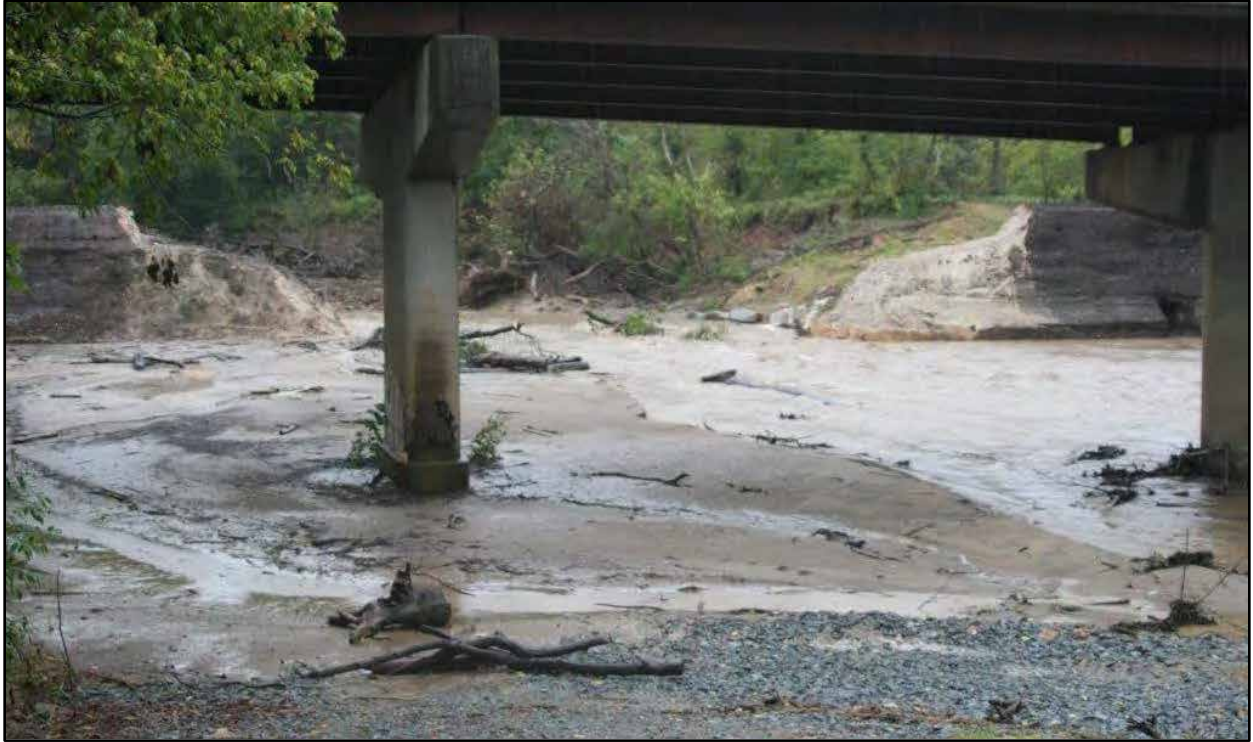
**25. Floodplain deposition in downstream scour area during high flow event, view southeast (11/9/16) (credit FORVA)**

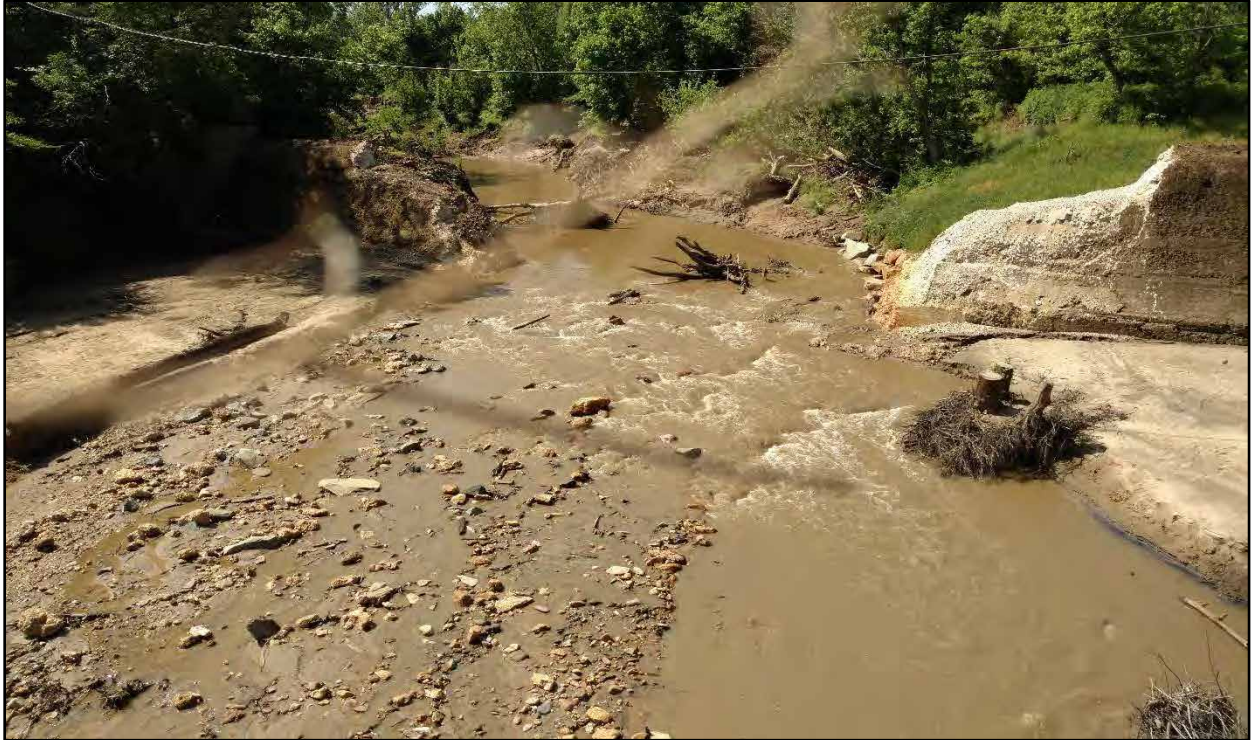
**29. Cobble and gravel sediment transport through breach in dam (5/25/17)**
