## **Blacksburg Country Club**

# North Fork Roanoke River Restoration and Riparian Buffer Establishment

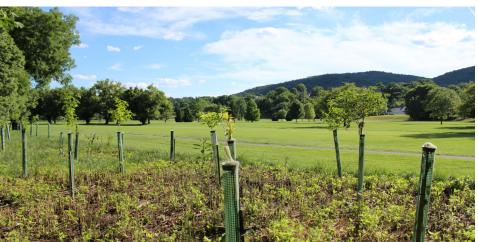
Trees planted on the riverbank of the North Fork of the Roanoke River as part of the habitat restoration. A total of 3 acres of river buffer was planted with native grasses and trees, including birch, oak, and dogwood species.

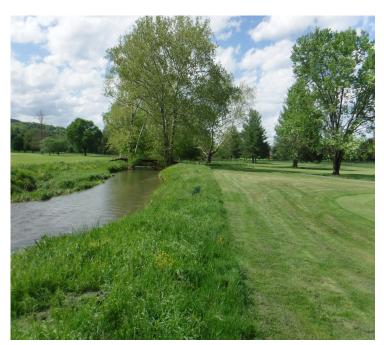
Before (left), during (middle), and after (right) photos of a restoration project at BCC. This section of river had significant bank erosion. Restoration activities included installation of a rock vane structure where the most excessive erosion was occurring to deflect flows to the center of the channel and reduce stress on the banks. Riverbanks were planted with woody vegetation and native grasses. Below shows the buffer of native grasses in an area that is in-play.

Modest management adjustments, such as reducing the frequency of moving along river banks, allowed for the establishment of a grassy riparian buffer that will contribute to improved water quality without obstructing in-play areas of the golf course.
