Cross Section 7

Pigg River Dam Removal Restoration - Monitoring
 Rocky Mount, Virginia
 Year 2 - XS 7
 Copyright © 2018

Photographic Documentation of Tributary Channels

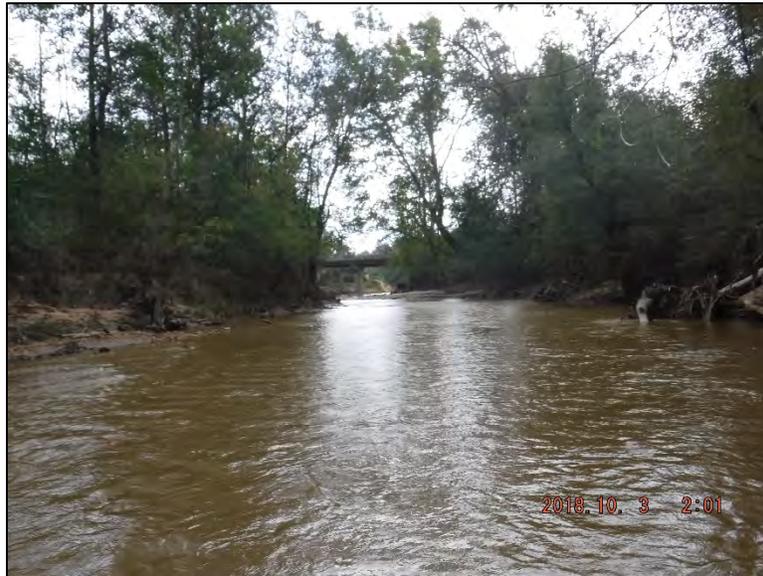
Photo 7-1

Description: View looking upstream from the middle of Cross Section 7

Woody Debris: 20

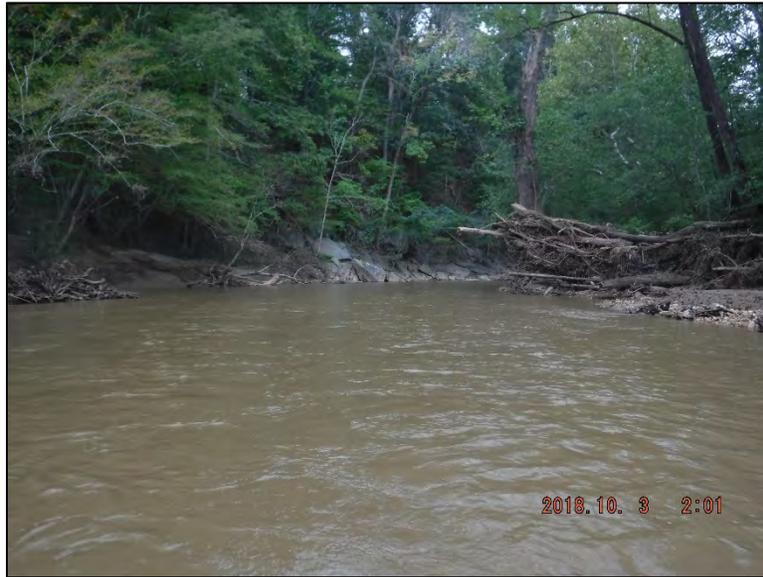
Photo 7-2

Description: View looking downstream from the middle of Cross Section 7

Woody Debris: 80 (pile up)

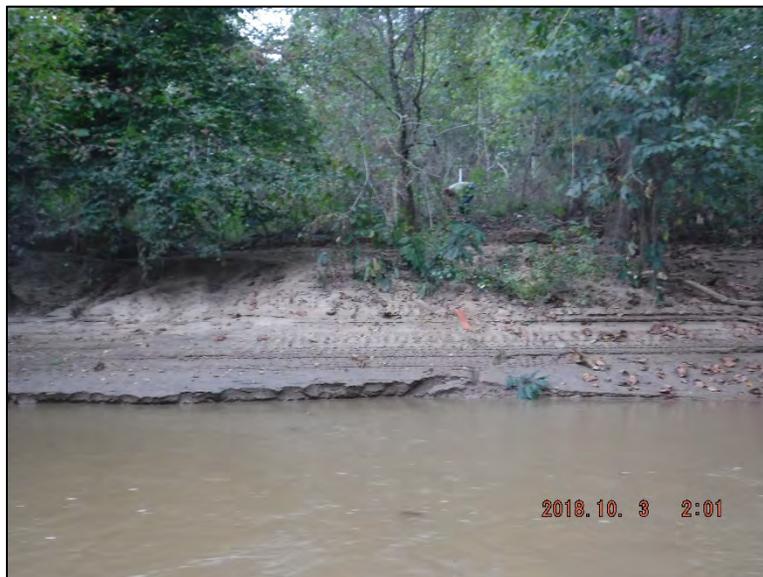
Photo 7-3

The water surface width at this section was significantly wider than in previous years due to the observed high baseflow conditions. Fine sediment released from behind the dam has deposited on left bank where little vegetation is established, and minor scour marks are visible at the toe of the slope. The right bank also had fine sediment deposited but also contained large woody debris. The right bank had a 5-ft. wide bar with some pebbles at the toe of slope.

Description: View looking left from the middle of Cross Section 7

Vegetation: 15% herbaceous cover, few trees

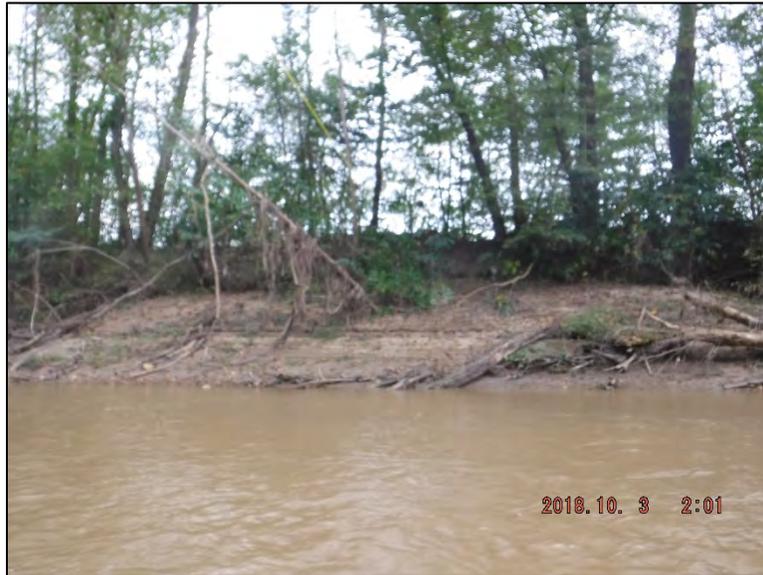
Photo 7-4

Description: View looking right from the middle of Cross Section 7

Vegetation: 20% herbaceous plants, trees at bankfull

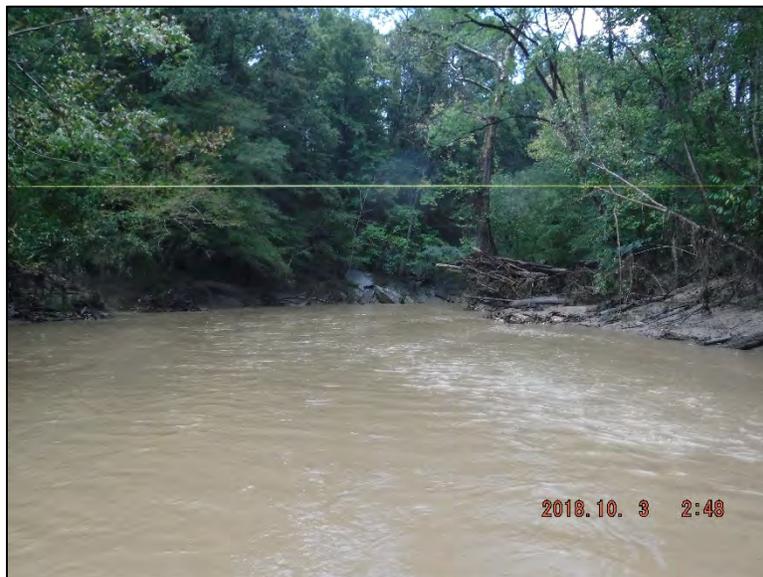
Photo 7-5

Location, Orientation: XS 7, Upstream looking down

Description: View looking downstream at Cross Section 7 from an upstream position

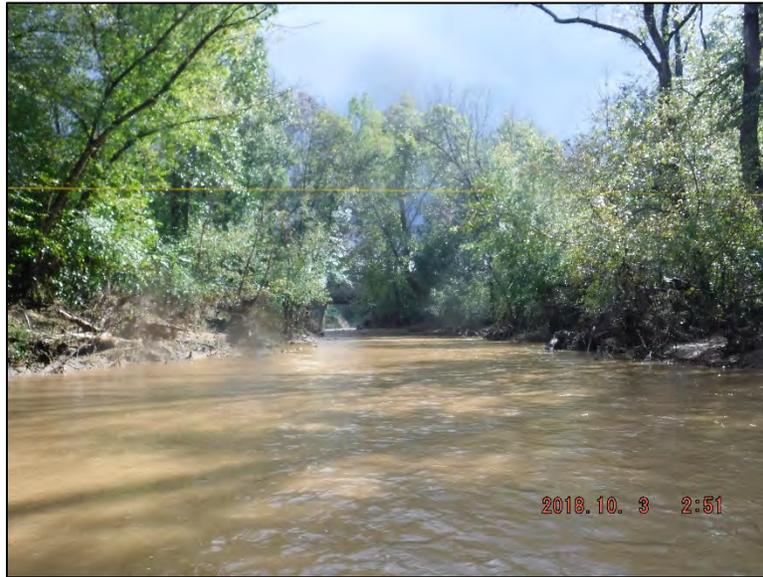
Photo 7-6

Location, Orientation: XS 7, Downstream looking up

Description: View looking upstream at Cross Section 7 from a downstream position

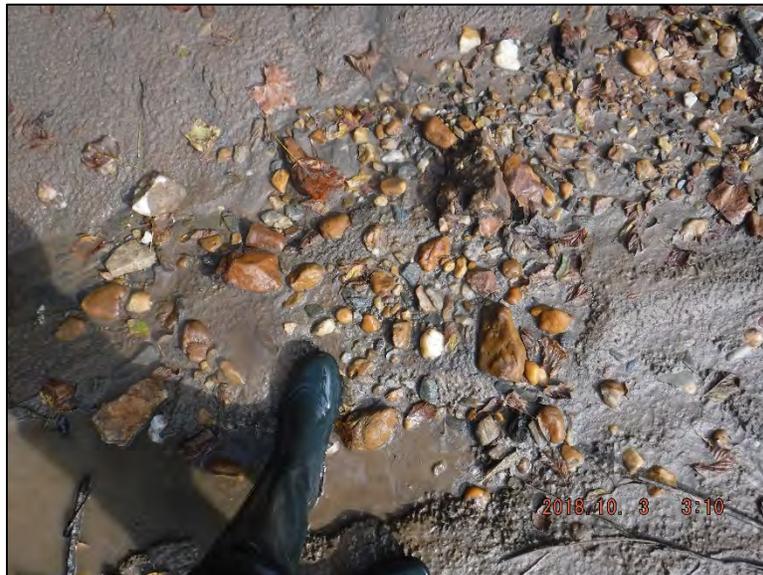
Photo 7-7

The instrument setup for this cross section was at the right bank (HI = 3.20 ft.). The cross section plot and thalweg profile are shown below. No pebble count was taken at this location due the generally uniform fine-grained (sandy) nature of bed sediments, however, a narrow band of coarse bed material (pebbles 2-4-in in diameter with a few 10-25-in diameter cobble in the center of the stream and on a nearby bar (see photo 7-7).

Description: Bed material at Cross Section 7 was almost entirely silt/sand with some pebbles this size

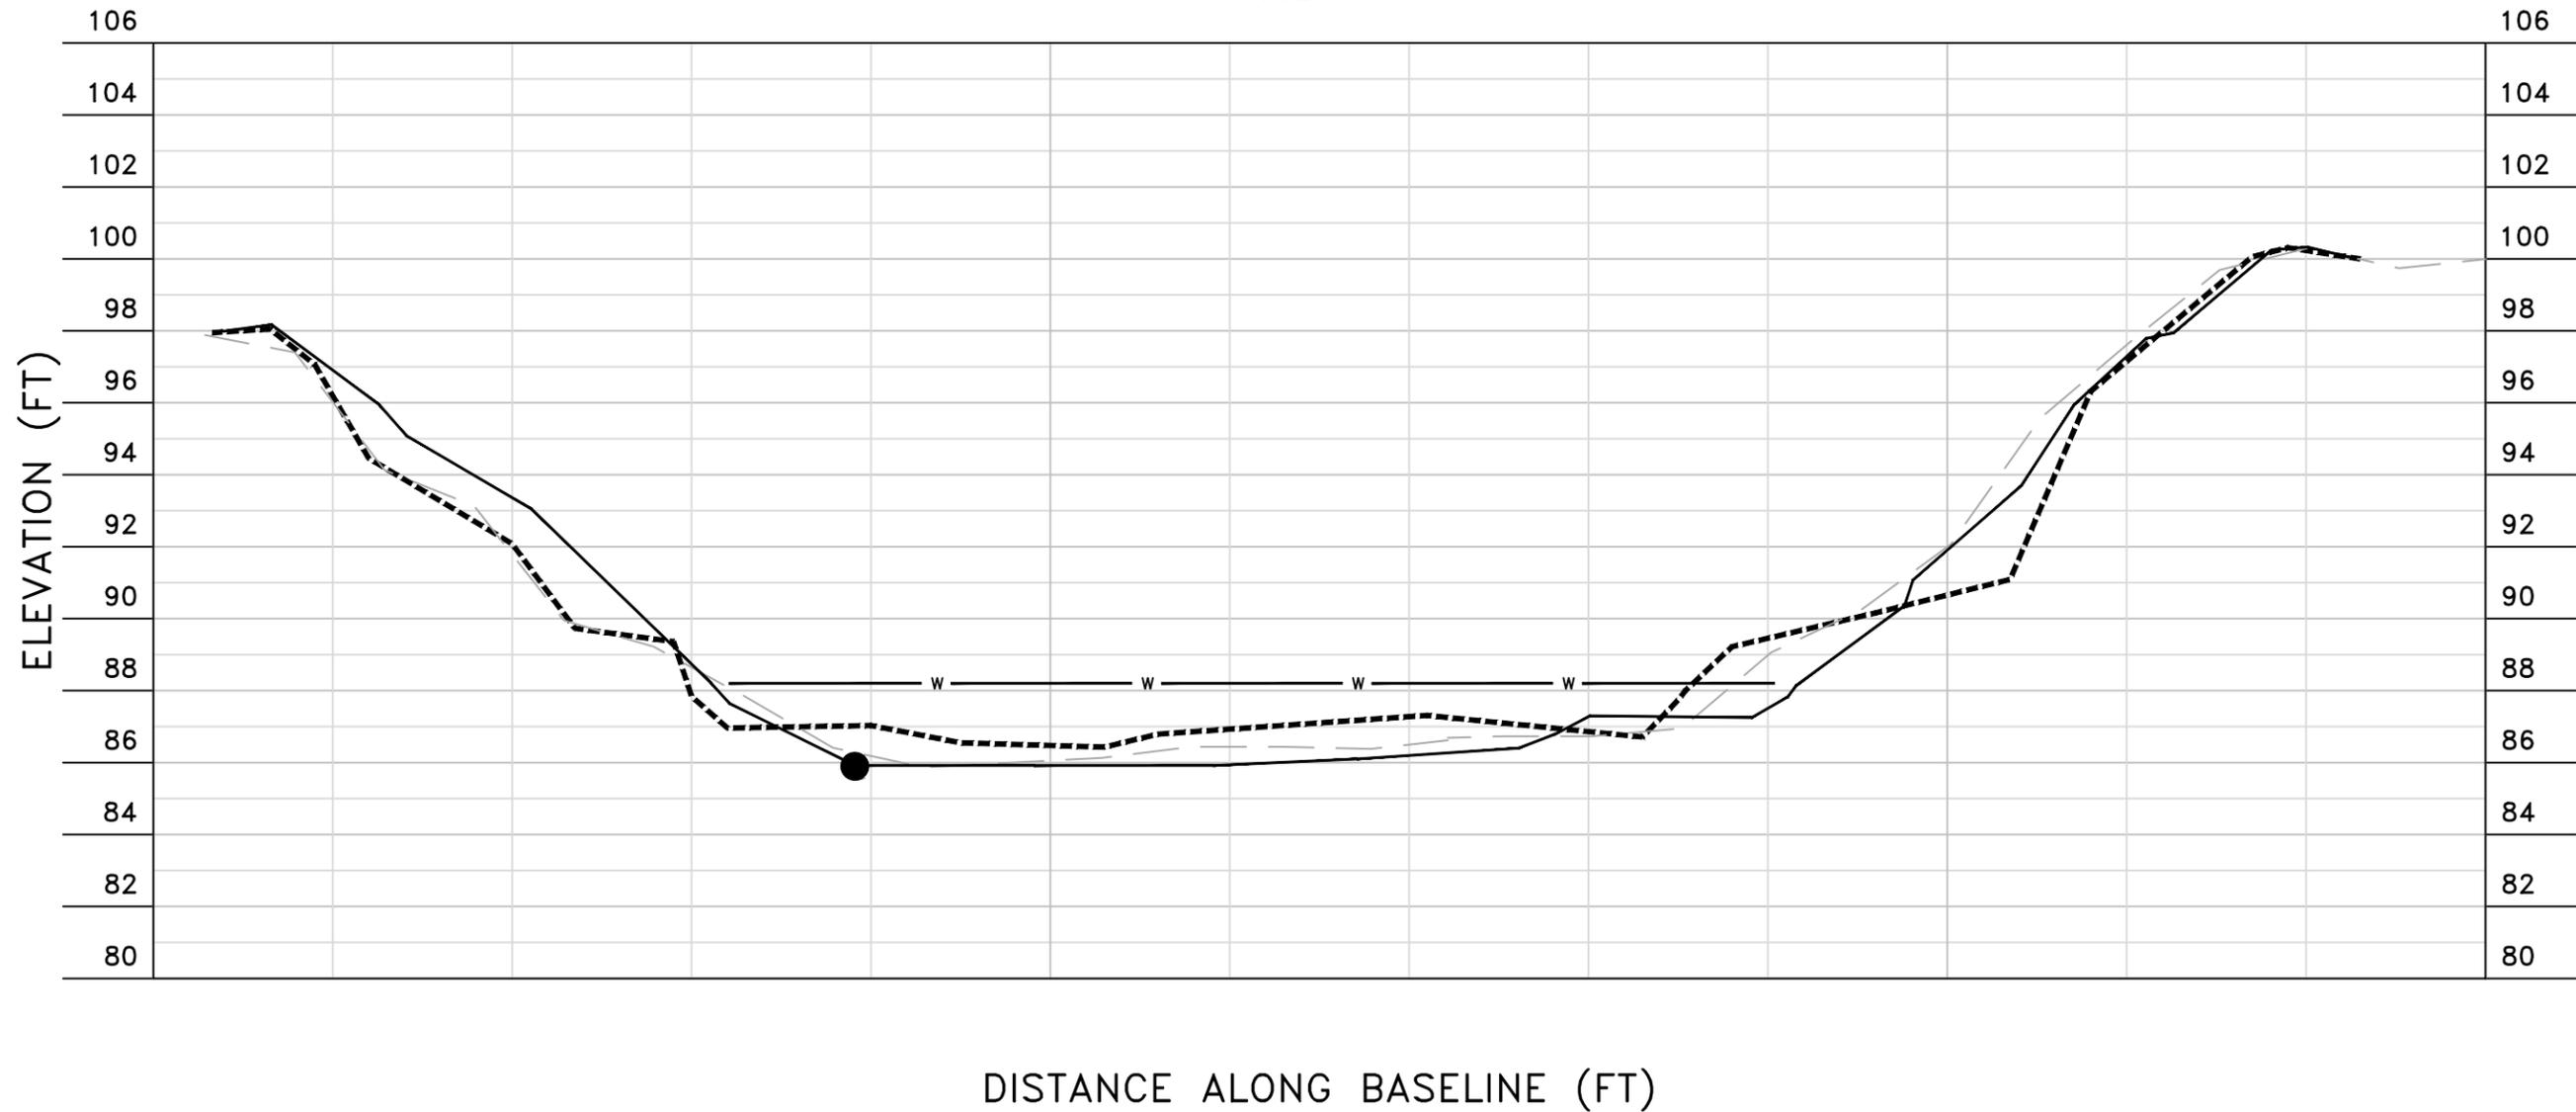
XS 7

PROFILE SCALE:
 HORIZ: 1"=10'
 VERT: 1"=5'
 (ELEV. RELATIVE TO ASSUMED XS END PIN AT 100.)

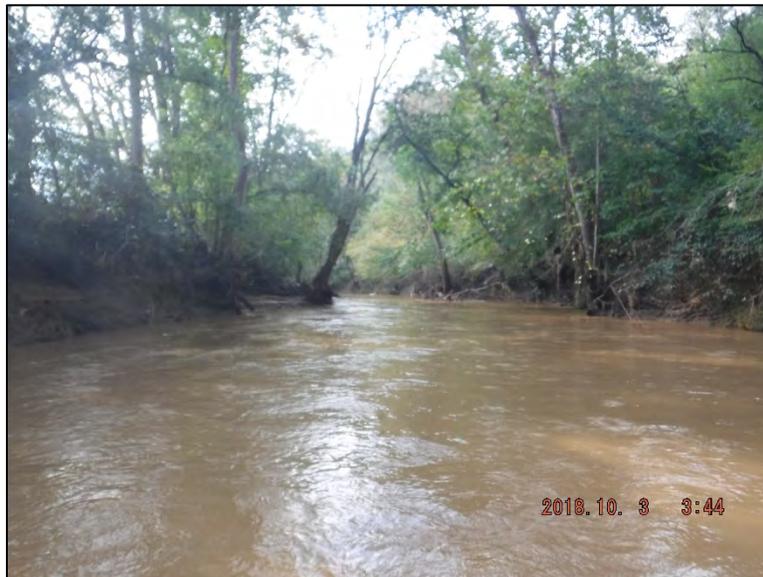
Photo 8-1

Description: View looking upstream from the middle of Cross Section 8
Woody Debris: 9

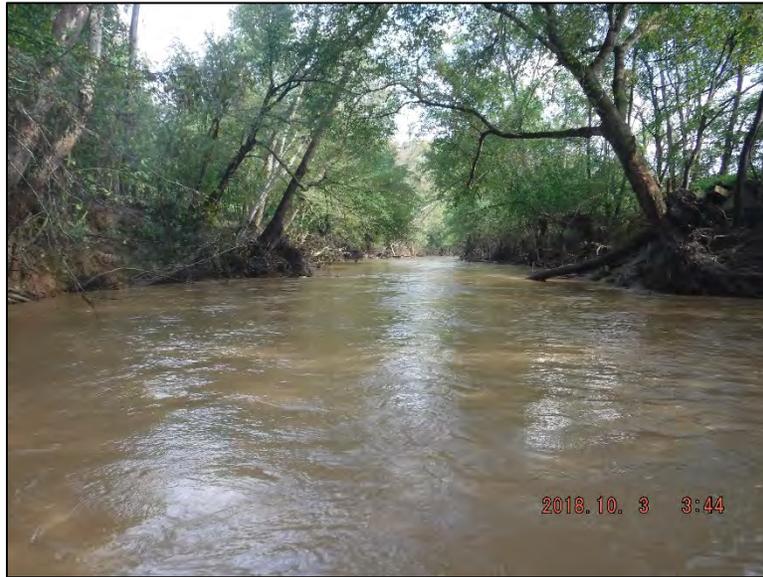
Photo 8-2

Description: View looking downstream from the middle of Cross Section 8

Woody Debris: 8

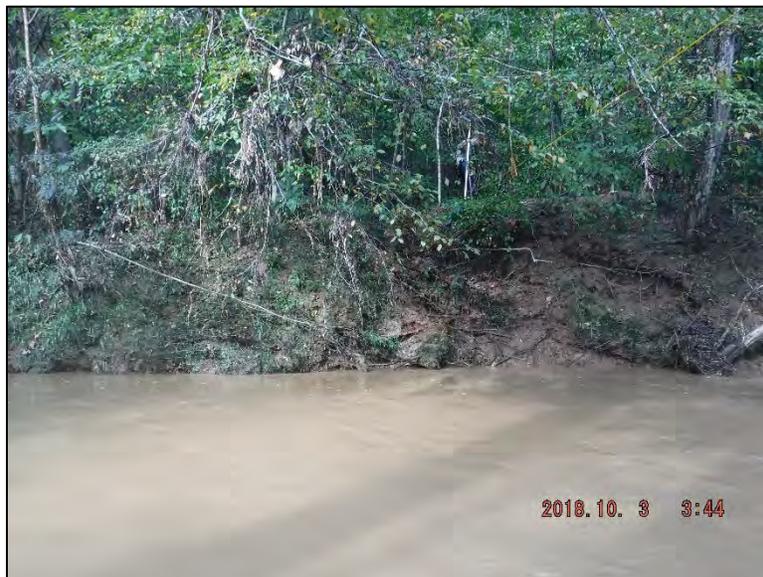
Photo 8-3

This section had mature woody vegetation to within five feet of the baseflow water surface elevation. The water surface width at this section was consistent with that seen at Cross Section 7. The banks contain fine sediment released then deposited from behind the dam. The fine sediment also buried bed features and filled the thalweg, resulting in little variation in flow depth across the section. The right bank was all sediment with woody debris, the left bank had some herbaceous vegetation.

Description: View looking left from the middle of Cross Section 8

Vegetation: 40% herbaceous cover, saplings, small trees

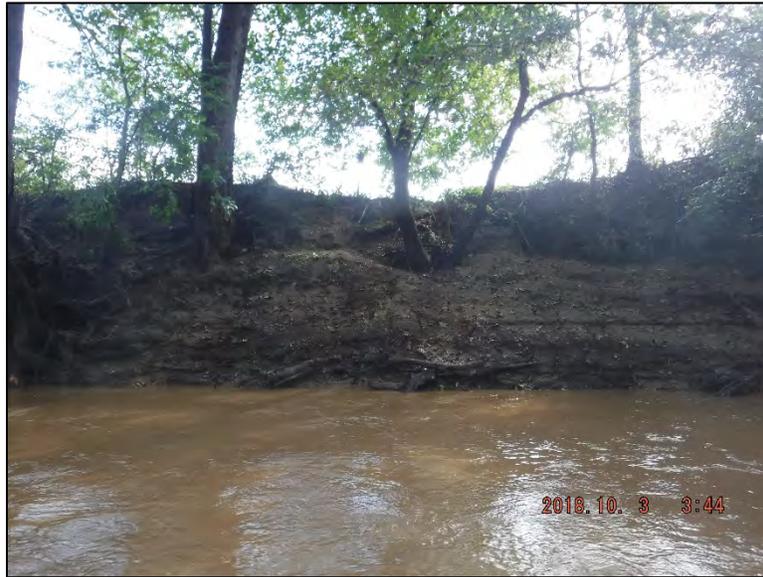
Photo 8-4

Description: View looking right from the middle of Cross Section 8

Vegetation: 25% herbaceous plants, trees

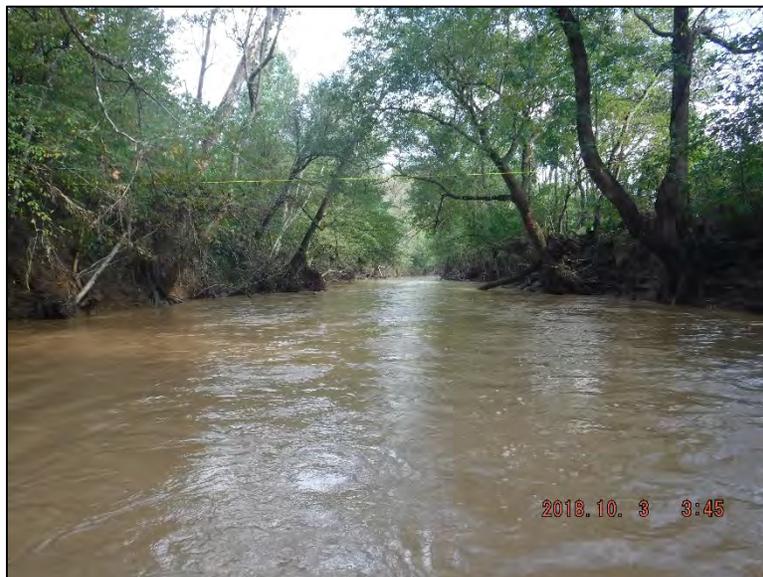
Photo 8-5

Location, Orientation: XS 8, Upstream looking down

Description: View looking downstream at Cross Section 8 from an upstream position

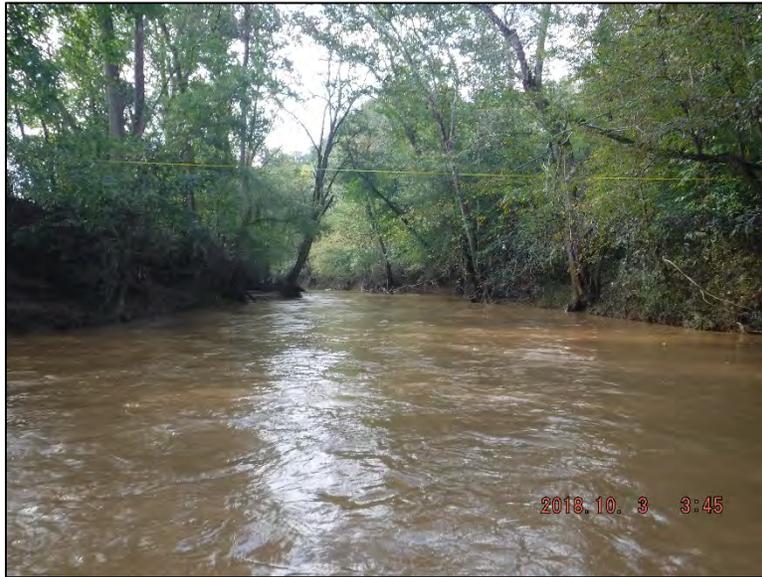
Photo 8-6

Location, Orientation: XS 8, Downstream looking up

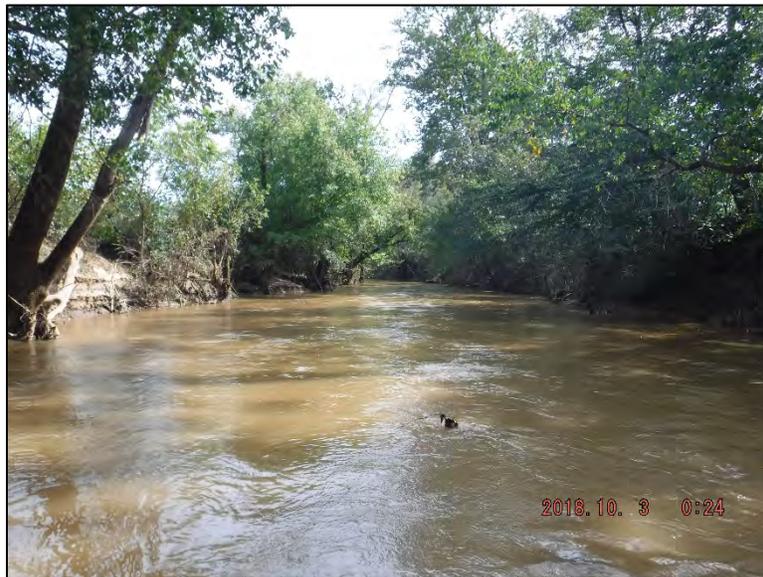
Photo 9-1

Description: View looking upstream from the middle of Cross Section 9
Woody Debris: 3

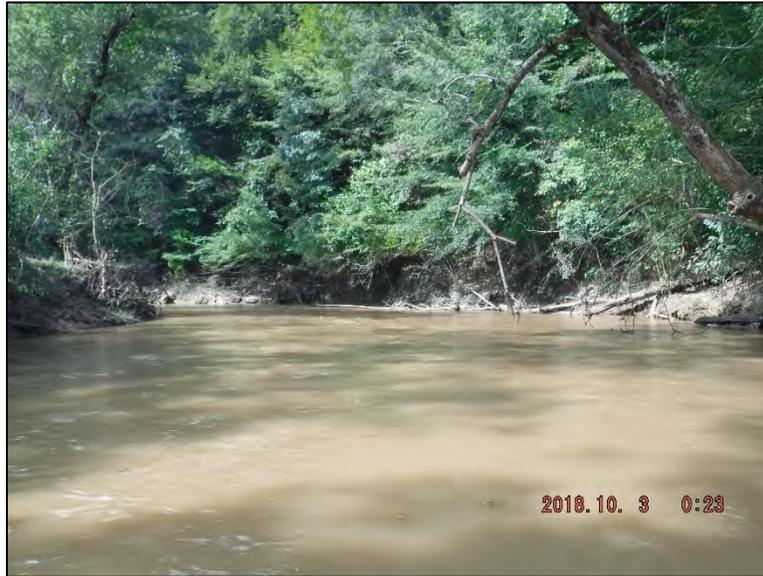
Photo 9-2

Description: View looking downstream from the middle of Cross Section 9

Woody Debris: 10

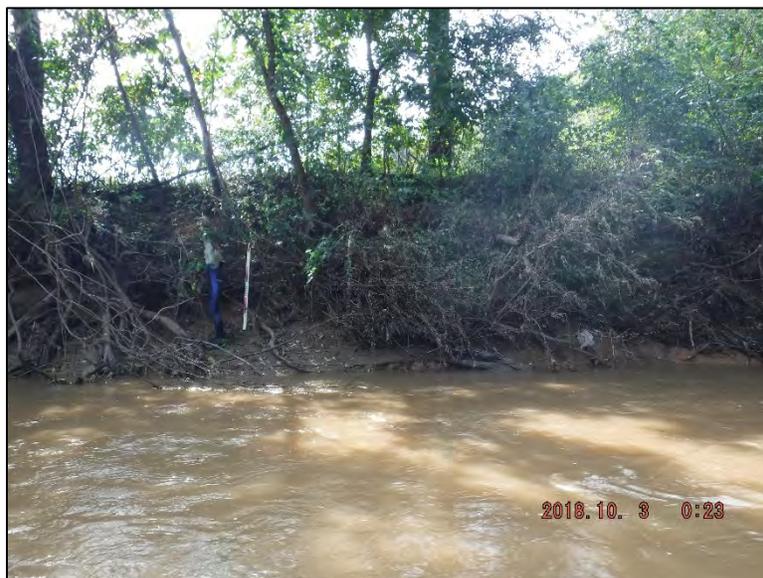
Photo 9-3

The cross section was bounded on both banks by a narrow band of trees along the top of bank with agricultural fields just beyond. Woody root structure made the steep banks relatively stable, despite significant incision (~15-ft bank heights). The water surface width at this section was consistent with that seen at Cross Section 8. Sediment deposition of sand were on both lower half of the banks. Banks were relatively stable due to good coverage by woody root structure. Fine sediment had buried bed features and filled the original thalweg location, which has since shifted to the opposite side of the river. This change in bed character has resulted in little variation in flow depth across the section.

Description: View looking left from the middle of Cross Section 9

Vegetation: 65% herbaceous cover with small trees on top of bank

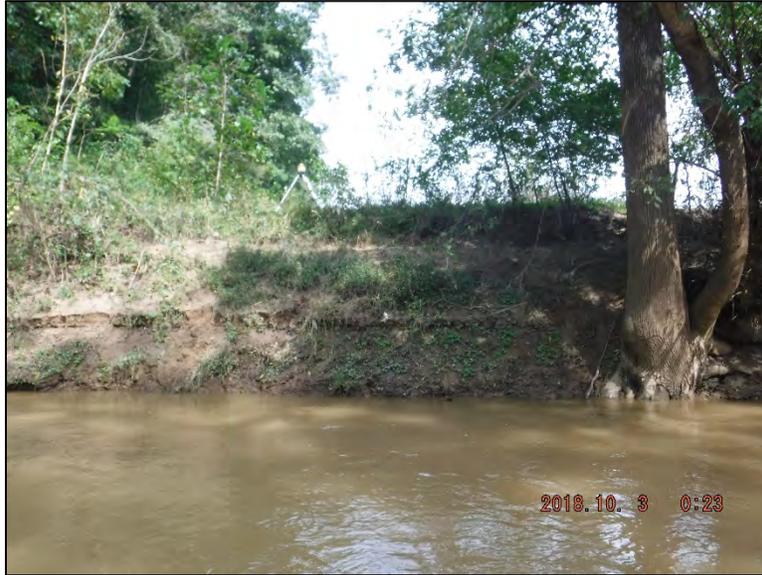
Photo 9-4

Description: View looking right from the middle of Cross Section 9

Vegetation: 55% herbaceous cover on bank

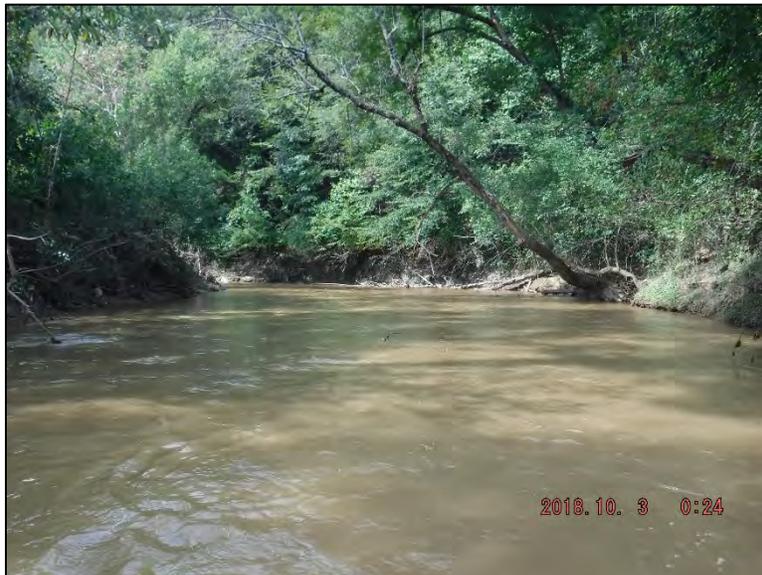
Photo 9-5

Location, Orientation: XS 9, Upstream looking down

Description: View looking downstream at Cross Section 9 from an upstream position

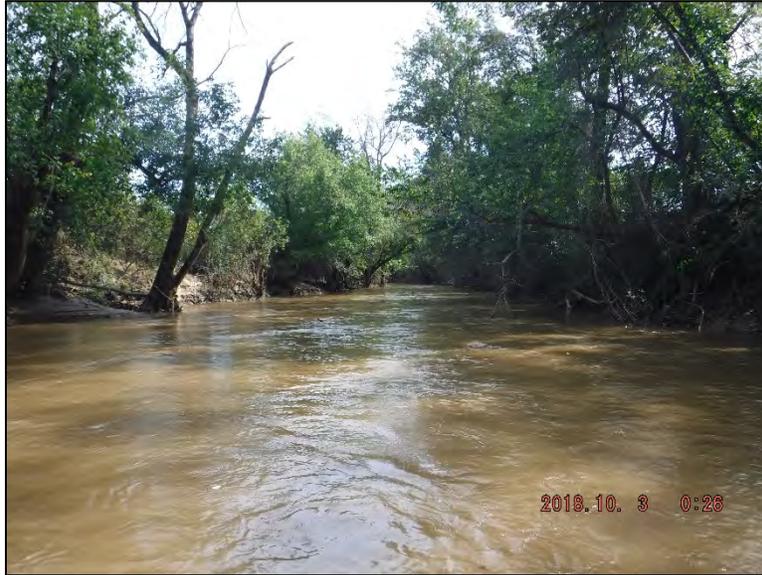
Photo 9-6

Location, Orientation: XS 9, Downstream looking up

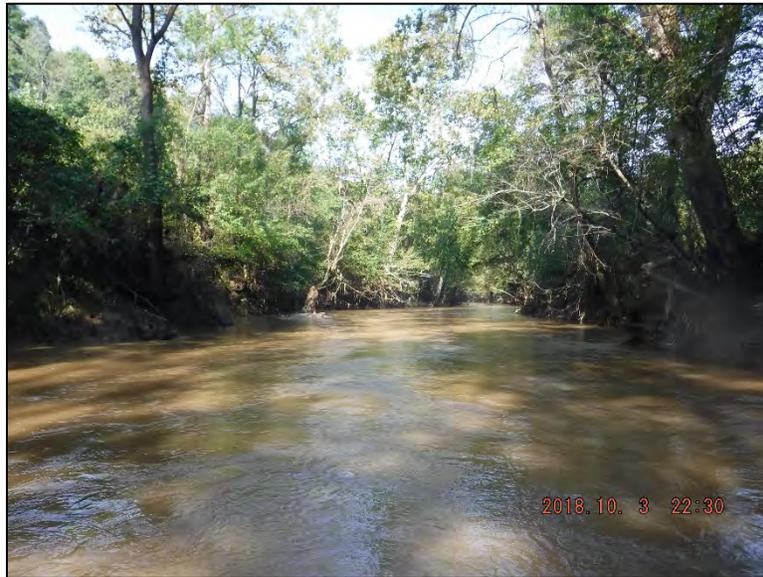
Photo 10-1

Description: View looking upstream from the middle of Cross Section 10

Woody Debris: 3

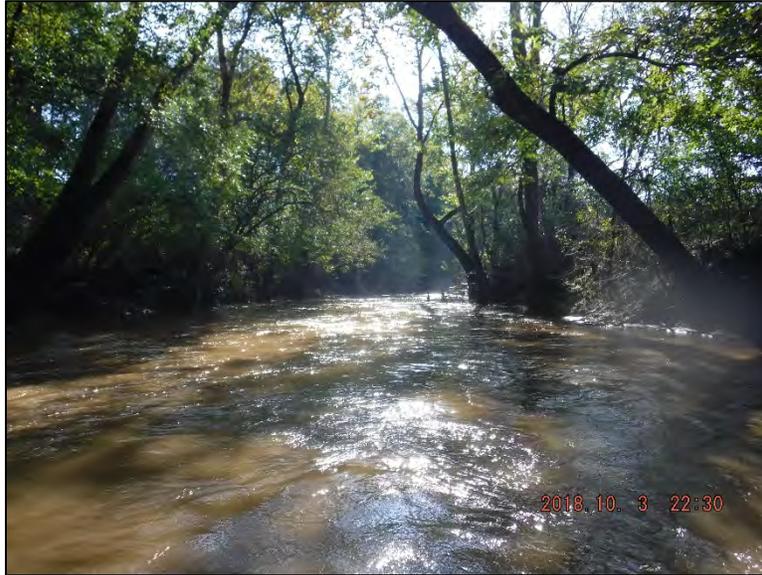
Photo 10-2

Description: View looking downstream from the middle of Cross Section 10

Woody Debris: 20

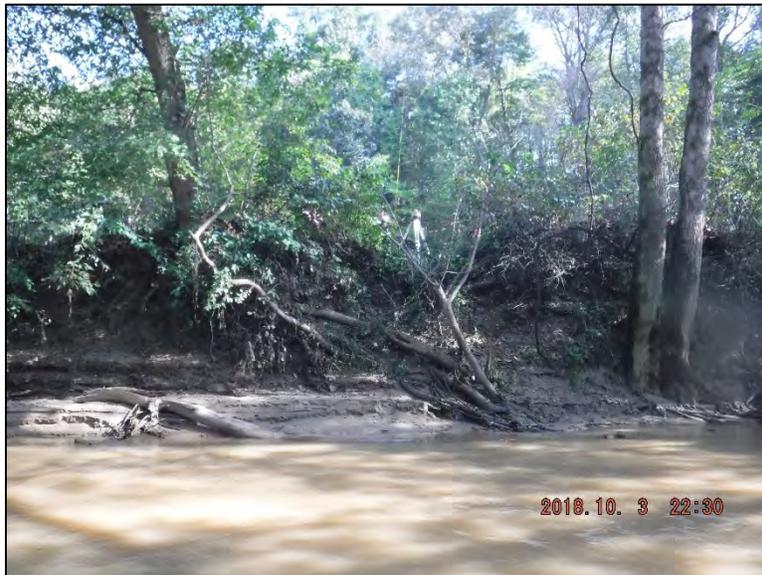
Photo 10-3

Description: View looking left from the middle of Cross Section 10

Vegetation: 30% herbaceous cover, trees

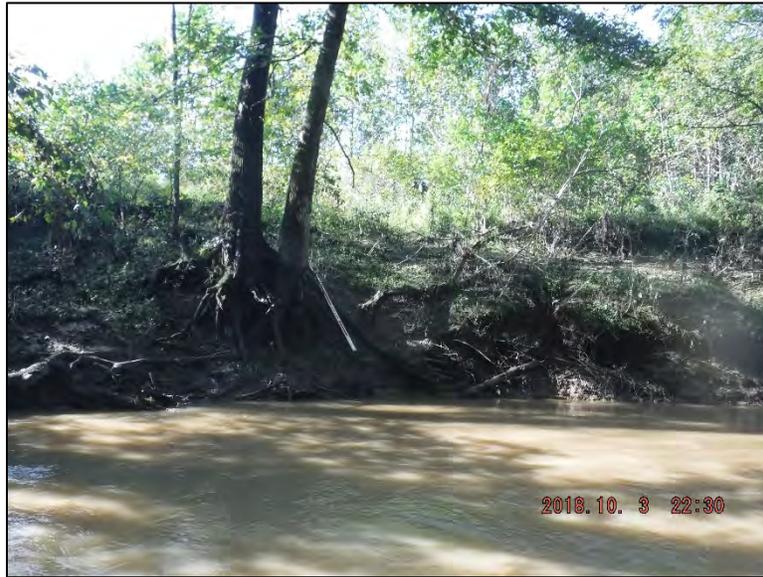
Photo 10-4

Description: View looking right from the middle of Cross Section 10

Vegetation: 50% herbaceous cover, some trees higher on bank

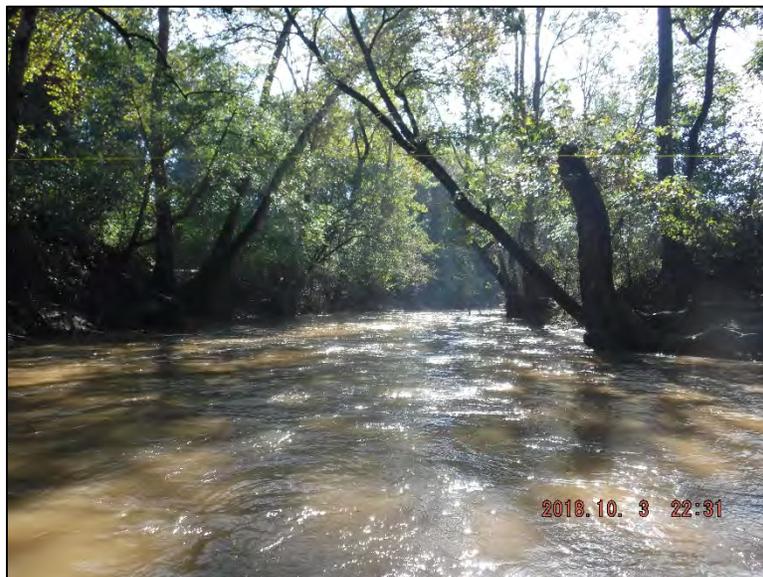
Photo 10-5

Location, Orientation: XS 10, Upstream looking down

Description: View looking downstream at Cross Section 10 from an upstream position

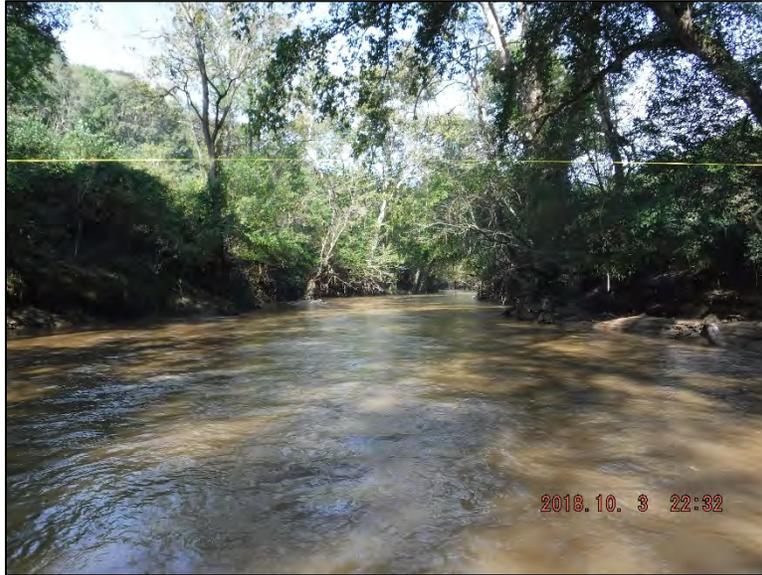
Photo 10-6

Location, Orientation: XS 10, Downstream looking up

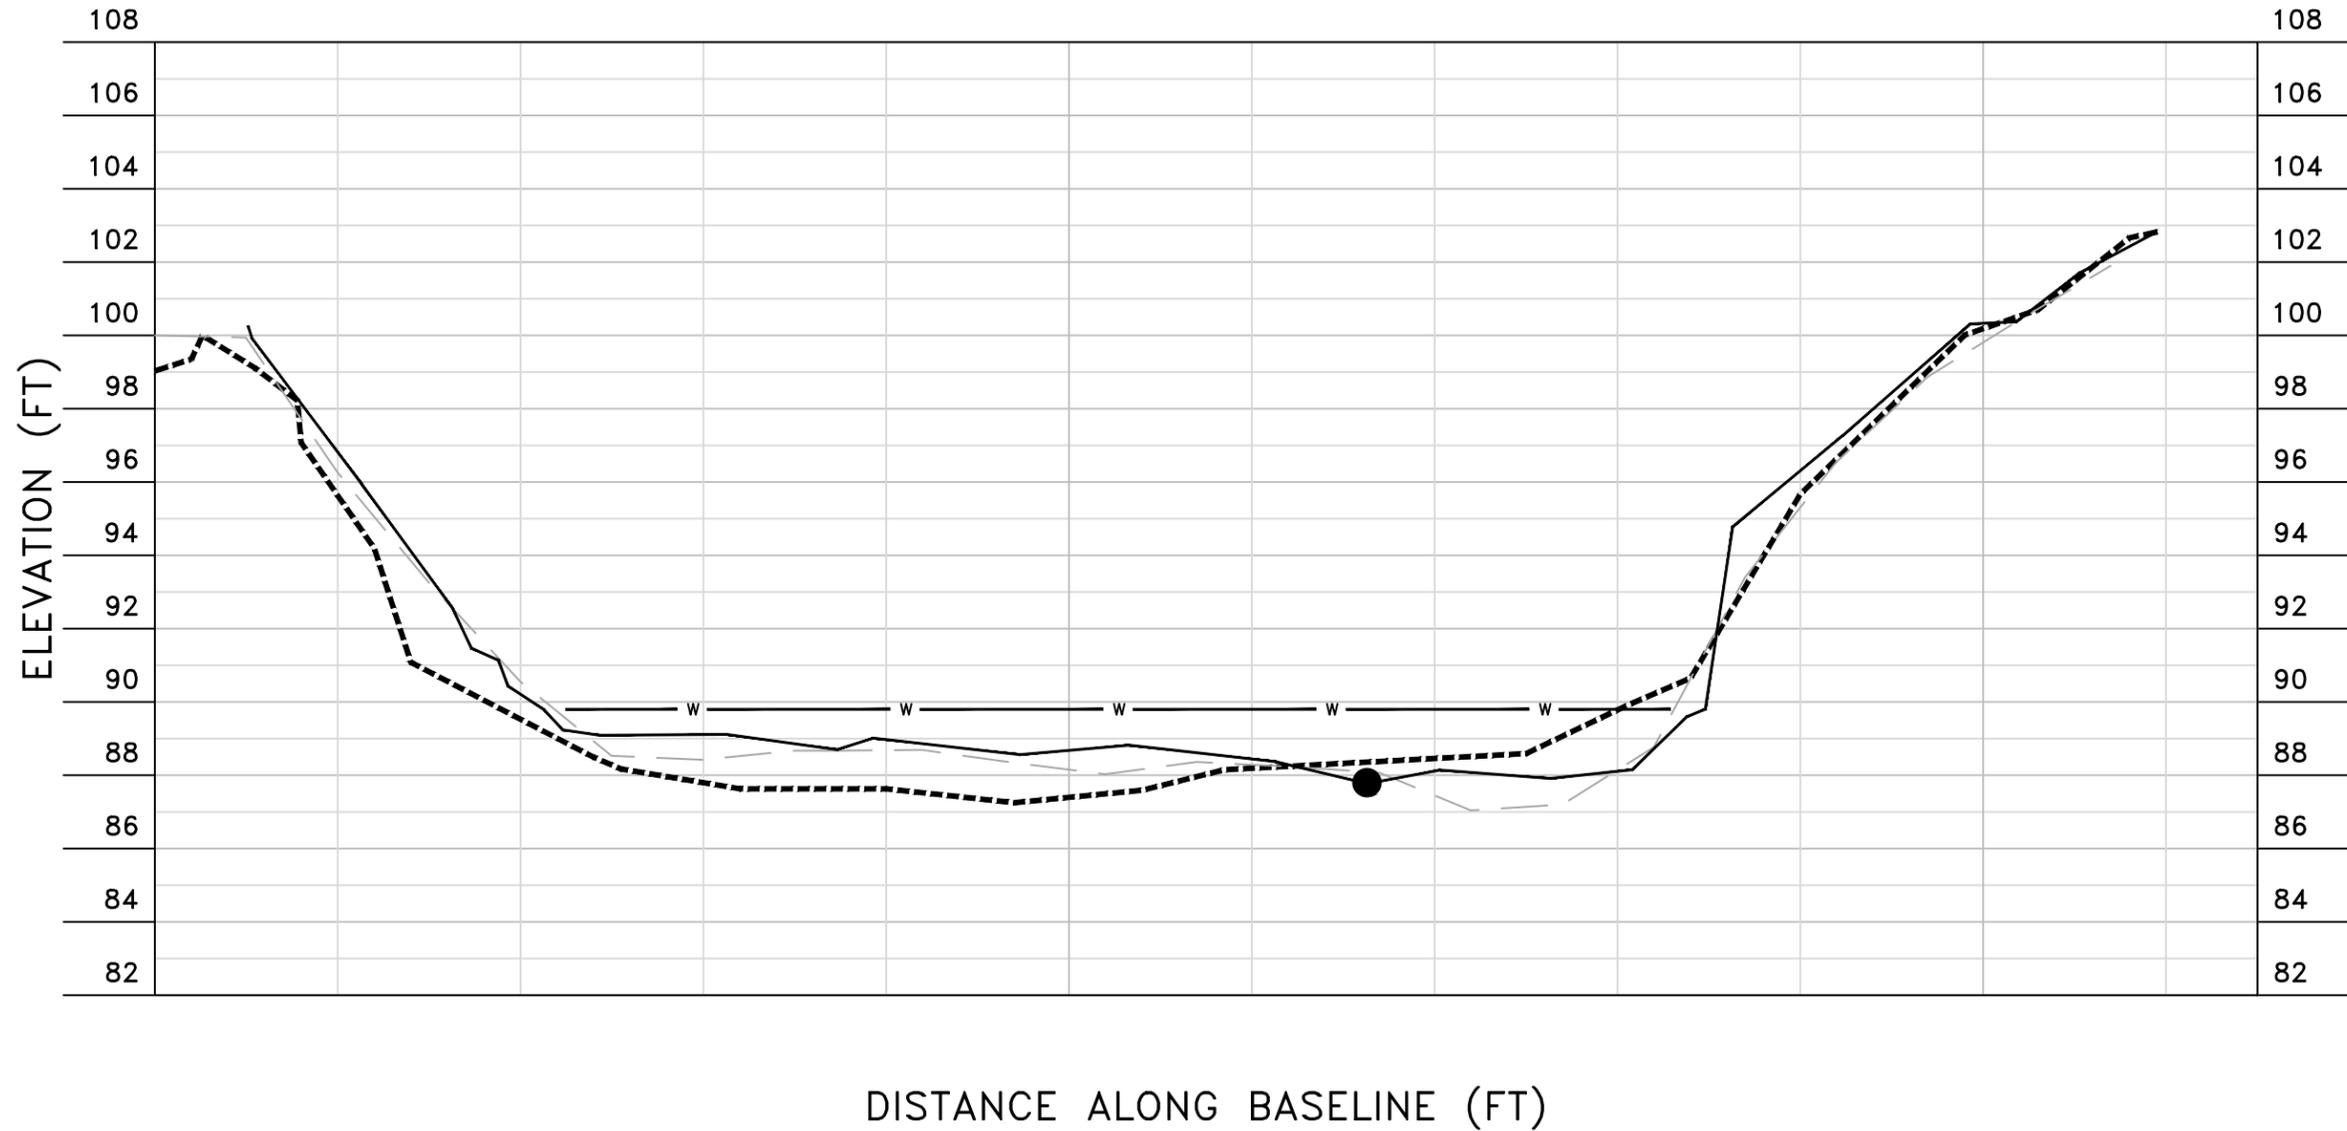
XS 10

The instrument setup for this cross section was at the left bank (HI = 4.07 ft.). The cross section plot and thalweg profile are shown below. Thalweg measurements were taken as water depths due to thick stream-side vegetation. Water depths were then added to the rod height associated with water surface elevation as taken for the cross section. This allowed approximation of bed elevation (with the longitudinal drop in water surface elevation considered insignificant). No pebble count was taken at this location due the uniform fine-grained (sandy) nature of bed sediments.

(ELEV. RELATIVE TO ASSUMED XS END PIN AT 100.)

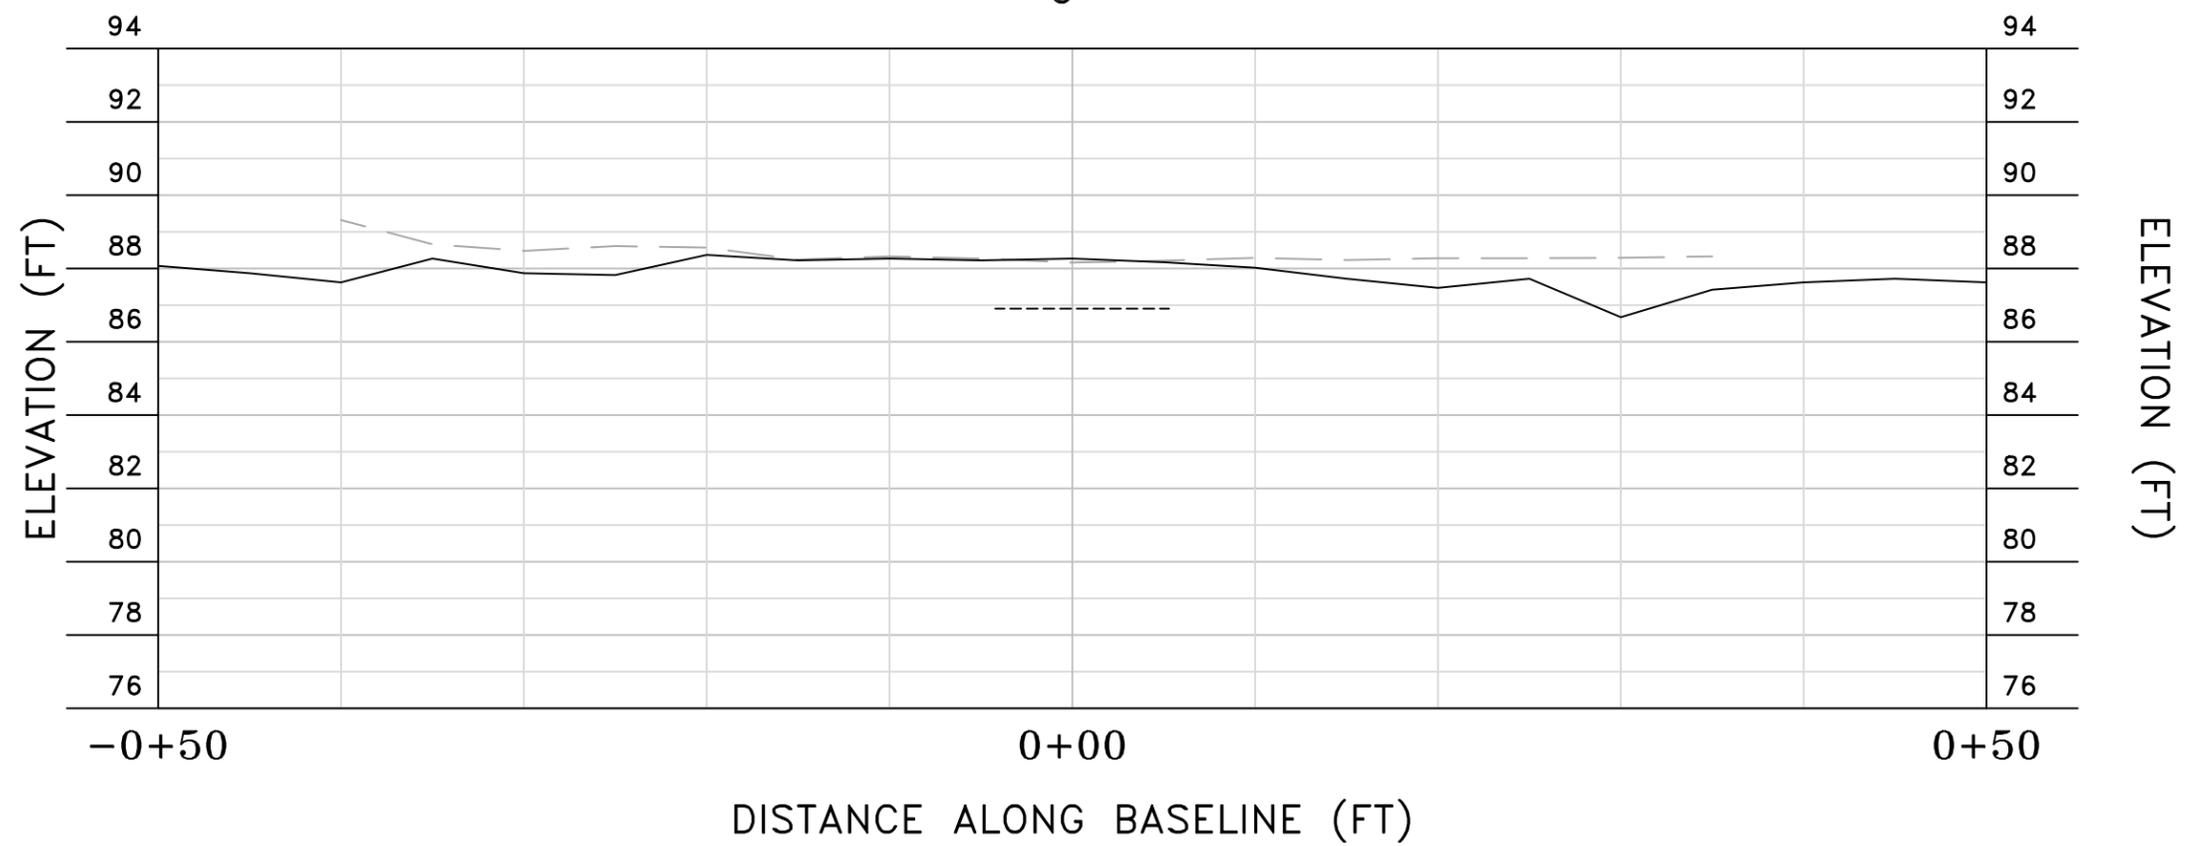
Thalweg XS 10

PROFILE SCALE:
 HORIZ: 1"=10'
 VERT: 1"=5'
 (ELEV. RELATIVE TO ASSUMED XS END PIN AT 100.)

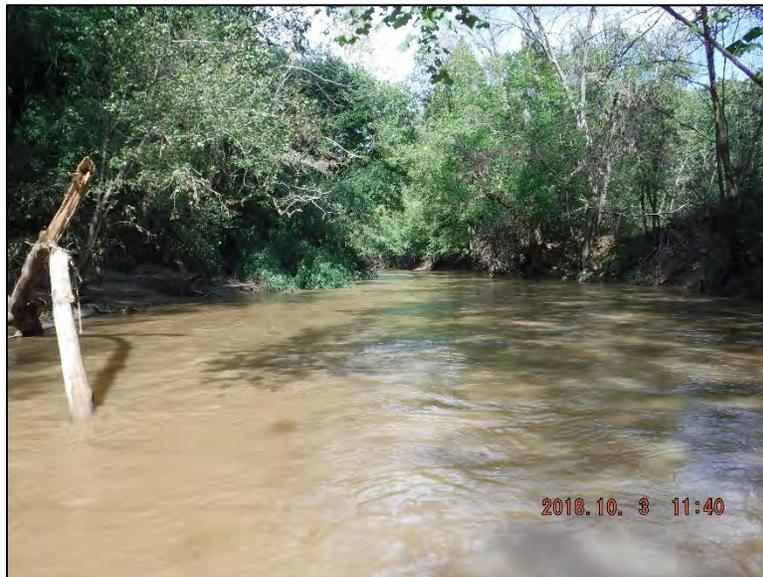
Photo 11-1

Description: View looking upstream from the middle of Cross Section 11
Woody Debris: 4

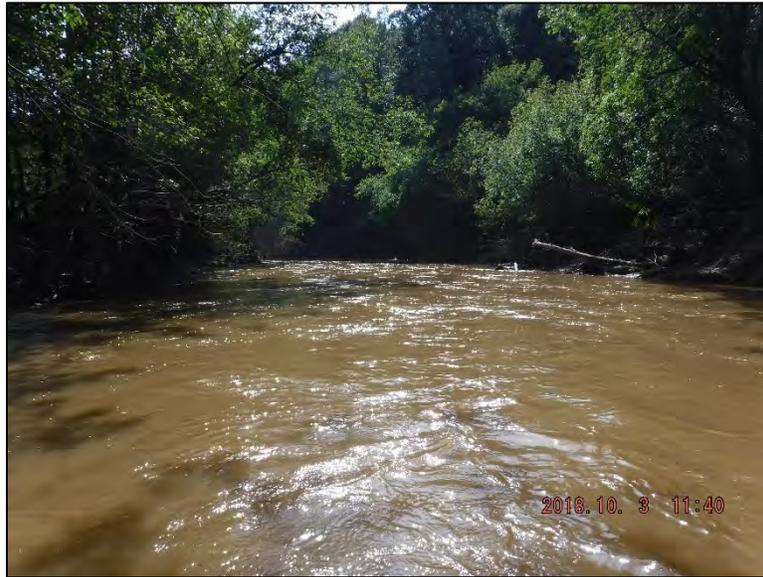
Photo 11-2

Description: View looking downstream from the middle of Cross Section 11

Woody Debris: 5

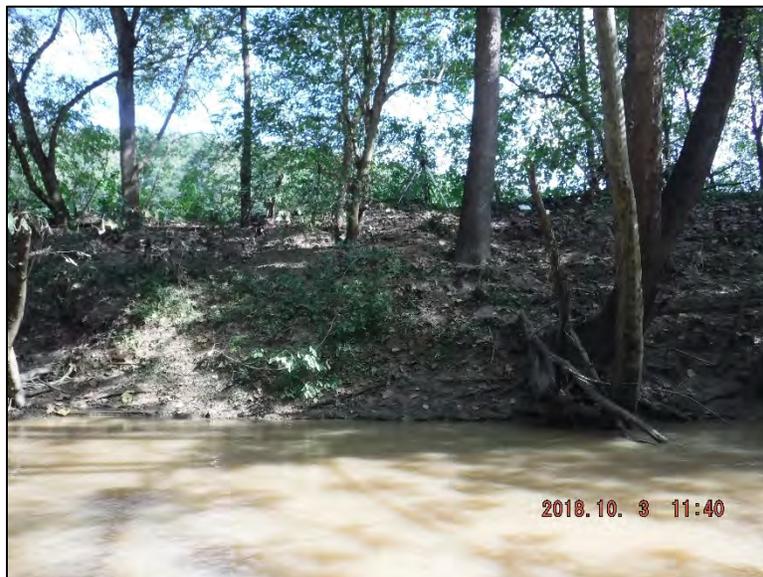
Photo 11-3

Description: View looking left from the middle of Cross Section 11

Vegetation: 25% herbaceous cover, trees

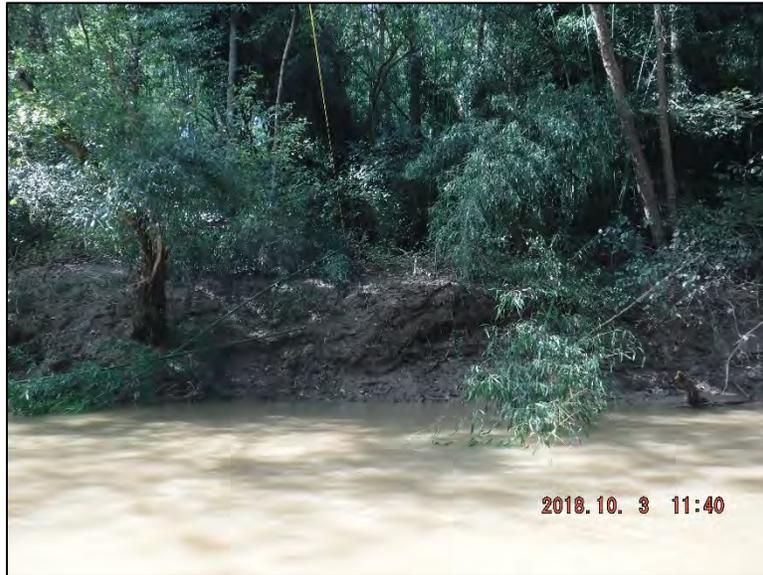
Photo 11-4

Description: View looking right from the middle of Cross Section 11

Vegetation: 25% herbaceous cover and bamboo/forest at bankfull

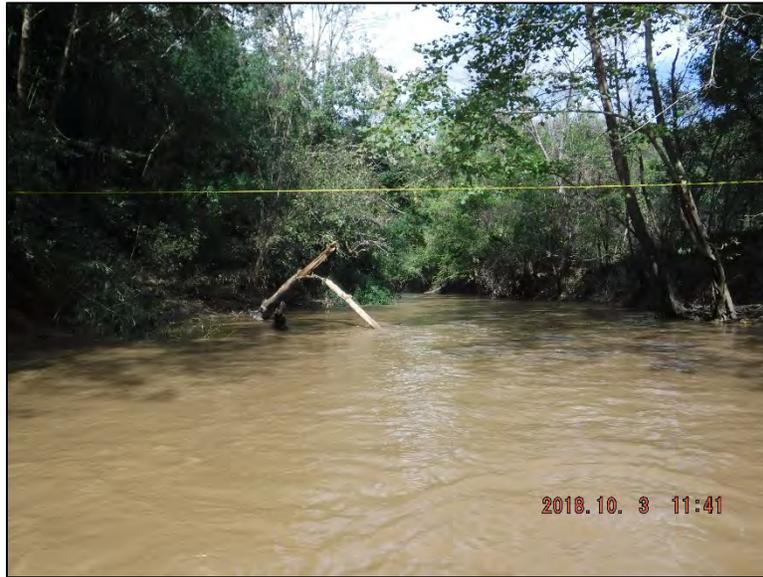
Photo 11-6

Location, Orientation: XS 11, Downstream looking up

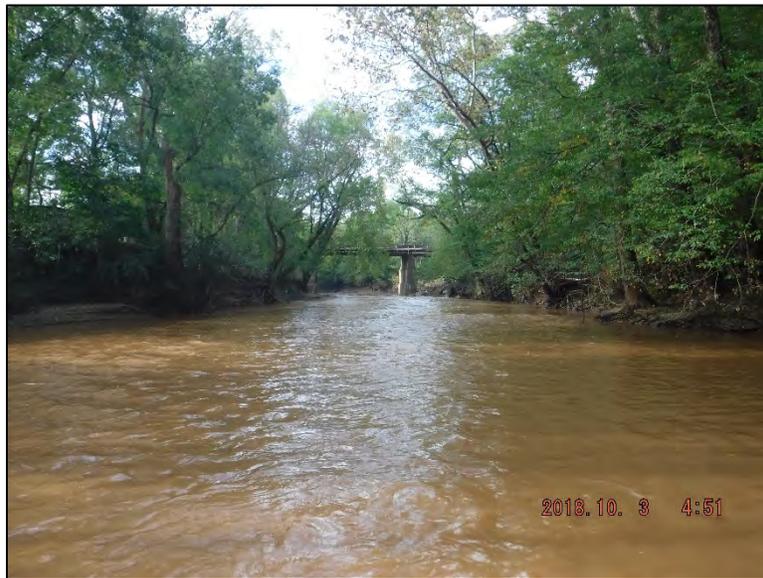
Photo 12-1

Description: View looking upstream from the middle of Cross Section 12

Woody Debris: 2
