Cross Section 7

Pigg River Dam Removal Restoration - Monitoring
 Rocky Mount, Virginia
 Year 2 - XS 7
 Copyright © 2018

Photographic Documentation of Tributary Channels

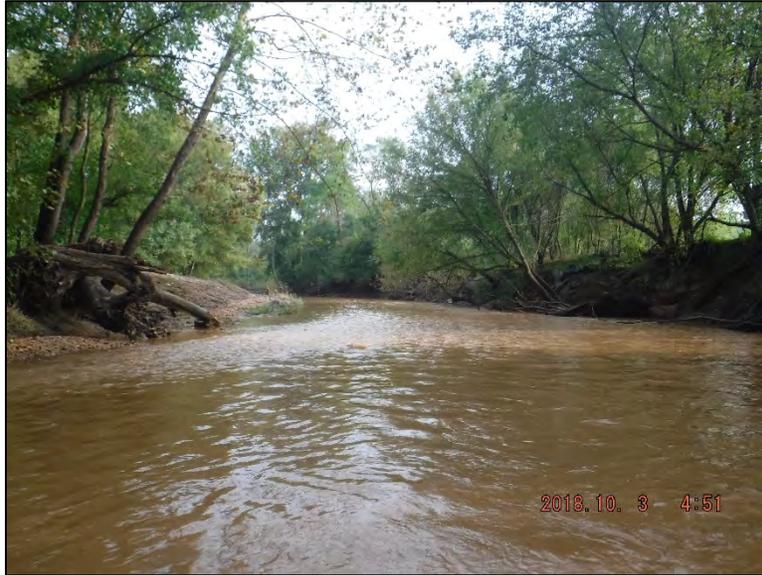
Photo 12-2

Description: View looking downstream from the middle of Cross Section 12

Woody Debris: 2

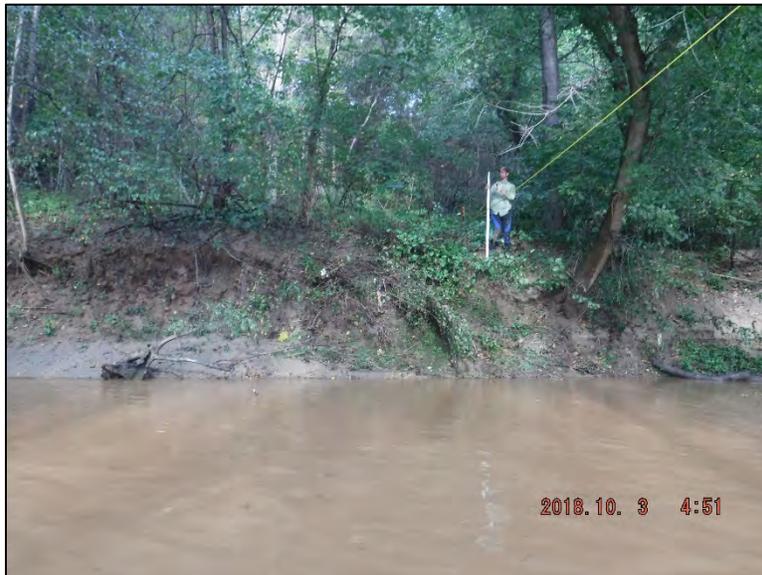
Photo 12-3

Description: View looking left from the middle of Cross Section 12

Vegetation: 35% herbaceous cover, trees

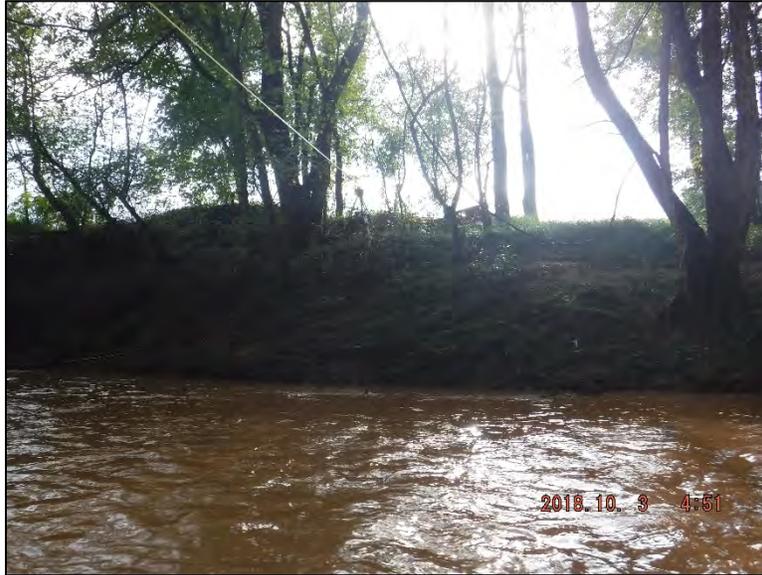
Photo 12-4

Description: View looking right from the middle of Cross Section 12

Vegetation: 80% herbaceous cover, trees at top of bank

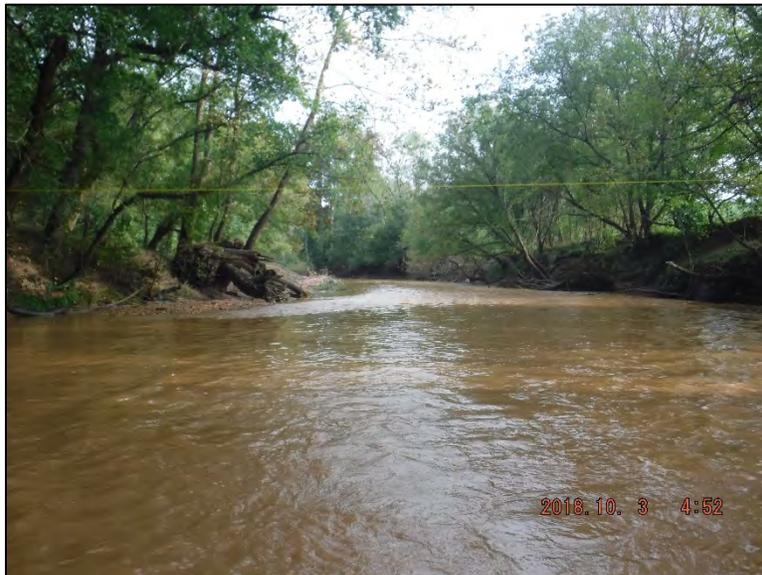
Photo 12-5

Location, Orientation: XS 12, Upstream looking down

Description: View looking downstream at Cross Section 12 from an upstream position

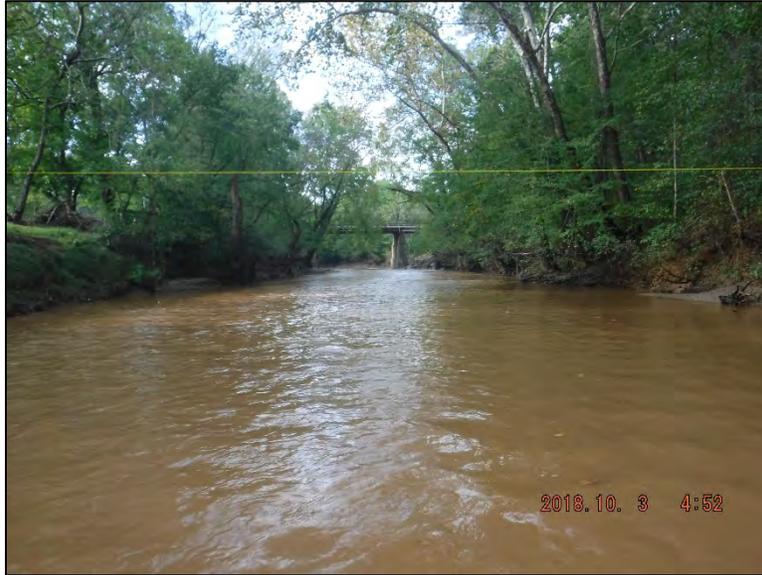
Photo 12-6

Location, Orientation: XS 12, Downstream looking up

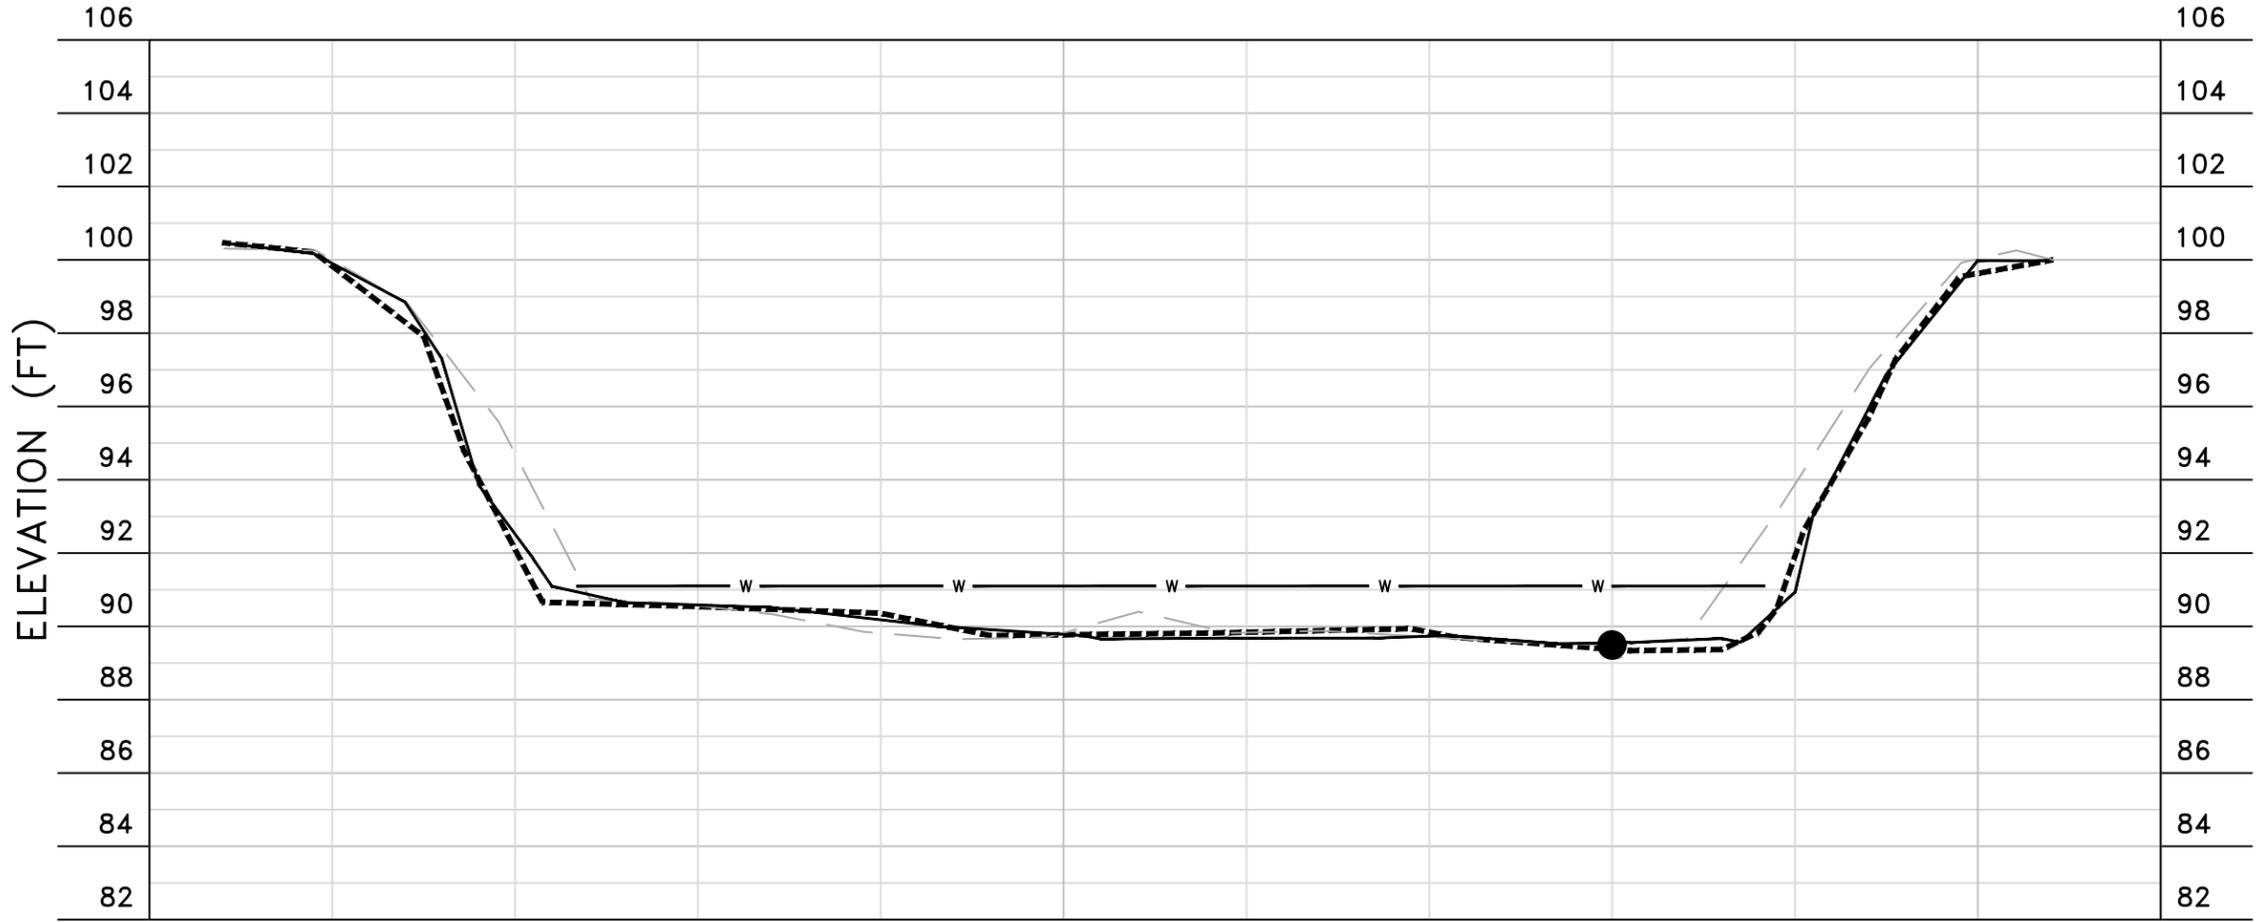
XS 12

The instrument setup for this cross section was at the right bank (HI = 3.65 ft.). The cross section plot and thalweg profile are shown below. Pebble count information is summarized on Sheet 1 of Appendix D and indicates a gravel-dominated bed composition.

(ELEV. RELATIVE TO ASSUMED XS END PIN AT 100.)

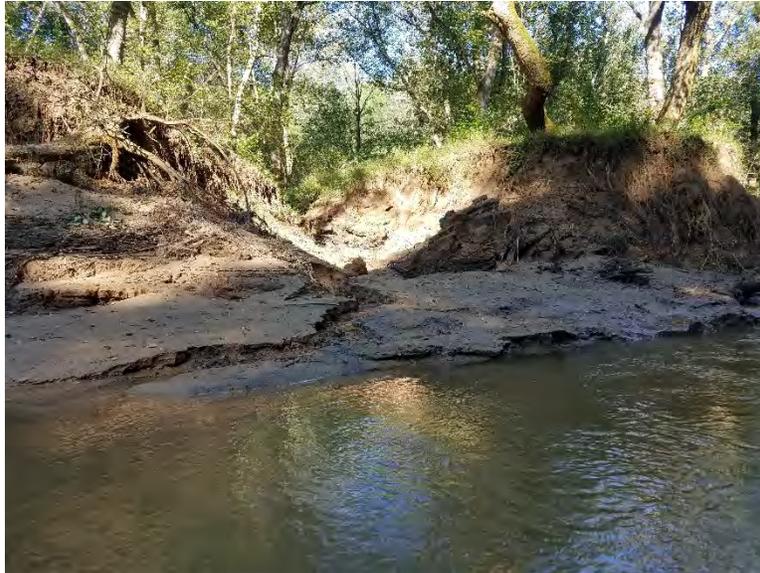
Photo T1

The following photos are provided as documentation of conditions seen at the mouth of tributaries located along Pigg River for areas upstream of the dam remains. Conditions at these confluence points can be generally characterized as having a deeply incised tributary channel which has downcut through deposits created during the past 100 years of backwater created by the dam. A steep drop (typically 1-2 feet) in invert elevation is typical as tributaries enter the main channel.

Location, Orientation: Tributary 1*, Looking Upstream from Pigg River

Description: Approximately 500 feet upstream of XS2

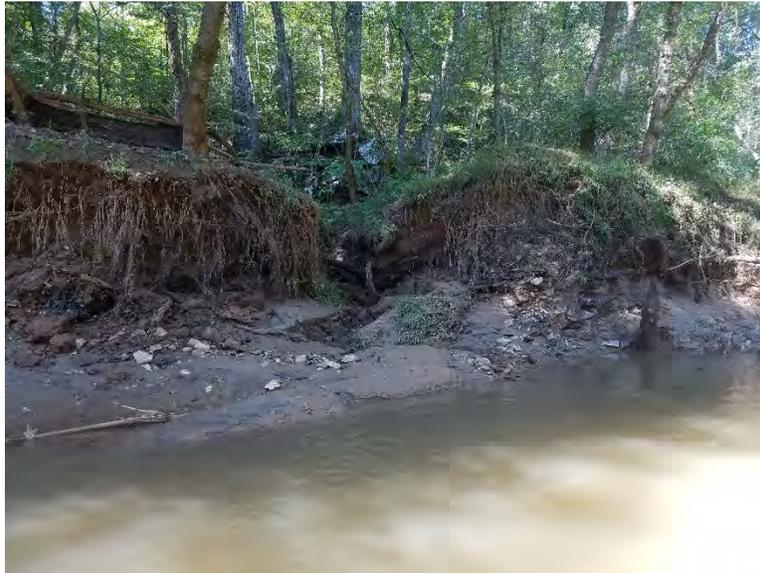
Photo T2

Location, Orientation: Tributary 2, Looking Upstream from Pigg River
Permit Number: JPA #15-1551
Wetland Data Sheet Reference: n/a
10/01/17, 12:26 PM

Description: Approximately 100 feet downstream of XS2

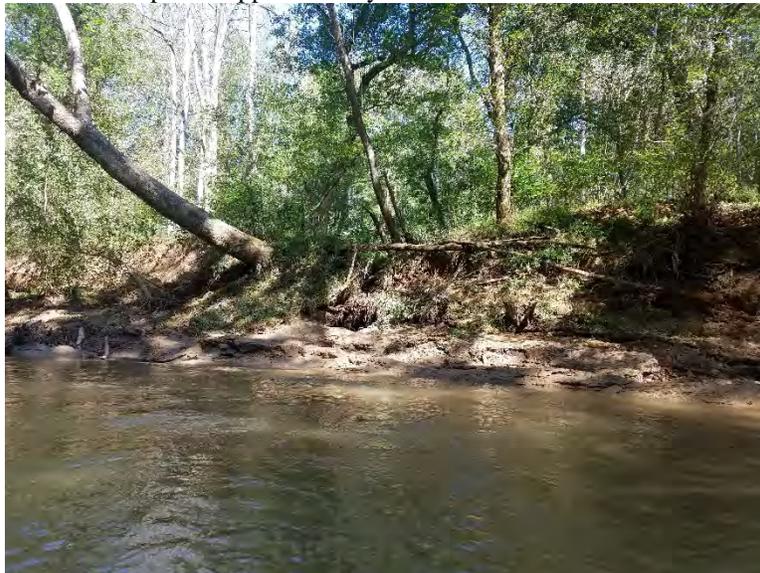
Photo T3

Location, Orientation: Tributary 3, Looking Upstream from Pigg River
Permit Number: JPA #15-1551
Wetland Data Sheet Reference: n/a
10/01/17, 12:30 PM

Description: Approximately 500 feet downstream of XS2

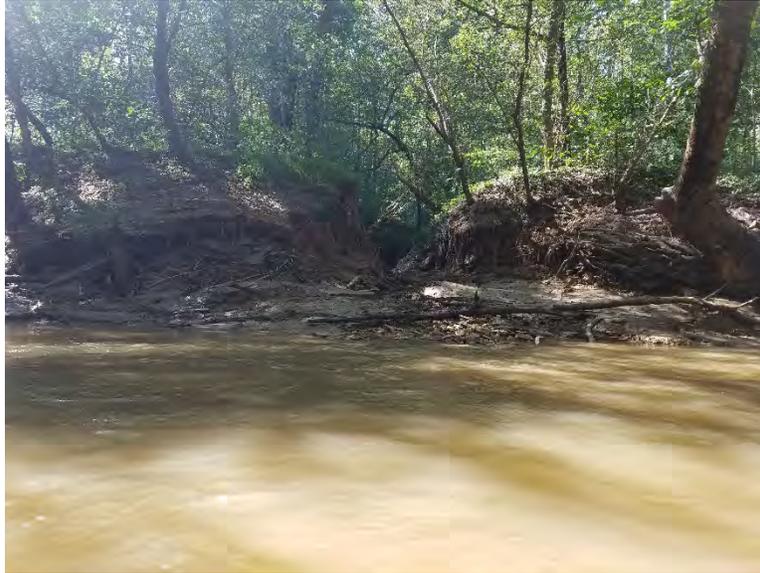
Photo T4

Location, Orientation: Tributary 4, Looking Upstream from Pigg River

Description: Approximately 1,000 feet downstream of XS2

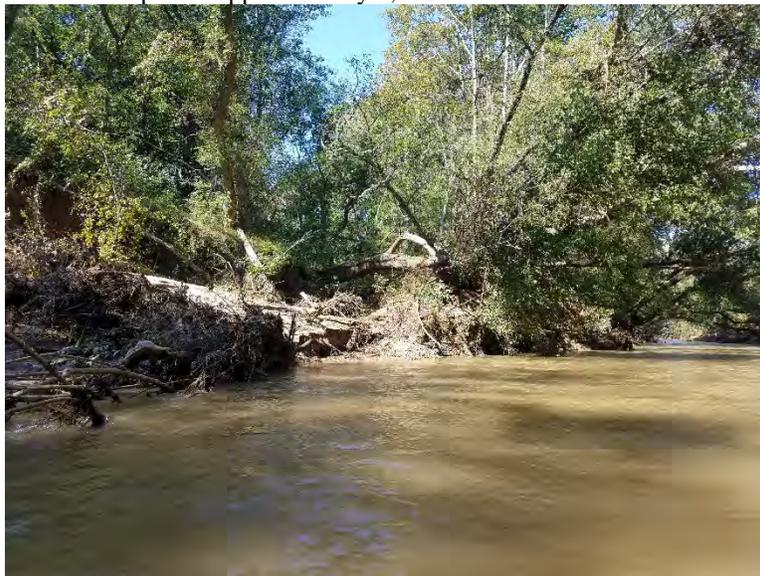
Photo T5

Location, Orientation: Tributary 5, Looking Upstream from Pigg River

Description: Approximately 200 feet upstream of XS3

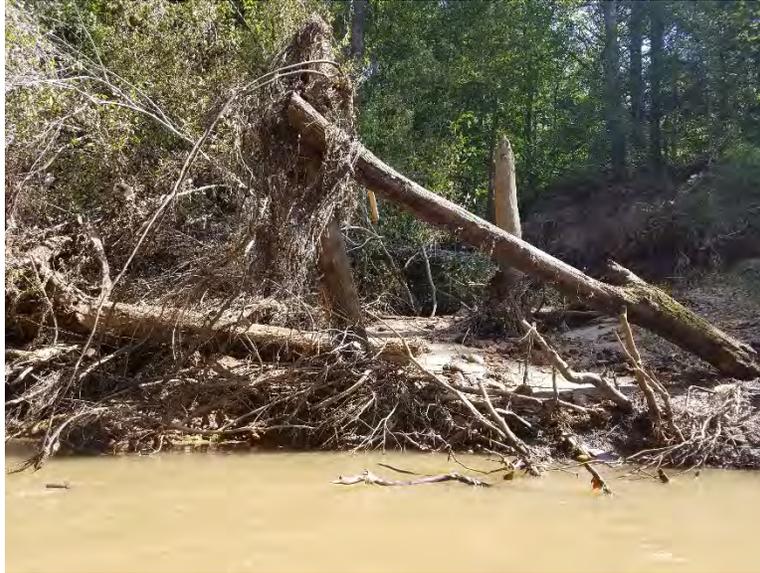
Photo T6

Location, Orientation: Tributary 6, Looking Upstream from Pigg River
Permit Number: JPA #15-1551
Wetland Data Sheet Reference: n/a
10/01/17, 1:00 PM

Description: Approximately 300 feet downstream of XS3

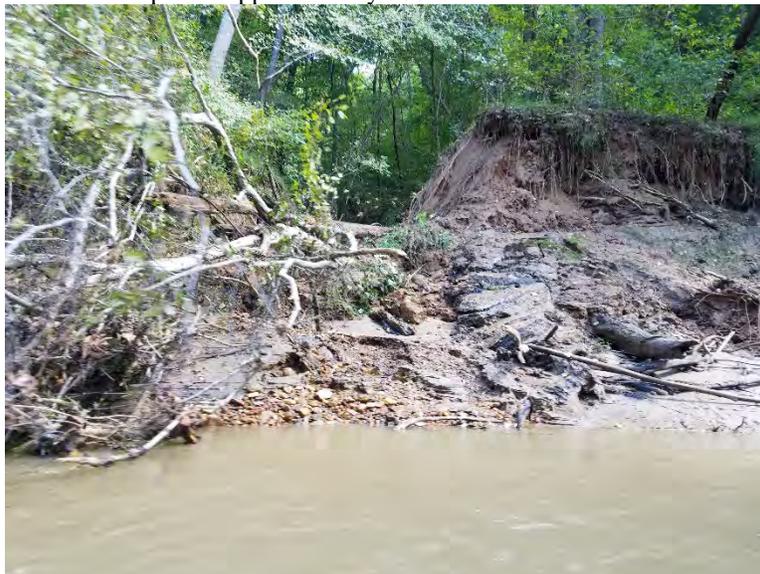
Photo T7

Location, Orientation: Tributary 7, Looking Upstream from Pigg River
Permit Number: JPA #15-1551
Wetland Data Sheet Reference: n/a
10/01/17, 1:01 PM

Description: Approximately 300 feet downstream of XS3, opposite bank from Tributary 6.

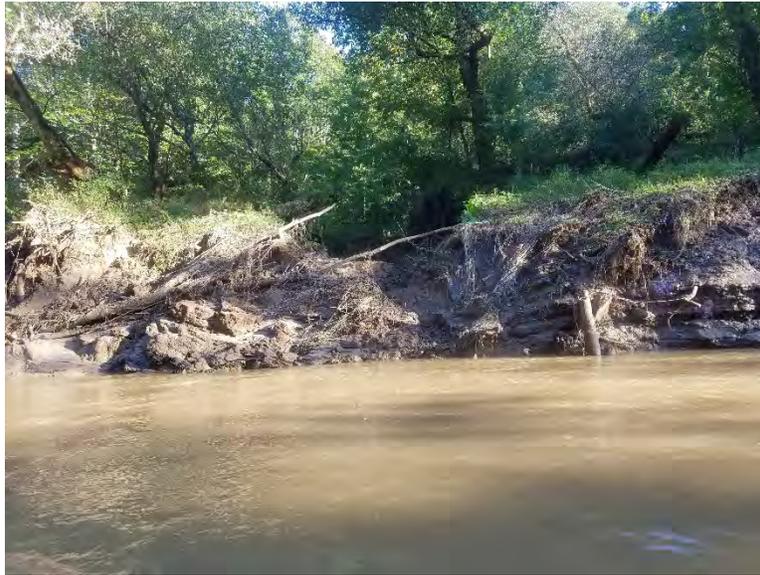
Photo T8

Location, Orientation: Tributary 8, Looking Upstream from Pigg River

Description: Approximately 500 feet downstream of XS4

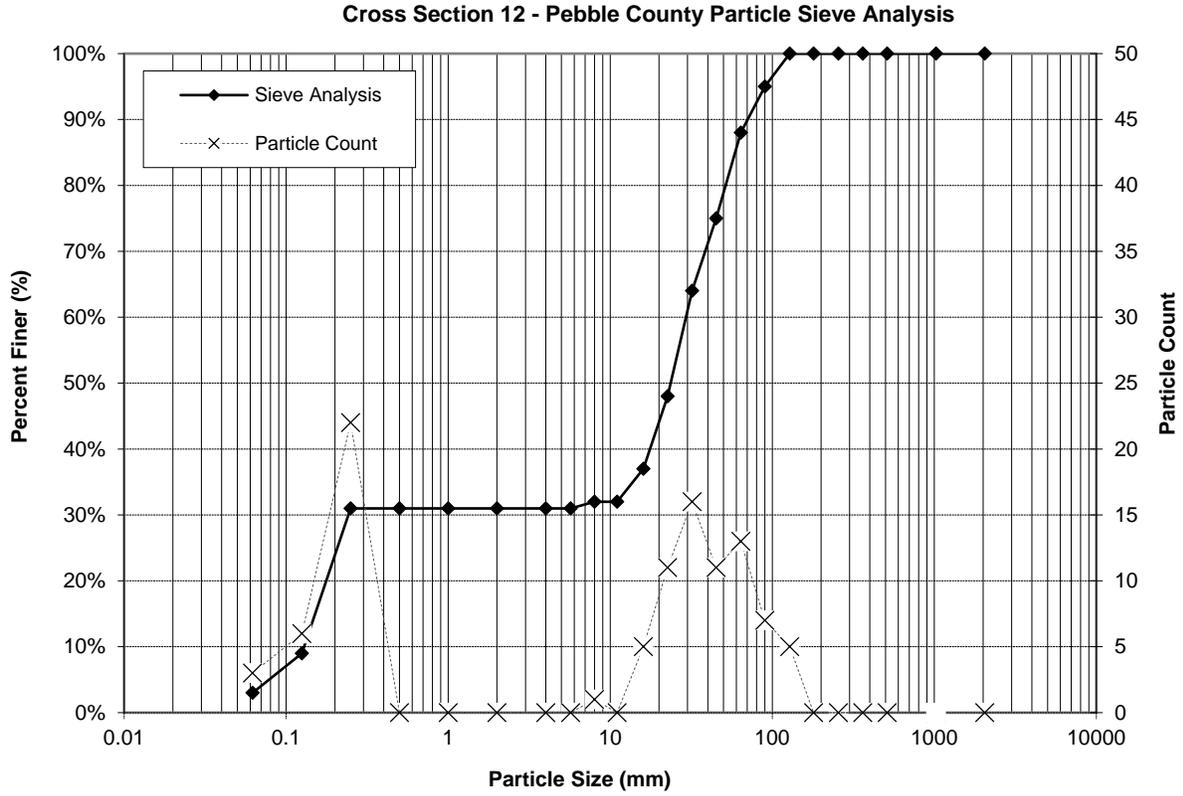
RIFFLE CROSS SECTION PEBBLE COUNT DATA WITH PARTICLE SIZE ANALYSIS								
Project Name: Pigg River Monitoring (WSSI# 22906.01)								
Stream ID & XS Station: XS12 (Located 50 ft. downstream in nearest riffle)					Date: Oct. 2018			
Evaluators: MEH, NAS					FORVA			
Pebble Count Data								
	Particle			Particle Count	ITEM %	CUM %	Particle Size Analysis	
	Description	Size (mm)		Total				
	Silt/Clay	0	0.062	3	3%	3%		
SAND	Very Fine	0.062	0.125	6	6%	9%		Silt/Clay (%) <u>3%</u>
	Fine	0.125	0.25	22	22%	31%		Sand (%) <u>28%</u>
	Medium	0.25	0.5	0	0%	31%		Gravel (%) <u>57%</u>
	Coarse	0.5	1.0	0	0%	31%		Cobble (%) <u>12%</u>
	Very Coarse	1.0	2.0	0	0%	31%		Boulder (%) <u>0%</u>
GRAVEL	Very Fine	2.0	4.0	0	0%	31%		Bedrock (%) <u>0%</u>
	Fine	4.0	5.7	0	0%	31%		D16 (mm) <u>0.16</u>
	Fine	5.7	8.0	1	1%	32%	D35 (mm) <u>14.01</u>	
	Medium	8.0	11.03	0	0%	32%	D50 (mm) <u>23.78</u>	
	Medium	11.3	16.0	5	5%	37%	D84 (mm) <u>58.15</u>

Coarse	16.0	22.6	11	11%	48%	D95 (mm) <u>90.00</u>	
	Coarse	22.6	32.0	16	16%	64%	D100 (mm) <u>128.00</u>	
	Very Coarse	32	45	11	11%	75%		
COBBLE	Very Coarse	45	64	13	13%	88%		
	Small	64	90	7	7%	95%		
	Small	90	128	5	5%	100%		
	Large	128	180	0	0%	100%		
BOULDER	Large	180	256	0	0%	100%		
	Small	256	362	0	0%	100%		
	Small	362	512	0	0%	100%		
	Medium	512	1024	0	0%	100%		
	Large - Vry Large	1024	2048	0	0%	100%		
	Bedrock	2048		0	0%	100%		
Total Particles				100
