The Tubbs Setback Restoration Project: 2006 Final Report

**Isa Woo, John Y. Takekawa, Aariel Rowan,
and Rachel J. Gardiner**

Vallejo, California
[2007]

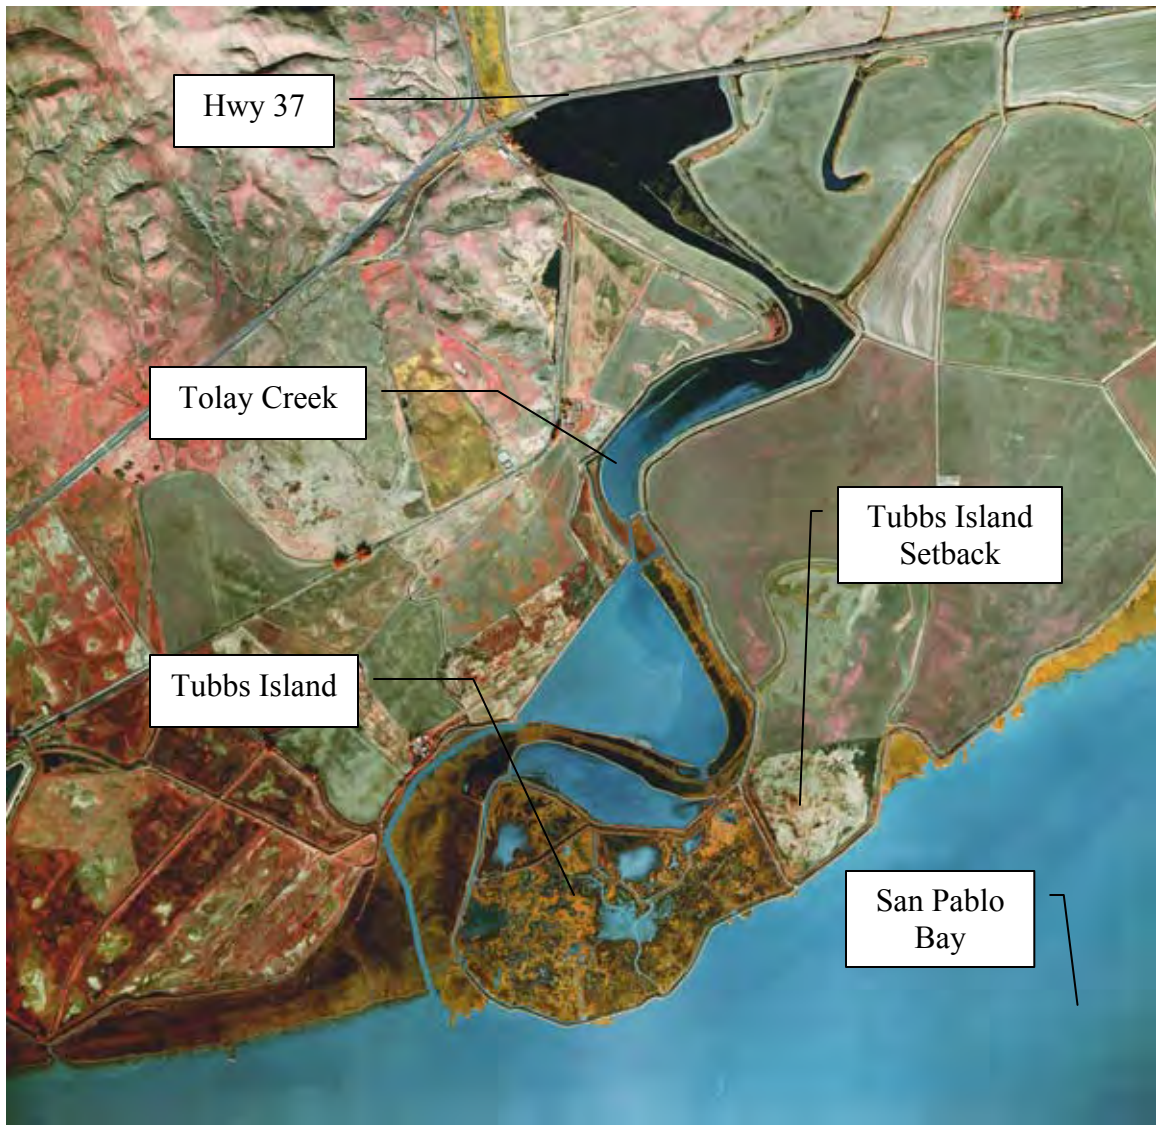
Figure 1. Regional map showing Tubbs Island Setback, Tubbs Island and Tolay Creek Restoration Marshes in the northern San Pablo Bay. Photo was taken in 1998 before restoration was implemented at Tubbs Setback.

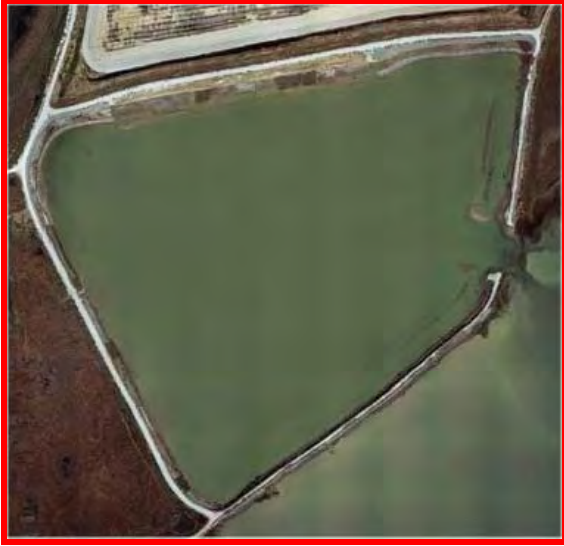
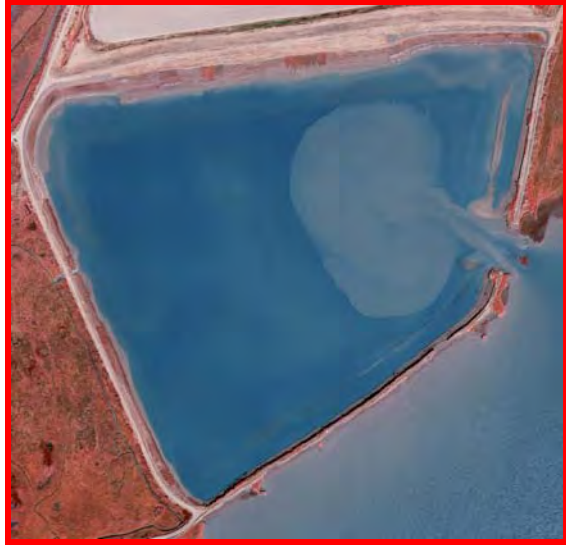
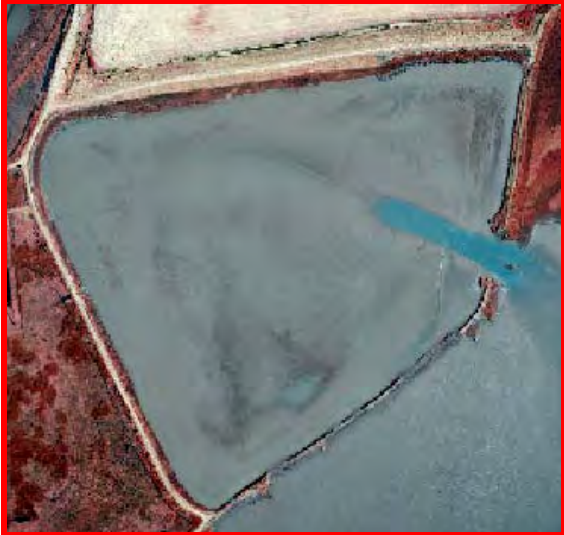
A. Oct. 9, 2002; Tide = -0.1 ft MLLW

B. Sept. 23, 2003; Tide < 2.0 ft MLLW

C. Sept. 1, 2004; Tide < 2.0 ft MLLW

D. Aug. 22, 2005; Tide = 0.9 ft MLLW

E. Aug. 9, 2006; Tide = -0.6 ft MLLW

Figure 3. The 29-ha Tubbs Setback restoration project color infrared aerial photographs taken in Oct. 2002 (A) Sept. 2003 (B), Sept. 2004 (C), Sept. 2005 (D) and Aug. 2006 (E).

A low-level, color infrared aerial photograph was taken in Oct 2002, Sep 2003, Sep 2004, Aug 2005 and Aug 2006 (Fig. 3). We georectified the Sep 2004, 2005, and 2006 aerial photographs to UTM NAD83 (ArcGIS; ESRI, Inc.) using control points. Control points ($n = 7$ for 2004 and 2005, $n = 4$ for 2006) consisted of large white “X’s” spray-painted on 1.5 m² black plastic squares attached to the ground with landscape staples. We used a Trimble GeoXT Pocket Global Positioning System unit with a PDOP (position dilution of precision error) of <3 (the lower the PDOP, the greater the precision) to establish control point coordinates.

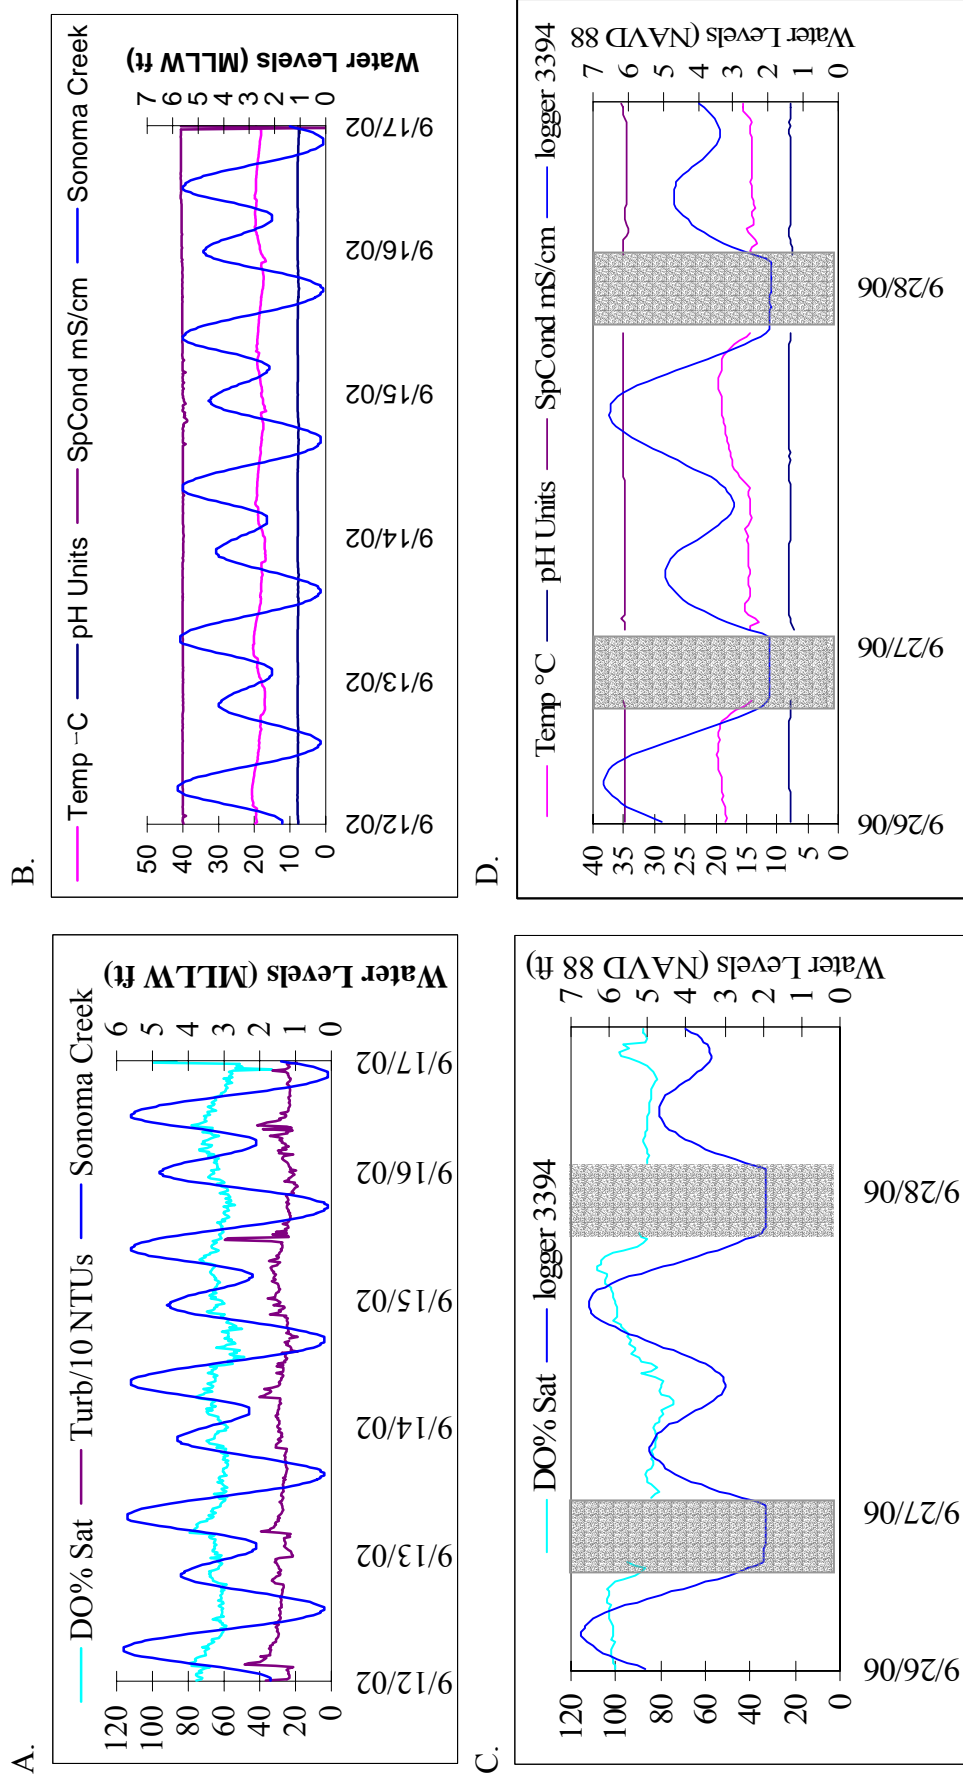
Figure 7. Water quality data from Tubbs Setback from 12 to 17 September 2002 (A, B), and 26 to 28 Aug 2006 (C, D). Percent dissolved oxygen, turbidity (divided by 10 for scale) are shown with the Sonoma Creek tide profile (A) and the water level logger data (C). Temperature (degrees Celsius), pH, and specific conductivity (mS/cm) are shown with Sonoma Creek tide profile (B) and with the water level logger data (D). By July 2005, water quality parameters are inaccurate during low tides due to sedimentation during times indicated by grey bars.

Water quality parameters differed from Sep 2002 to Sep 2006 (Fig. 7), which reflect natural fluctuations. In Sep 2002 the conductivity reached 40.1 mS/cm, while in Sep 2006 the water was fresher at 34.9 mS/cm (Fig. 6), probably because an above-average rain season and abundant freshwater release from dams and tributaries that enter San Pablo Bay. Other measurements varied by tide, season, and year, but mean pH remained relatively constant. Spikes in the turbidity readings were presumably caused by sediment re-suspension with the incoming tide or high wind fetch.

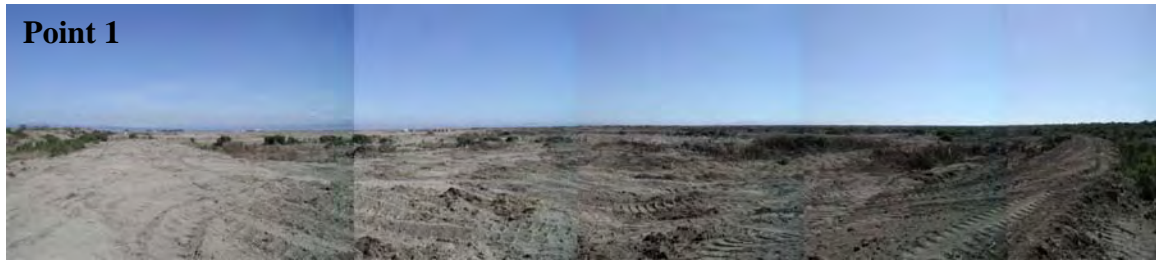
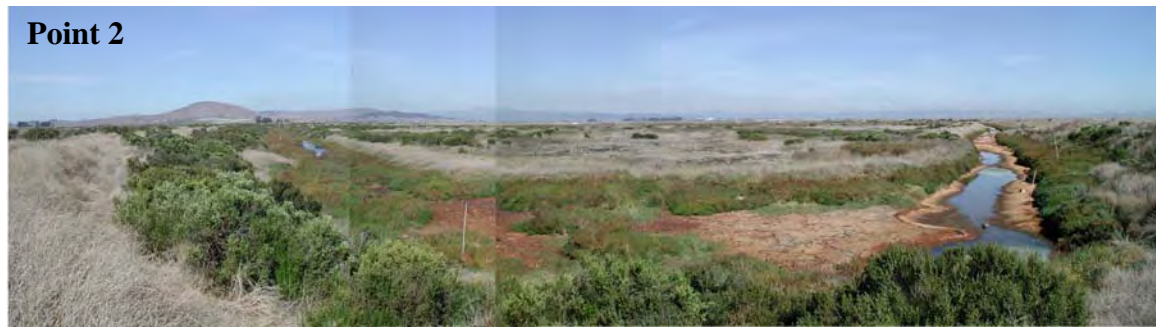
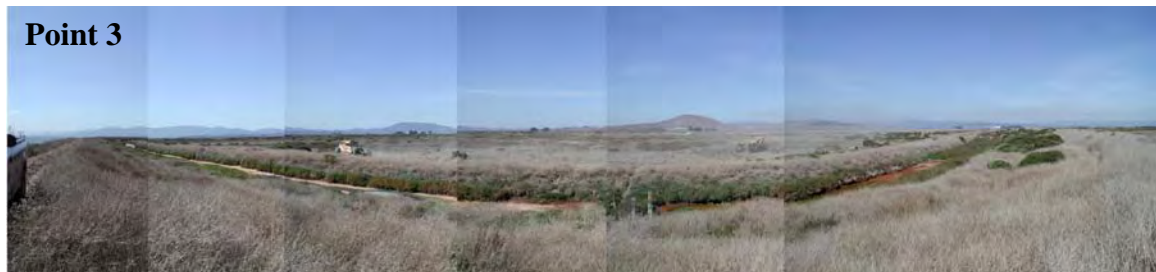
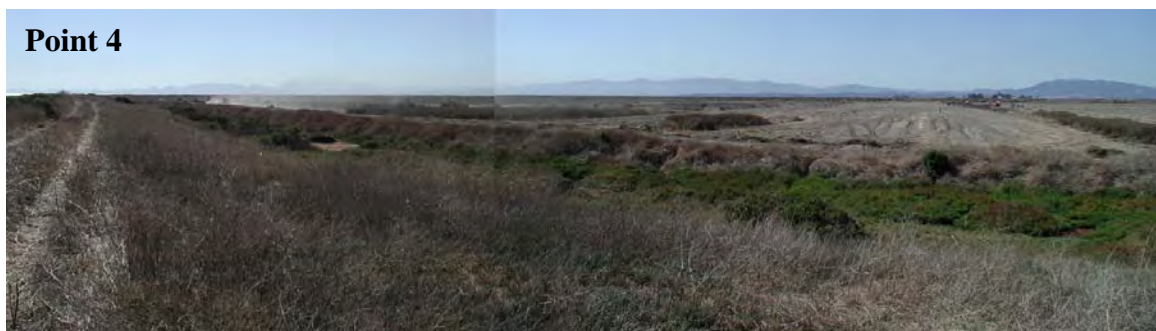
Figure 9. Panoramic views of photopoints of pre-breach conditions at Tubbs Setback showing typical fallow field vegetation, October 2000 (See Figure 2 for locations).

Photographs of the project area were taken annually from four established points along the project boundary (Fig. 2), although additional pictures were taken each year. In October 2000, the first set of images was taken to document pre-breach conditions (Fig. 9). During the low tide of 8 March 2002, the breach was excavated to allow reintroduction of water to Tubbs Setback (Fig. 10). Vegetation plantings along the levee bench were designed to hasten plant colonization; however, native colonization of the levee bench occurred rapidly (Fig. 11). These images clearly show the upland site dominated by weed species typical of fallow oat-hay fields. In the latest set of images (Sep 2006), post-breach conditions show the evolving tidal marsh along the levee bench (Fig. 12).

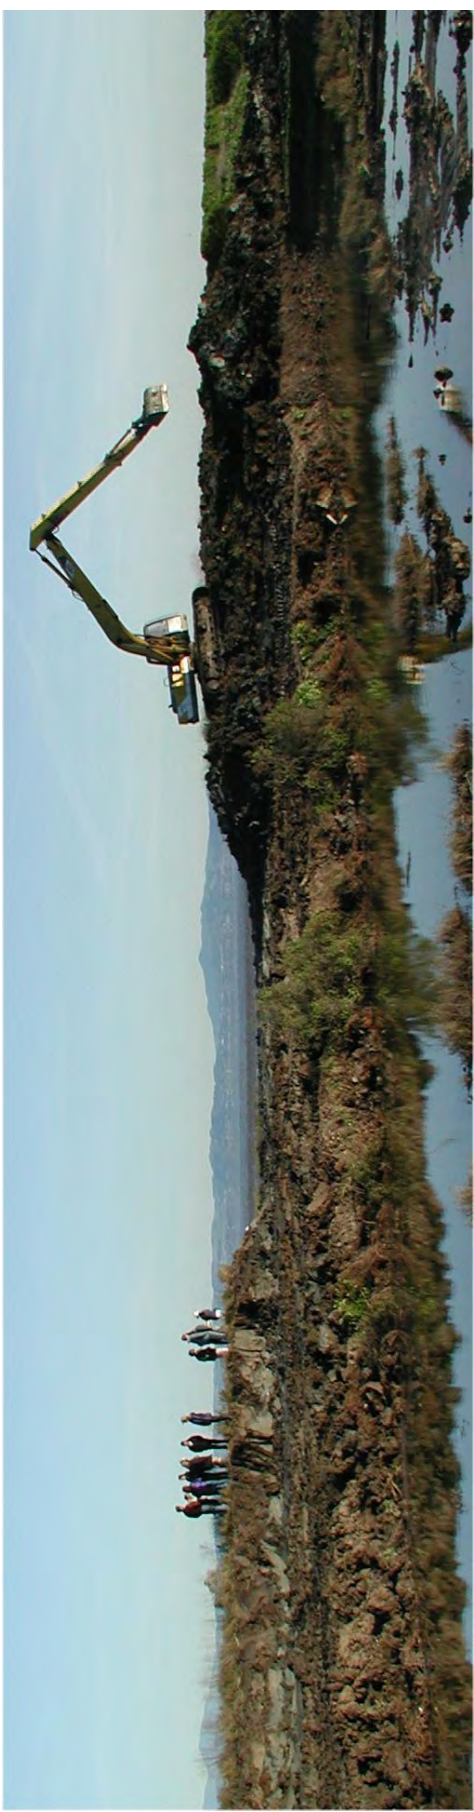
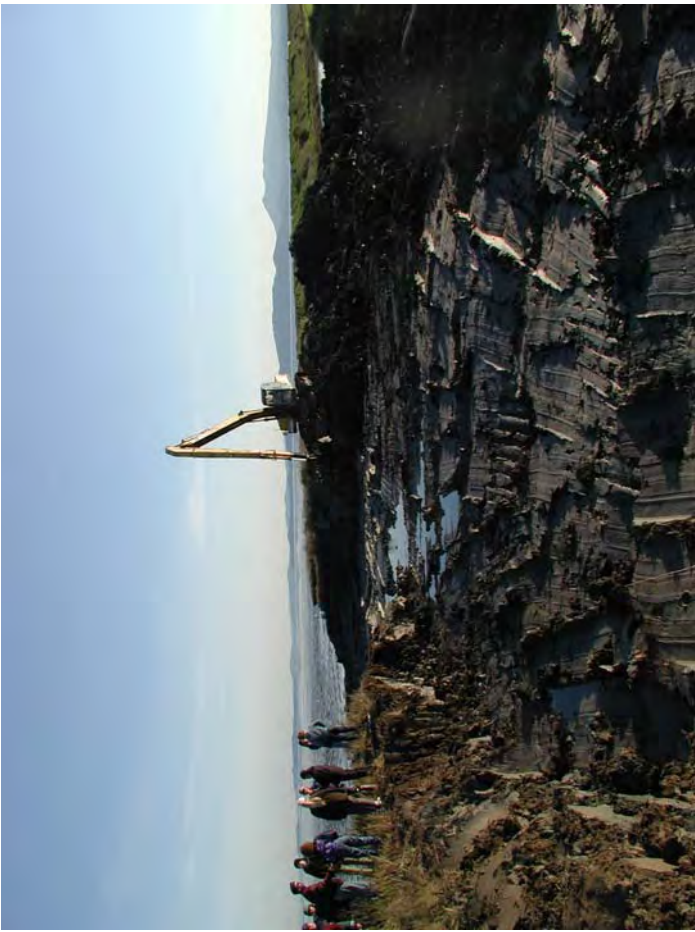
Figure 10. Images of breach construction at Tubbs Setback on March 8th, 2002.

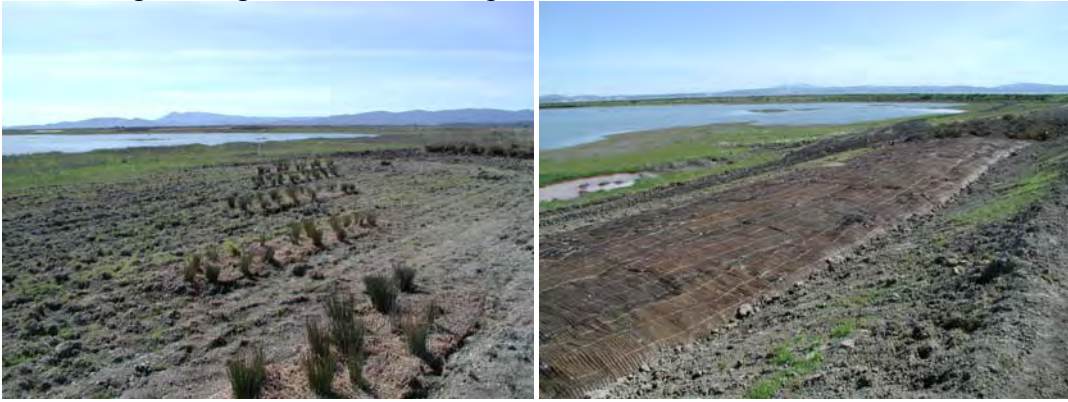
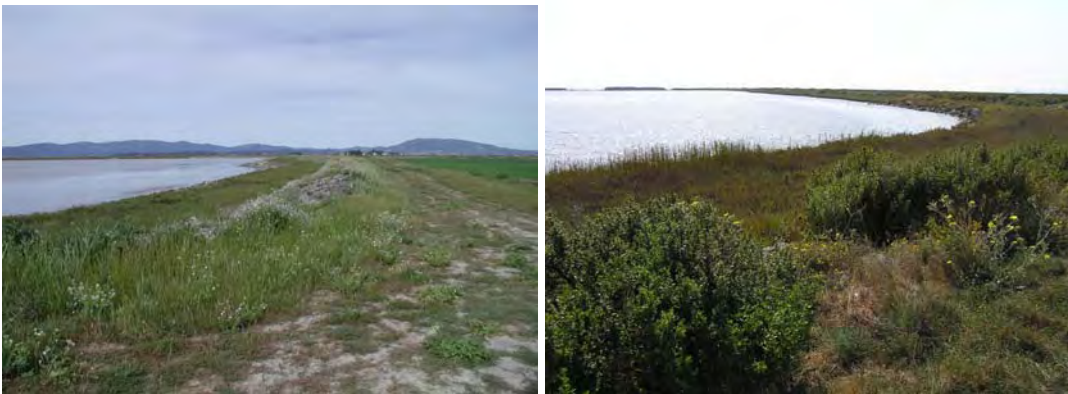
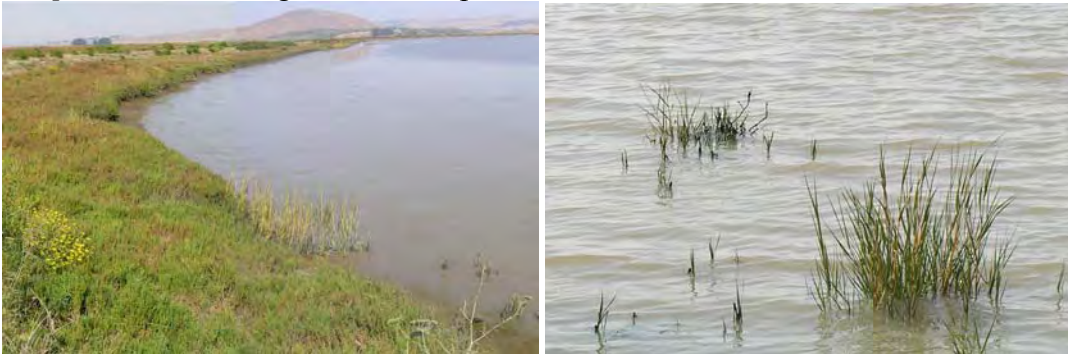
A. Plantings during initial restoration phase, Mar 2002.

B. Current conditions of vegetative cover, Aug 2006.

C. *Spartina* colonizing mudflats, Sep 2006.

Figure 11. Images of Tubbs Setback when vegetation was first planted in 2002 (A) and condition of vegetation in August 2006 (B). No bare ground remains between levee upland and high water line. *Spartina* is beginning to colonize the intertidal zone (C).

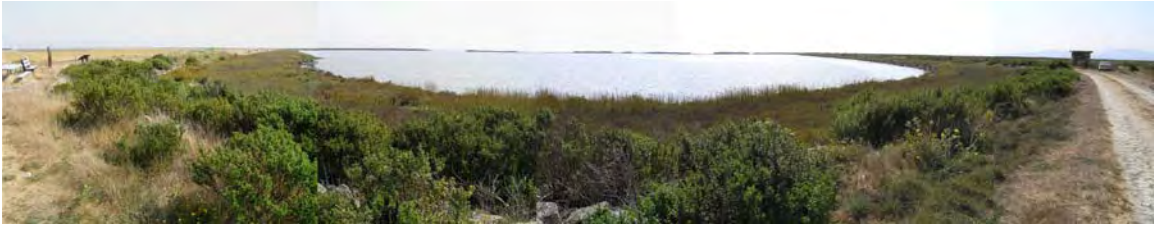
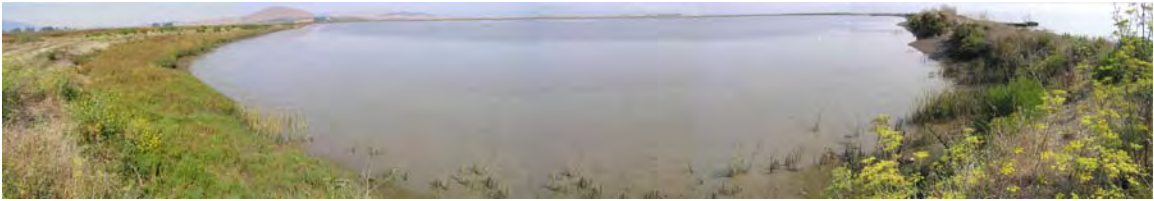
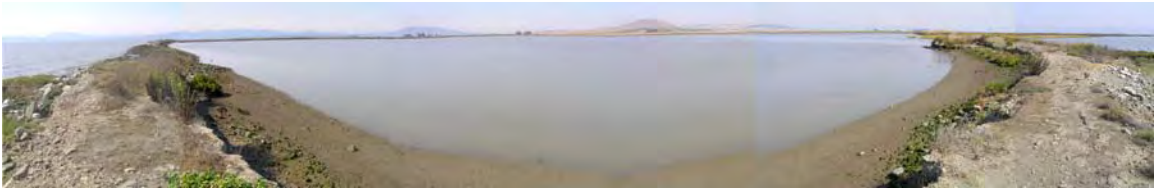
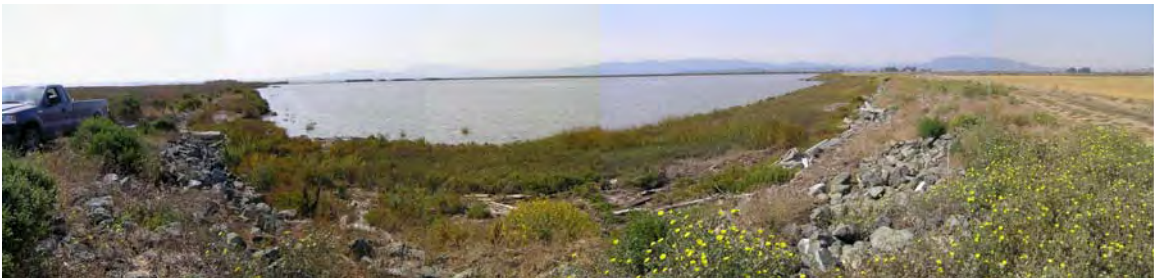
Figure 12. Panoramic views of photopoints of post-breach conditions at Tubbs Setback showing sedimentation and pickleweed establishment on levee bench, September 2006 (See figure 2 for locations).

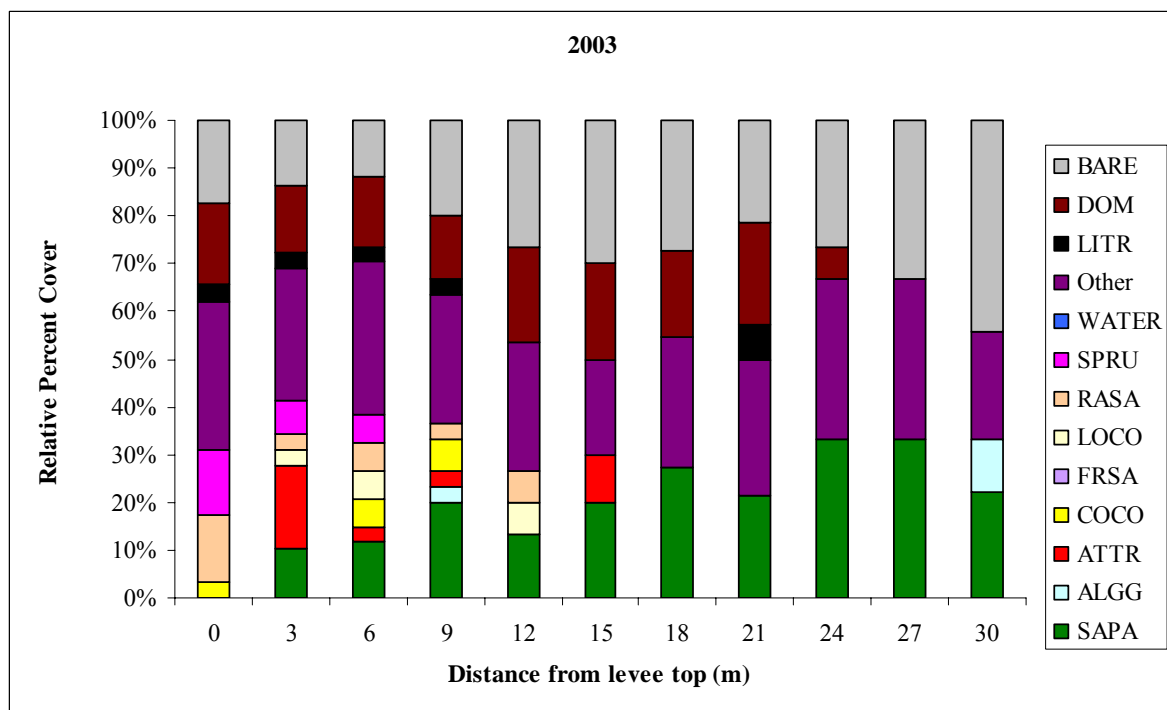
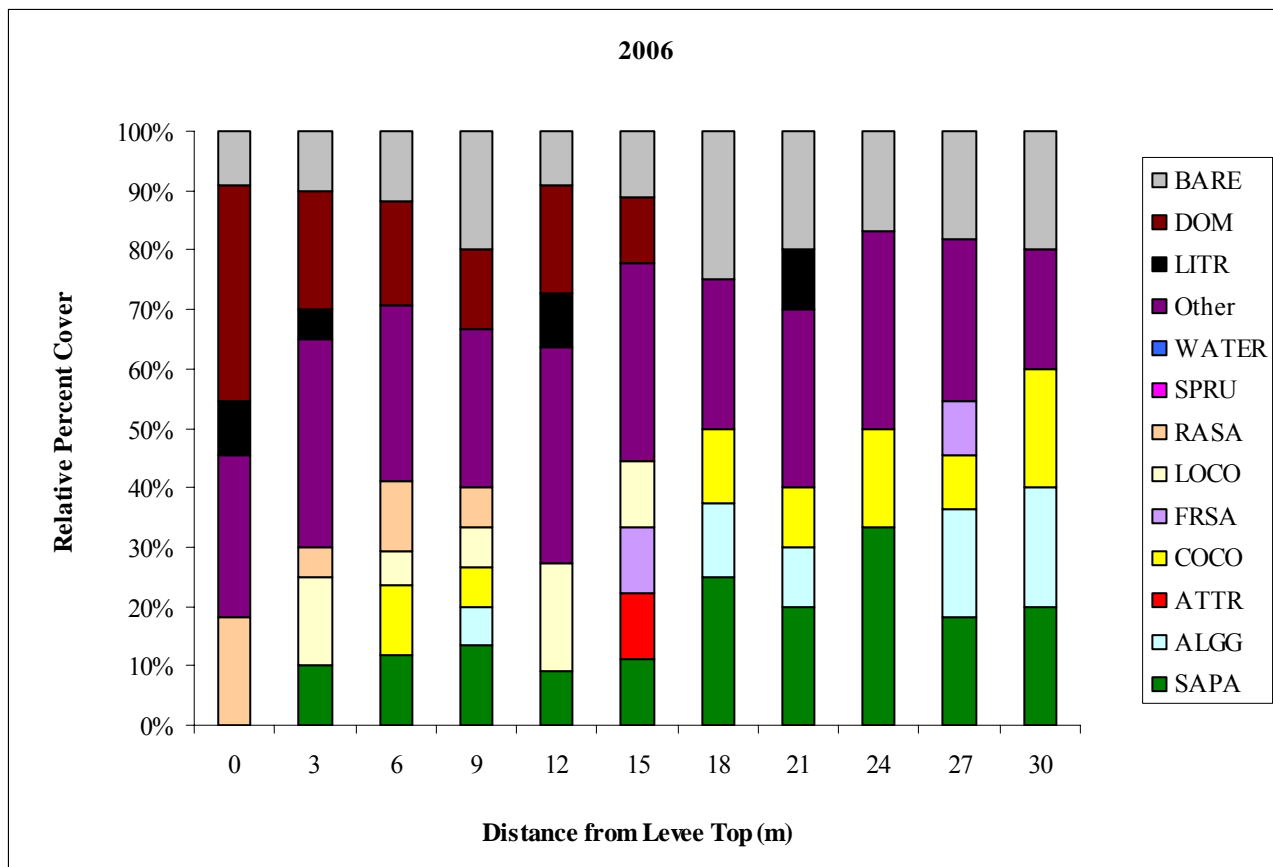
Figure 19. Relative percent vegetated cover from quadrat surveys by distance from the levee top to marsh interior from 2002 to 2006.

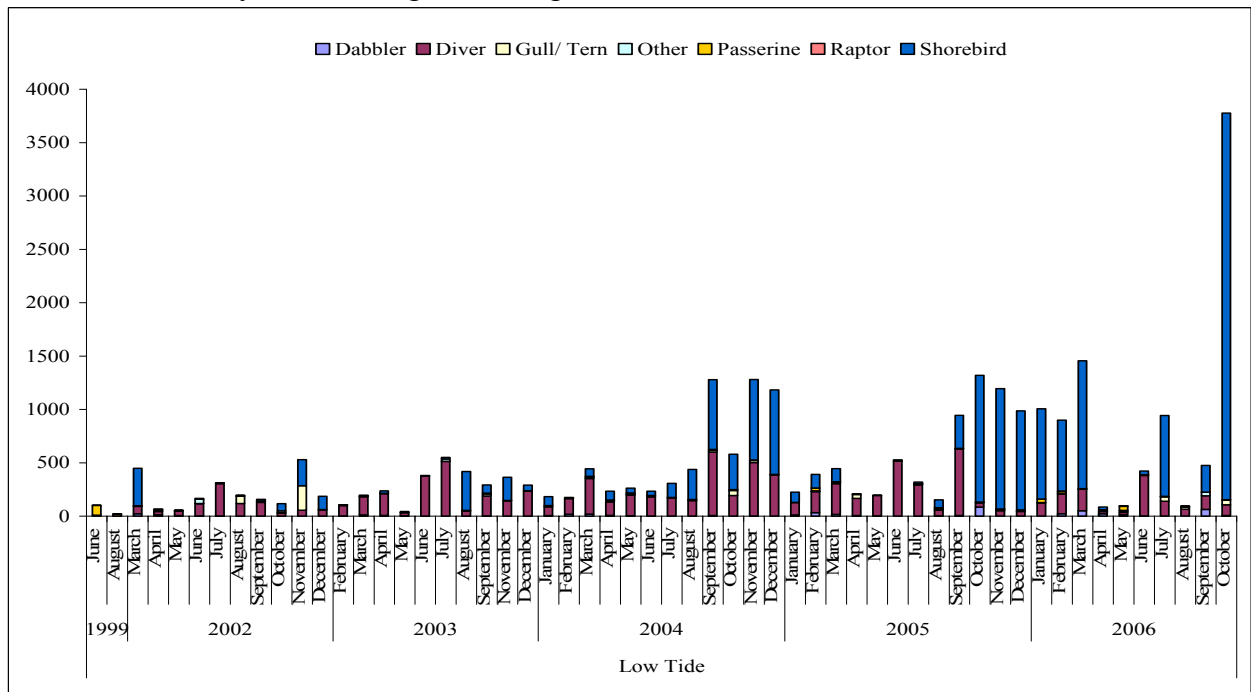
A. Bird numbers by month and guild during low tide.

B. Bird numbers by month and guild during high tide.

Figure 22. Monthly bird abundances by guild at Tubbs Setback at low tide (A) and high (B) tide. Other includes: American White Pelican, Black-crowned Night Heron, Canada Goose, Double-crested Cormorant, Great Blue Heron, Great Egret, Ring-necked Pheasant, Snowy Egret, and Turkey Vulture.

Species composition varied by season and tide (Fig. 22). Greater shorebird numbers have traditionally been detected during low tide surveys; however, as mudflat areas increased and expanded, shorebird numbers during high tide surveys have increased as well (Fig 22). In Nov 2005, over 1,000 shorebirds were observed during a high tide. Divers were consistently abundant in high and low tide throughout the year, but with peak abundances during high tides in the summer months (Fig. 22). Scaup usually winter in the estuary and migrate to breeding grounds in the spring, but a summer population observed at the site was likely comprised of non-breeding individuals. The greatest number of birds was recorded at a single low tide survey in October 2006 with >4,000 birds in which 90% were shorebirds (Fig. 22). During this survey, the tide was just below 2 ft MLLW at Sonoma Creek, the mudflat was completely exposed at Tubbs Setback, and no mudflat was available in the adjacent bay. Though shorebirds were typically most abundant during low tide, they could be found during higher tides foraging along the edges of the mudflat and roosting on the levee bench (Fig 22). We also recorded behavior during our survey. Divers primarily utilized the site for foraging (16%) swimming (44%) and roosting (40%) on the open water during high tide while shorebirds were mostly observed foraging (67%), flying (17%), and roosting (15%).
