The Impact of a Ship Grounding and Associated Fuel Spill at Rose Atoll National Wildlife Refuge, American Samoa

**U.S. Fish and Wildlife Service
Pacific Islands Ecoregion
Honolulu, Hawaii**

September 1997

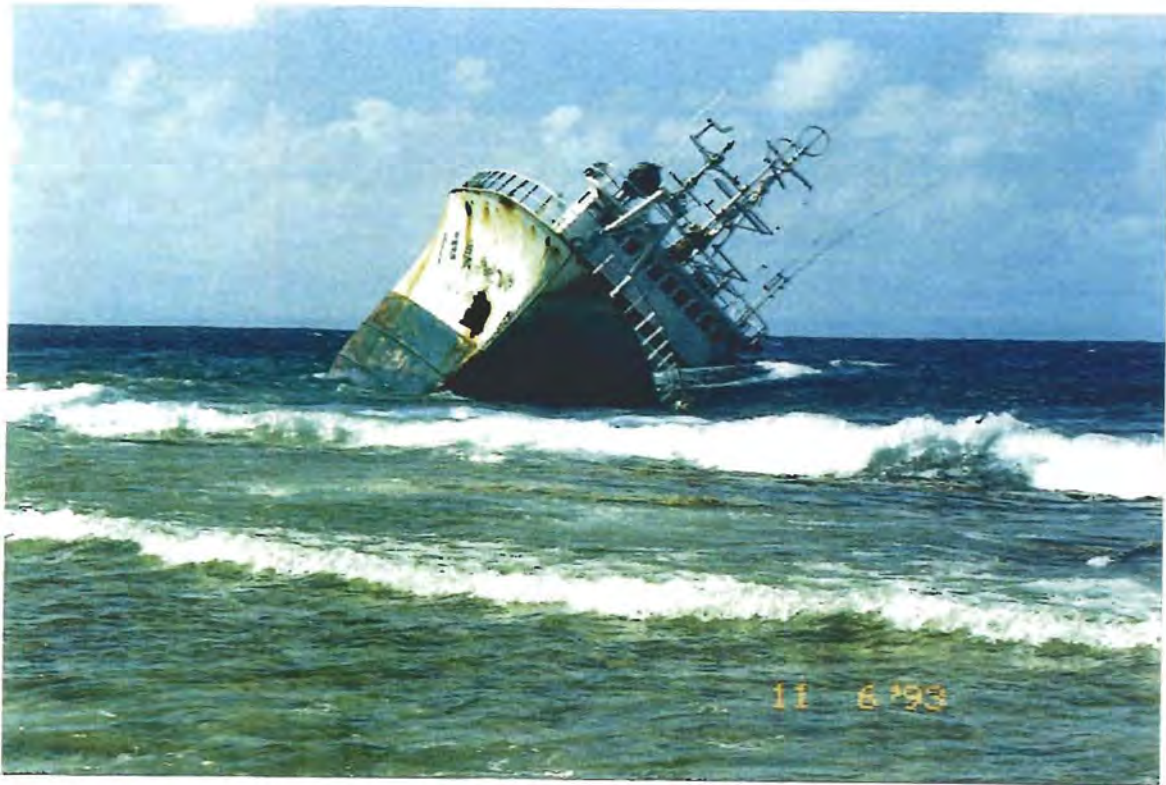
Cover photo: The longline fishing vessel *Jin Shiang Fa* hard aground on the southwest arm of the Rose Atoll in November 1993.

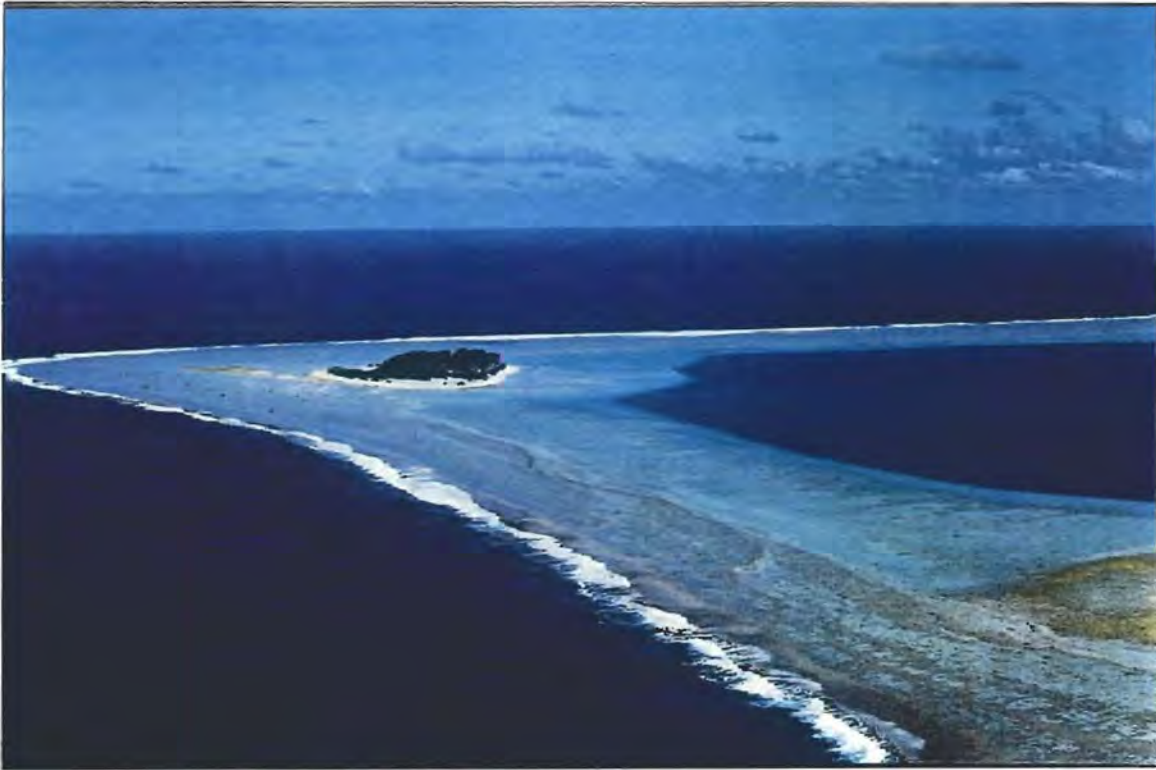
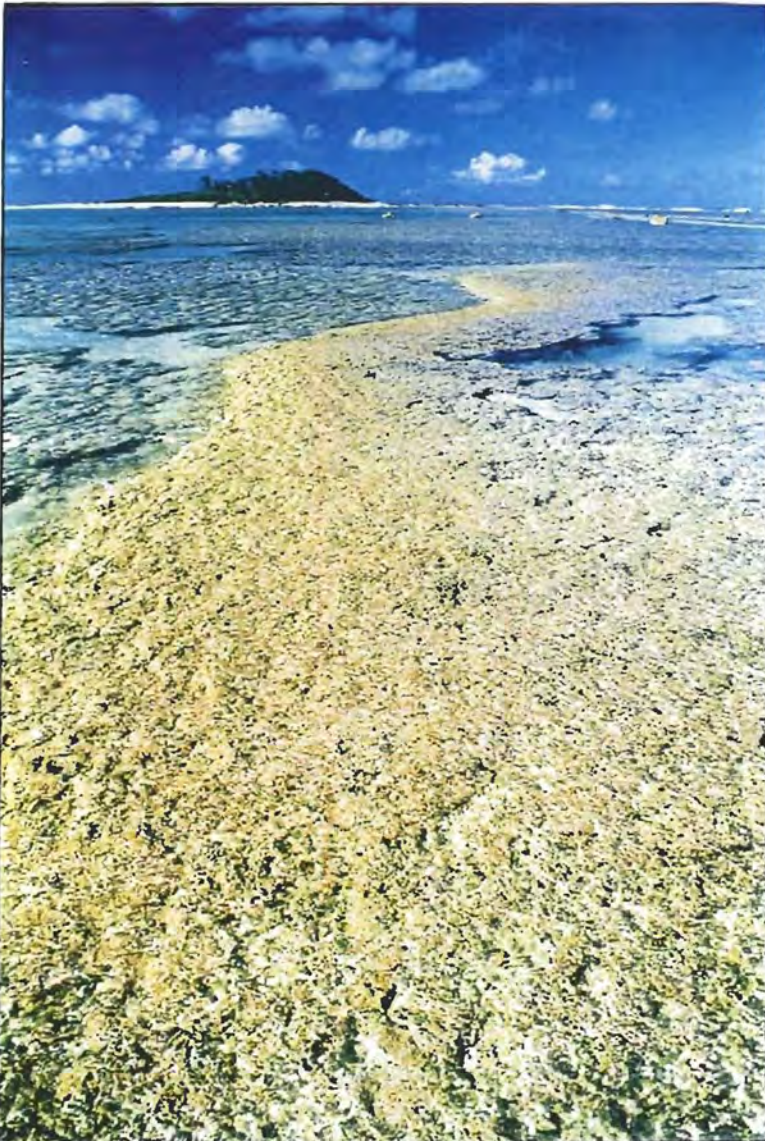
Figure 3 Rose Island and adjacent coral reef habitats on the northeastern and southeastern arms (top) and crustose coralline algae on the inner edge of the reef flat on the southeastern arm (bottom) of Rose Atoll.

The coral reef ecosystems at Rose are unique in Samoa, since they are dominated by crustose coralline algae⁴ rather than hermatypic corals (Figs. 3 & 5, Mayor 1921, Green 1996). Although a "coral" atoll dominated by crustose coralline algae is not unique in the central Pacific Ocean, Rose is an excellent example of this type of reef. Initial observations of the crustose coralline algae, as well as the fleshy and filamentous algae, indicate that the species present at Rose are typical of atolls in the central Pacific Ocean, although the species diversity appears to be somewhat low. The most recent published list of algae for all of Samoa, including Rose, is by Setchell (1924). Only recently have algae at Rose been collected by experienced phycologists, and then only in the austral winter (July and August). The lack of seasonal collecting, as well as very limited subtidal collecting, may account for the low diversity of algal species thus far observed.

Observations by field biologists indicate that, prior to the ship grounding, the reef flat at Rose Atoll was dominated by crustose coralline algae, giving the atoll a distinctive pink color (B. Flint and P. Craig, pers. comm., see Fig. 3). This coralline algal community was relatively uniform on the reef flat on all four arms of the atoll (Fig. 19).

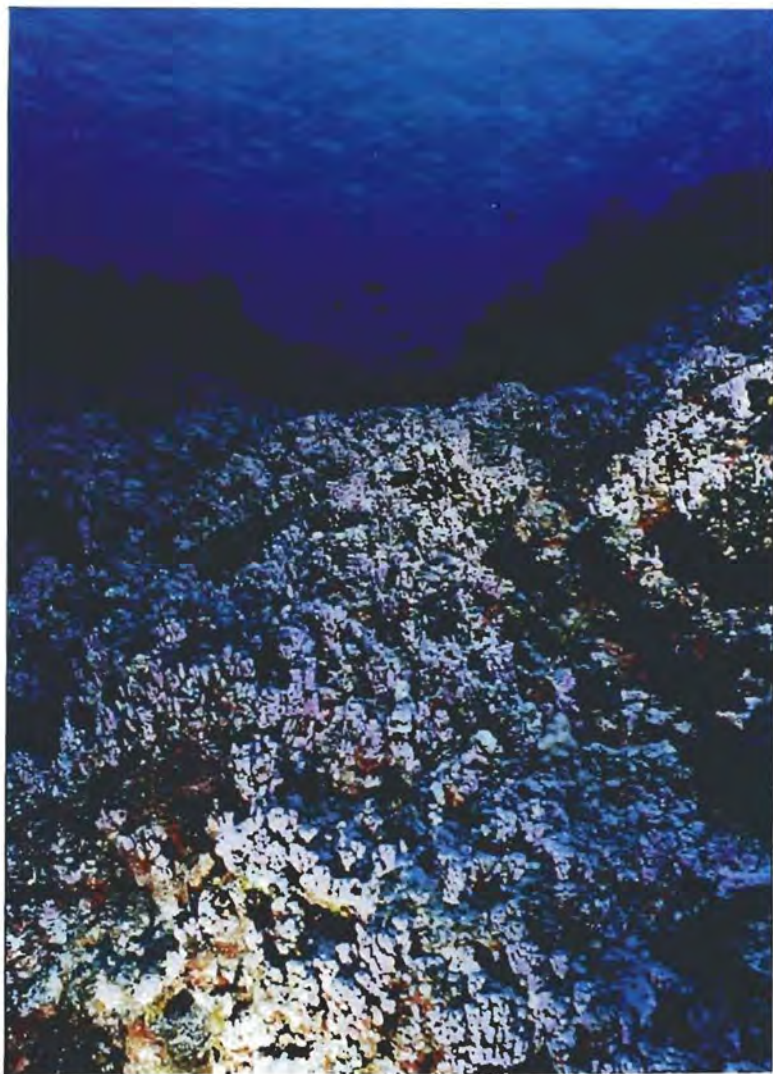
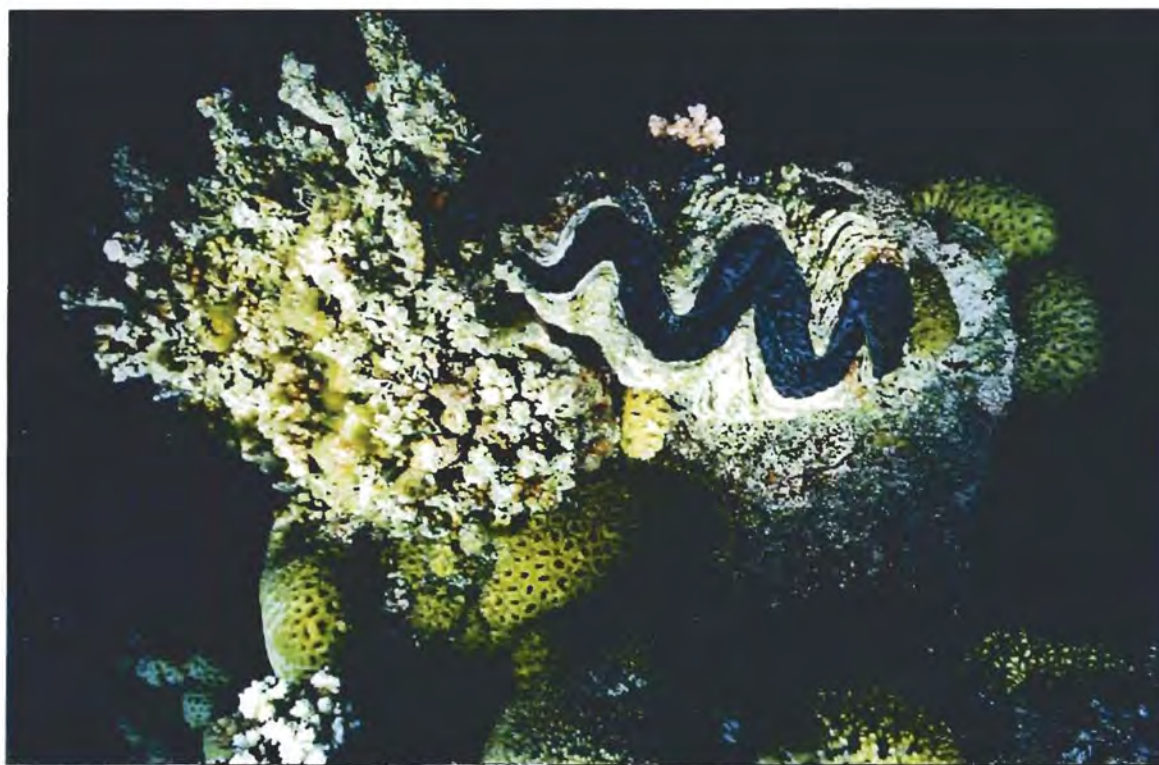
Figure 5 Crustose coralline algae on the reef slope (top) and corals and a giant clam (*Tridacna maxima*) on the base of a pinnacle in the lagoon (bottom) at Rose Atoll.

The reefs at Rose Atoll are also characterized by high densities of giant clams (*Tridacna maxima*), which are most abundant on the bottoms of the pinnacles in the lagoon (Fig. 5 & 6: Wass 1981b, Radtke 1985, Green and Craig 1996). By comparison, giant clam densities are much lower throughout the rest of the Samoan Archipelago, where their populations appear to have been overharvested (Green and Craig 1996).

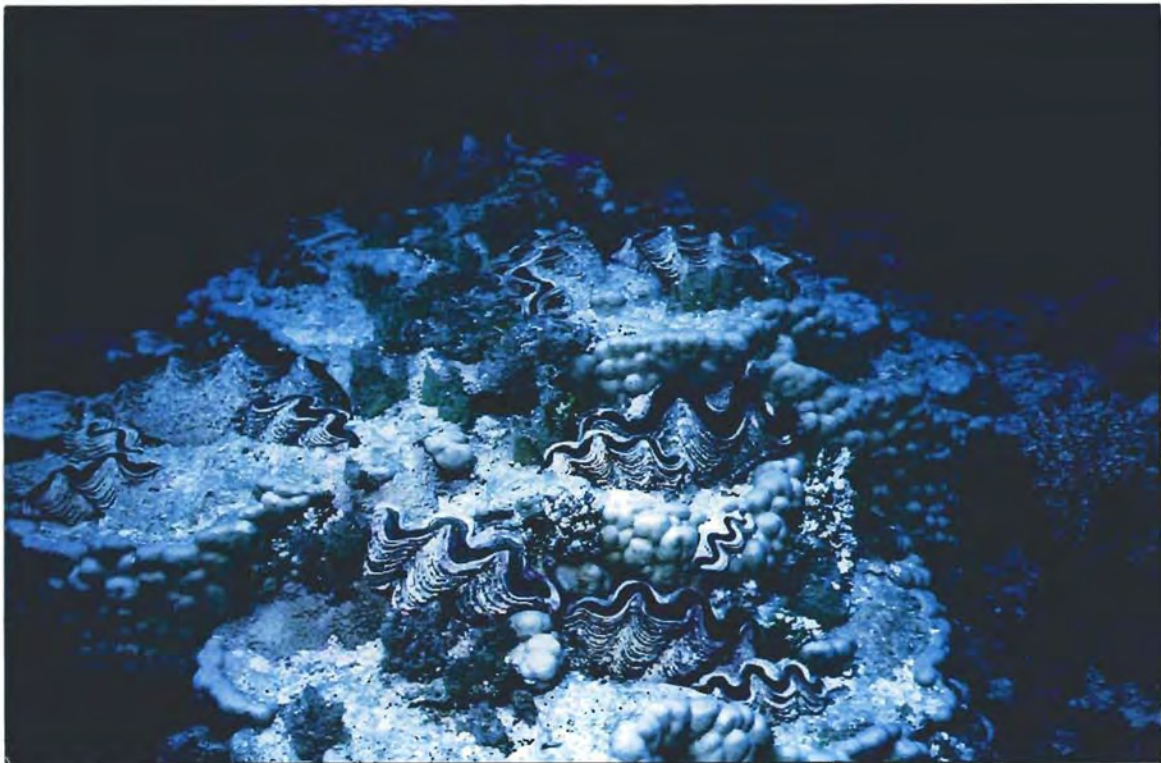
Figure 6 School of unicornfishes (*Naso literatus*) on the outer reef slope (top) and giant clams (*Tridacna maxima*) on the base of a pinnacle in the lagoon (bottom) at Rose Atoll.

The fish communities at Rose are also distinctly different from those that occur elsewhere in the Samoan Archipelago (Green 1996). Fish density is very high and species richness is moderately high at Rose, although fish diversity and biomass are low because of the dominance of small, planktivorous species (Green 1996). The fish assemblages at Rose also differ from the rest of the archipelago by having a much lower diversity of herbivorous species (especially parrotfishes and damselfishes), and a high density of planktivorous and carnivorous species (especially damselfishes, unicornfishes and snappers; Fig. 6. Wass 1981a, Green 1996, unpubl. data).

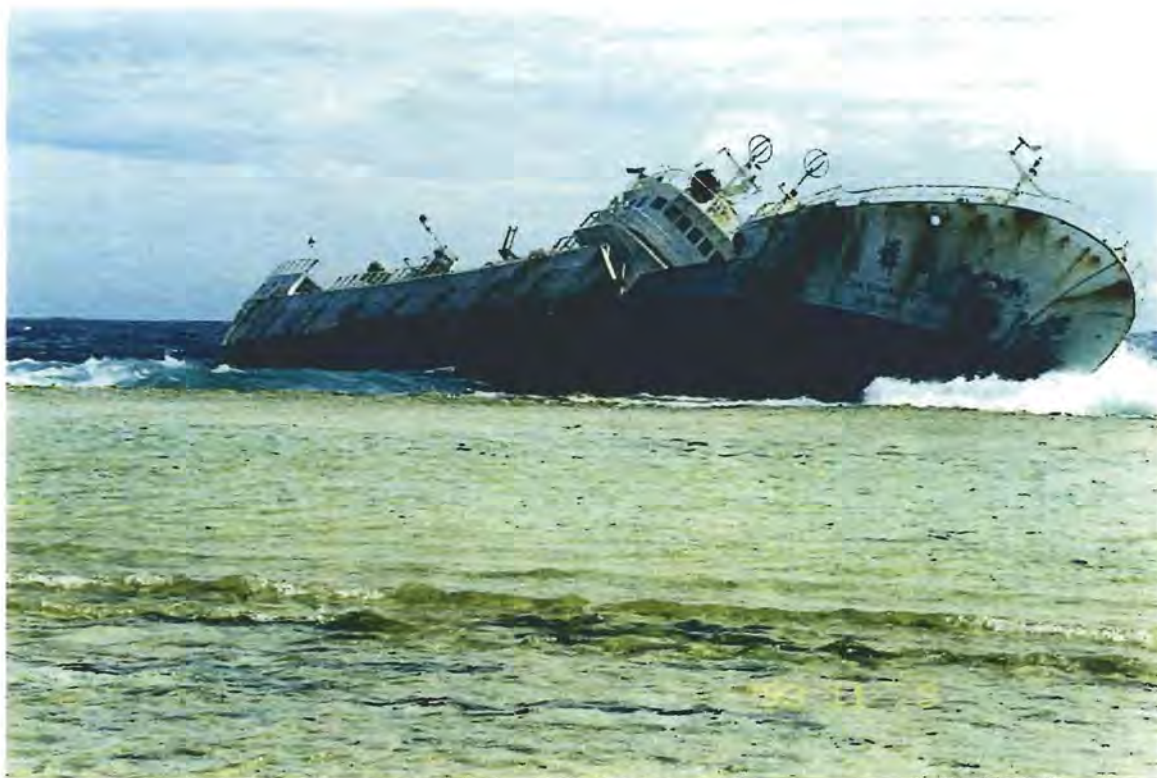
Figure 7 The longline fishing vessel *Jin Shiang Fa* hard aground on the southwest arm of Rose Atoll in November 1993.

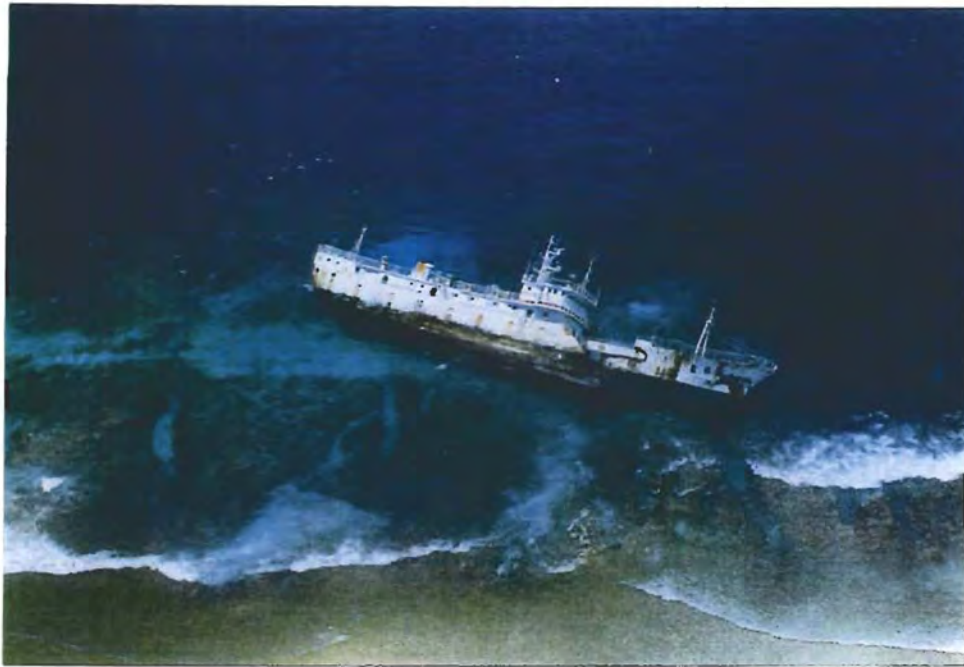
Figure 8 The *Jin Shiang Fa* hard aground across spurs on the reef slope at Rose Atoll in October 1993 (top) and the contaminant spill north of the vessel on October 23, 1993 (bottom).

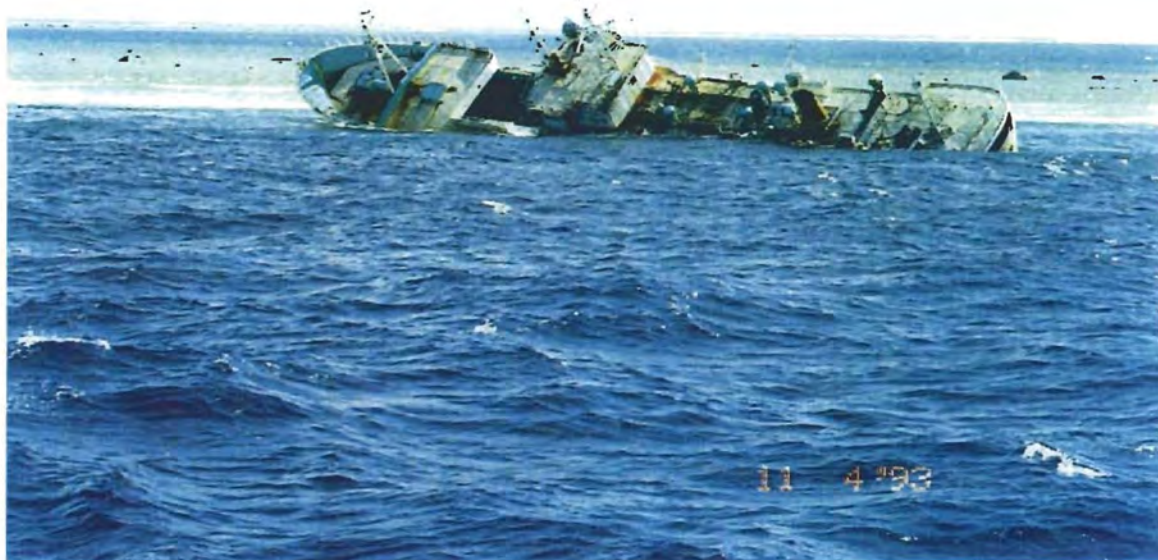
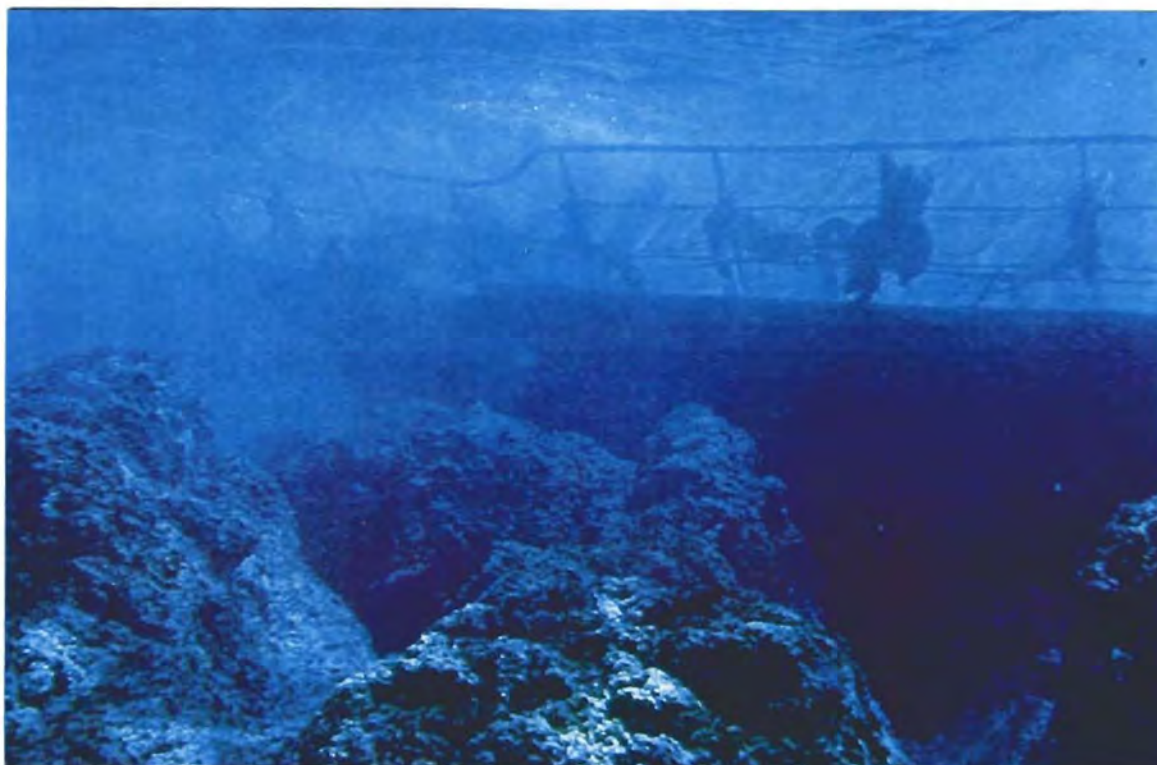
Figure 9 The outer reef slope at Rose Atoll in November 1993 showing the *Jin Shiang Fa* keeled over on its port side (top) with the port side railing under water (bottom).

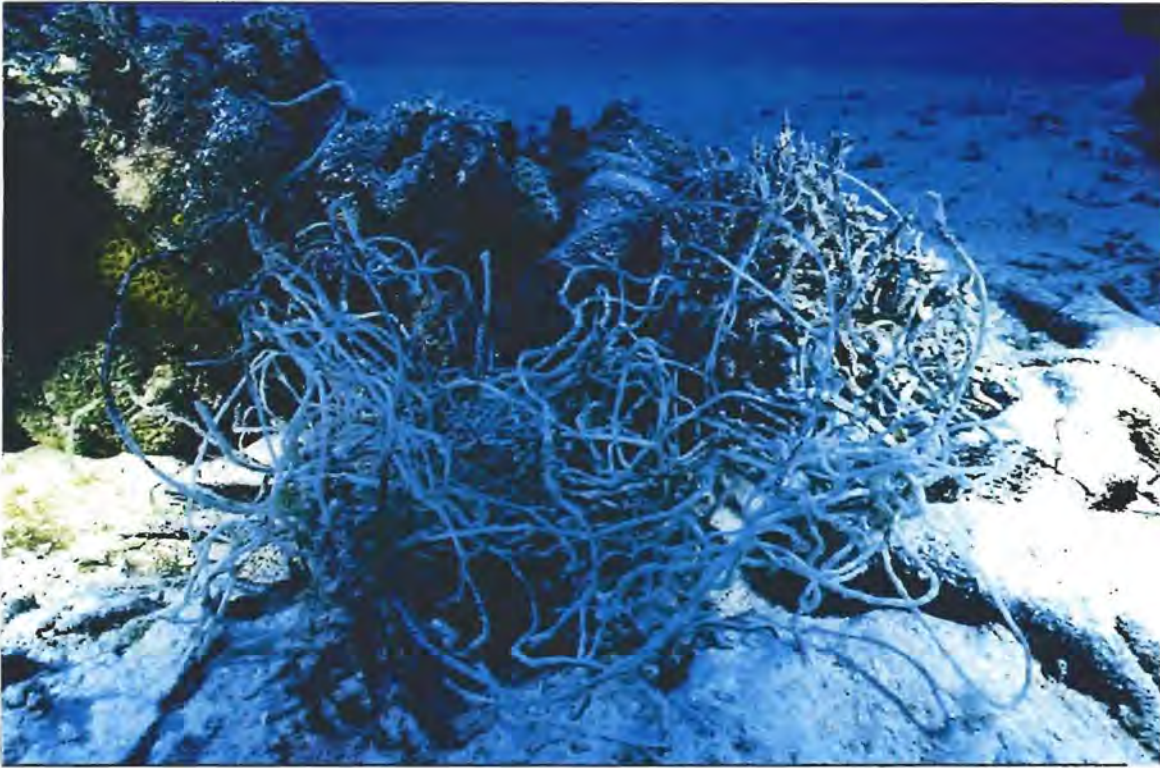
Figure 10 Monofilament longline fishing gear on the lagoon floor at Rose Atoll two years after the grounding.

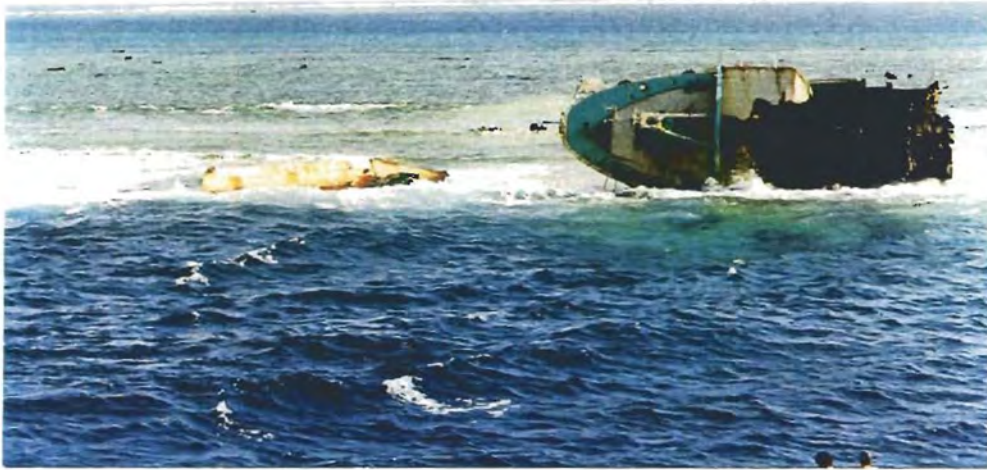
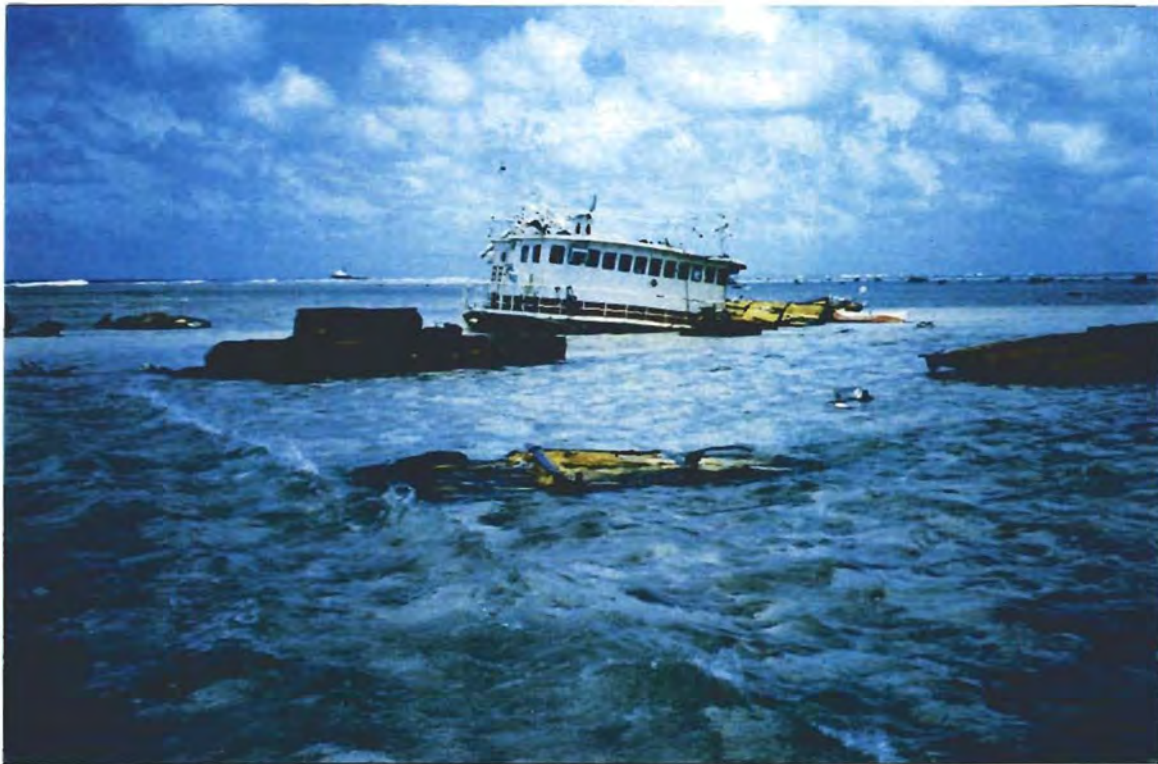
Figure 11 The bow section (top), wheelhouse and other pieces of wreckage (bottom) on the reef flat at Rose Atoll six weeks after the grounding.

The area where the vessel ran aground is periodically subject to strong wave action, and the vessel broke up four to six weeks after grounding and before a salvage operation could take place (Fig. 11, Barclay 1993). When the salvage operation began on November 27, 1993, the stern half of the vessel (approximately 250 tons) was nearly submerged on the shallow reef slope (approx. 50 m seaward of the reef margin) with only a small amount of rigging above water (Barclay 1993). The bow section (76 tons), wheelhouse (5 tons), shelter deck (2 tons) and 18 miscellaneous pieces of the shipwreck (38 tons) were scattered over the reef flat in close proximity to the grounding site and fully exposed at low tide (Fig. 11, Barclay 1993). This wreckage was estimated to cover

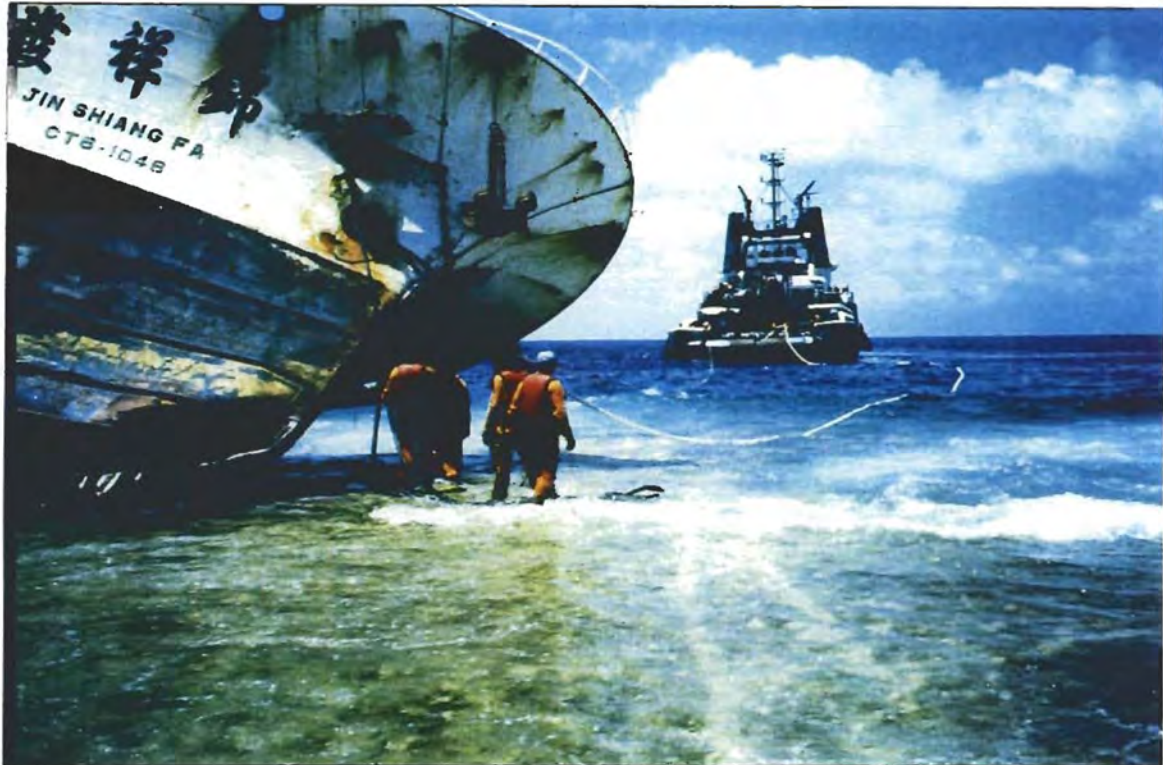
Figure 12 Salvage operation to remove the wreckage from the reef flat six weeks after the grounding.

Salvage operations (Fig. 12) were successful in removing most of the larger pieces of wreckage and debris from the reef flat (Barclay 1993). This included pulling the bow, wheelhouse, shelter deck, and miscellaneous pieces of ship wreckage off the reef flat into deeper water (600-1,000 m). However, the salvage crew did not attempt to move the stern and its associated debris from the shallow reef slope because the sheer mass of the stern made it impossible to move (Barclay 1993). In the months following the salvage operation, the stern was broken up into smaller pieces by high wave energy.

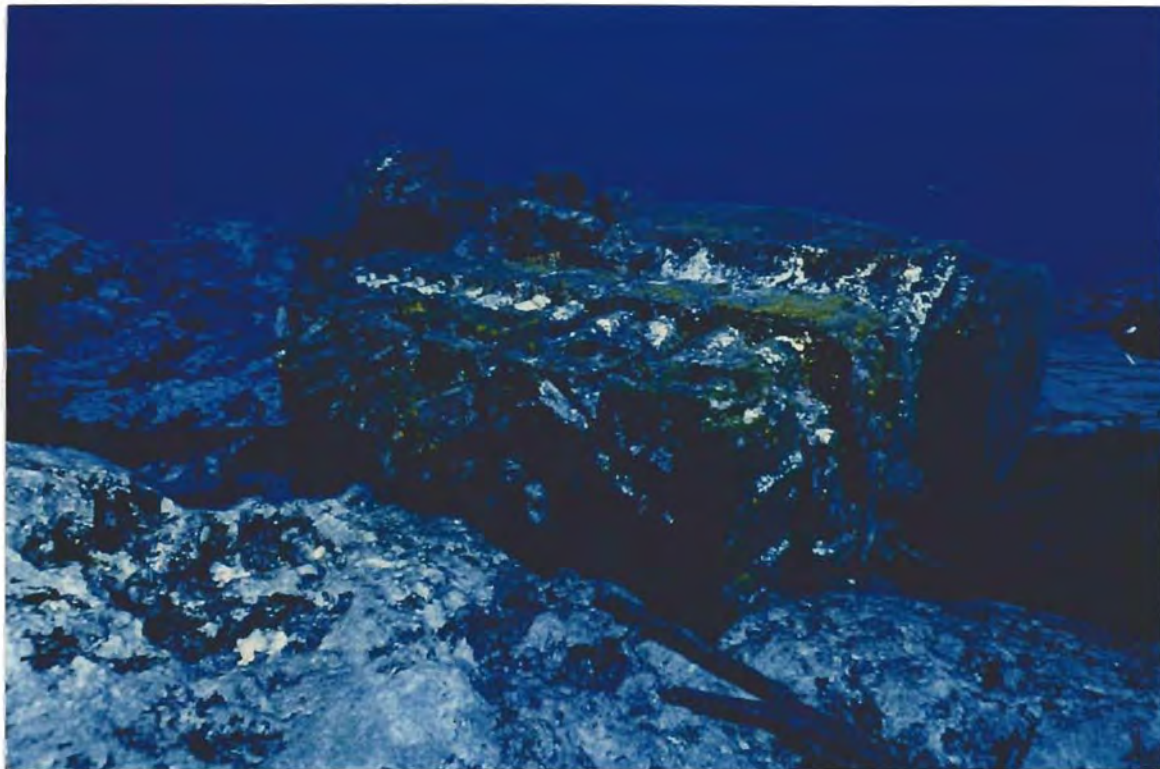
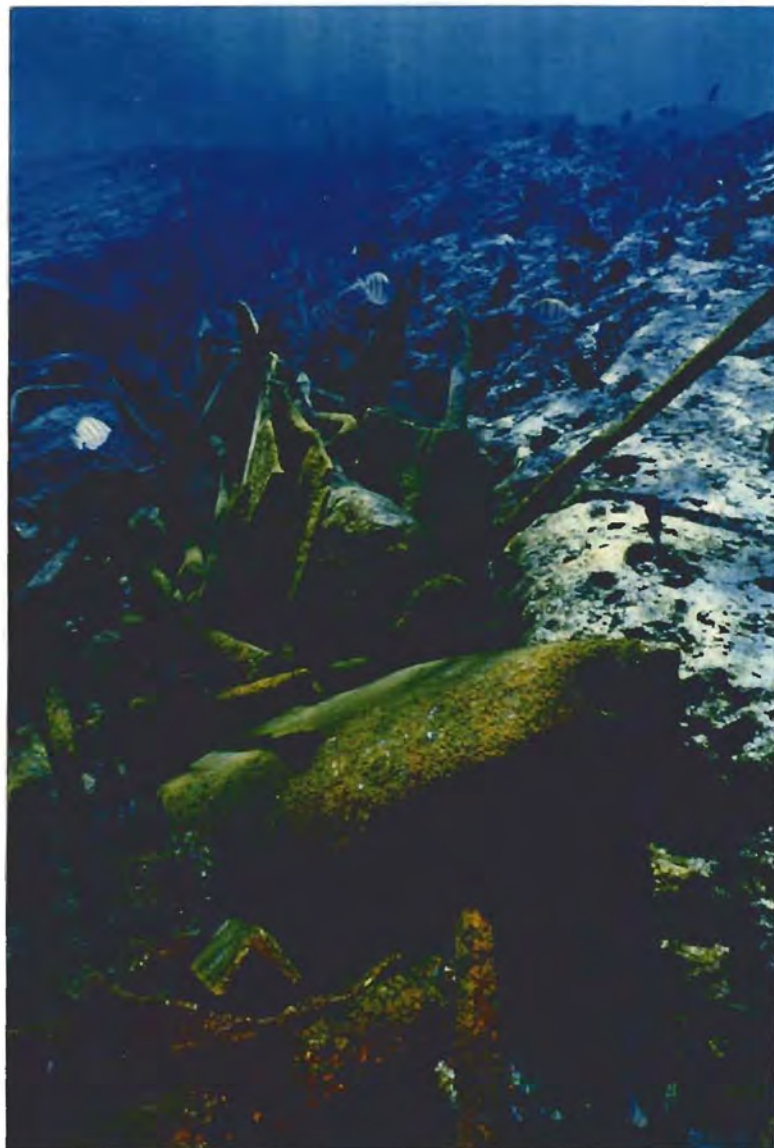
Figure 13 Wreckage on the outer reef slope two years after the grounding, including the engine block (top) and other metal sections of the stern and ship debris (below).

Four months after the grounding, a large amount of wreckage and debris was still present on the reef slope, covering an area of approximately 3,500 m² (Molina 1995). The engine block was on the reef slope just below the surf zone (Fig. 13), and numerous other pieces of wreckage and debris were distributed in the area, mostly within the natural reef groove where the vessel came to rest (Fig. 13, Molina 1995). The remaining wreckage included coils of longline fishing gear, large metal plates, twisted engine conduit, pieces of super structure, and many other miscellaneous items (Molina 1995). Molina (1995) also noted that much of the debris appeared to be very unstable, although some had been imbedded in a large rubble pile below the main area of the wreckage (see *Generation of Berms*).

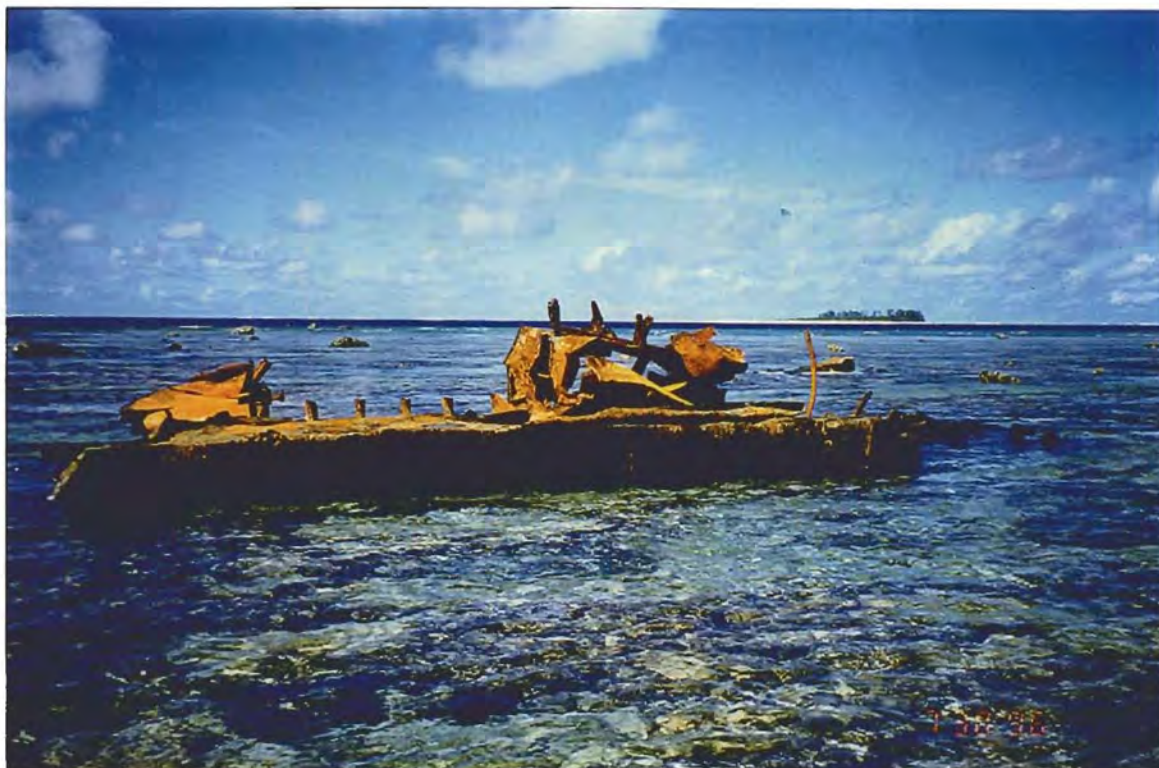
Figure 14 Wreckage from the *Jin Shiang Fa* on the reef flat two years after the grounding.

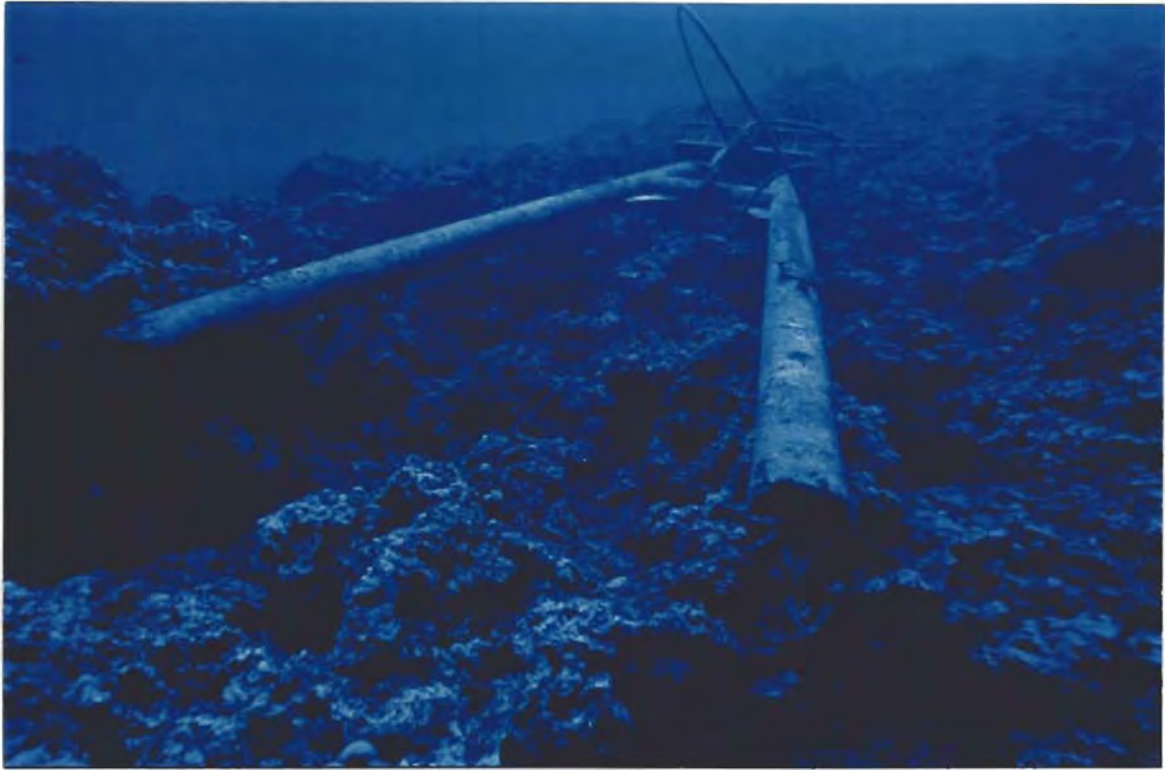
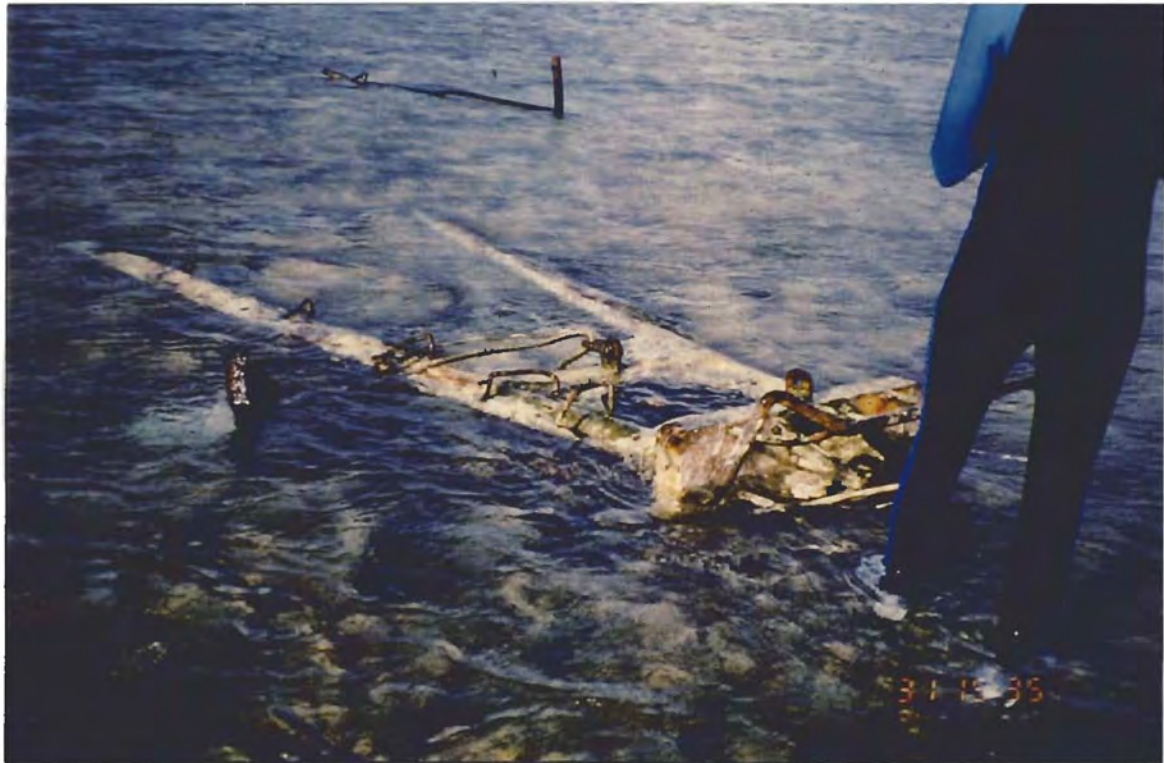
Figure 15 Foremast on the outer reef slope five months after the grounding (top) and the same piece of wreckage on the reef flat 1 ½ years later (bottom).

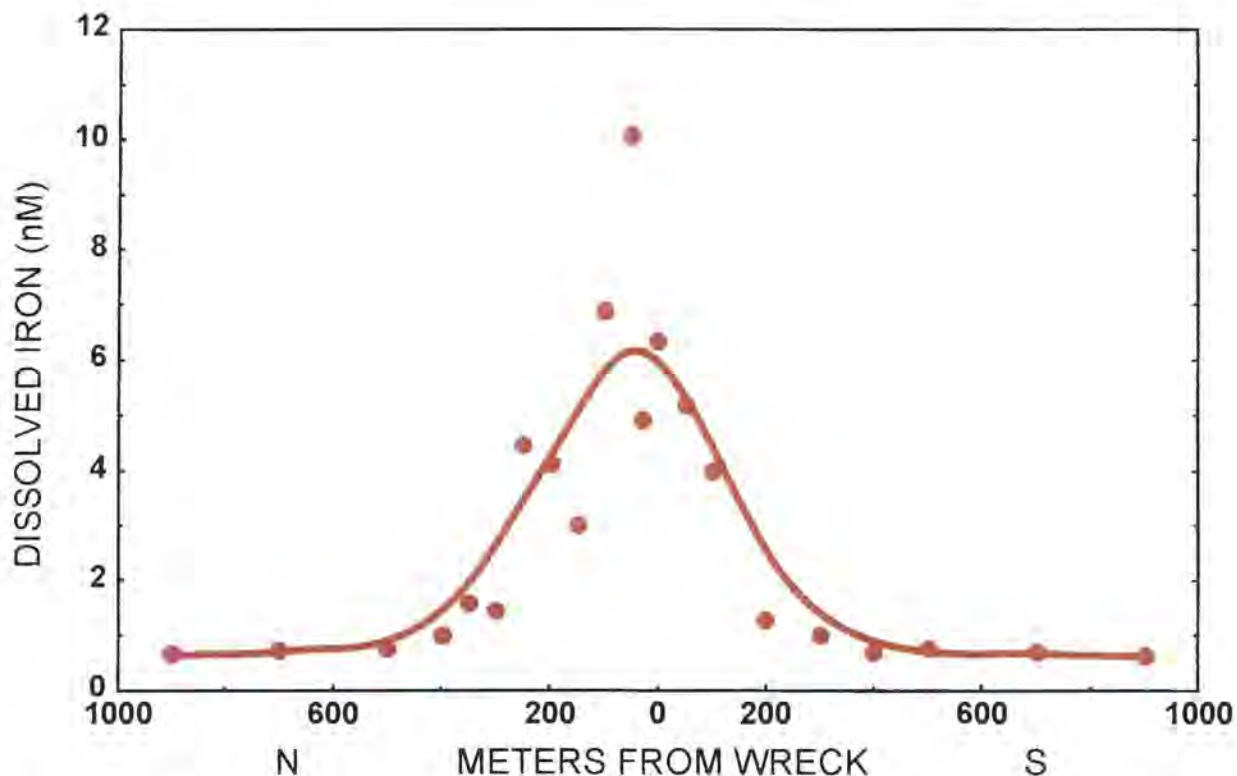
A clear peak in iron concentration was found on the outer reef flat at the wreck site (Fig. 16). Given water circulation patterns on the atoll (see *Study Area*), the source of the iron is most likely the large amount of submerged wreckage on the outer reef slope. Limited sampling suggests that a plume of iron-rich water, approximately 500 m wide, flows across the reef from the outer reef slope to the lagoon and that the debris on the reef flat contributes relatively little iron to the plume (J. Burgett unpubl. data). By comparison, low background iron levels found away from the plume (< 1 nM; Fig. 16) are typical of oceanic waters in which iron is the limiting nutrient.

Figure 16 Iron (Fe) concentrations (and least squares curve) on the outer reef flat on the southwest arm of Rose Atoll in January 1997.

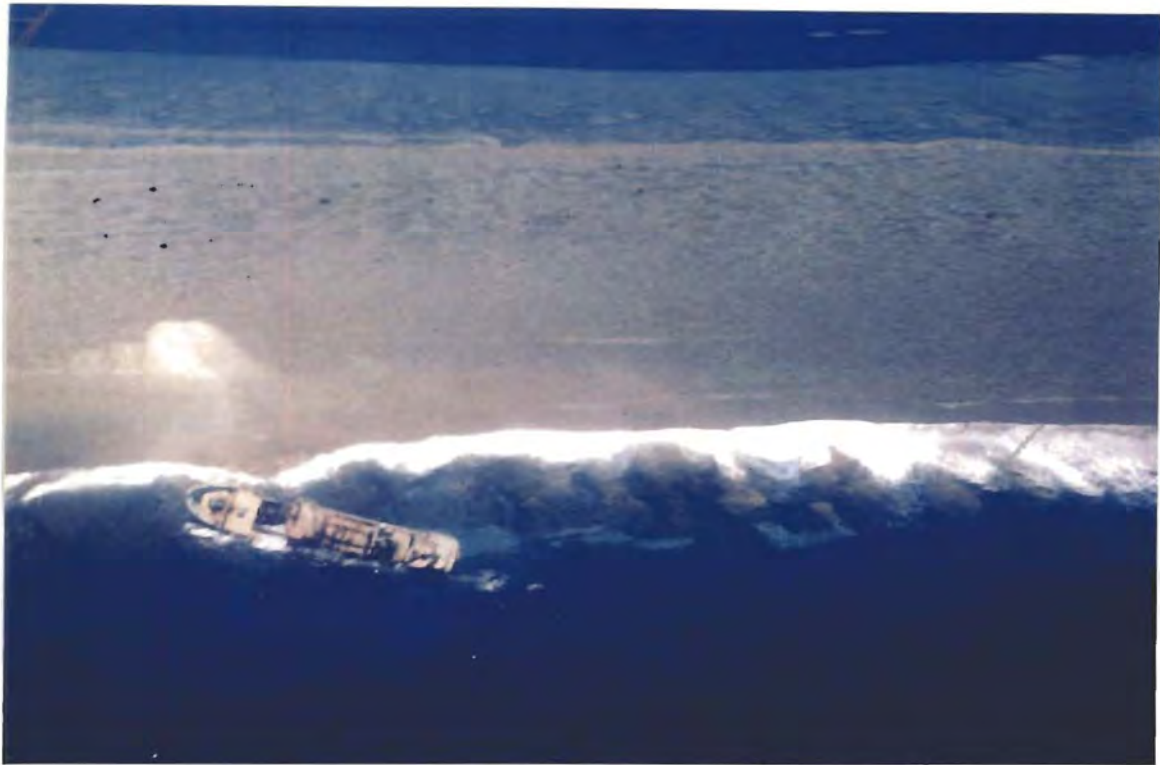
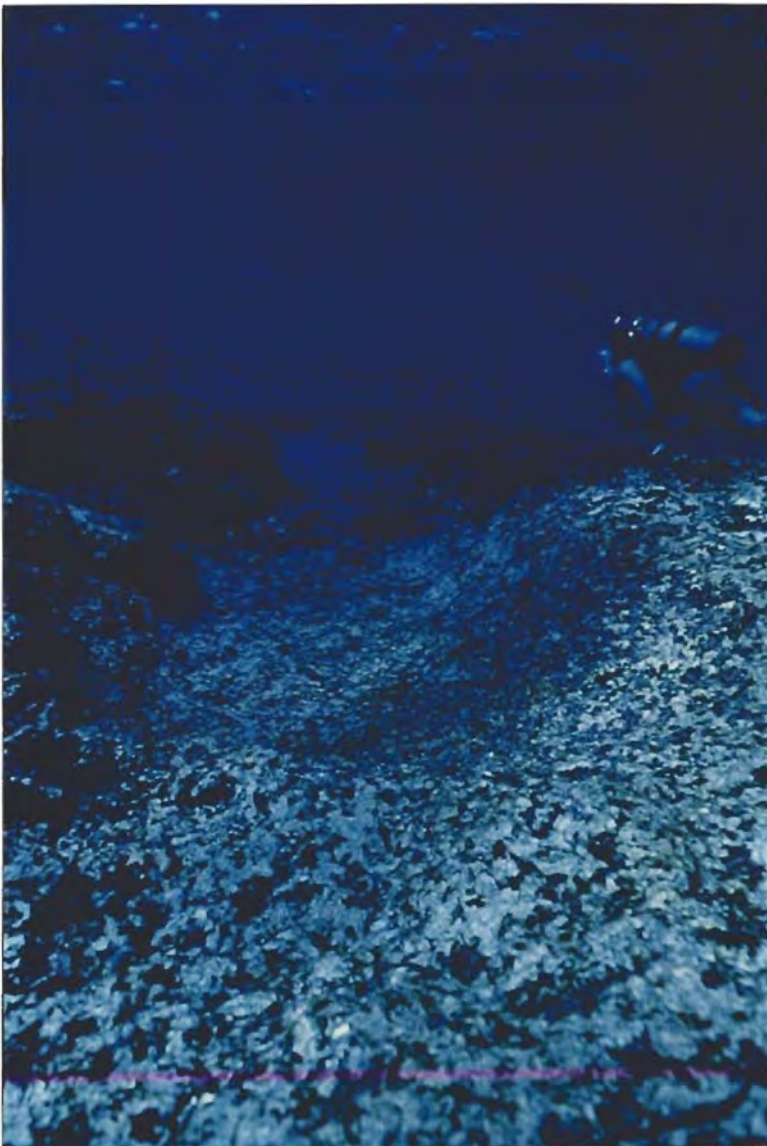
Figure 17 Scarring on the outer reef slope caused by the passage of the vessel as seen from the air (top) and underwater (bottom).

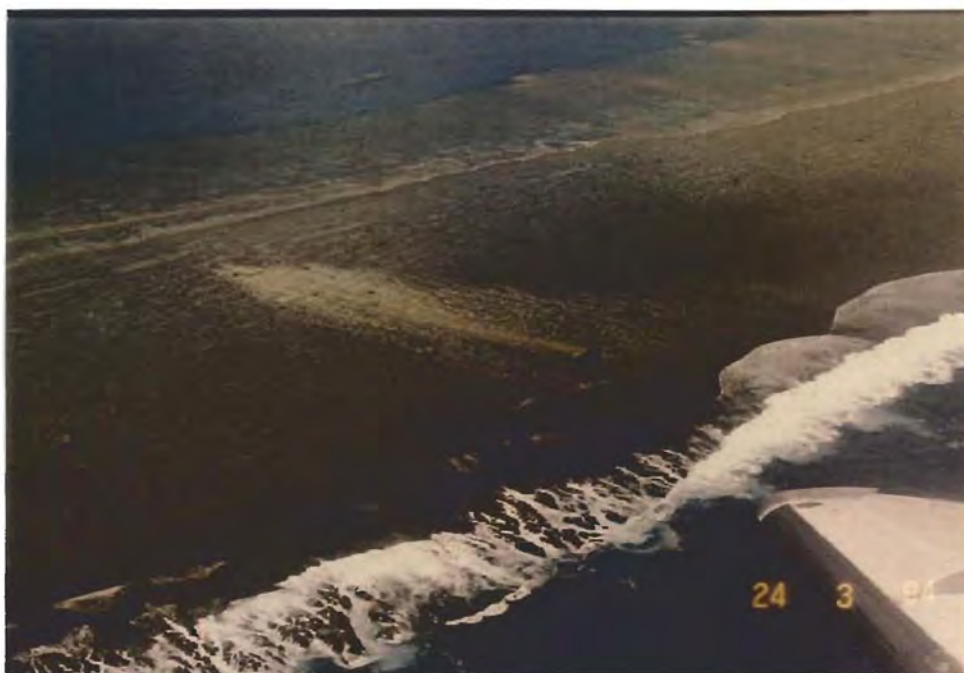
In the weeks following the grounding, the rocking of the vessel by waves and surge caused additional injury to the outer reef slope, by enlarging the groove in which the ship's keel and hull were lodged. Calcareous sediments (i.e. pulverized reef) generated by the movement of the hull formed two large piles which extended down the reef slope below the vessel (Fig. 18: Molina 1994). Both of these berms were large enough to be clearly visible from the air (Fig. 18). The largest of the berms spread down the slope from just below the surf zone to a depth of 46 m (Molina 1995). Two weeks after the grounding, this berm was 78 m long, and ranged in width from 21 to 42 m at depths of 14 m and 9 m respectively (Molina 1995). These berms are believed to have buried benthic marine organisms and a large amount of ship debris, as evidenced by the pieces of fishing line and other items protruding from within the sediments (Molina 1994). Subsequently, this berm has migrated down the outer reef slope to the seaward terrace in deeper water below the wreck (J. Burgett pers. obs.).

Over time, the sediments from the reef flat berm have spread laterally and moved towards the lagoon, scouring and filling in numerous cracks and depressions in the reef flat, and burying and abrading reef organisms (Molina 1994, 1995, see *Corals* and *Echinoderms*). Three years after the grounding, these sediments remain prominent in depressions in the reef flat near the wreck (J. Burgett pers. obs.).

Figure 18 Sand-rubble berms on the outer reef slope below the vessel two weeks after the grounding (top) and the berm on the reef flat adjacent to the wreck site five months after the grounding (bottom).
