The Impact of a Ship Grounding and Associated Fuel Spill at Rose Atoll National Wildlife Refuge, American Samoa

**U.S. Fish and Wildlife Service
Pacific Islands Ecoregion
Honolulu, Hawaii**

September 1997

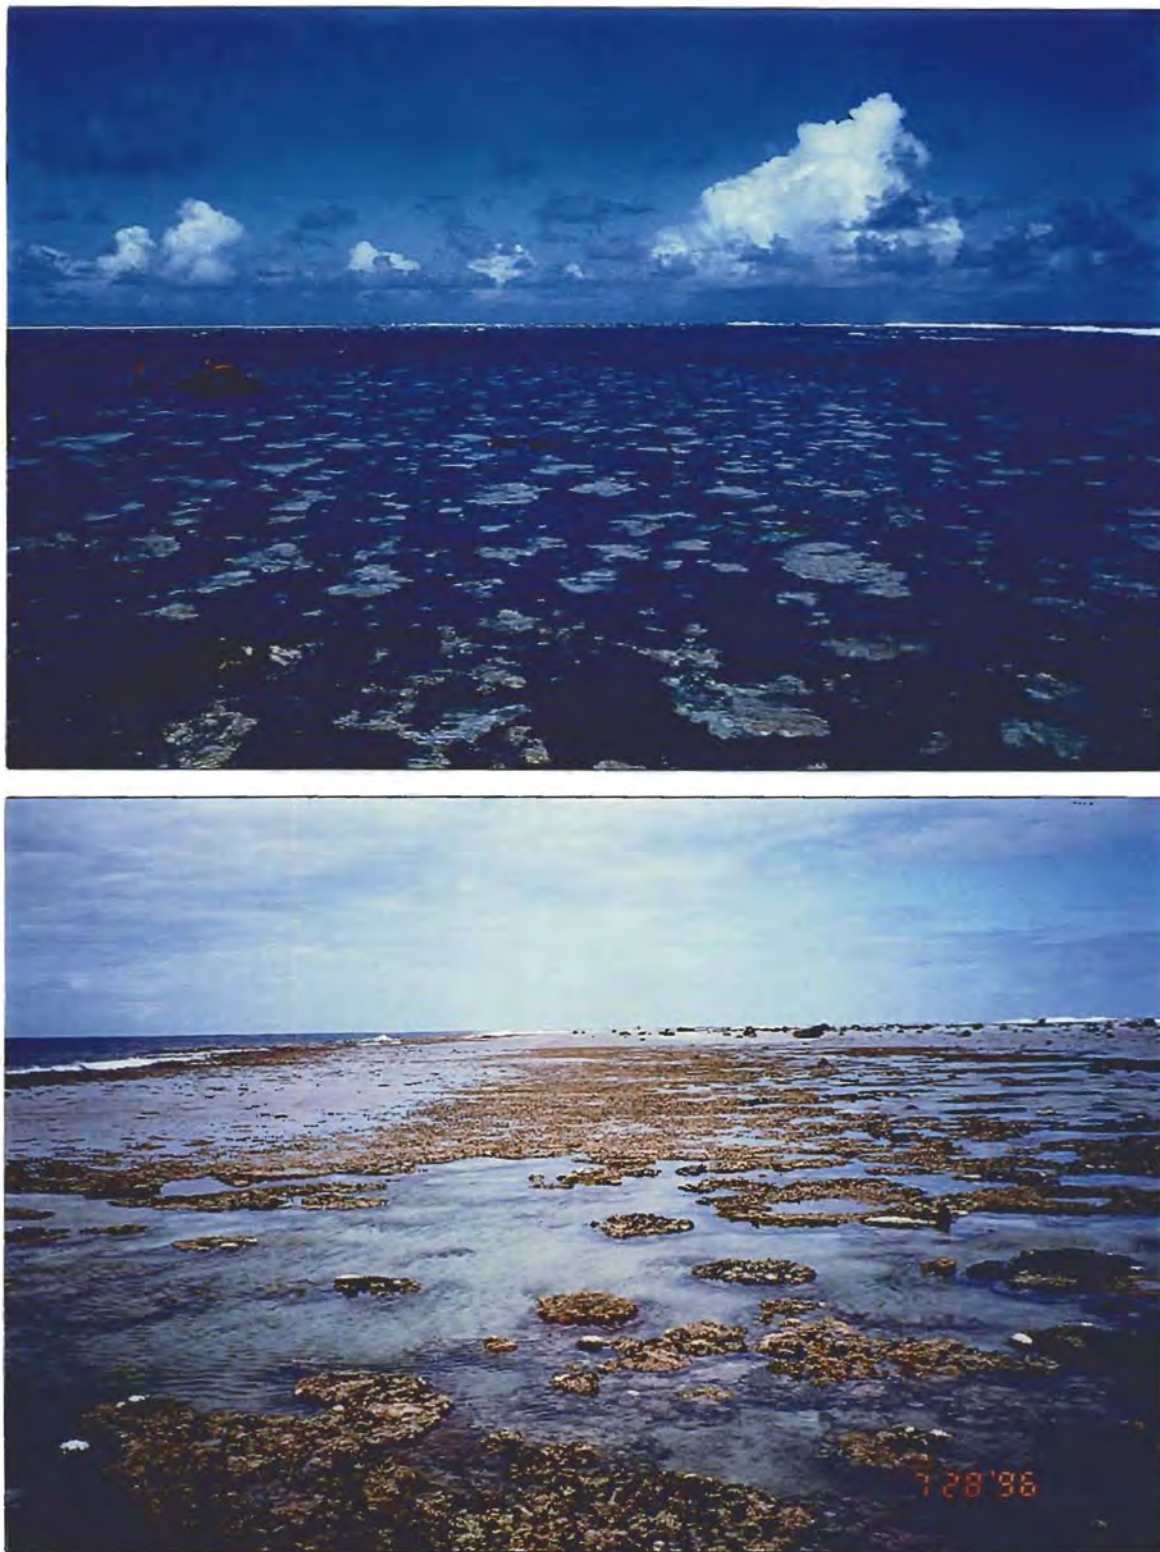
The algal communities on the southwest arm have changed dramatically as a result of the grounding. By 1995, it was apparent that the previously dominant crustose coralline algae were no longer abundant on this arm (0-35% cover: Fig. 21), and that they had been replaced by opportunistic species. At that time, the dominant algae on the southwest arm were a mixed community of cyanobacteria species and a finely branched, turf-forming coralline alga, *Jania adherens*, which together accounted for up to 90% of the cover (Fig. 21). The *Jania*, like cyanobacteria, is usually rare on the atoll, and became abundant on the southwest arm sometime between March 1994 and August 1995. As a result of this change in the algal communities the reef flat on the southwest arm had changed from pink, the color of healthy crustose coralline algae, to black, the color of the mixed cyanobacteria community (Figs. 19 & 22). This pattern was most pronounced on the outer reef flat (Figs. 22).

Figure 22 Reef flat adjacent to wreck site showing dominance of dark opportunistic algae (cyanobacteria and *Jania adherens*) six months after the grounding (top) and healthy reef flat on southeast arm of the atoll showing typical dominance of pink crustose coralline algae (bottom).

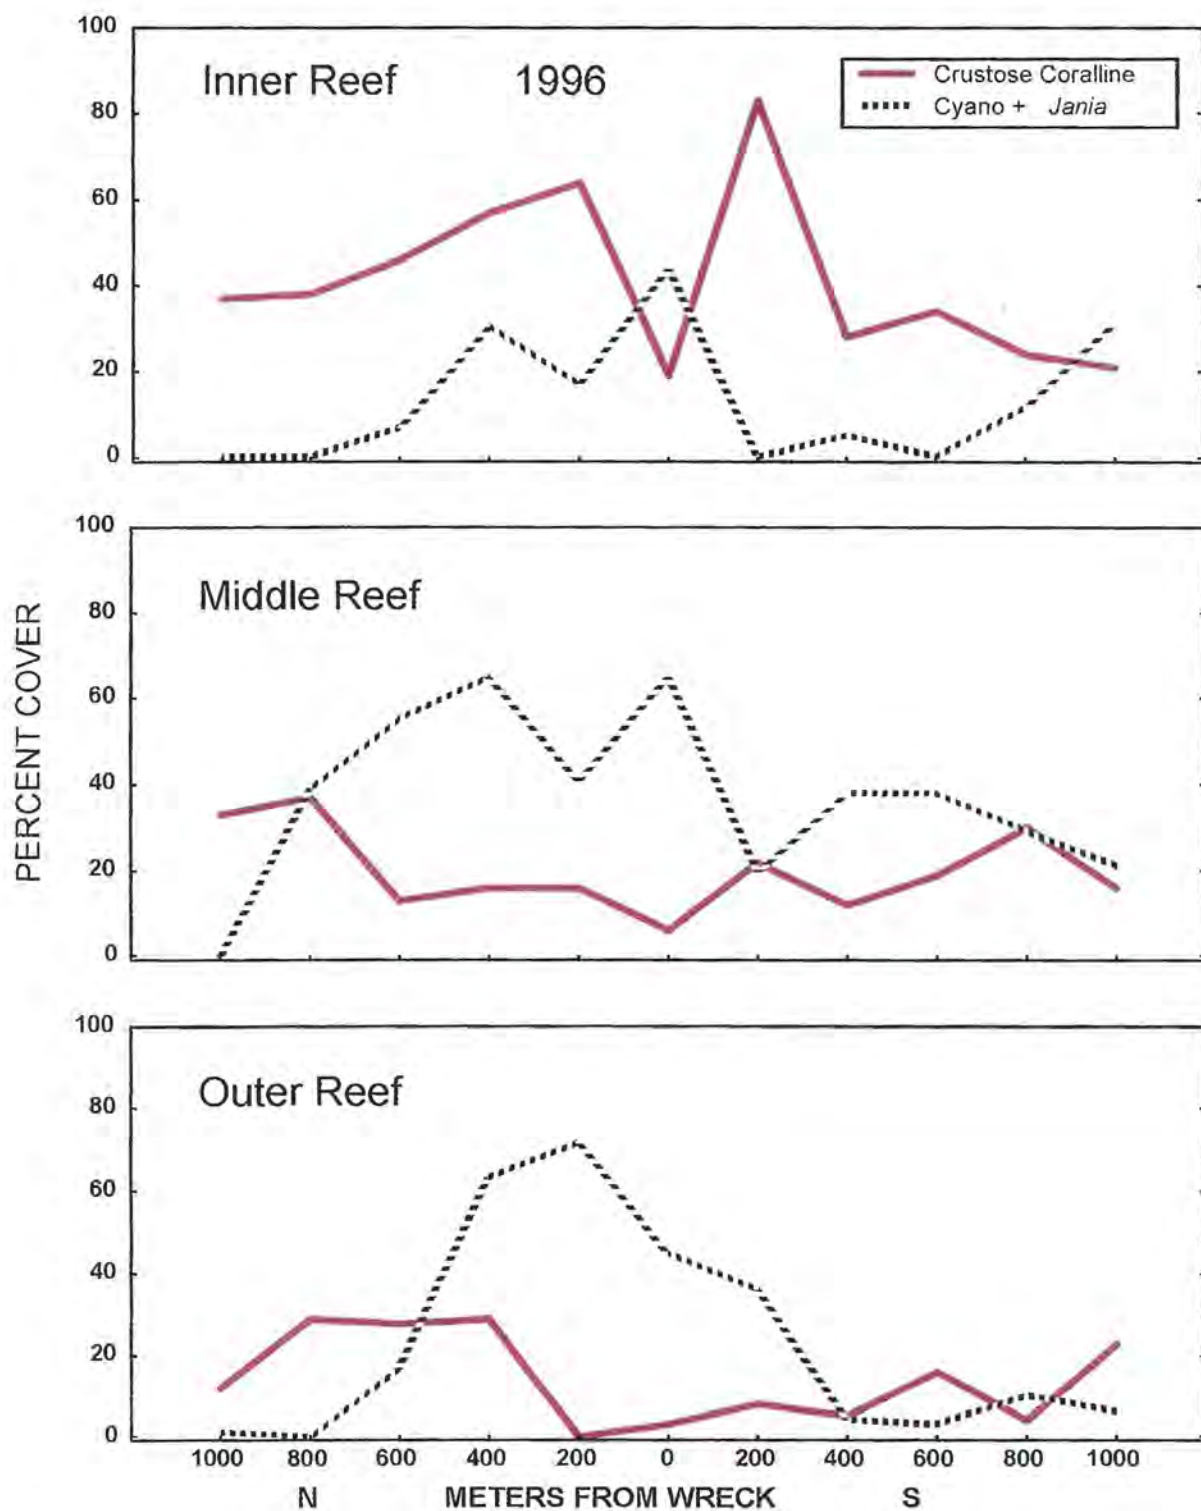
Figure 23 Abundance of crustose coralline algae and opportunistic algae (cyanobacteria and *Jania*) in a gradient away from the wreck site on the southwest arm of Rose Atoll almost three years after the grounding (1996). Data is presented for each of three zones across the reef flat: inner, middle, and outer (see Fig. 20).

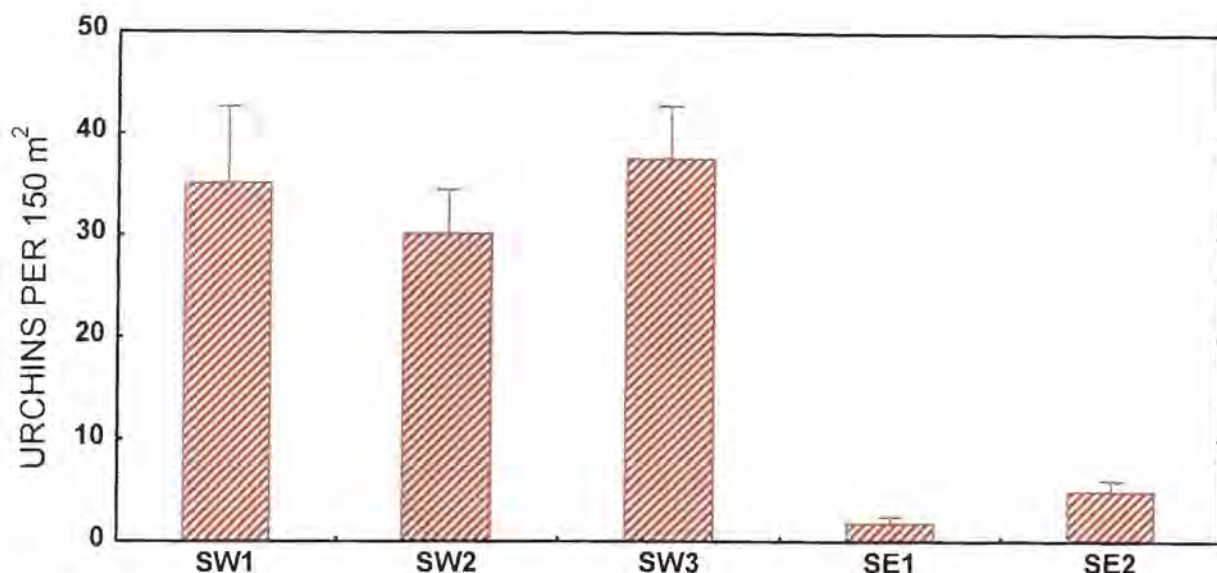
Figure 27 Mean density (and standard error) of sea urchins (*Diadema* spp.) on the reef flat at three sites on the southwest arm and two sites on the southeast arm of Rose Atoll two years after the grounding. Where SW1 is the wreck site (see Fig. 2)

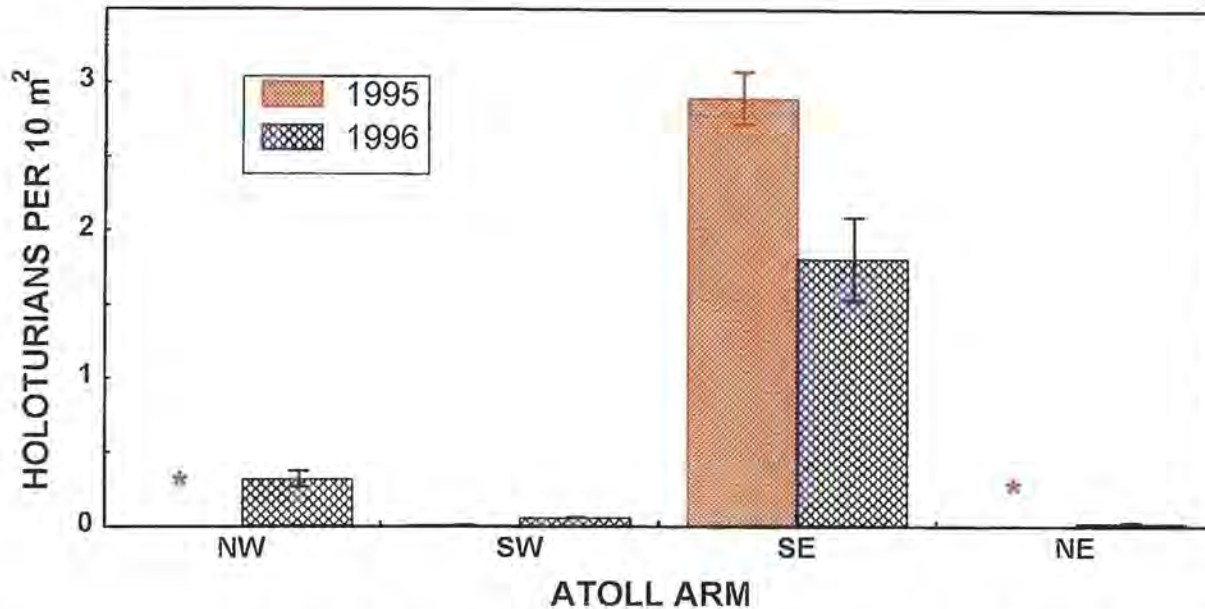
Early observations suggested that holothurian density was unusually low at the wreck site (M. Molina pers. comm.). To determine if this was true, sea cucumber surveys were done on the southwest and southeast arms of the atoll two years after the grounding. These surveys were repeated and expanded to include the other two arms one year later. Holothurian abundance was measured by five observers walking approximately 20 m apart across the reef flat in the center of the arm from the edge of the lagoon to the outer, seaward margin of the reef flat. Each observer counted the number of sea cucumbers observed within 1 m either side of the track. Holothurians were not recorded at the species level, but it was apparent that the dominant species was

Figure 28 Mean density (and standard error) of holothurians on each of the four arms of Rose Atoll two and three years after the grounding. Asterisks represent counts that were not done on the northwest and northeast arms in 1995.

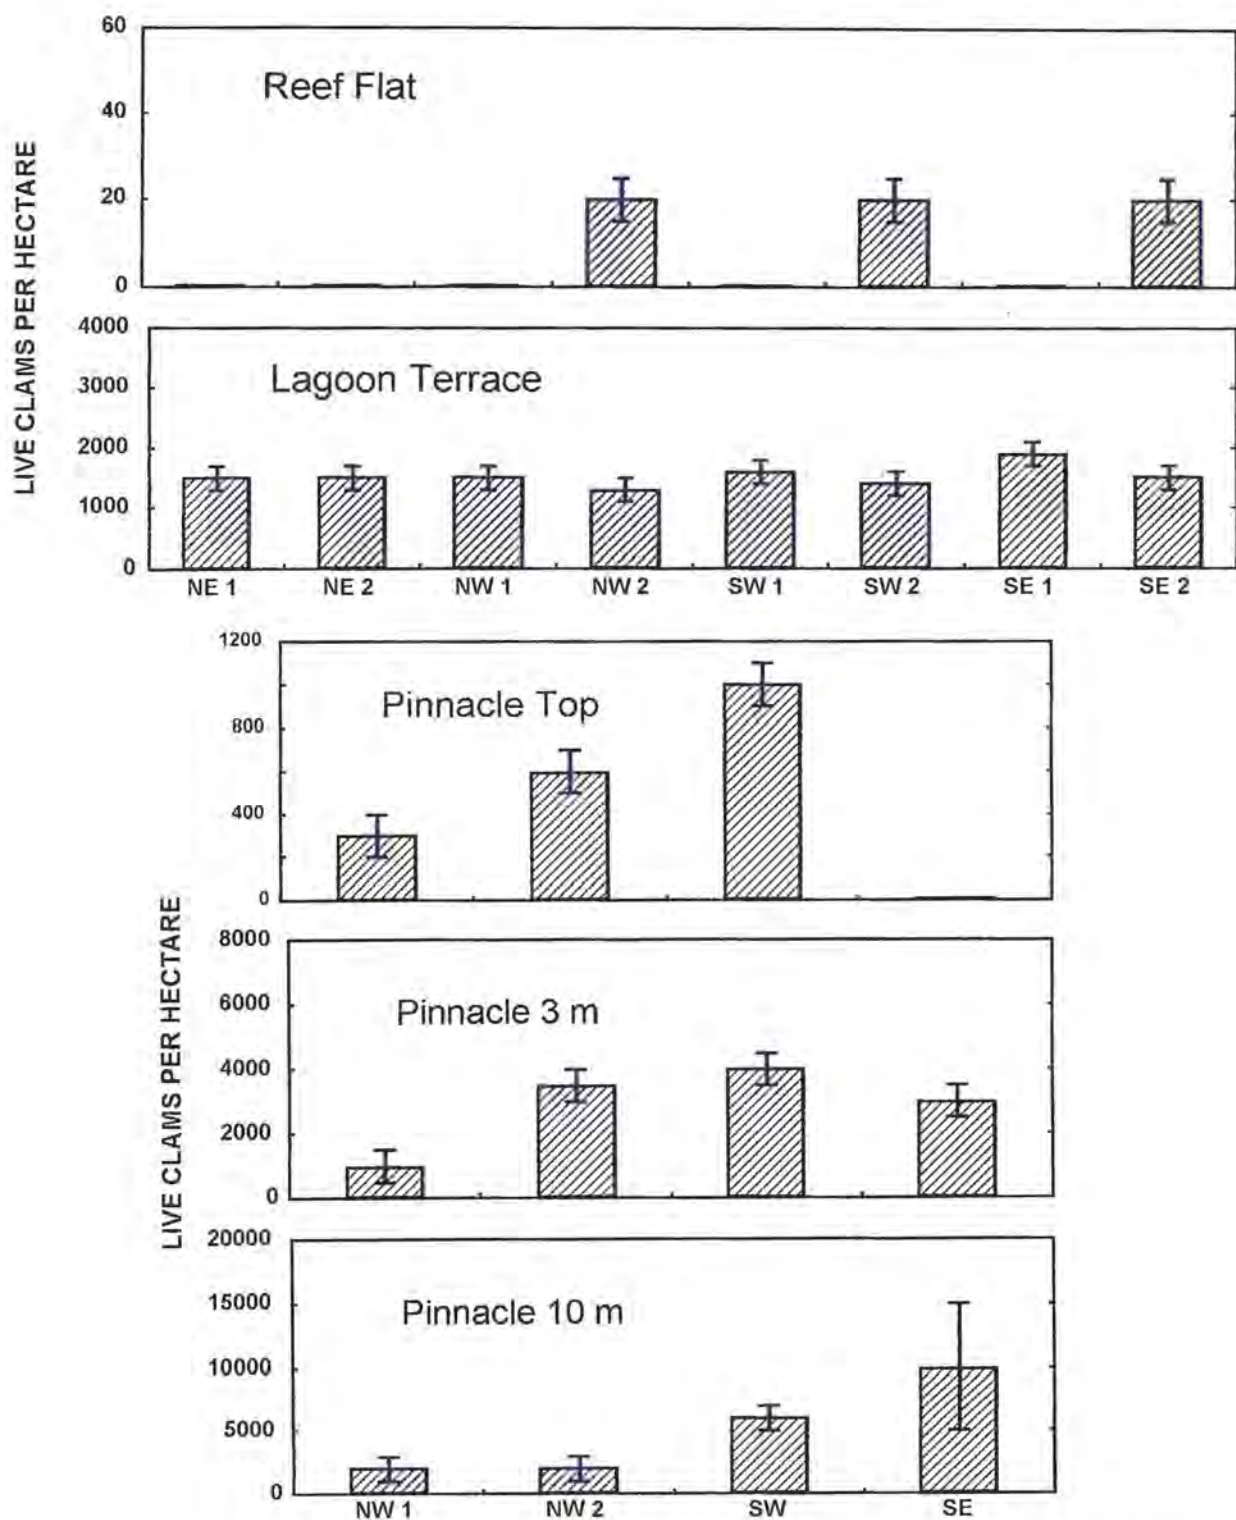
The results of this study show that giant clams have recruited to the southwest arm since the grounding. Clam recruits were common on four of the five transects at the wreck site (mean=285 clams per ha, $se=83.3$). However, no recruits were recorded on the transect which ran through the large pieces of ship debris that remain on the reef flat at that site (see Fig. 14). High densities of clam recruits were also recorded on the reef flat south of the wreck (mean=240 clams per ha, $se=62.0$), although fewer recruits were present north of the wreck (mean=53.3, $se=24.7$).

Figure 29 The abundance of giant clams on the reef flat, lagoon terrace, and three depths on the pinnacles, at a range of sites around Rose Atoll approximately one year after the grounding. Where SW1 is the wreck site (see Fig. 2).

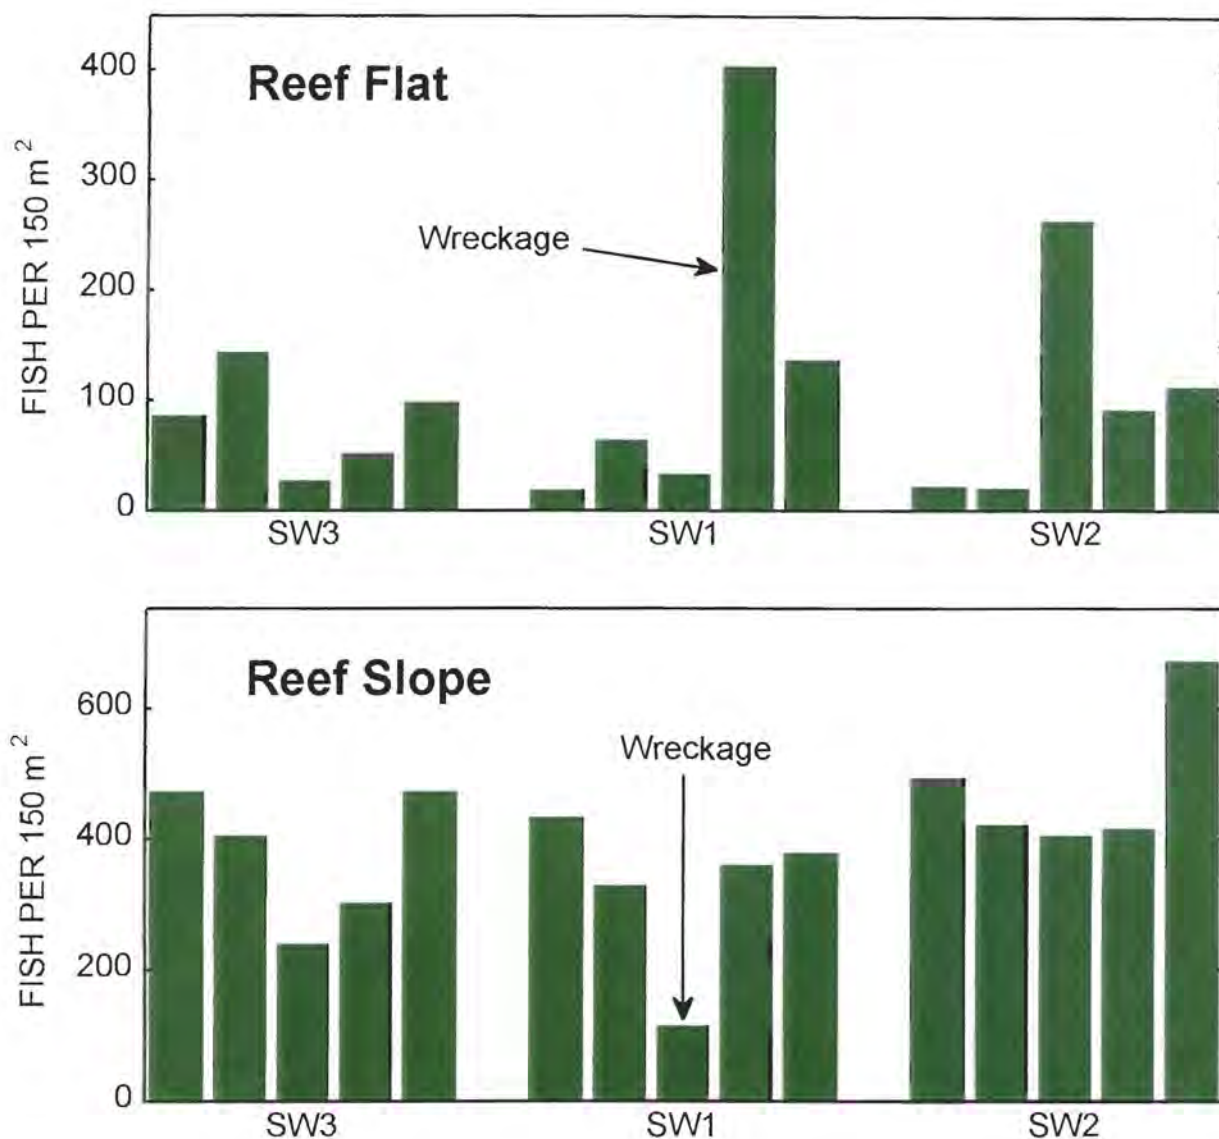
In contrast, fish abundance on the outer reef slope was substantially lower around the wreckage at the wreck site than it was on any of the other transects on the southwest arm (Fig. 31). This was because some species usually associated with healthy reef slopes, such as butterflyfishes and the abundant damselfish *Chromis acares*, were less abundant around the wreckage than on the other transects. However, in a similar pattern to that described for the reef flat, the majority of fishes that were present at the wreckage were herbivorous surgeonfishes, mostly *Ctenochaetus striatus* and *Acanthurus triostegus* (Fig. 32), which were probably attracted to the area because of the algal bloom (see *Algae*) and the cover provided by the wreckage.

Figure 31 Abundance reef fishes on the reef flat and reef slope on each of the transects on the southwest arm of Rose Atoll one to two years after the grounding. Where SW1 is the wreck site (see Fig. 2) and the arrow shows the location of most of the wreckage.

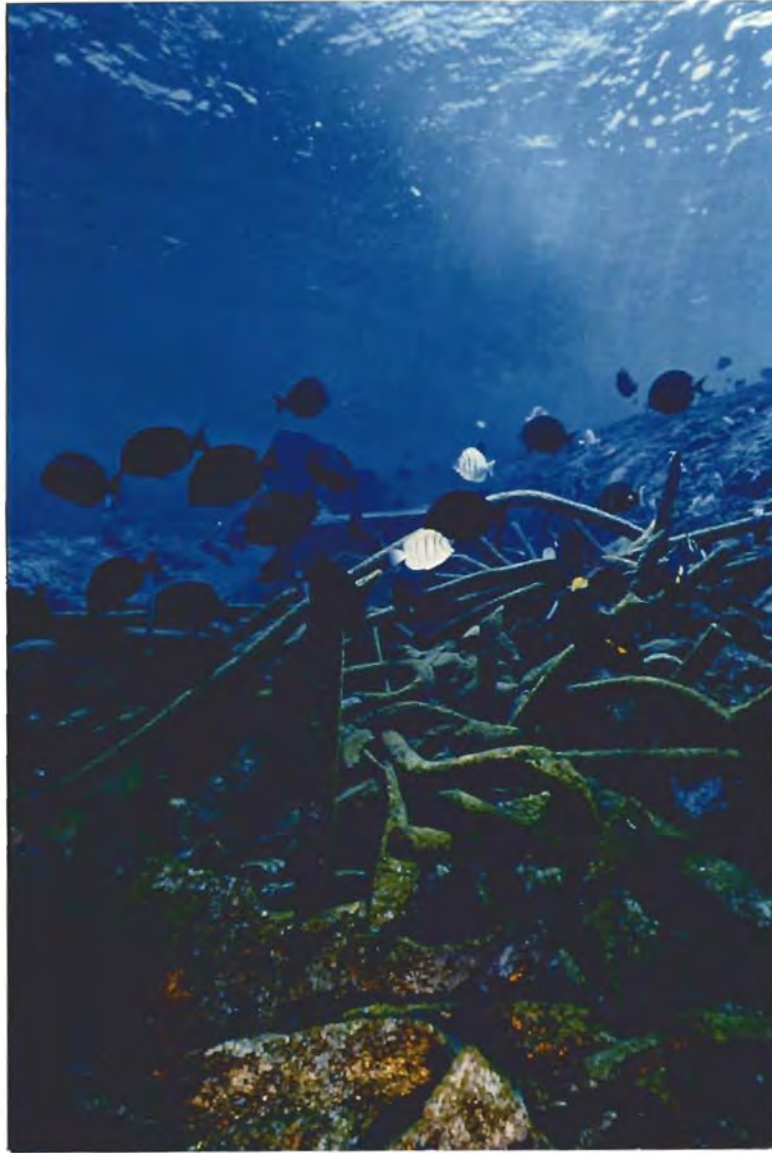
Figure 32 Herbivorous surgeonfishes (*Ctenochaetus striatus*, *Acanthurus triostegus*, and *Acanthurus olivaceus*) around the wreckage on the outer reef slope.

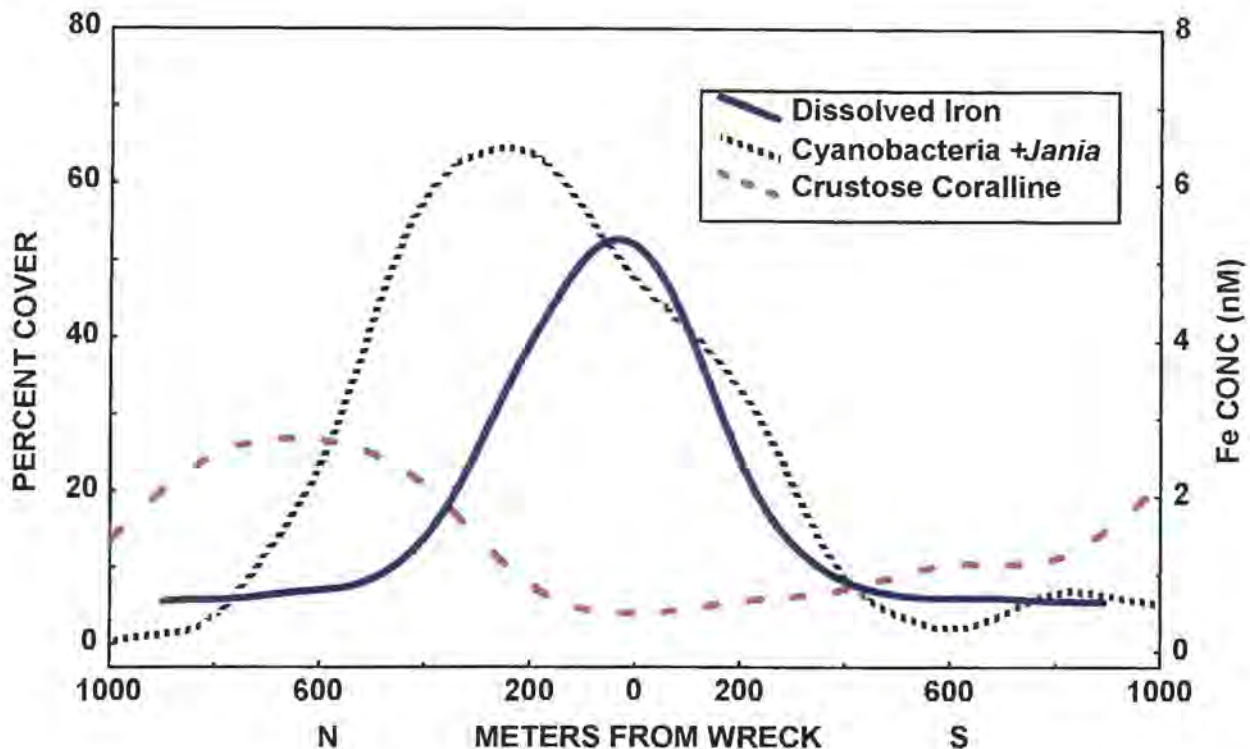
Figure 33 Iron concentrations and the cover of crustose coralline algae and opportunistic algal species (cyanobacteria and *Jania*) along the outer reef flat on the southwest arm of Rose Atoll three years after the grounding.
