Scope of Work for ARCG II Restoration Workplans

This restoration Work Plan describes natural resource restoration activities that will be undertaken by the Railroads pursuant to Section VII of the Consent Decree in *United States and State of Ohio, ex rel. Richard Cordray, Attorney General of Ohio v. Cabot Corp., et al.* (N.D. Ohio) that resolves specified claims relating to alleged natural resource damages at the Ashtabula River and Harbor Site. This restoration Work Plan provides for implementation of natural resource restoration projects in a portion of an area known as the “Slip 5A peninsula,” which is currently owned by Norfolk Southern Railway Company (NSRC). The restoration projects to be implemented by the Railroads pursuant to this restoration Work Plan occupy approximately 6.45 acres. In addition, the restoration area includes an additional area, up to approximately 0.70 acres, along the eastern edge of the northern part of the Slip 5A peninsula, where NSRC has authorized the United States Environmental Protection Agency (USEPA) and its contractors to create and enhance fish habitat as part of a habitat mitigation project that is a component of an Ashtabula River dredgin

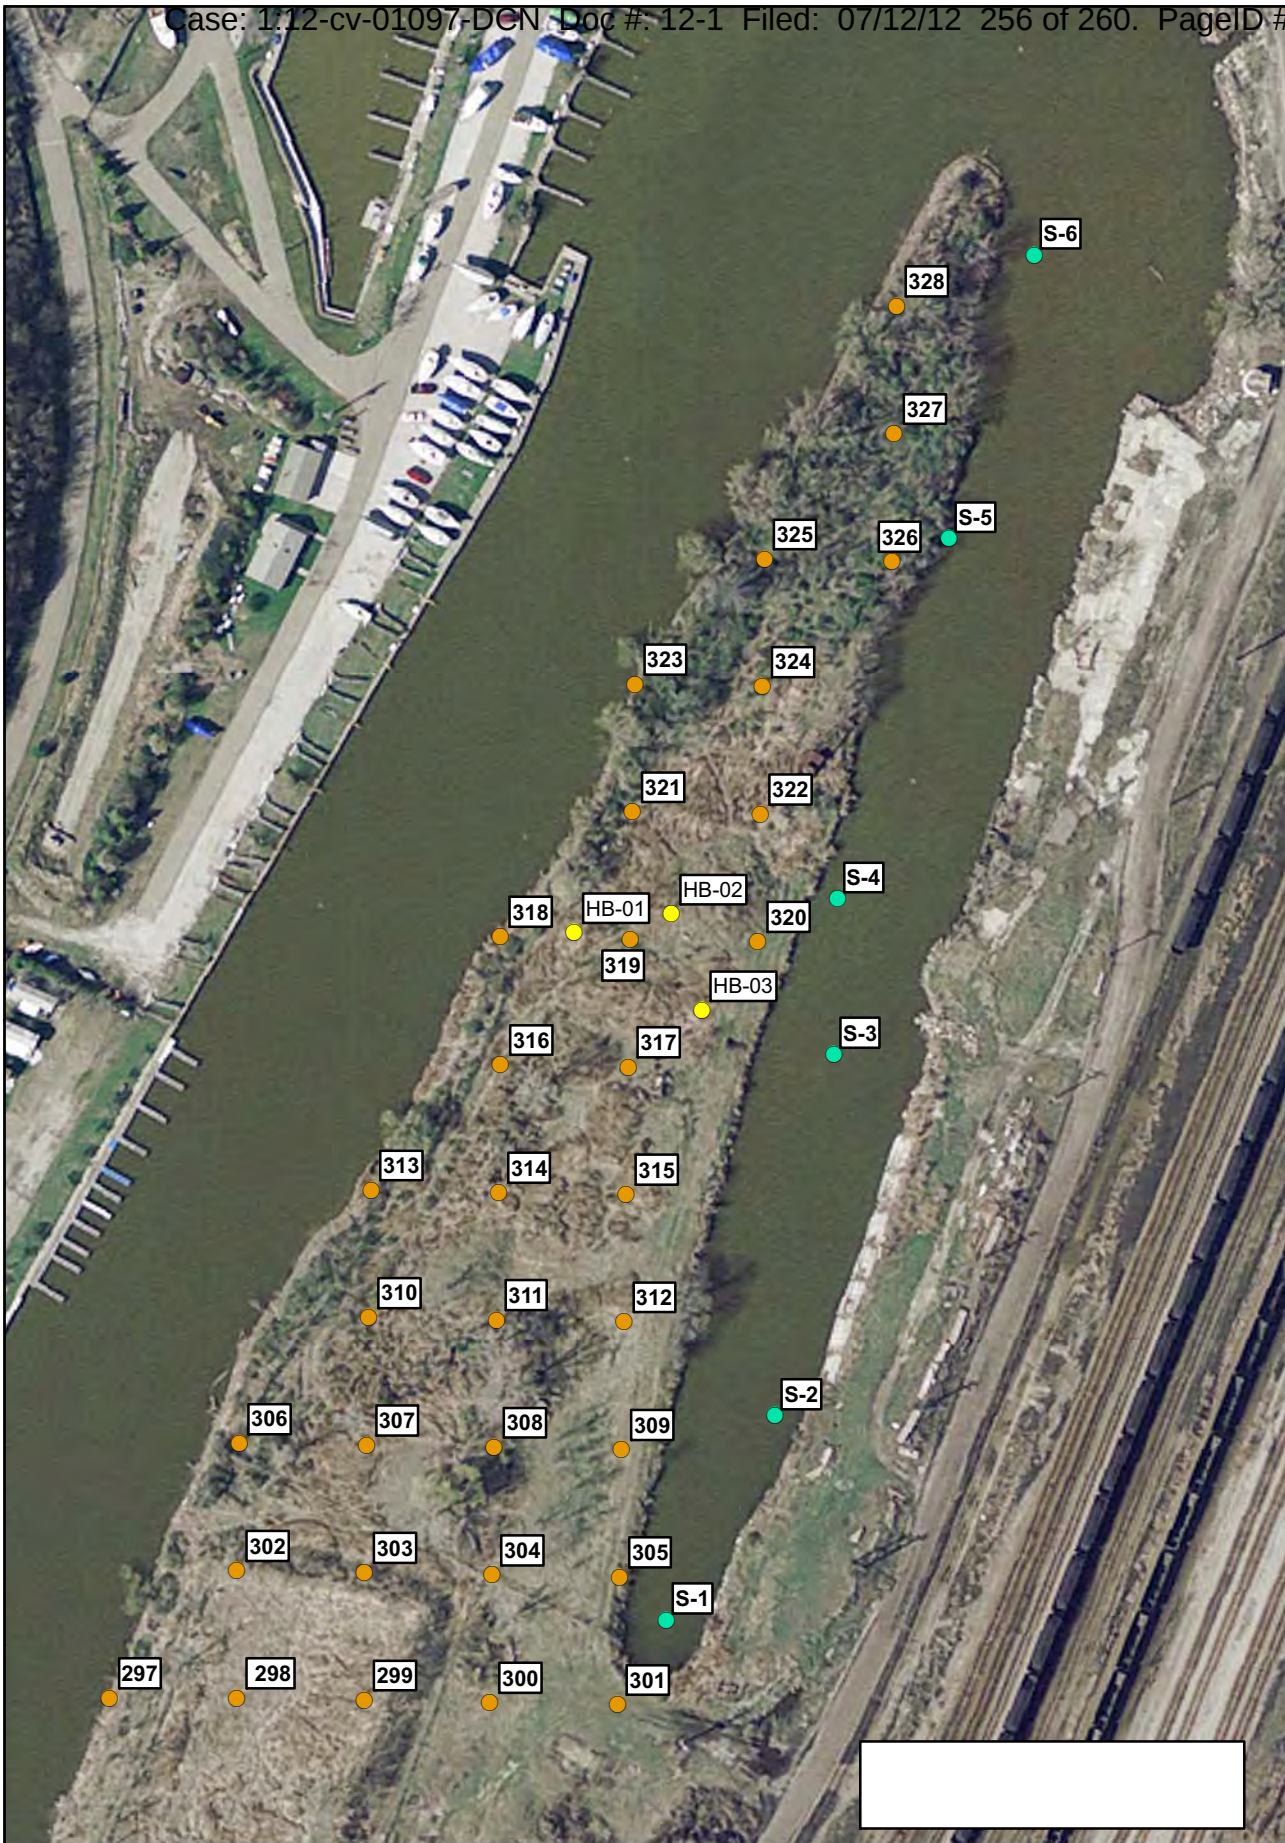
Figure
1

**Previous Soil and Sediment Sample Locations
Slip 5A
Ashtabula, Ohio**

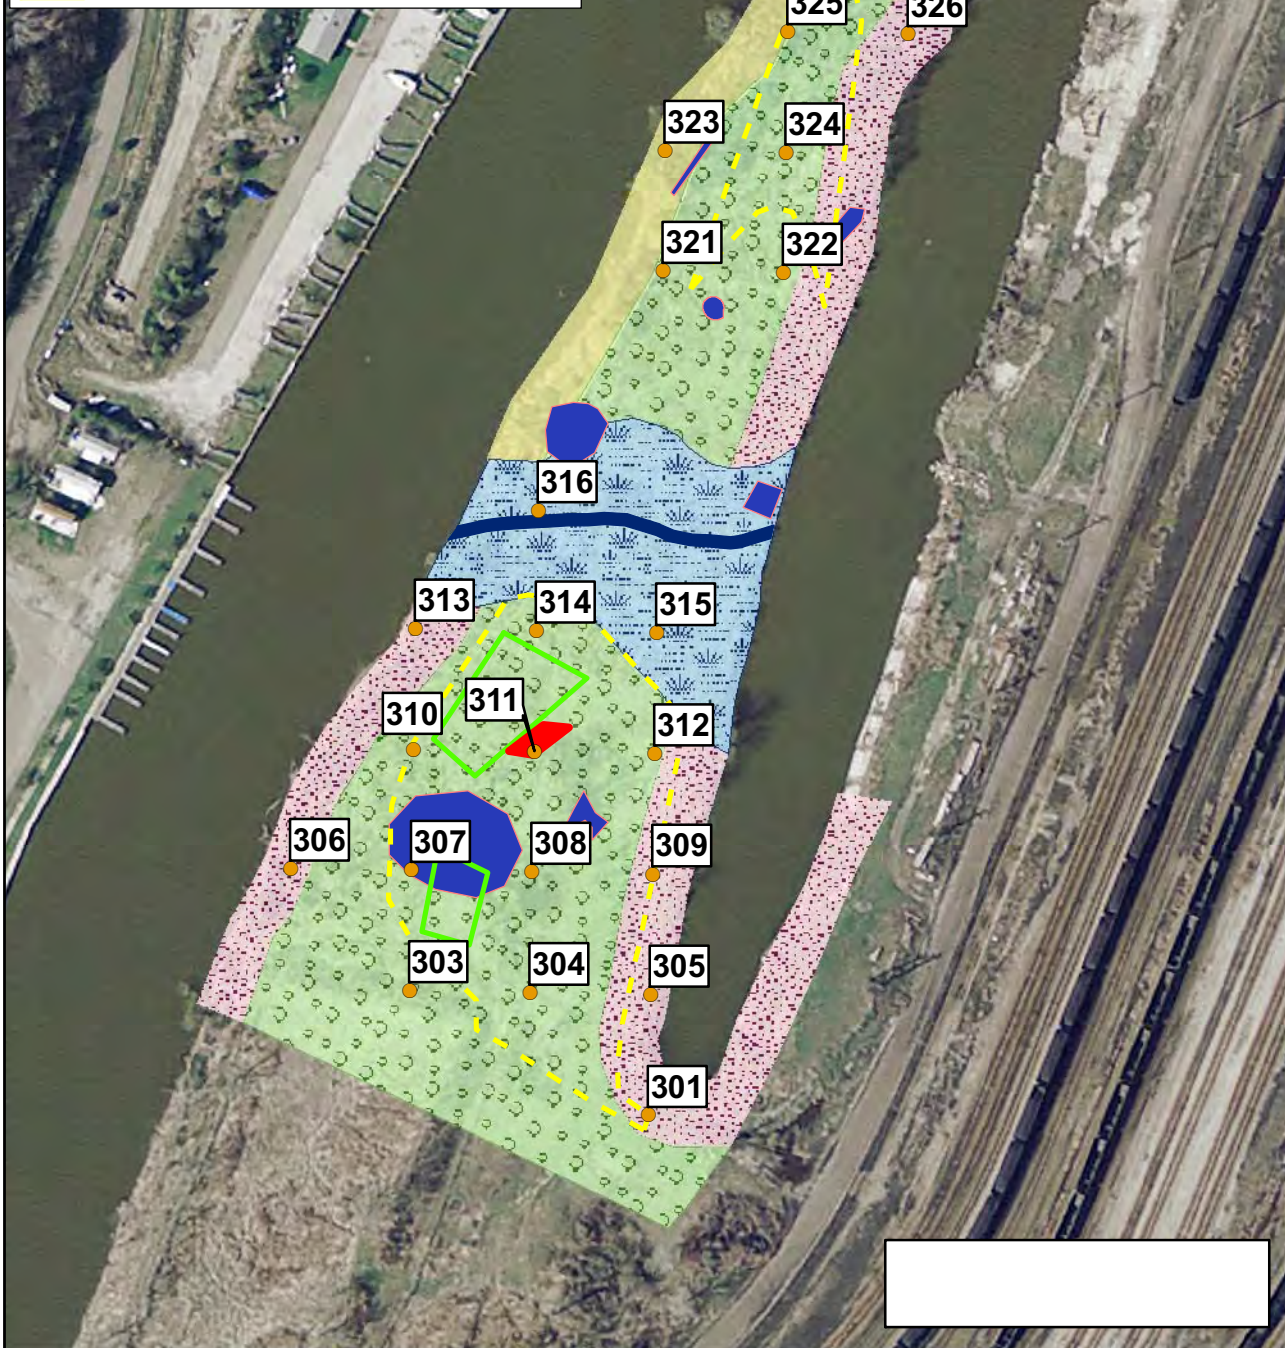
Figure
3

Adjacent to the hydraulic channel, connected emergent wetland habitat will be created by removing targeted soil to approximately one foot below surface water elevation, creating a low-lying elevation with direct connection to the hydraulic connector. This targeted depth is based on Ohio wetland conditions which best support emergent vegetation (Sherman et al., 1996). The connected emergent wetland will have a width of approximately 20 feet and may be characterized by a very slight (target 4:1) slope or steeper slopes (3:1) with a terraced structure. The target width and slopes of the emergent wetland area incorporate the existing topography, proposed soil excavation depths,

Restoration projects are commonly implemented to compensate for natural resource damages. The proposed restoration projects are presented in Figures 3 and 4, respectively. Details of the conceptual restoration described in the following subsections may be refined during the final design phase.

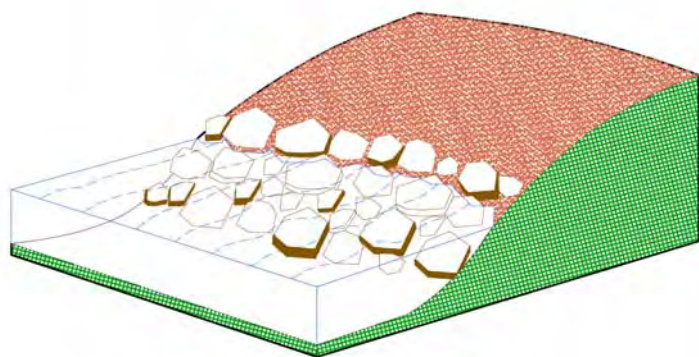
**STONE TOE PROTECTION**

- NOTES:**
1. PLACE STONE TOE PROTECTION MECHANICALLY OR BY HAND ACROSS FULL HEIGHT OF BANK TO ENSURE UNIFORM DISTRIBUTION OF ROCK PARTICLE SIZES ACROSS DISTURBED AREA.
 2. STAKES PLACED RANDOMLY BETWEEN ROCKS (ONE STAKE EVERY 2 TO 3 FEET) DURING OR AFTER ROCK INSTALLATION.
 3. THE BOTTOM END OF CUTTINGS TO EXTEND INTO SOIL AND PROTRUDE SLIGHTLY FROM ROCKS. SLDS PLACED UPWARD WHEN PLANTED AND CUTTINGS TO REMAIN UNDAUNTED.

Bank stabilization measures (Figure 5) will be implemented near the created hydraulic connection and wetland area and along the targeted connected riparian streambank (Figure 4), to reduce the possibility of erosion. The specific locations requiring bank stabilization will be identified in the design phase. Erosion issues can be addressed by regrading the banks and planting soil-stabilizing vegetation. A 3:1 slope will be considered the target where adjacent land use and conditions permit (FISWRG, 1998). Where the 3:1 target is not attainable, erosion control matting may be placed to stabilize the slope until vegetation is fully established.

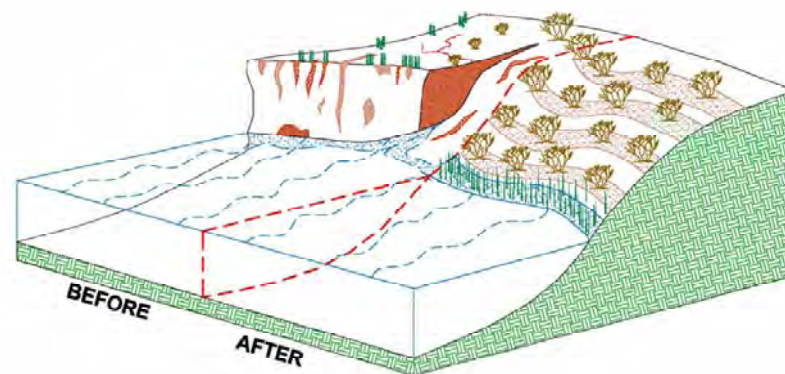
**BANK REGRADING**

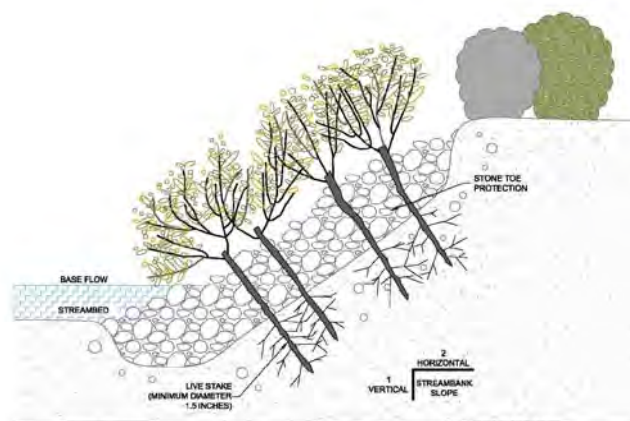
JOINT PLANTING DETAIL

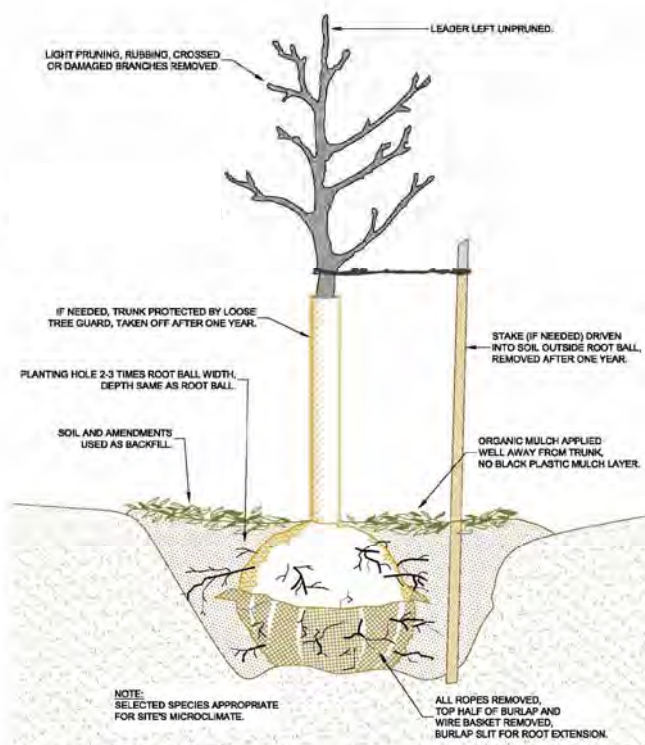
**TREE PLANTING DETAIL**

Tree and shrub planting will most likely take place in the fall or spring, during the early root growth period. Transplant timing will be determined after consideration of seasonal rainfall/ice-melt variability to reduce the likelihood of washout, as flood events could occur before tree roots became established. To afford added support, trees may be staked and anchored with wooden stakes and biodegradable twine. The planting schedule will be coordinated with restoration activities in an effort to minimize physical disruption of the planting area. Performance standards will be specified in the design document. As described below, plant survival and condition will be periodically monitored. In the event that significant loss is identified, alternative species and/or propagation methods may be utilized.

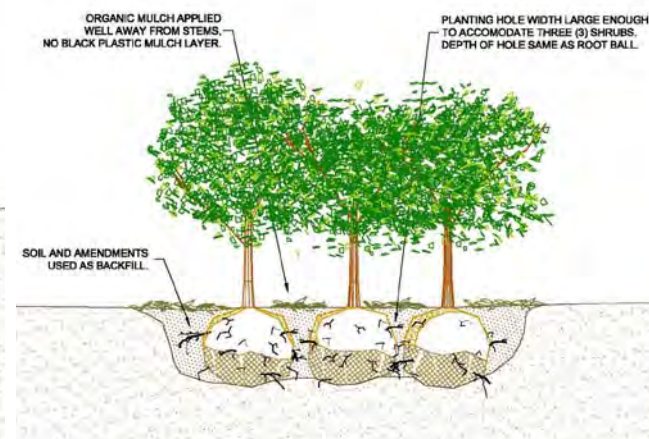
**SHRUB PLANTING DETAIL**
