**2014 Monitoring Report**  
**Helmet Creek Restoration**  
**Adak Petroleum Diesel Spill**

**December 18, 2014**

This Compliance Inspection Report is timely submitted to the Trustee Council for approval in accordance with paragraph 9 of the Consent Decree, No.3:13-cv-00121-HRH.

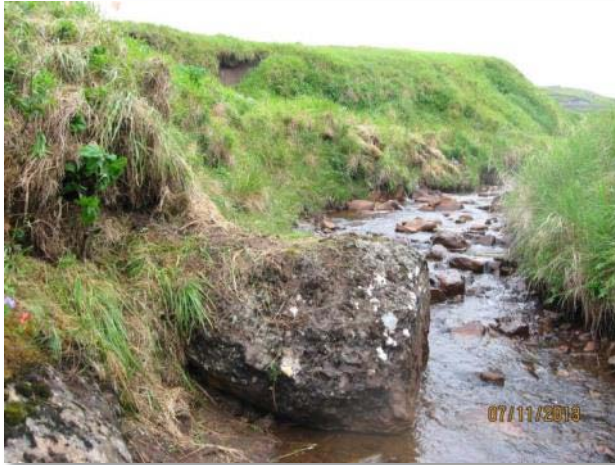
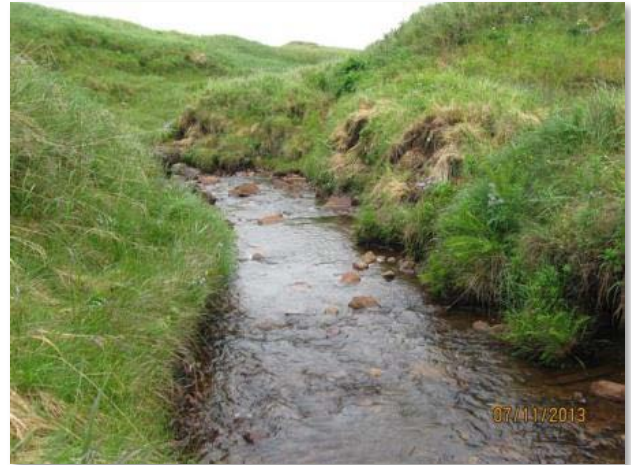
- Restoration included removal of all barrels that could be removed without significant disturbance to the channel, and revegetation of all disturbed areas on the banks. Photo points were established in 2013 (Figure 11) and a visual assessment of stream bed and stream bank integrity looking downstream and upstream over the area of removal was completed. Stream width was measured through the restoration area.

Figure 11: Site #1 – Post Construction 2013 looking upstream (L) and downstream (R)

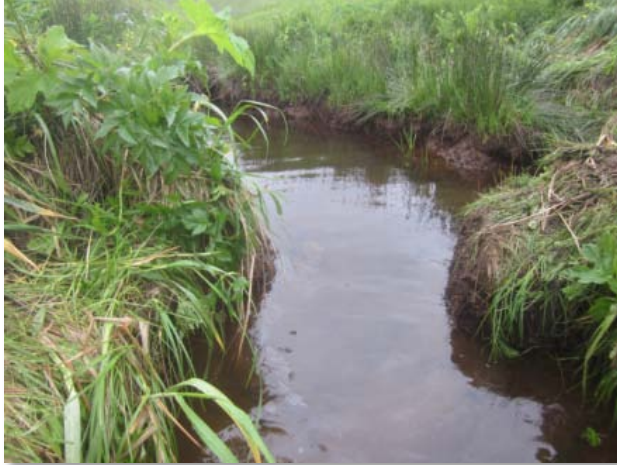
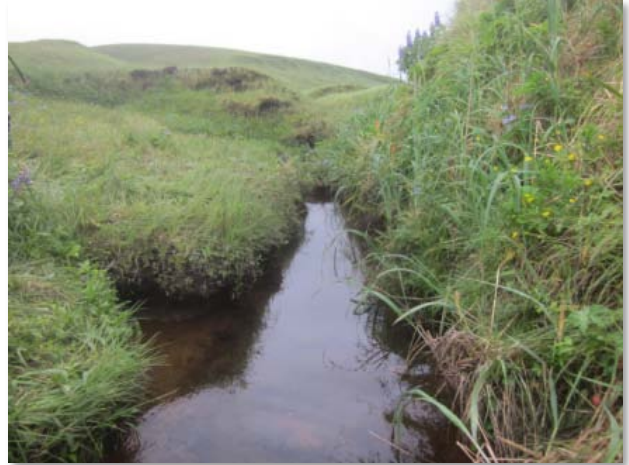
- In 2013, numerous instream barrels were removed at Site #2 (Figure 15) and a single barrel was removed at Site #3 (Figure 17). A large rock present in the middle of the stream at Site #2 created a small jump but did not create a fish passage barrier. All disturbed areas on the banks were revegetated and photo points were established. A visual assessment of stream bed and stream bank integrity looking downstream and upstream over the area of removal was completed. Transect measurements of in-stream parameters including stream width, depth, and grade were completed at Site #2. Only minimal channel disturbance occurred at Site #3 and no physical channel measurements were deemed necessary.

Figure 15: Site #2 – Post Construction 2013 looking upstream (L) and downstream (R)

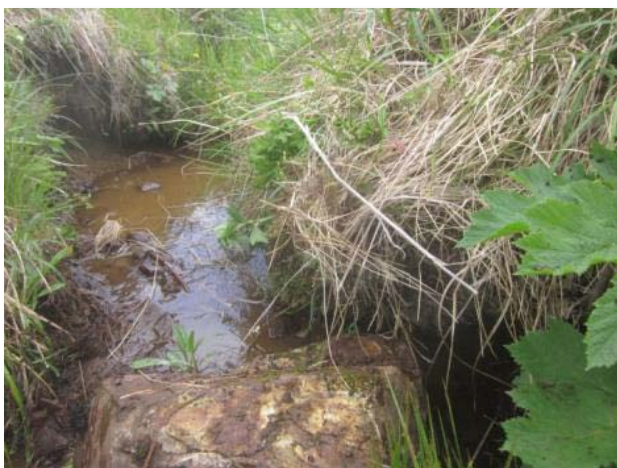
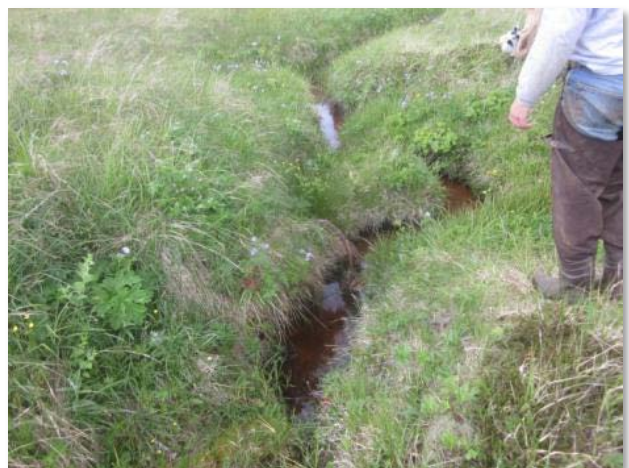
Figure 17: Site #3 – Post Construction 2013 looking upstream (L) and downstream (R)

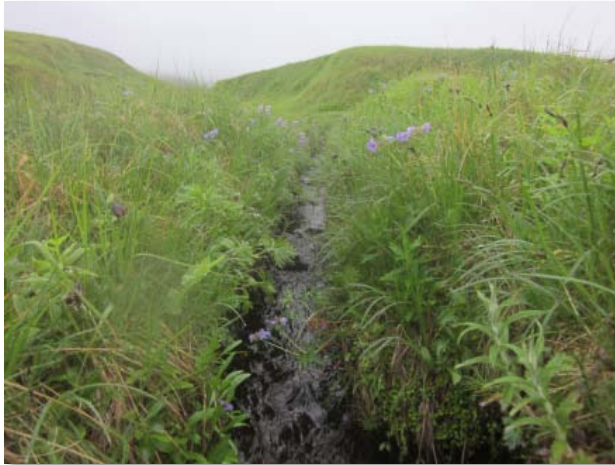
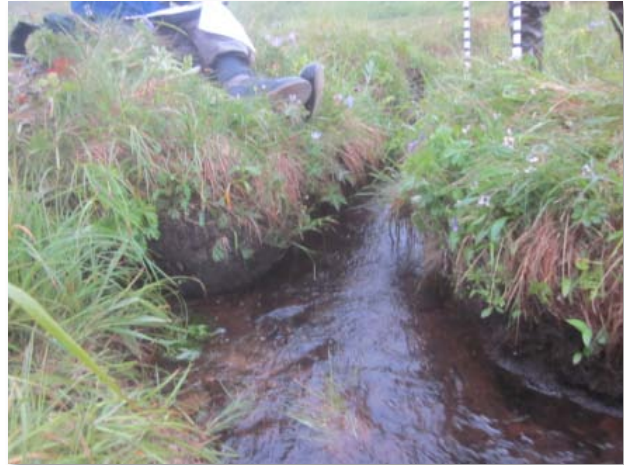
- The mouth of the culvert complex was plugged in 2013 and covered with a vegetation mat (Figure 20). All disturbed areas on the banks were revegetated. A photo point and visual assessment of stream bed and stream bank integrity was made.

**Figure 20: Site #4 – Post Construction (2013) looking upstream (L) and downstream (R)**

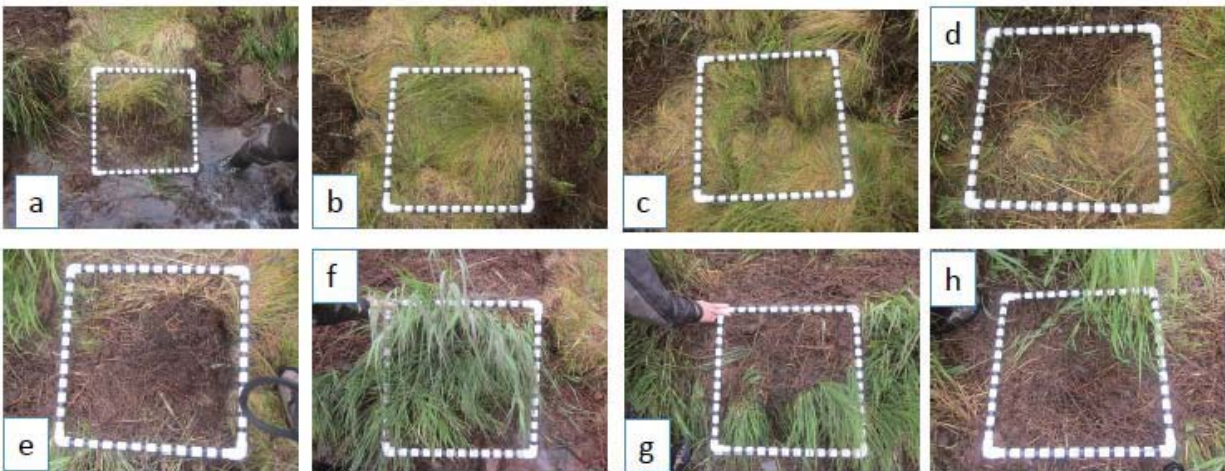
Figure 22: 2013 Photo Quadrats for Trash Rack #1

Bank disturbance that occurred during removal of the wooden timber and pipe near Trash Rack #1 was revegetated using vegetation plugs and seed mix. Photo quadrats for 2013 are provided in Figure 22. Photo quadrats for 2014 are provided in Figure 23.

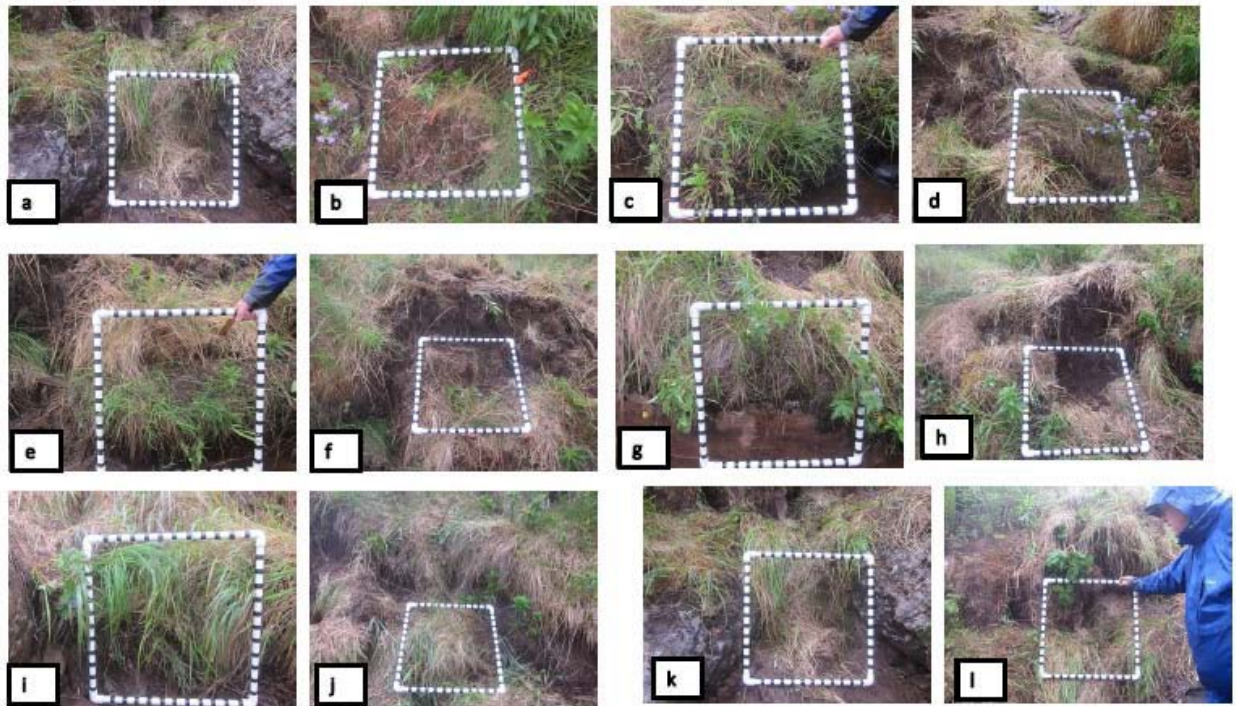
Figure 24: 2013 Photo Quadrats for Barrel Removal Site #1

Photo quadrat and visual assessment of stream bank integrity was conducted. Post-construction bank condition for areas of bank disturbance that occurred during removal of the barrels was recorded for Site #1. In addition to recording percent cover, the photos were taken so that visual comparisons of the bank could be made. Some of the bank instability is natural and pre-existing as noted (Figure 24). Photo quadrats for 2014 are provided in Figure 25.

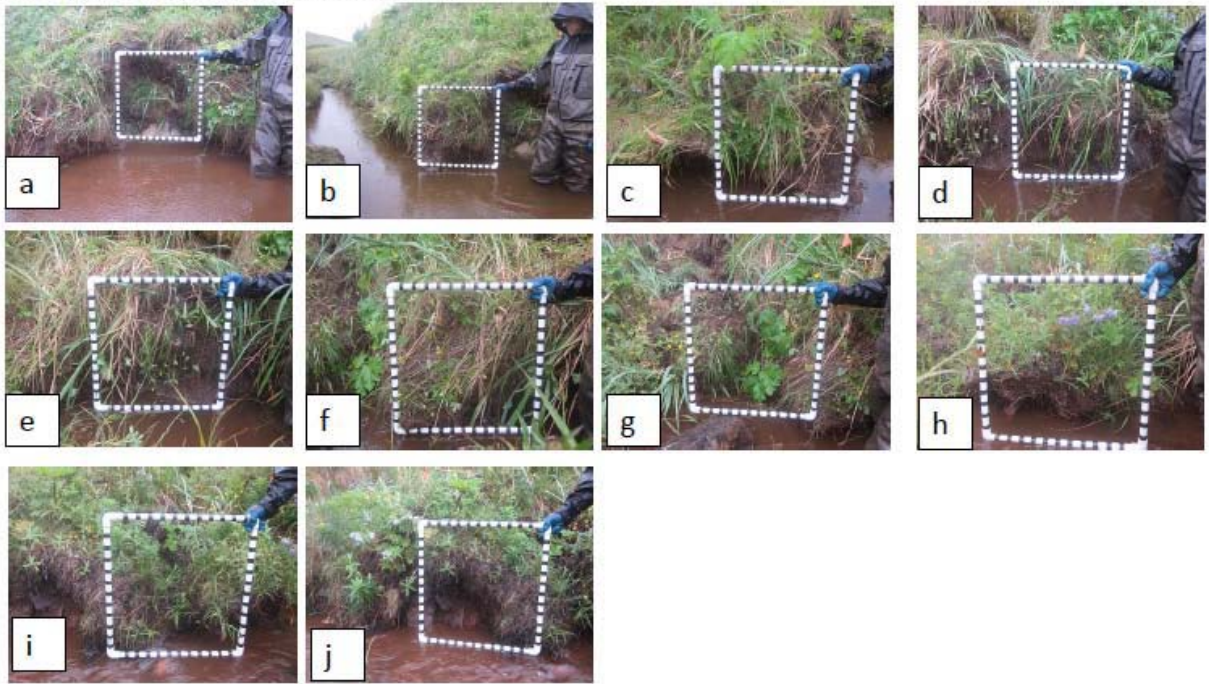
Figure 26: 2013 Photo Quadrats for Barrel Removal Site #2

Photo quadrat and visual assessment of stream bank integrity was conducted. Post-construction bank condition for areas of bank disturbance that occurred during removal of the barrels was recorded for Site #2 (Figure 26) and Site #3 (Figure 28). Photo quadrats for 2014 are provided in Figure 27 (Site #2) and Figure 29 (Site #3).

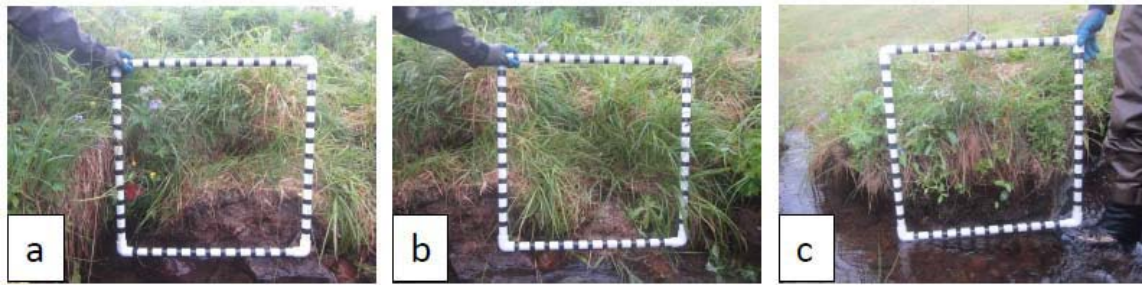
Figure 30: 2013 Photo Quadrats for Barrel Plug Site #4

Photo quadrat and visual assessment of stream bank integrity was conducted. Post-construction bank condition for areas of bank disturbance that occurred during plugging of the barrel complex was recorded in 2013 for Site #4 (Figure 30). 2014 monitoring photos are provided in Figure 31.
