# **Santa Clara River Steelhead Trout: Assessment and Recovery Opportunities**

**December 2005**

**Matt Stoecker**

**The Santa Clara River Trustee Council and The Nature Conservancy**

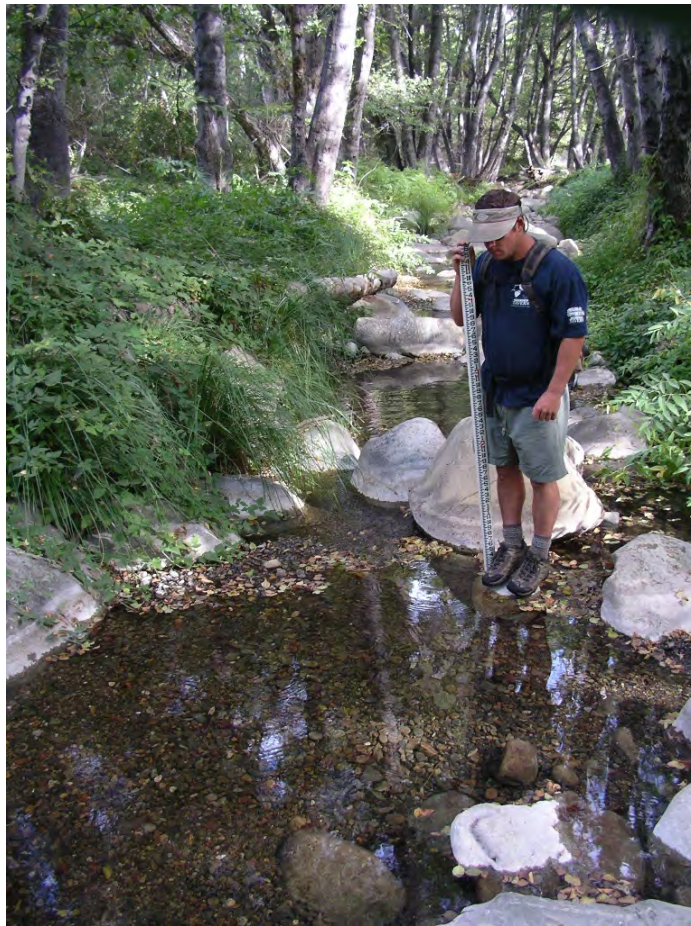
*Excellent spawning and rearing habitat on Lion Creek*

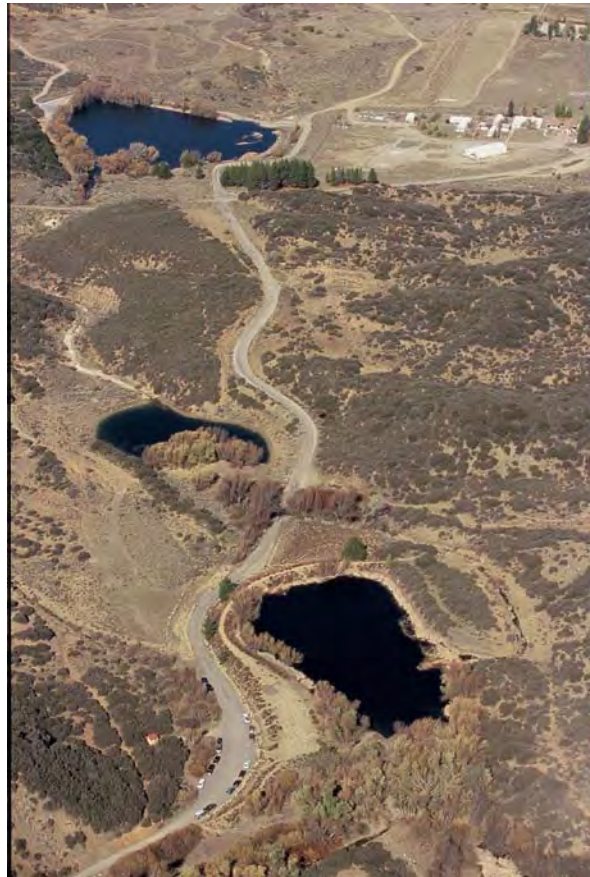
*Rose Valley Lakes*

2. Reservoirs located on Rancho Grande in the upper Howard Creek tributary to Sespe Creek may also be contributing to the spread of exotic fish species and degradation of water quality and downstream quantity within Sespe Creek. Removal of these dams would also provide upstream fish passage.

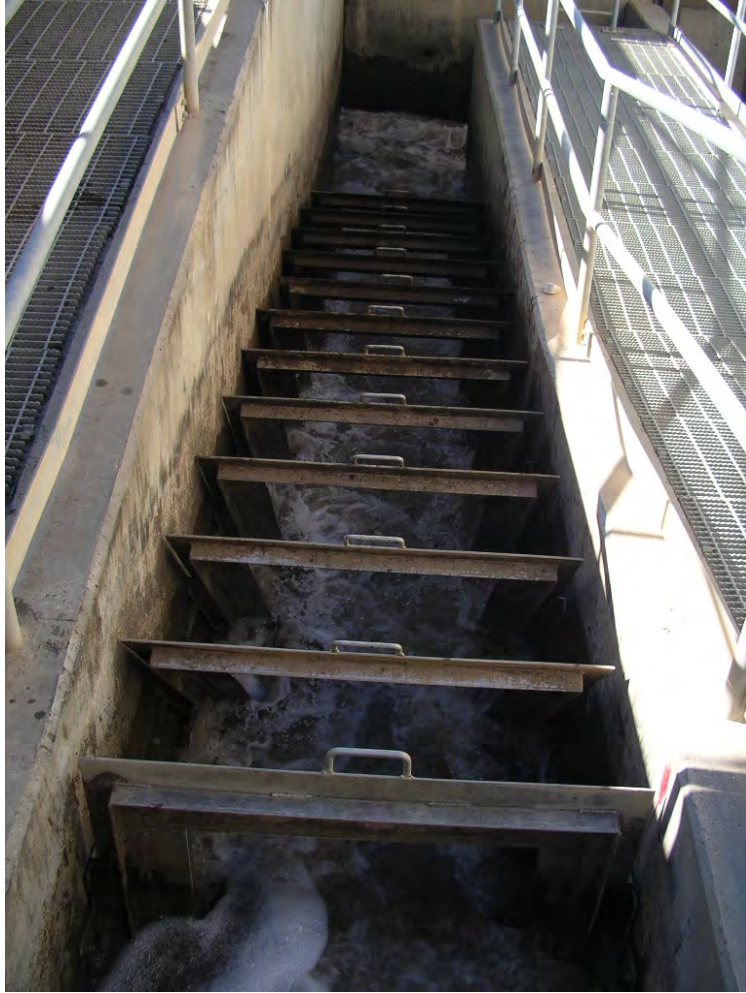
McEachron reported that a trap set at the inlet (upstream end) of the fish ladder caught seven adult steelhead from 1994 to 2001 that apparently made it through the fish ladder and upstream into the river. No adult steelhead have been observed since the fish trap was removed, or since a fish counter/video system was installed in 2002 (pers. comm. McEachron 2005). One of the main problems with assessing the effectiveness of the fish ladder is that it is not possible to count how many steelhead are migrating into the river that may not be able to find the ladder and navigate through it successfully. Insufficient attraction flows, debris blockage, and elevated flow velocities within the ladder may also contribute to problems with the existing Denil Fishway. In addition, the fish ladder has a pipe outfall located directly above it that drops water at the entrance. This additional turbulence at the fish ladder entrance may confuse upstream migrating steelhead. The existing ladder and dam likely represent at least a partial barrier some of the time and a complete barrier when operations are not providing adequate fish ladder flows for passage, as was observed during a field visit in 2005.

The documented historic occurrence of adult steelhead and anadromous lamprey runs up the Santa Clara River prior to the construction of the current Vern Freeman Dam are well documented. Fish ladder designs such as the type at the Vern Freeman Diversion Dam are not a preferred NOAA or DFG fish passage alternative due to the many inherent problems associated with debris blockages, baffle failures, and difficulty in attracting and allowing effective fish passage. Attraction flows have been identified by NOAA personnel as a potential problem for upstream migrating steelhead trying to find a route around the dam.

*Denil Fishway at the Vern Freeman Diversion*

**Recommended Action:** Without effective upstream adult steelhead passage at the Vern Freeman Dam that mimics the timing, duration, and magnitude of natural flow events and flow range, steelhead restoration within the Santa Clara River will not be possible. Because the principal steelhead spawning and rearing habitats within the Santa Clara River system are located in

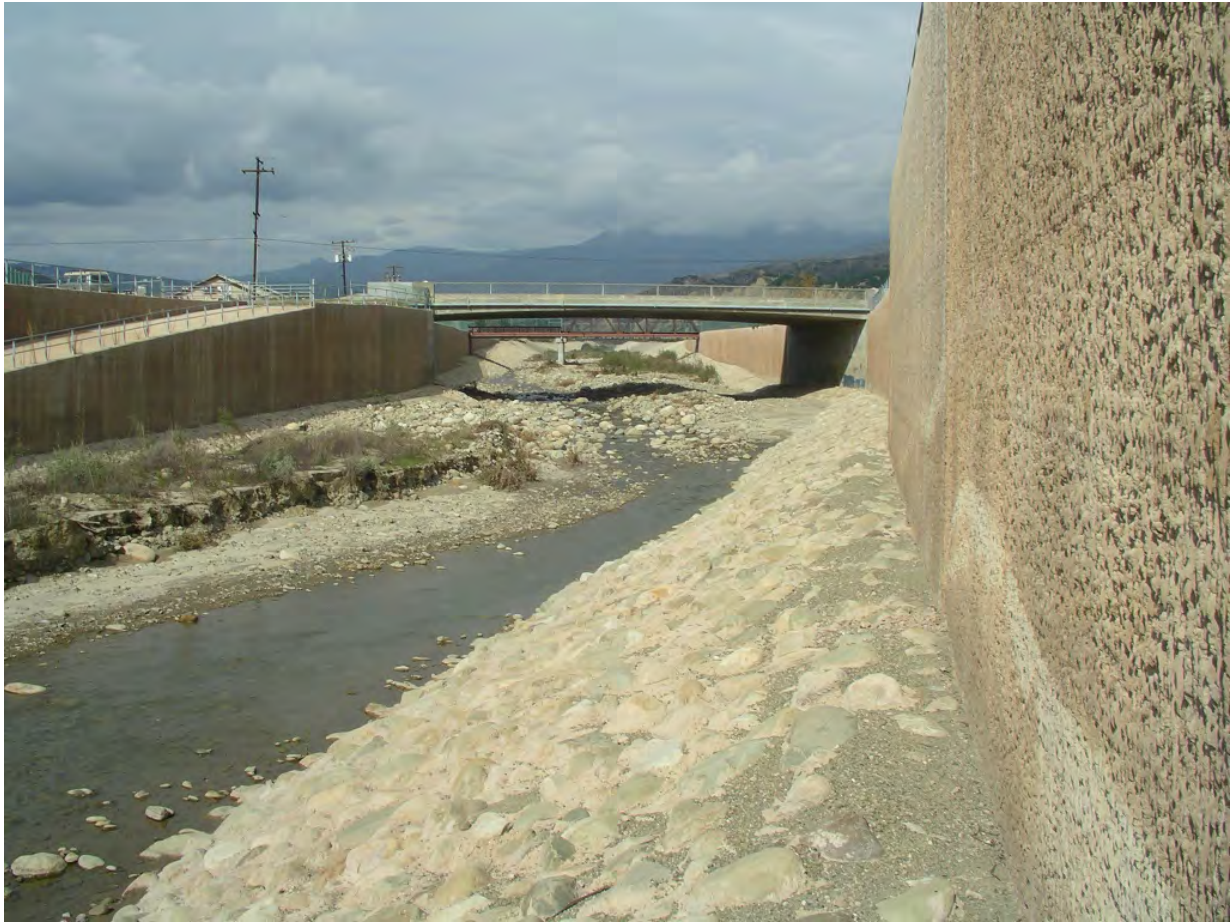
*ACOE Channel adjacent to city of Santa Paula*

**Description:** The Army Corps of Engineers built this extensive project in order to protect the City of Santa Paula from flooding. The channelized reach extends approximately 8625 feet from just upstream of the Santa Clara River to a concrete grade control structure downstream from a long fishway. The 215-foot long fishway rises 18 feet 6 inches with an overall slope of 8.6%. Following the 2005 flows the fishway and grade control were completely destroyed.

**Diagnosis:** The concrete channel is periodically dredged of sediments; this eliminates natural channel complexity and thus also creates unfavorable conditions for fish passage (pers. comm. Mark Capelli). Prior to the 2005 flows that destroyed the fishway and downstream grade control, this facility failed to meet DFG and NOAA fish passage criteria at all flows for strongest swimming species presumed present. The downstream grade control structure had an excessive outlet drop of 3 feet 4 inches and excessive concrete apron slope of 26%. Even the elaborate fishway failed to meet DFG and NOAA fish passage criteria at all flows due to inherent debris blockages that completely blocked the weir notches and produced drops exceeding 2 feet on 5 of the 17 weirs. In addition, many of the weirs were filled with substrate and some had large boulders located in the ideal steelhead jump location and landing zones.

**Recommended Action:** A comprehensive alternatives analysis needs to be conducted and removal of the fishway and downstream grade control seriously considered. Reconstruction of similar fishway facilities will continue to have inherent failure risks, annual debris blockage, and require continual maintenance, or result in limiting or preventing upstream steelhead passage. Replacing the fishway with a roughened channel combined with channel-wide weirs tied into the existing trapezoidal concrete walls may provide the most effective steelhead passage and structural integrity with minimal maintenance. Such a design would need to extend downstream into the channelized reach to reduce the slope of the roughened channel and create a milder transition between the 18-foot 6-inch elevation difference between the current fishway inlet and outlet. The downstream channel appears to have sufficient capacity to allow for such an alternative.

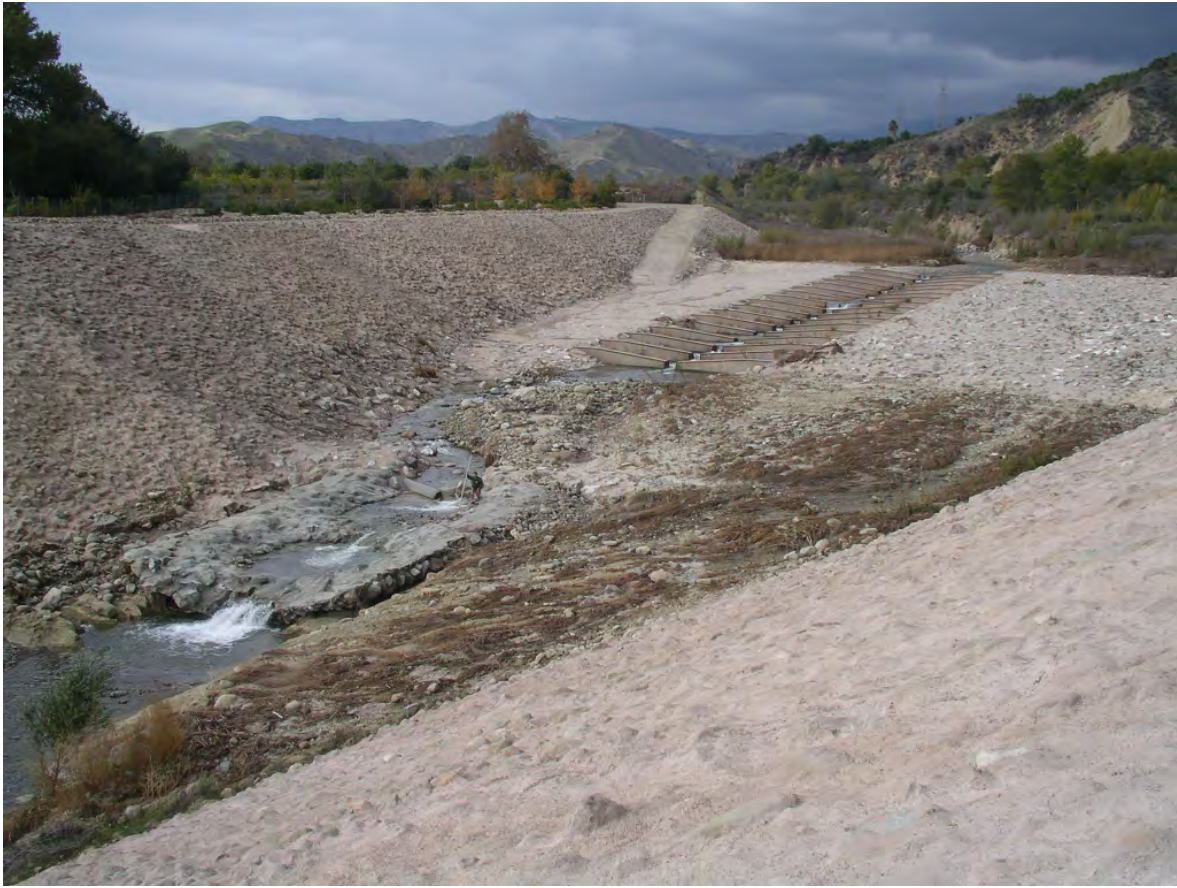
*Grade control and fishway before 2005 failure*

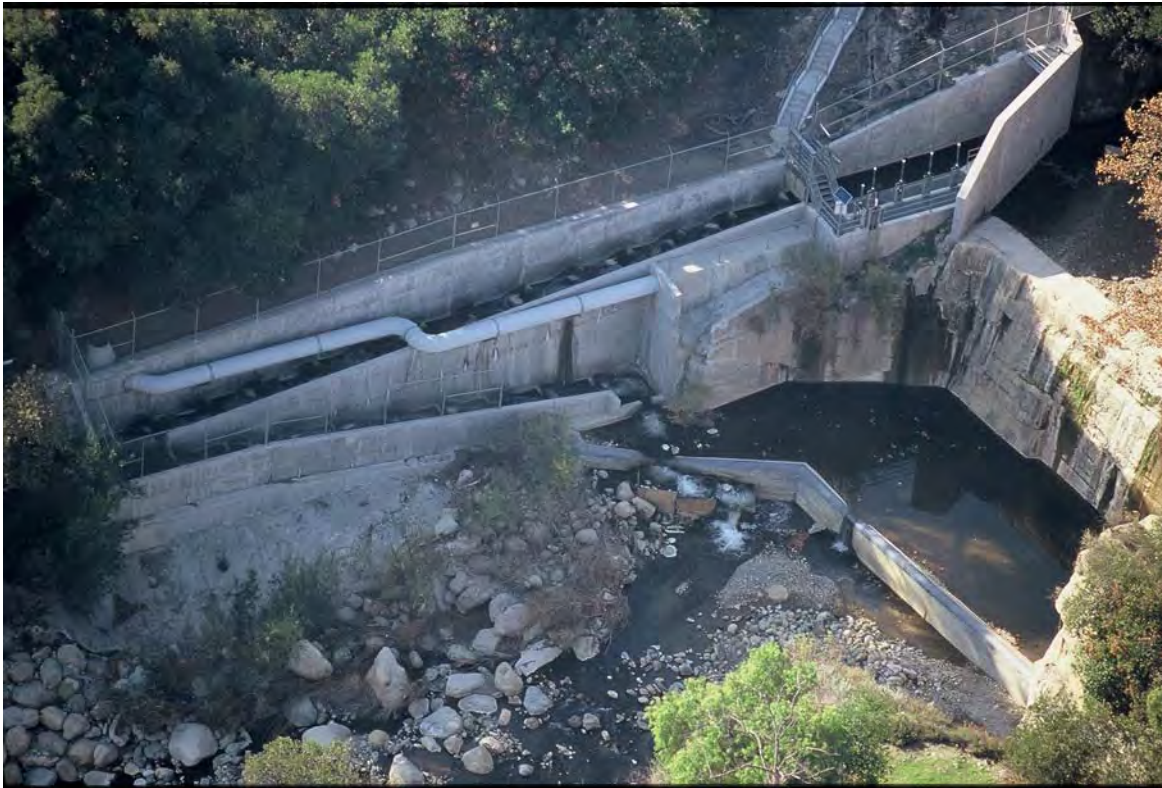
*Dam and ladder before 2005 damage*

**Description:** Permission to conduct a ground survey at Harvey Dam was not obtained and limited observations were made from Highway 150 before and after the record stream flows during January 2005. The concrete dam was built in 1923 and is owned and operated by Canyon Irrigation District. The dam occurs immediately upstream of Mud Creek. Though our initial observation of Harvey Dam was conducted in the fall of 2004, conditions at the dam and fishway were dramatically altered during the high stream flows of early 2005. We observed the dam again in the spring of 2005 and it is that observation that is presented here. Harvey Dam experienced major damage and substrate mobilization with the 2005 winter flows. The dam was side-cut by flows on the river-left side and flows were observed cutting between the concrete dam and adjacent bedrock. Much of the dam's concrete sill was destroyed exposing the re-bar underneath. The force of the high flows dropped the substrate elevation below the dam, downstream of the weir, by more than 5 feet, leaving a drop of greater than 7 feet. The fishway was also extensively damaged, completely filled in with substrate, and rendered ineffective following the high flows. The Fishway's outlet jump boxes were filled with substrate and the metal was so damaged they are likely destroyed. The outlet drop of the most-downstream jump box was observed to be over 4 feet in height following the elevation drop of downstream substrate. The inlet to the fishway at the upstream end of Harvey Dam was also completely buried by substrate.

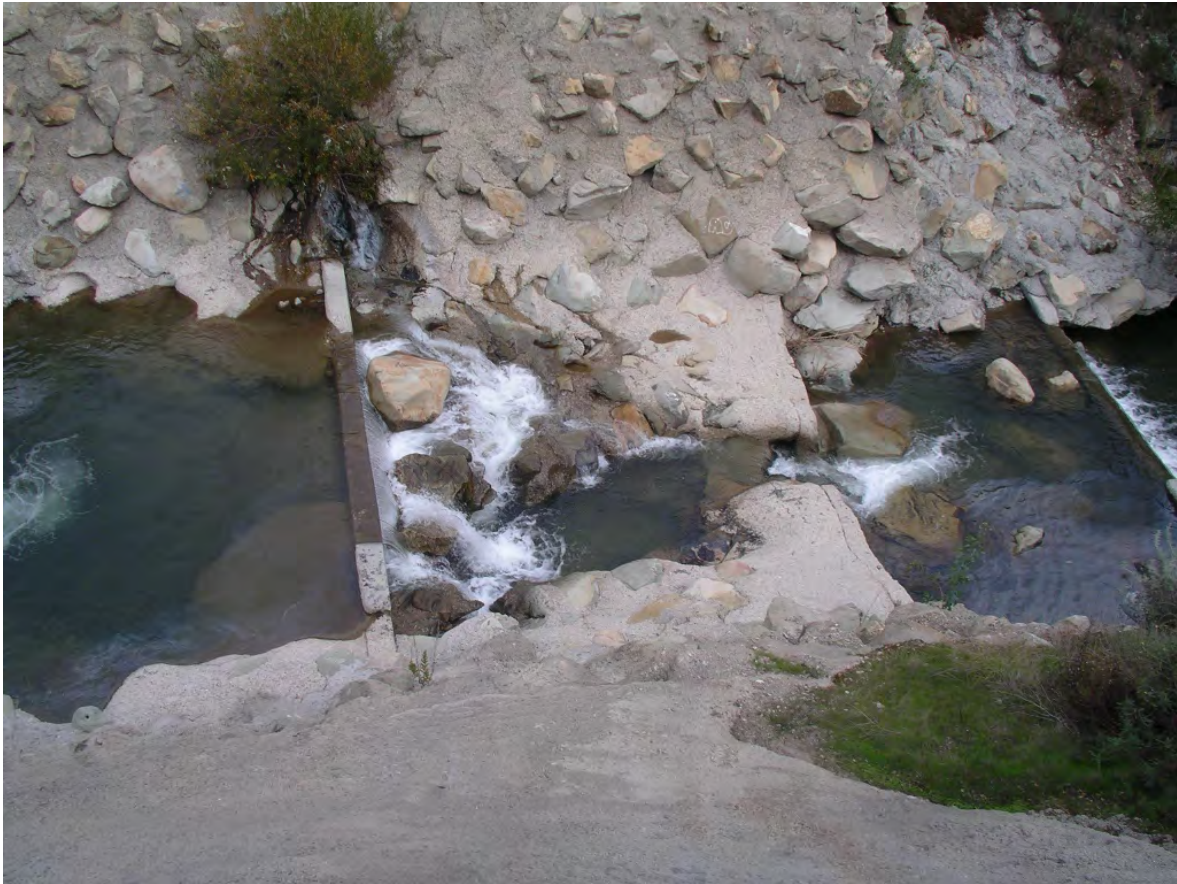
*Downstream grade controls before 2005 flood*

**Description:** Prior to the record rainfall and stream flows on Santa Paula Creek during January 2005, seven grade control structures occurred in association with the Highway 150 Bridge. These concrete curbs and associated concrete bank revetment stretched for over 400 feet from the upstream side of the Highway 150 Bridge downstream. During November 2004 surveys several of the curb drops exceeded 3 feet and the most severe drop measured 6 feet 4 inches in height. Large boulder cascades also occurred on the downstream side of several curbs and interfered with ideal steelhead jump locations. The fifth curb upstream also contained a steeply sloped apron extending 8 feet and with a slope exceeding 26%. High stream flows in January 2005 devastated much of Santa Paula Creek and dramatically changed the configuration of these Highway 150 grade control structures. The two most downstream curbs and bank revetments were completely destroyed and washed downstream.

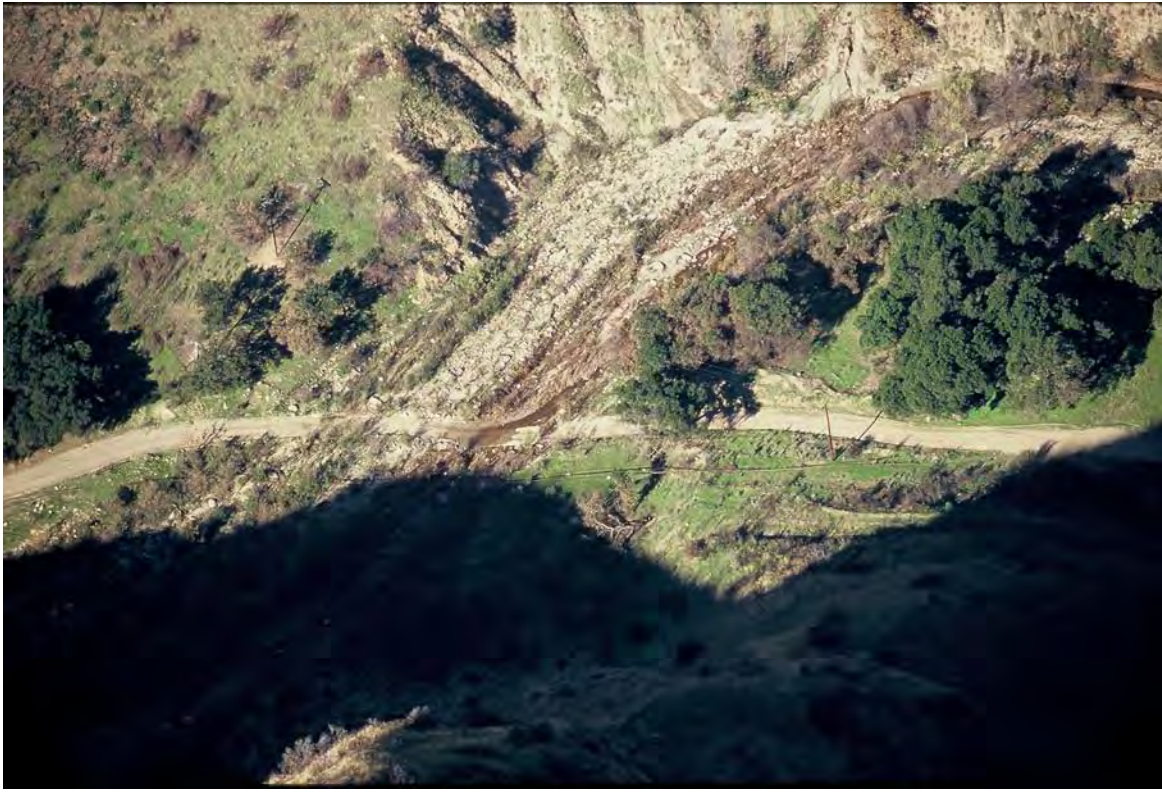
*Hopper Creek barrier #2*

**Description:** Permission to survey upper Hopper Creek was obtained, but access through locked gates on private land was never provided and observations were limited from the air and adjacent road up to the locked gate. A total of 14 private road crossings were observed on Hopper Creek upstream of Highway 126 while conducting the aerial survey. Three of the crossings appear to be constructed of concrete, while the remaining 11 appear to be in-stream fords on natural substrate that may not impede fish passage. The 3 concrete crossings were observed to have considerable outlet drops associated with them up to 4 or more feet in height. The crossings appear to service oil facilities in the canyon.

**Diagnosis:** Ground surveys are needed to determine the impacts of these crossings on fish passage, but aerial observations indicate that the three concrete crossings represent partial or complete barriers to upstream fish migration and limit or prevent upstream fish passage to excellent habitat located upstream. SC\_HR\_2 appears to have a 2-foot outlet drop while SC\_HR\_3 and SC\_HR\_4 appear to have outlet drops exceeding 4 feet in height.

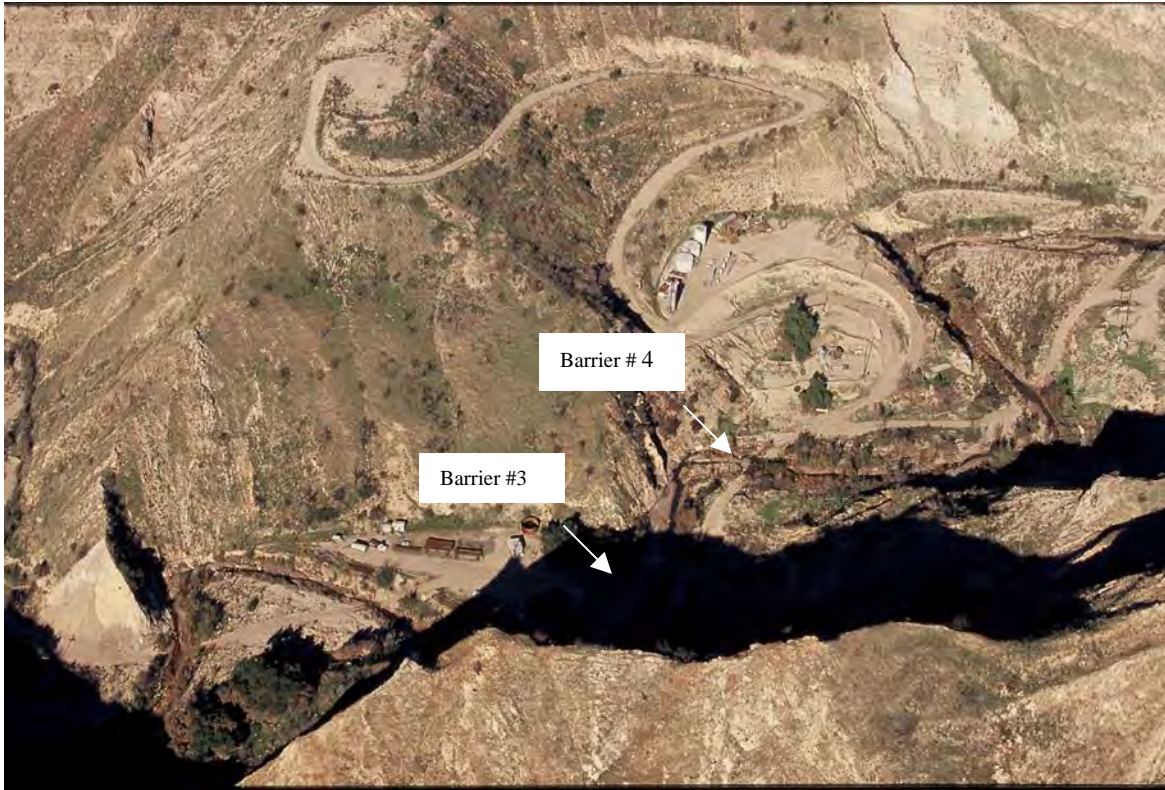
*Hopper Creek Barriers #3 and #4 and other at-grade oil facility road crossings*

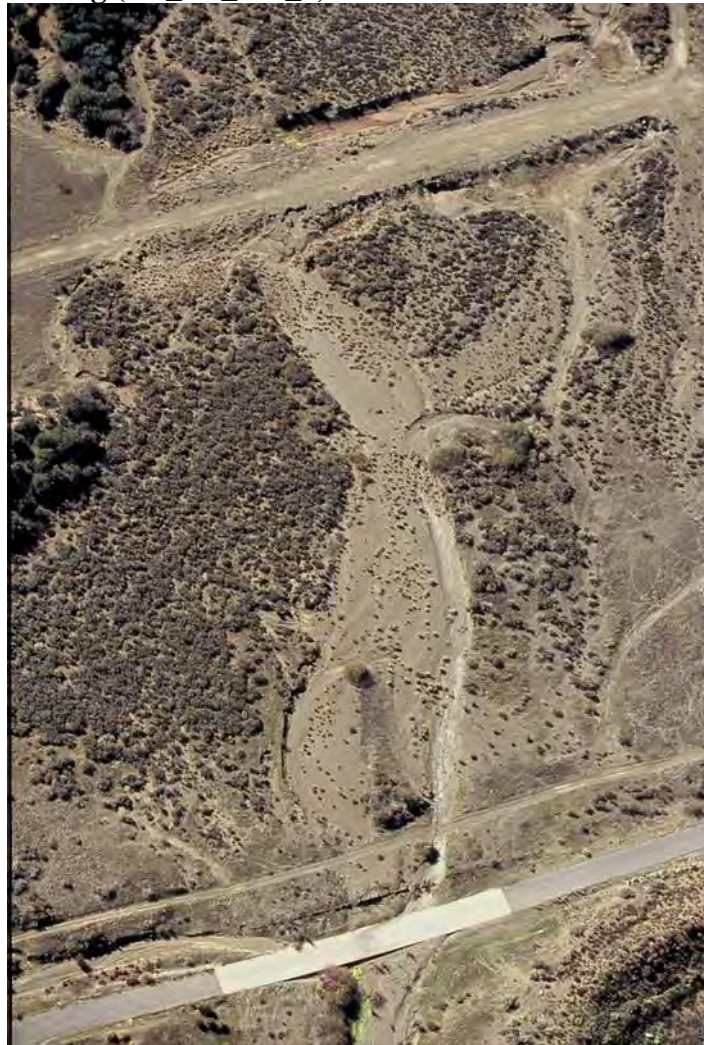
*Rose Valley Road (bottom) and Airstrip (top)*

**Description:** This concrete low-flow crossing spans 198 feet across a braided and unconfined reach of Howard Creek at the edge of a large meadow and private ranch (Rancho Grande). The crossing is 22 feet wide with a slope of 1.5 %. The outlet sill drops flows 1-foot 4 inches to the downstream substrate.

**Recommended Action:** See survey recommendation for the downstream culvert (SC\_SE\_HD\_2). These culverts should be further assessed in coordination with unsurveyed upstream barriers and habitat on Rancho Grande that will influence potential alternatives at this site.

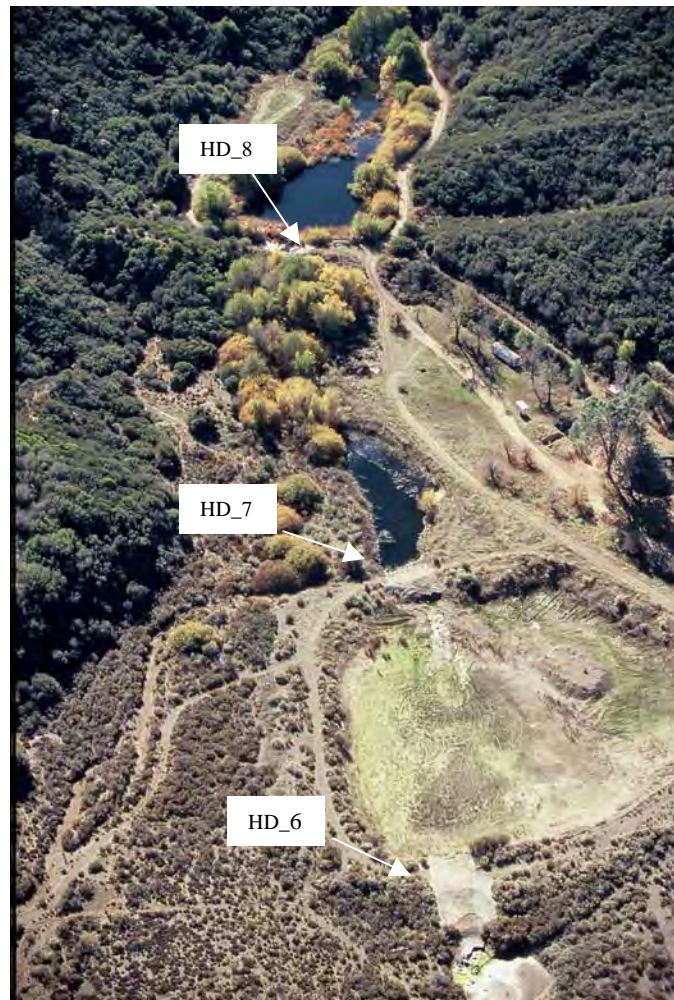
*Upper Three Dams and Reservoirs #6-#8 (lower dam not visible)*

**Description:** Access to survey these four dams was not obtained and limited observations were made from the air. All dams appear to be earth filled dams with concrete spillways. The dams occur in sequence with the reservoir elevation at the next upstream dam. The concrete spillways also appear to be used for vehicle access across the dam crest.

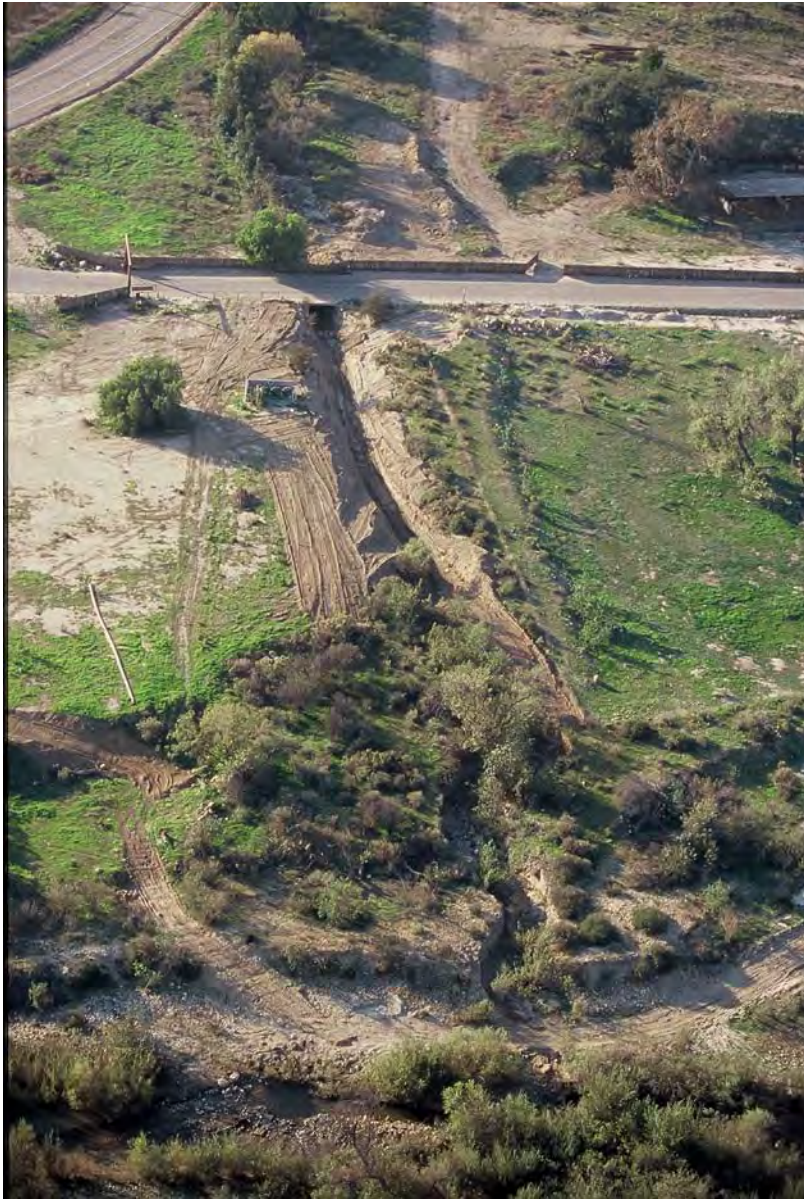
*Private Box Culvert (SC\_PU\_LE\_1) on Lime Creek*

**Description:** Permission to survey these lower Piru Creek tributary crossings was not obtained and observations were limited from Piru Canyon Road and the air. The downstream-most box culvert on Lime Creek occurs downstream of Piru Canyon Road. Concrete box culverts occur on Modelo and Blanchard Creek under Piru Canyon Road and Lime Creek has a circular culvert. The remains of an old structure that appears to be a failed culvert crossing occur upstream of Piru Canyon Road on Lime Creek.

**Diagnosis:** Additional assessment is needed to determine the impacts of these crossing on fish passage and ground surveying of upstream habitat conditions and summer flows is needed to determine if fish passage projects are warranted. Each culvert likely limits fish passage to some degree during various flow conditions.

**Recommended Action:** Contact the landowners and request permission to survey the crossings and upstream habitat. Discuss the desirability of the crossings and potential grant opportunities to improve the crossings for vehicle access and fish passage. If the crossings are limiting fish passage and restoration projects are warranted, the preferred NOAA Fish Passage guideline alternatives are removal of the crossing and road realignment to avoid crossing the stream, installation of a bridge, or streambed simulation strategy (NOAA 2001).

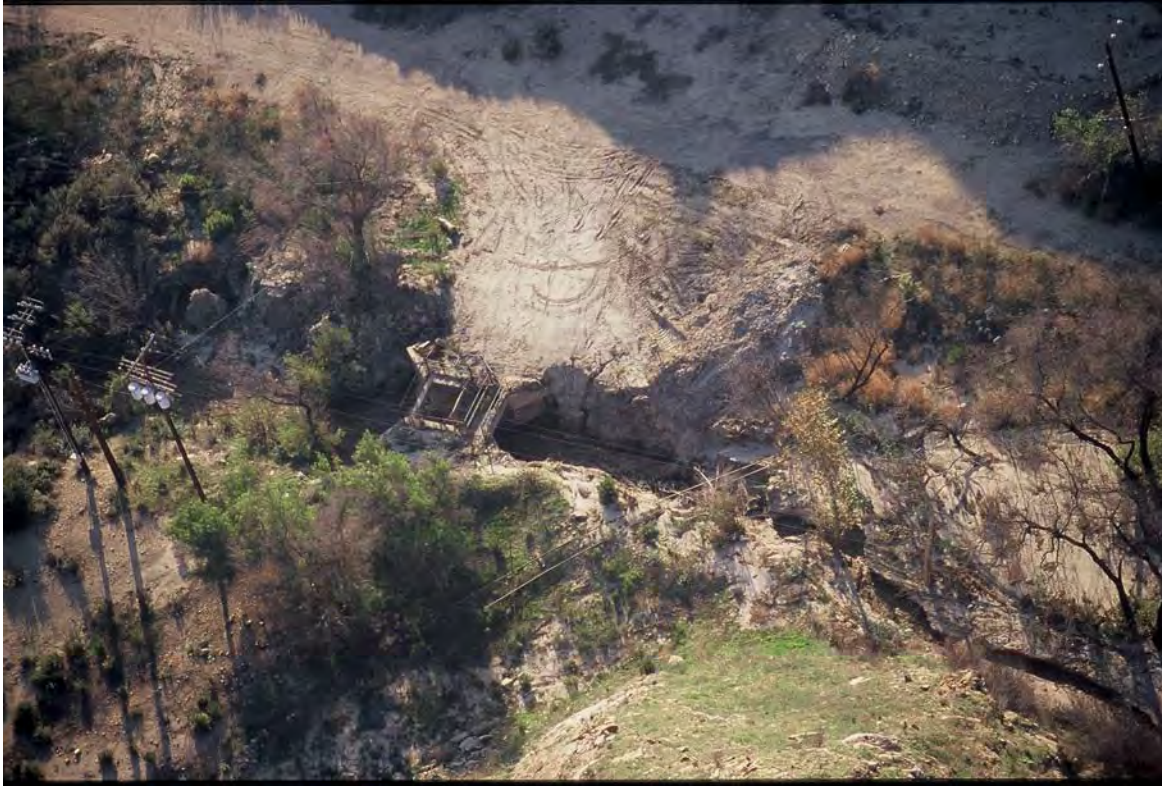
*Old structure (SC\_PU\_LE\_3) on Lime Creek*

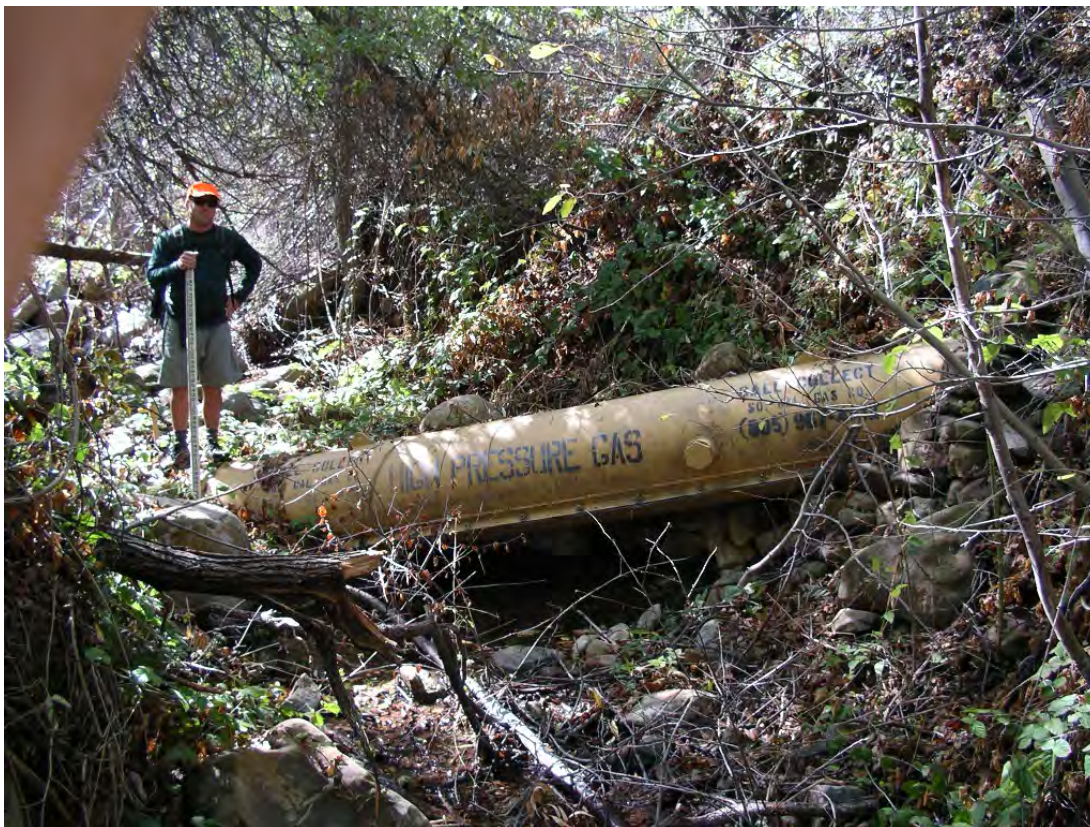
**Description:** This high-pressure gas line is highly exposed in the stream channel and presents a partial barrier to trout migrating into Cherry Creek from Sespe Creek. The 2-foot diameter pipeline has natural substrate occurring on top of it on the far river-left side of the channel and produced a 12-inch drop to the downstream pool that measured 12 inches in depth. Spray painted on the side is “High Pressure Gas” and “So. Cal. Gas Co. (805) 967-4612”

**Diagnosis:** The short jump height required to clear this pipeline would likely not limit upstream fish migration during moderate and high flows, but imposes a moderate degree of difficulty during lower flows and especially for small salmonids that occur upstream in Cherry Creek.

**Recommended Action:** So. Cal. Gas Co. should remove this pipeline and reroute it aerially in a “gooseneck” design to allow unimpeded fish passage and eliminate damage from the stream channel. A small population of *O. mykiss* were observed in Cherry Creek upstream of this pipeline this partial barrier and potential pollution hazard should be rerouted out of the active stream channel.

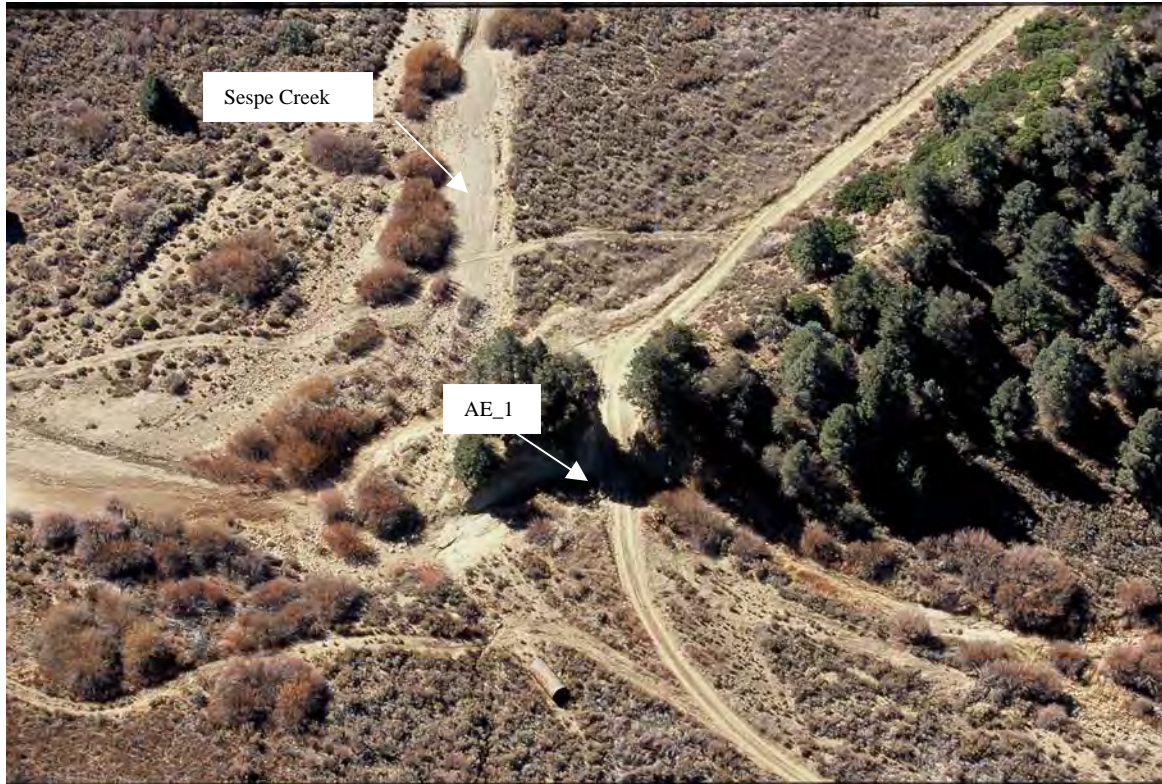
*Private culvert crossing on Adobe Creek just upstream of Sespe Creek*

**Description:** Permission to survey these crossings was not obtained and observations were limited from the air. The most downstream crossing appears to be a culvert pipe and dirt road crossing that occurs immediately upstream from the Sespe Creek confluence. The upstream crossing occurs upstream of the Highway 33 Bridge and observations could not determine the configuration of the crossing due to excessive vegetation cover.

**Recommended Action:** Contact the landowners and request permission to survey the crossings and discuss the desirability crossings and potential grant opportunities to improve the crossings for vehicle access and provide fish passage. If the crossings are limiting fish passage and habitat conditions warrant restoration projects, the preferred NOAA Fish Passage guideline alternatives are removal of the crossing and road realignment to avoid crossing the stream, installation of a bridge, or streambed simulation strategy (NOAA 2001).

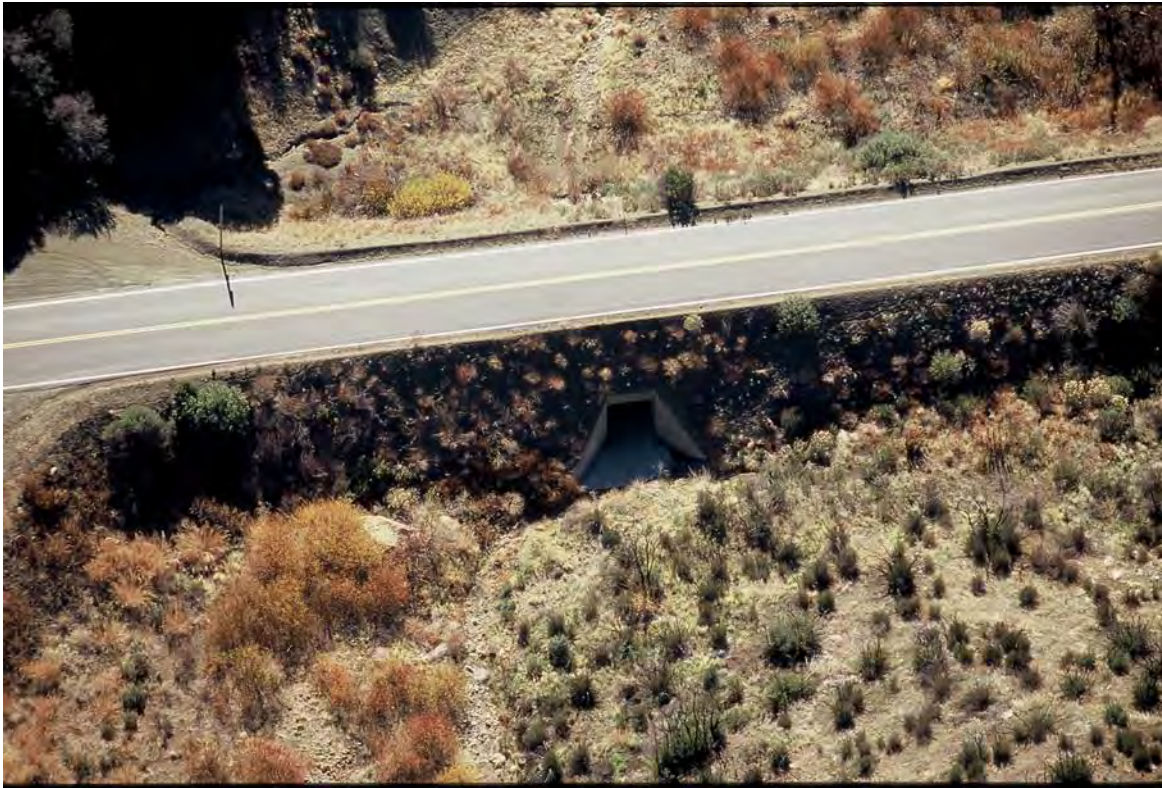
*Burro Creek Highway 33 Box Culvert*

**Description:** Two Highway 33 concrete box culverts occur on Burro Creek and the adjacent (unnamed) Burro Creek #2. The Burro Creek #2 box culvert measured 56 feet long and 6 feet wide by 8 feet tall. The steep slope of the culvert measured 11.8% with a total rise of 6 feet 7 inches from the inlet to the outlet at substrate level. The culvert bottom is damaged with exposed metal re-bar and worn concrete. No access was obtained to survey the Burro Creek culvert, but observations from the road reveal a similarly steep slope and approximately 2-foot outlet drop.

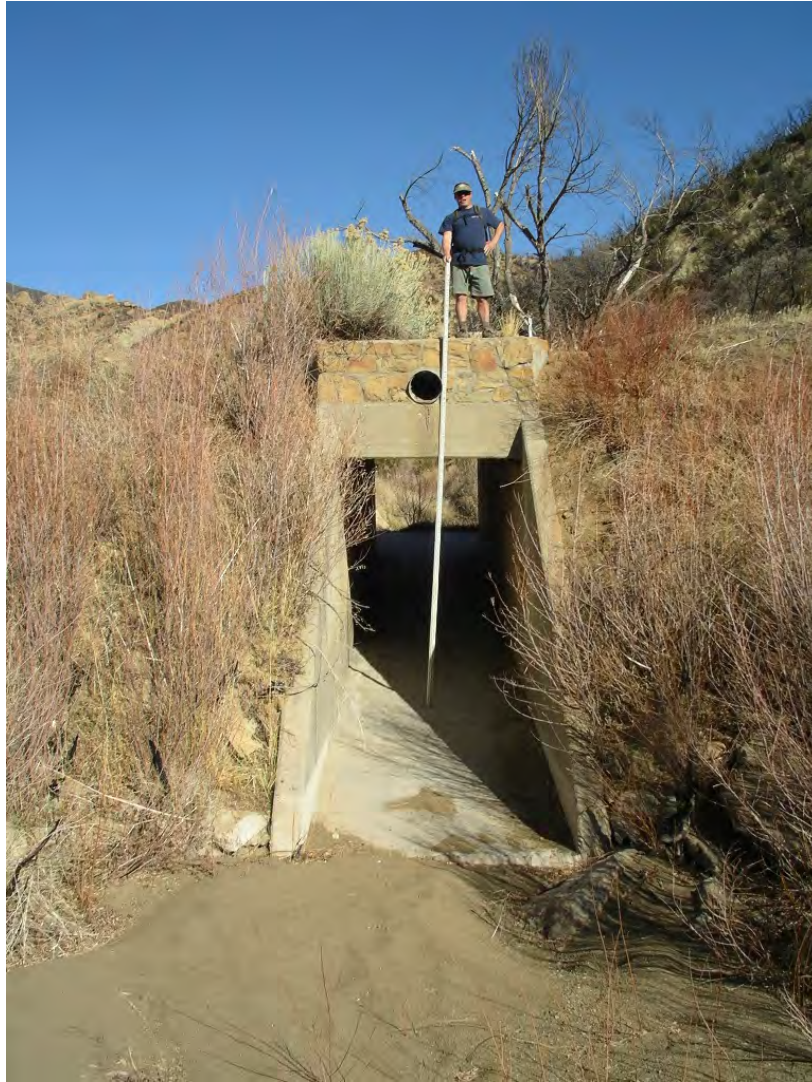
*Burro Creek #2 Highway 33 Box Culvert*

**Diagnosis:** Due to the steep slope of these culverts, the structures fail to meet DFG and NOAA passage criteria at all flows for strongest swimming species presumed present. During low flow conditions encountered in late November only 214 feet of habitat with surface was observed upstream of the Burro Creek #2 culvert and below an impassable 19-foot tall waterfall. However, much of the habitat observed was step-pool habitat with pools over 2 feet deep and one large plunge pool over 6 feet deep. This limited habitat may be able to support a small number of trout and provide one large over-summering pool. In accessible private lands occur upstream of Burro Creek #1 and habitat conditions were not surveyed upstream from the ground.

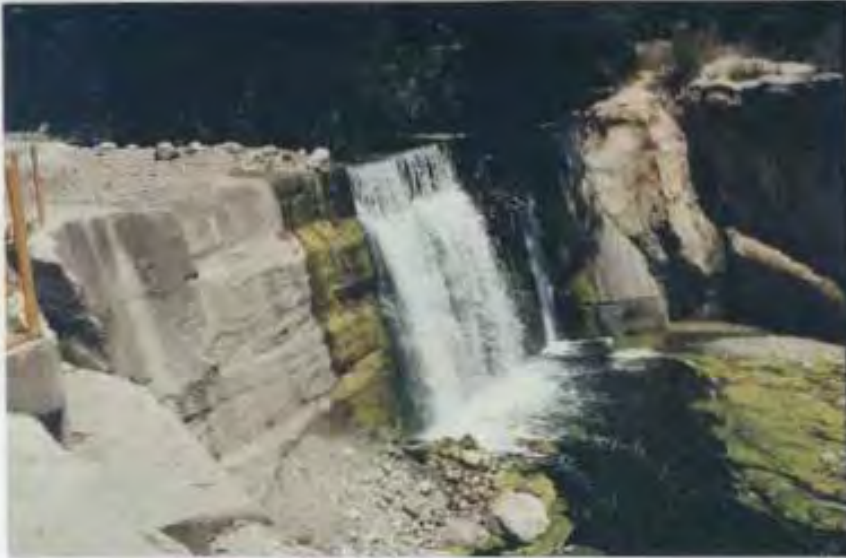
Photo #7  
Santa Paula Creek

Photos 7 & 8: Pool immediately above Santa Paula Falls; this also sig. barrier. Stream runs through short, steep gorge, along uplifted "slab of bedrock" stream elevation approx. 1700'. Much more exposed bedrock → Alders 20'-25' recovering and stable on east bank. Stream appears smaller, approx. 6 CFS, 0+ fry seen. gradient steeper, stream tight among large boulders or across slab rock with small pockets. Canyon walls steeper, better shade potential. 1st Tributary from west bank to Santa Paula Creek up from E. Fork Main Fork confluence has 0 flow entering Santa Paula Creek, but approx. 1/2" hose flow about 100 yds. upstream from Santa Paula Creek. See Photo 9. Elevation 1760'. Many small pools, boulder strewn, partially shaded stream, few riffles. A number of potential low flow barriers for upstream migrating resident trout in vicinity of Cross Camp, but resident population exists upstream. Water temp. 60, Air 66 @1500' in Santa Paula Creek. 100 yds. upstream from Cross Camp, elev. 1800'. Temp. of small trib. (.5 CFS) entering .5 miles upstream from East Fork Main Fork confluence = 63° Falls approximately 150 yds. upstream from Santa Paula Creek on tributary.

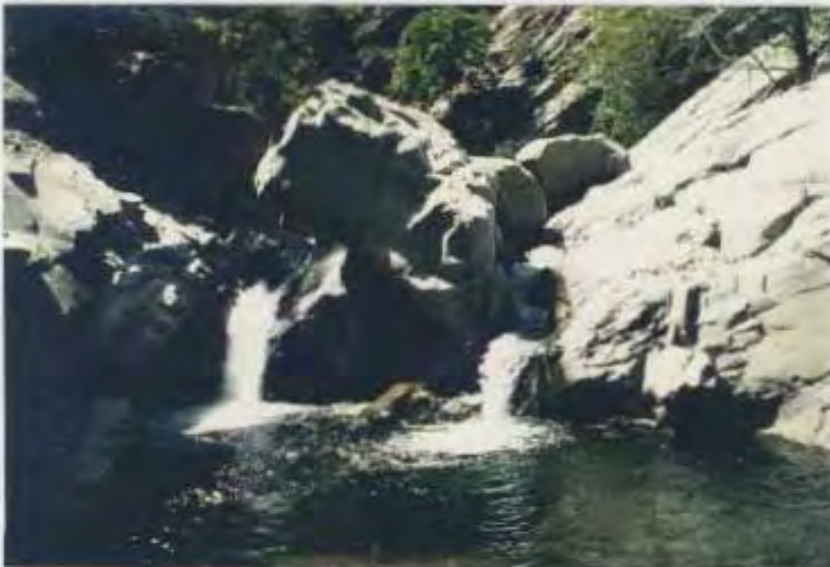
Photo #9  
Santa Paula Creek

Santa Paula Creek was surveyed on June 19, 22, and 23, 1992 by Michael Embury and Gale Bustillos. Survey began with visual observations at confluence of Santa Clara River. Both Santa Paula Creek and Santa Clara River have significant surface flows. Water temperature in this area was 18° C at 0930 hrs. Water is very turbid throughout lower reaches. Observed large schools of arroyo chub, and abundant tadpoles in this area. Approximately 0.5 km from the Santa Clara River, Santa Paula Creek enters a concrete channel which runs approximately 1 km through the east end of the city of Santa Paula. Water temperature at railroad crossing was 24 °C at 1245 hrs. Continuing upstream, large pools were snorkel-surveyed and abundant arroyo chub and threespine stickleback (*Gasterosteus aculeatus*) were observed. Santa Paula Creek was electrofished from approximately 1 km downstream of Bridge Road crossing (#29 & 30 on topo map) to the Santa Paula Water Works (SPWW) diversion structure. This 6 meter high dam represents the first artificial fish barrier (photo 7). Chub, stickleback, fathead minnow (*Pimephales promelas*), sucker (*Catostomus* sp.), redear sunfish (*Lepomis microlophus*), and approximately 12 RT that appeared to be of hatchery origin were found within this section. Habitat throughout this area was poor with high turbidity, high temperatures (26° C at 1330hrs), little to no riparian vegetation, and poor spawning areas. Habitat improves above SPWW dam. Other artificial impediments exists below the Highway 150 bridge, just downstream of the Sisar and Santa Paula creeks confluence (photo 8). Visual observations continued up Santa Paula Canyon revealing good trout habitat, ie. clear water, lower water temperatures, and abundant spawning areas. Only three wild RT, two adults, and one YOY, were observed below a series of large, 4-10 meter high water falls in the Big Cone Camp area located approximately 6 km upstream from Ferndale Ranch (photos 9 and 11).

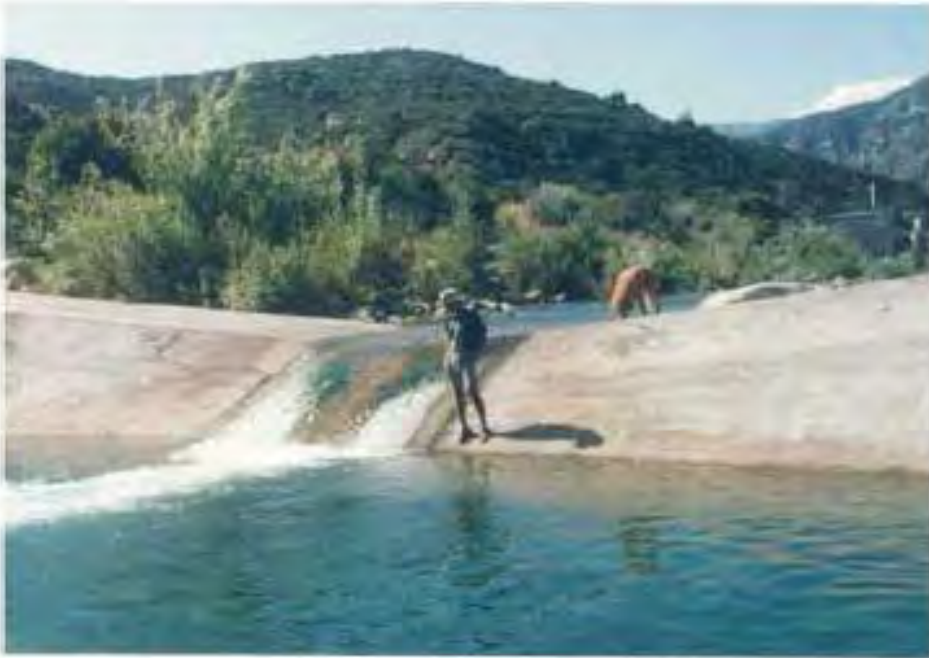
Photo # 13 Ventura River

An artificial barrier is present at a road crossing 150 meters downstream of the diversion dam (photo 13). Here, the stream flows over a concrete road and drops down a 1.5-2 meter slide into a large pool. This barrier may be passable during periods of high flows.

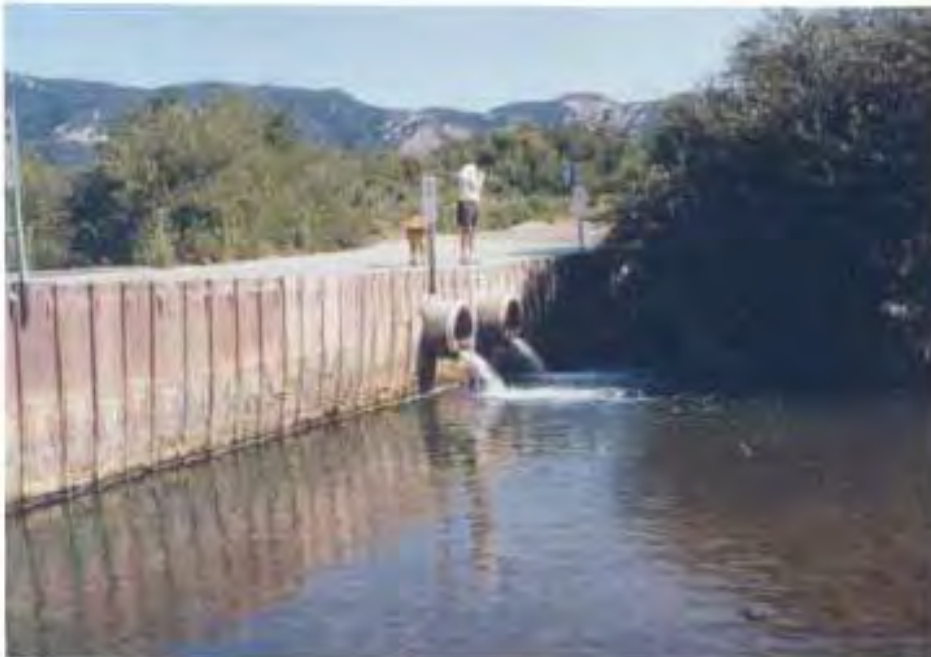
Photo #14 Gaviota Creek

located directly across northbound rest area on Highway 101, approximately 1 mile north of Gaviota State Park. One RT, 250-300 mm in length, was observed in a large pool. A series of road grade stabilization structures are present in the reach adjacent to Highway 101 between Gaviota State Park and the Highway 1 - 101 junction. These structures are approximately 1 to 2 m high and drop off a concrete apron, and probably impede or block passage at low flows. Another seasonal barrier is located downstream at the Gaviota State Park road crossing. Here the creek passes through two 50 cm culverts set in a concrete "fair weather" road crossing then falls 0.5-1 meter to a pool on the downstream side of the road<sup>2</sup> (photo 14).

<sup>2</sup> These culverts were replaced with a bridge in 1997, hence passage is no longer blocked or impeded at this site.
