Pigg River Dam Removal Restoration - Monitoring
Rocky Mount, Virginia

Year 1 - XS 2

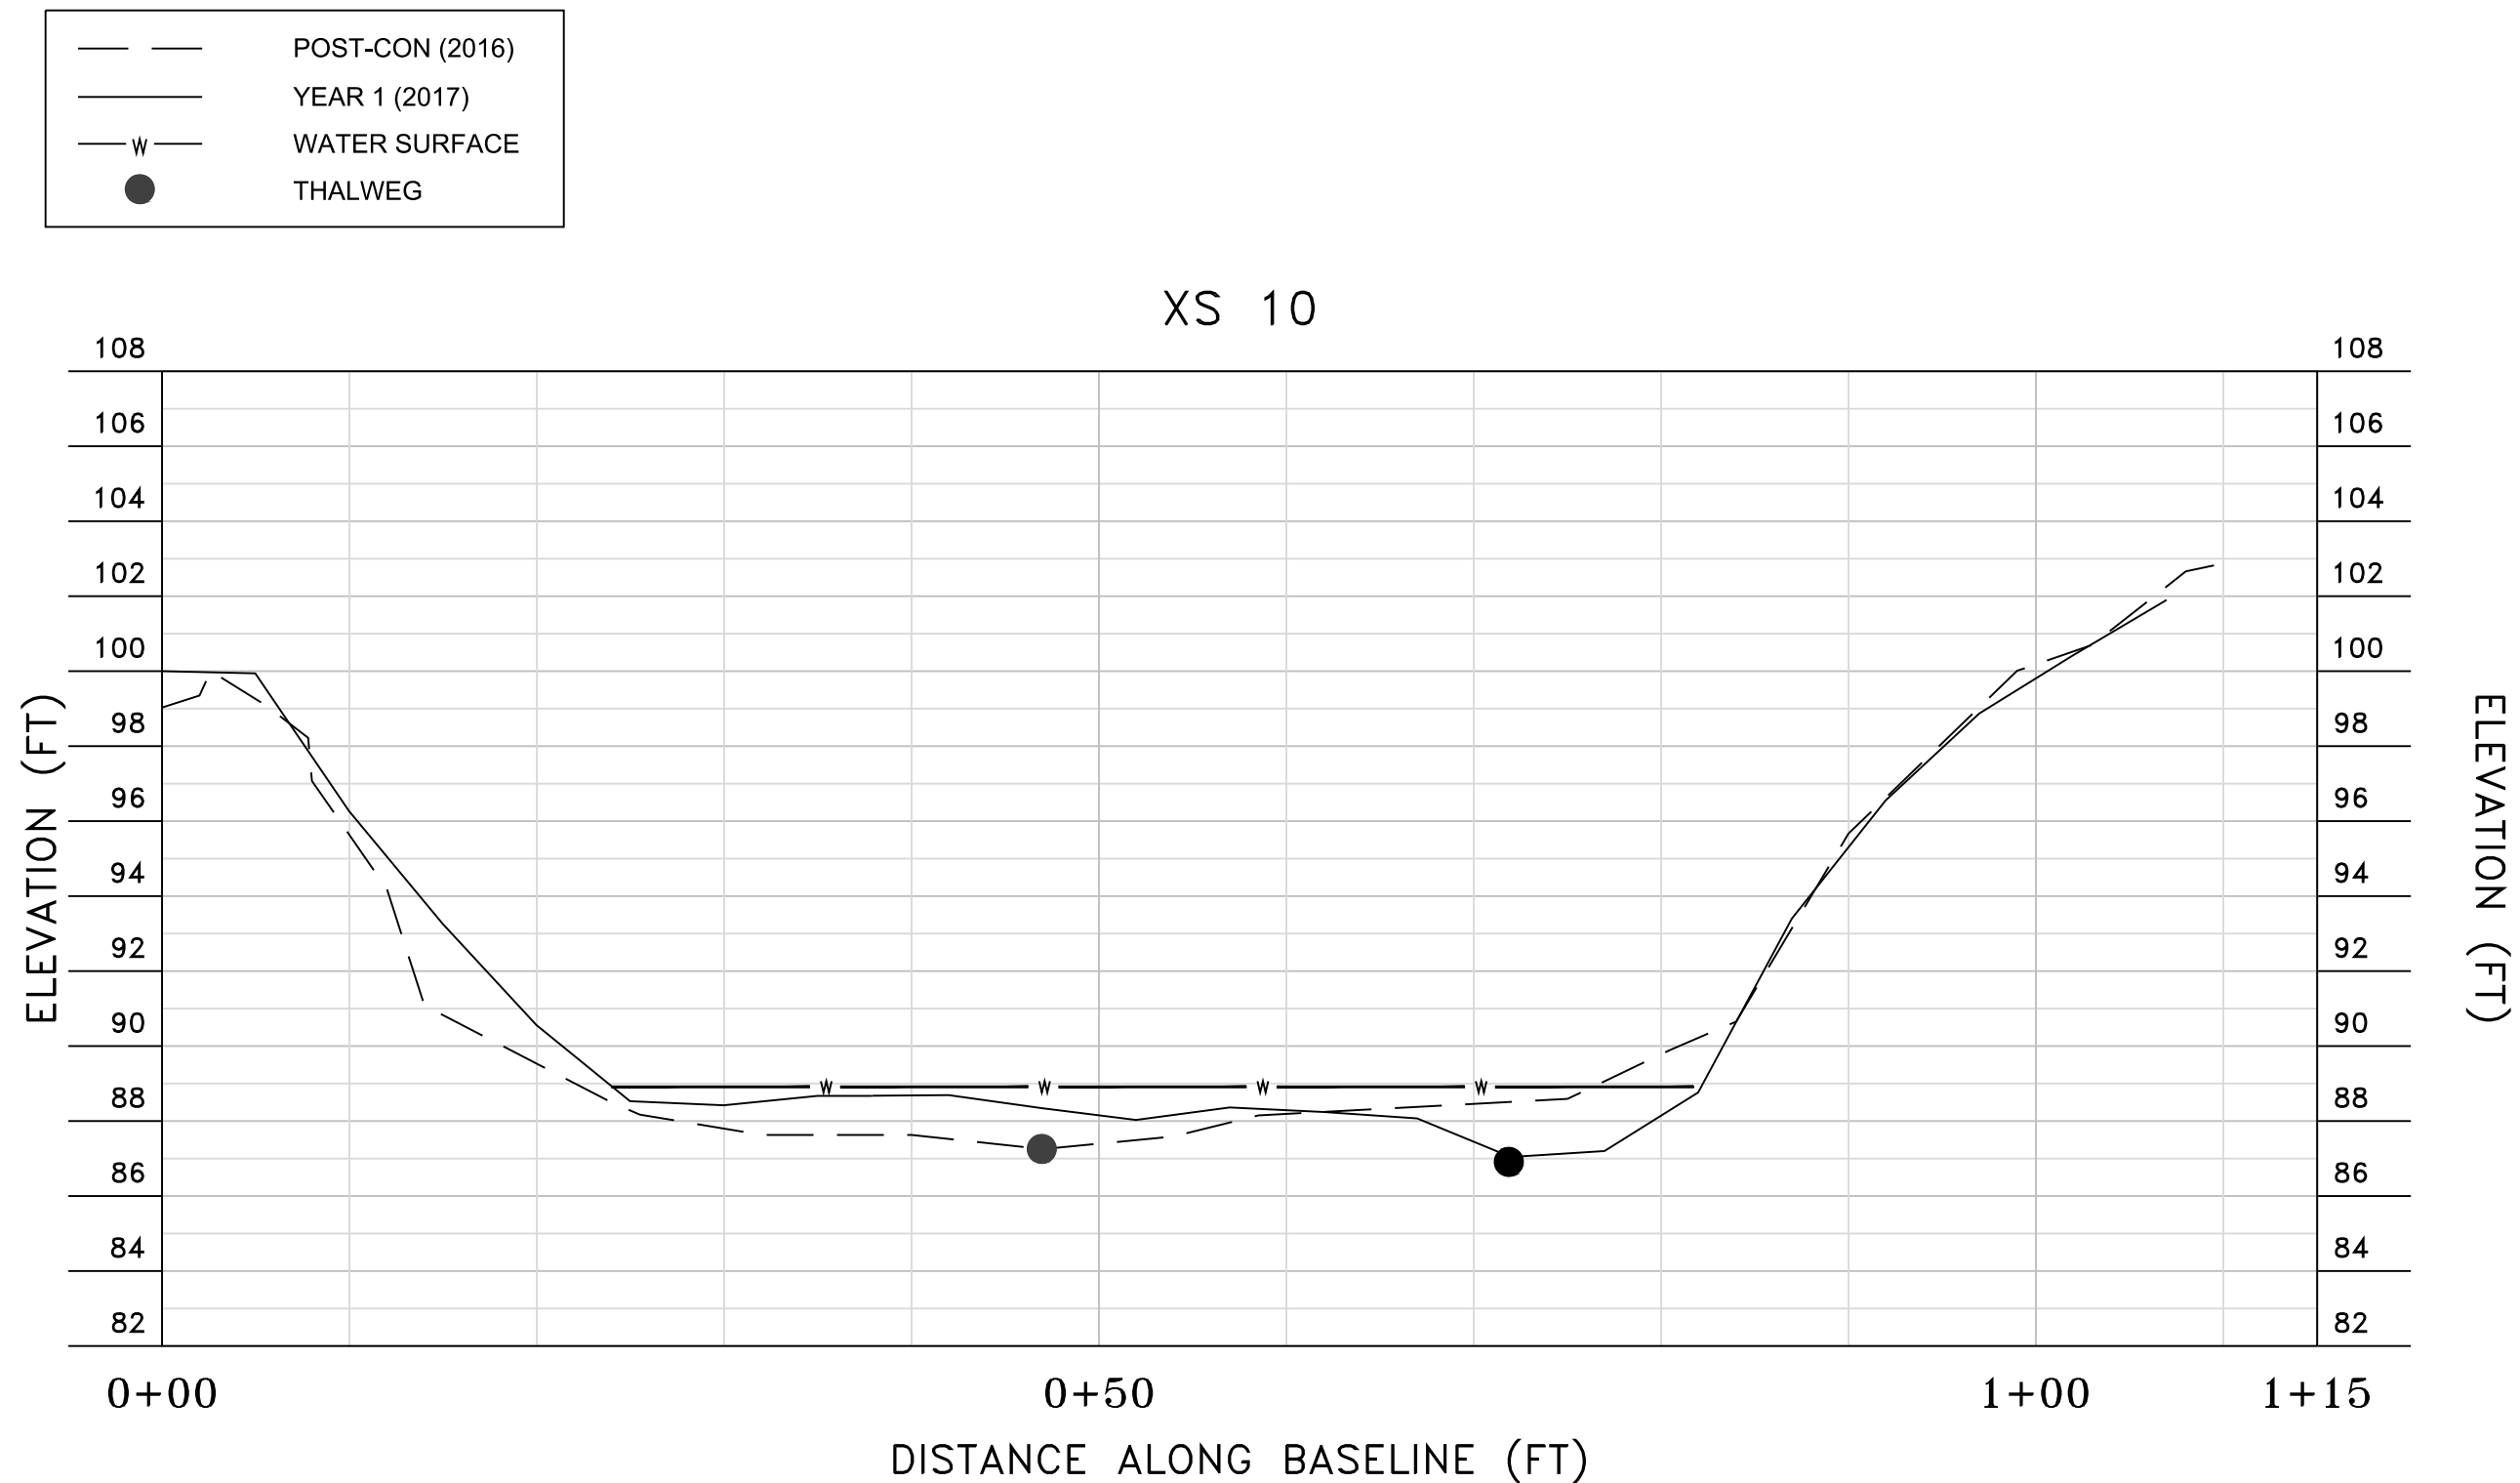
XS 10

Description: Cross Section 10 is located approximately 1.5 mi. downstream of the dam, or 2,700 feet downstream of Cross Section 9, east of Power Dam Road and north of the power line easement. Accessed via vehicle from Hudson Farm Lane. The section is flanked by fields on both sides, with a narrow band of trees along the tops of bank. Mature trees dotted the banks down to the edge of the observed water surface and root structure afforded good bank stability despite steep slopes and an incised section (~12-ft bank height). The water surface width at this section was consistent with that seen at Cross Section 9. Sediment deposition of sand was noted at or just above the observed water surface. Banks were relatively stable due to good coverage by woody root structure. Fine sediment had buried bed features and filled the thalweg, resulting in little variation in flow depth across the section.

The instrument setup for this cross section was at the left bank (HI = 3.54 ft.). The cross section plot is on Sheet 10 of Appendix B. No pebble count was taken at this location due the uniform fine-grained (sandy) nature of bed sediments. The small gravel (~1-in diameter) area was not representative of the overall bed conditions.
