Baseline Documentation Report

LORDSTOWN ENERGY CENTER PROPERTY

The Village of Lordstown, Trumbull County, Ohio

Report Prepared By: George Warnock Date of Site Visit: January 30, 2016

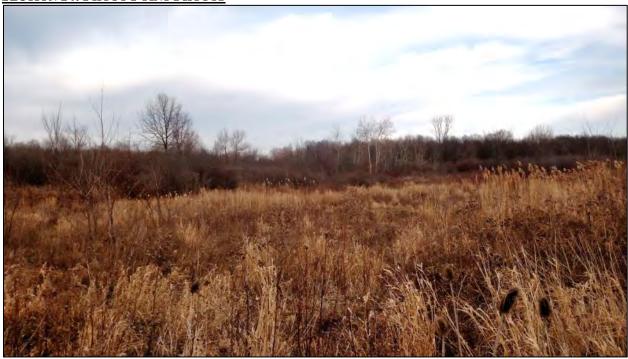
- 1. Looking northeast at a scrub shrub wetland on the western portion of the Protected Property. Note the phragmites.
- 2. Looking north along the western boundary from the southwestern corner of the western portion of the Protected Property. A survey pin and flagging tape was found.

Looking northeast at a scrub shrub wetland on the western portion of the Protected Property. Note the phragmites.

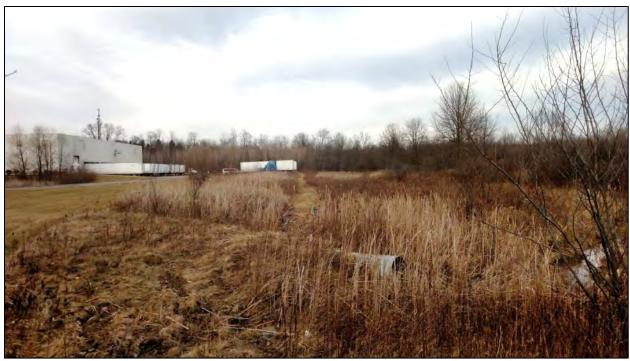
2. Looking north along the western boundary from the southwestern corner of the western portion of the Protected Property. A survey pin and flagging tape was found.

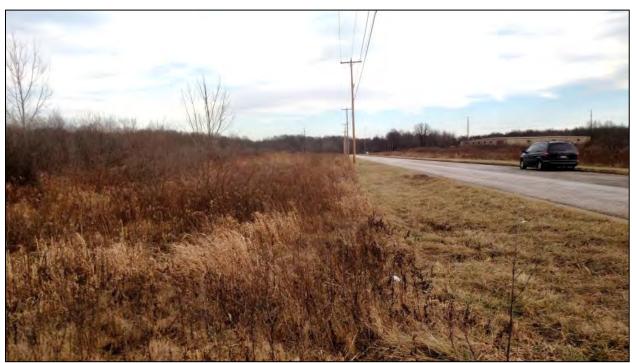
- 3. Looking east along the southern boundary along Henn Parkway from the southwestern corner of the western portion of the Protected Property. A survey pin and flagging tape was found.

3. Looking east along the southern boundary along Henn Parkway from the southwestern corner of the western portion of the Protected Property. A survey pin and flagging tape was found.

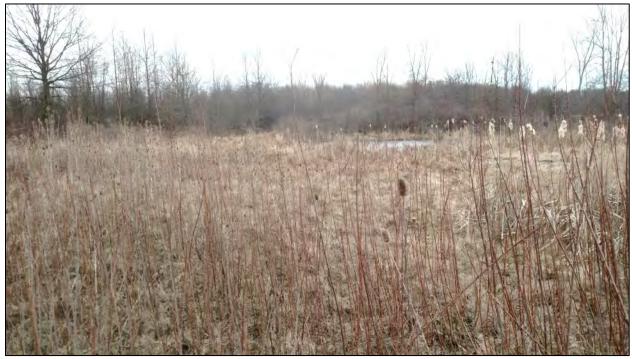
5. Looking east at a cattail wetland and pond near the western boundary on the western portion of the Protected Property.

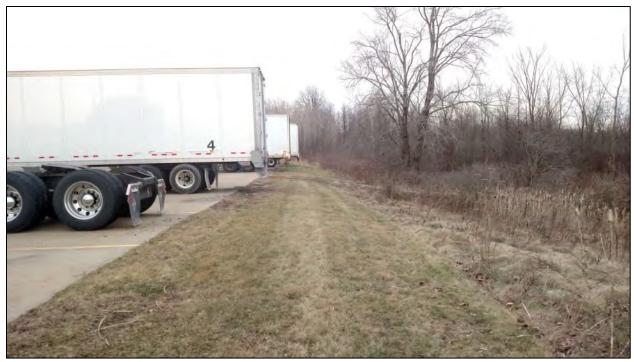
6. Looking north along the western boundary on the western portion of the Protected Property.

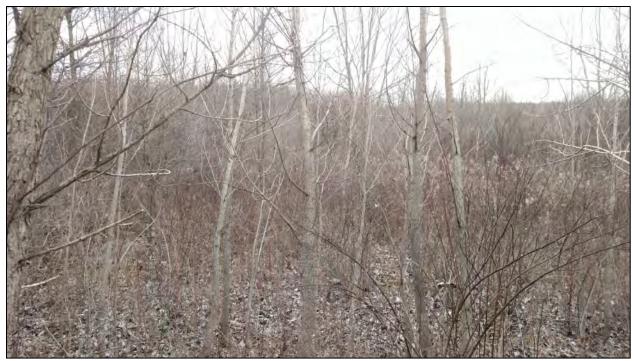
8. Looking east at the early successional mixed forest taking over the scrub shrub habitat near the northwestern corner of the western portion of the Protected Property.

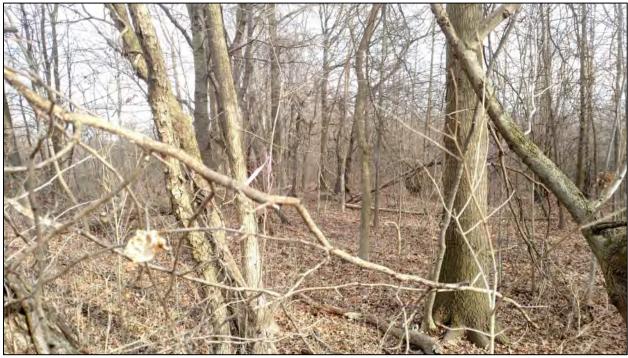
- 9. Looking east along the northern boundary from the northwestern corner of the western portion of the Protected Property. A survey pin and flagging tape was found.

9. Looking east along the northern boundary from the northwestern corner of the western portion of the Protected Property. A survey pin and flagging tape was found.

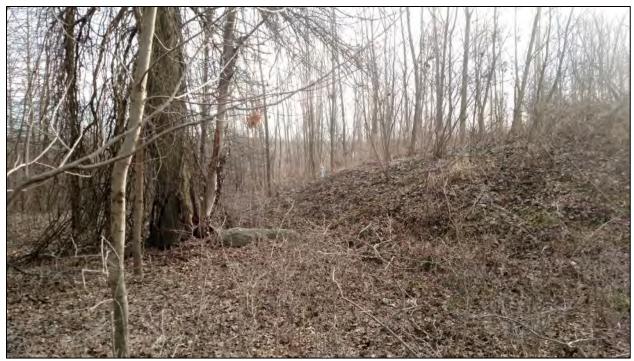
- 10. Looking south along the western boundary from the northwestern corner of the western portion of the Protected Property. A survey pin and flagging tape was found.

10. Looking south along the western boundary from the northwestern corner of the western portion of the Protected Property. A survey pin and flagging tape was found.

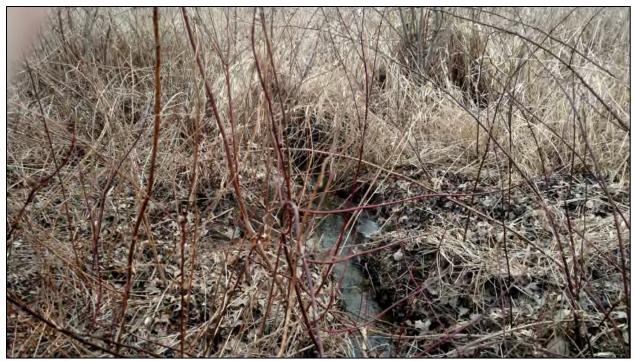
12. Looking south at the perennial stream flowing south onto the northern portion of the western portion of the Protected Property.

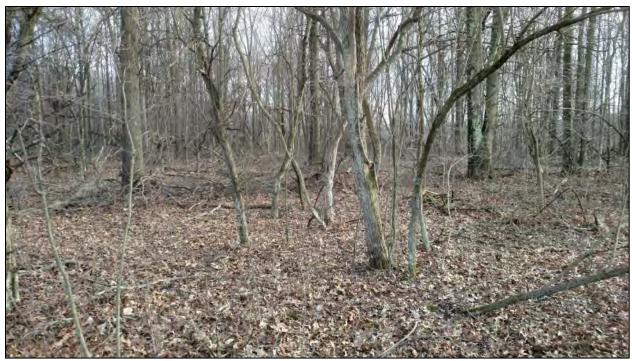
14. Looking southeast at the mid-successional hardwood forest on the eastern part of the western portion of the Protected Property. Note the sparse understory and ground cover.

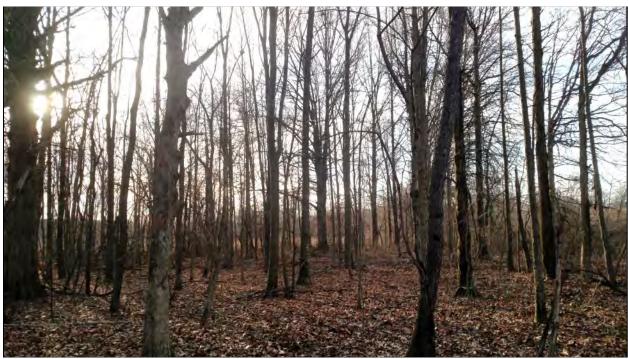
15. Looking west through the mid-successional hardwood forest on the eastern part of the western portion of the Protected Property. Note several large oak trees in the photo.

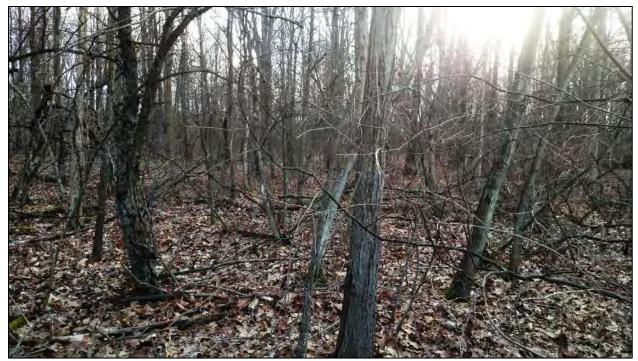
18. Looking southwest along the eastern boundary from the northeastern corner of the western portion of the Protected Property.

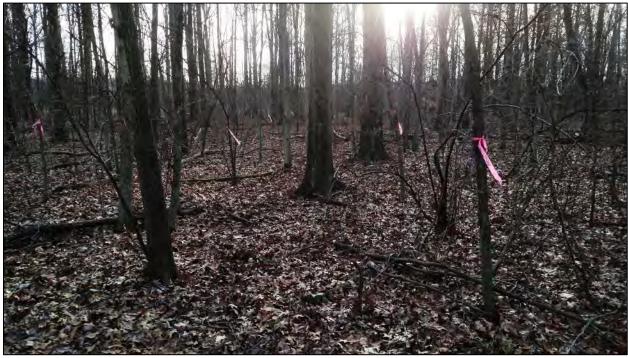
19. Looking southwest at a delineated wetland area near the northwest corner of the eastern portion of the Protected Property. Note the pink flagging tape marked with "Delineated Wetland."

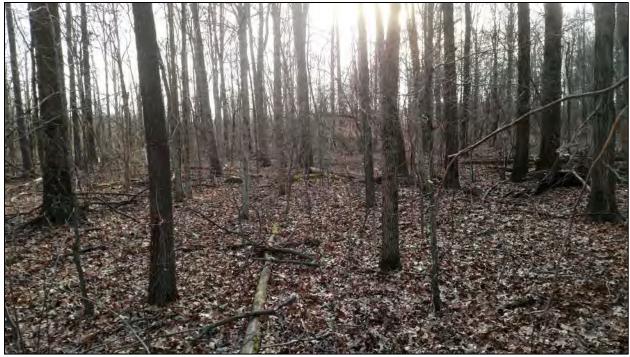
20. Looking southwest along the western boundary from the northwest corner of the eastern portion of the Protected Property.

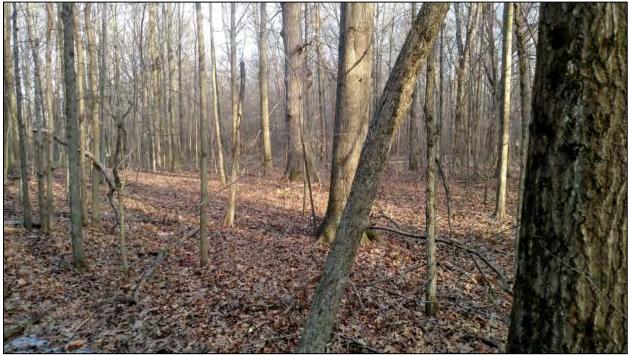
21. Looking east along the northern boundary from the northwest corner of the eastern portion of the Protected Property.

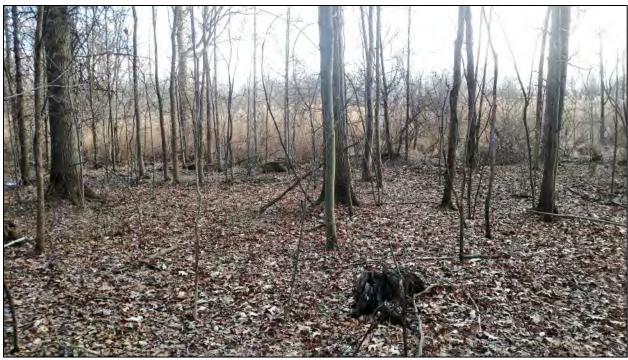
22. Looking south at a stand of phragmites along the edge of the oil/gas well head clearing in the southcentral part of the eastern portion of the Protected Property.

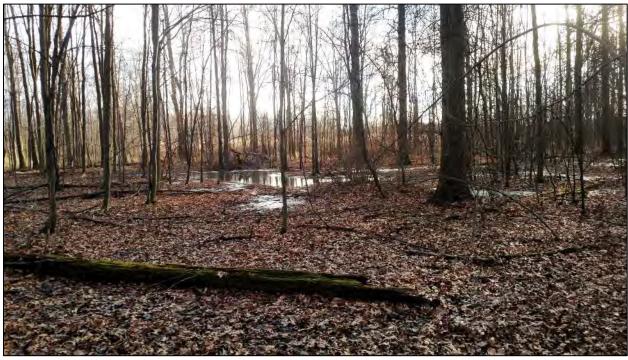
23. Looking south at vernal pools near the central part of the eastern portion of the Protected Property.

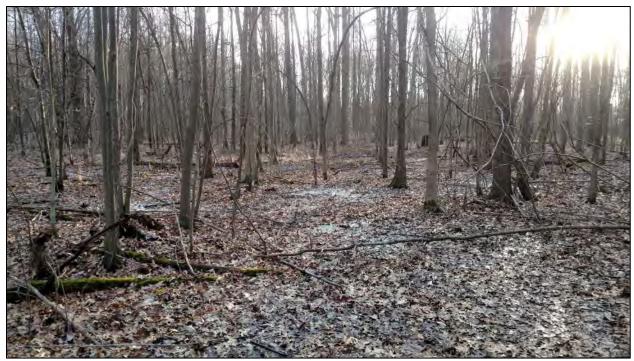
24. Looking southwest at vernal pools near the northeast corner of the eastern portion of the Protected Property.

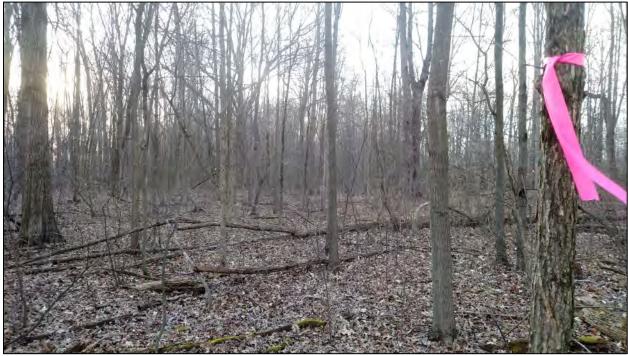
- 25. Looking west along the northern boundary from the northeast corner of the eastern portion of the Protected Property. A survey pin and flagging tape was found.

25. Looking west along the northern boundary from the northeast corner of the eastern portion of the Protected Property. A survey pin and flagging tape was found.

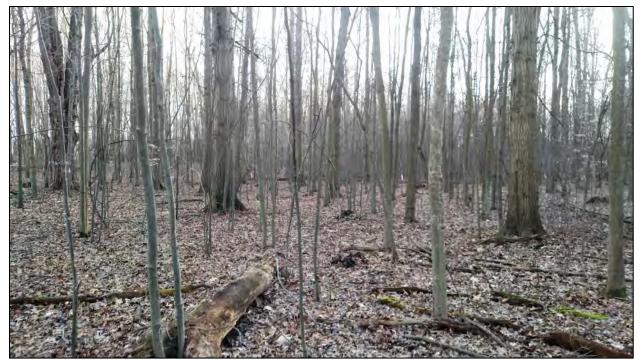
- 26. Looking south along the eastern boundary from the northeast corner of the eastern portion of the Protected Property. A survey pin and flagging tape was found.

26. Looking south along the eastern boundary from the northeast corner of the eastern portion of the Protected Property. A survey pin and flagging tape was found.

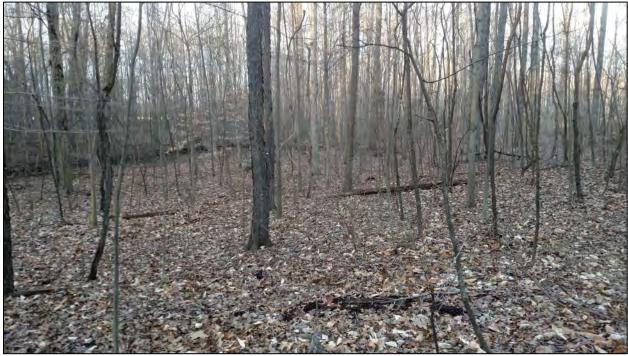
- 27. Looking north along the eastern boundary from a corner on the eastern portion of the Protected Property. A survey pin and flagging tape was found.

27. Looking north along the eastern boundary from a corner on the eastern portion of the Protected Property. A survey pin and flagging tape was found.

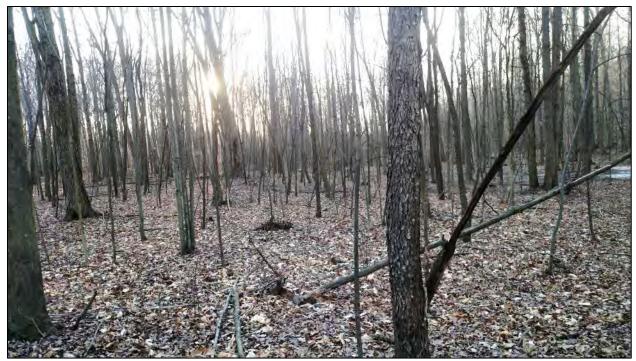
28. Looking southwest along a boundary from a corner on the eastern portion of the Protected Property. A survey pin and flagging tape was found.

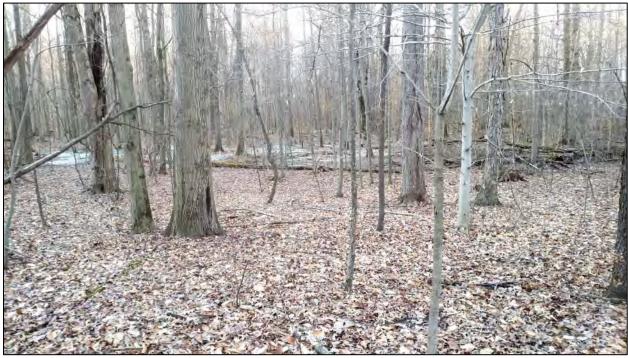
29. Looking northwest at a wet woods and vernal pools from near a corner on the eastern portion of the Protected Property.

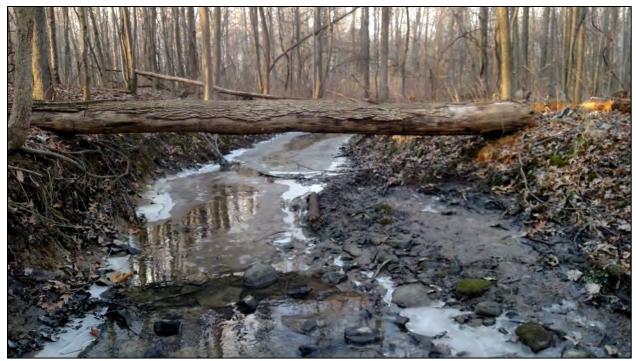
30. Looking north along a south flowing perennial stream from a boundary on the eastern portion of the Protected Property.

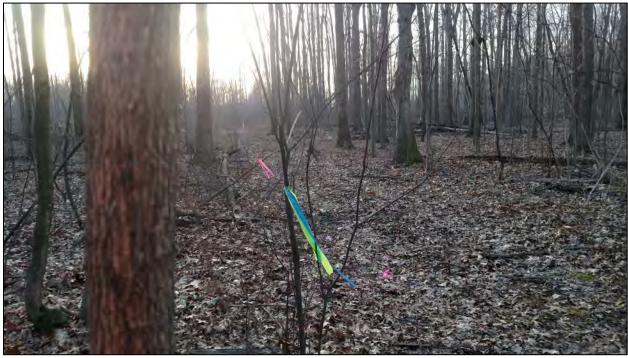
31. Looking west along the southern boundary from a corner on the eastern portion of the Protected Property. A survey pin and flagging tape was found.

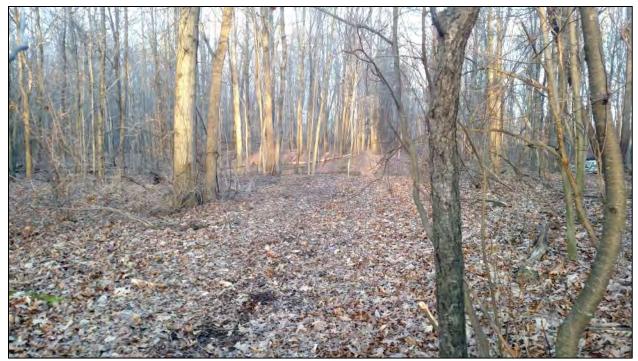
32. Looking northeast along a boundary from a corner on the eastern portion of the Protected Property. A survey pin and flagging tape was found.

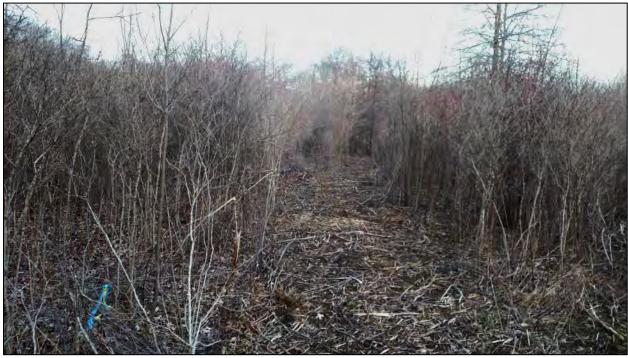
- 35. Looking east along the southern boundary from a corner on the eastern portion of the Protected Property. A survey pin and flagging tape was found.

35. Looking east along the southern boundary from a corner on the eastern portion of the Protected Property. A survey pin and flagging tape was found.

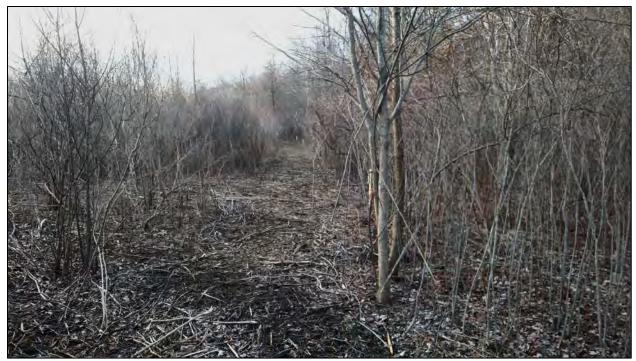
36. Looking northwest along a boundary from a corner on the eastern portion of the Protected Property. A survey pin and flagging tape was found.

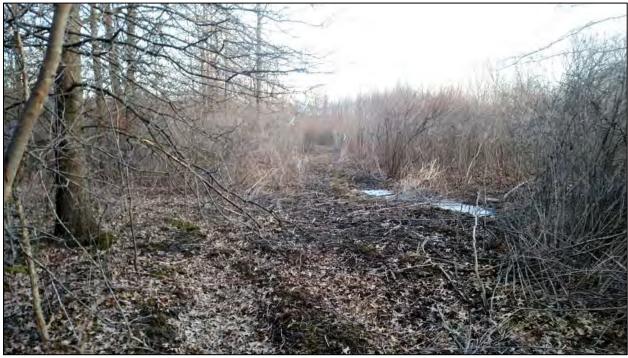
37. Looking southeast along a boundary from a corner on the eastern portion of the Protected Property. A survey pin and flagging tape was found.

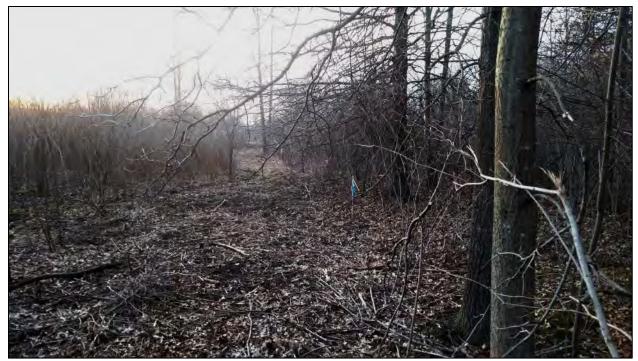
- 38. Looking west along a boundary from a corner on the eastern portion of the Protected Property. A survey pin and flagging tape was found.

38. Looking west along a boundary from a corner on the eastern portion of the Protected Property. A survey pin and flagging tape was found.

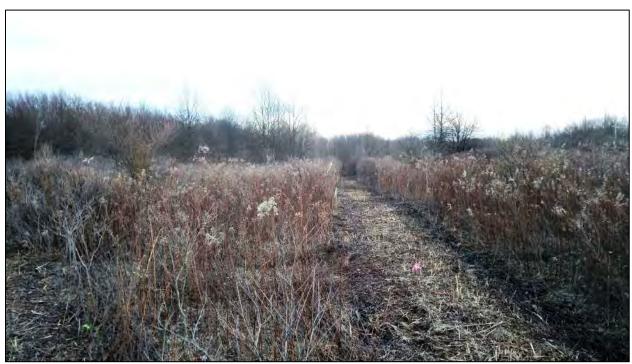
39. Looking east along a boundary from a corner on the eastern portion of the Protected Property. A survey pin and flagging tape was found.

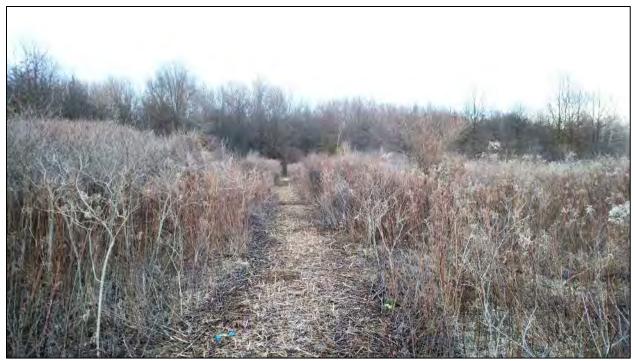
40. Looking northeast along a boundary from near a corner on the eastern portion of the Protected Property. A survey pin and flagging tape was found.

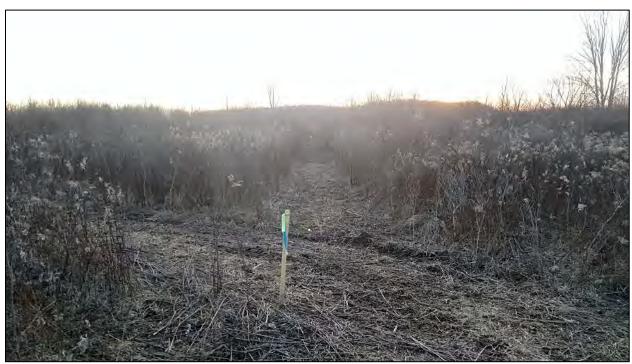
- 41. Looking southwest along a boundary from near a corner on the eastern portion of the Protected Property. A survey pin and flagging tape was found.

41. Looking southwest along a boundary from near a corner on the eastern portion of the Protected Property. A survey pin and flagging tape was found.

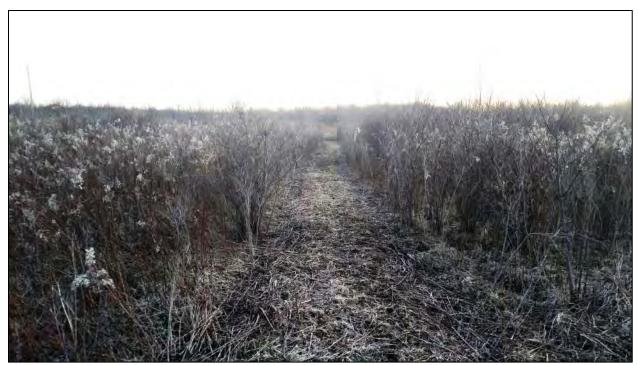
42. Looking south along a boundary from a corner on the eastern portion of the Protected Property. A survey pin and flagging tape was found.

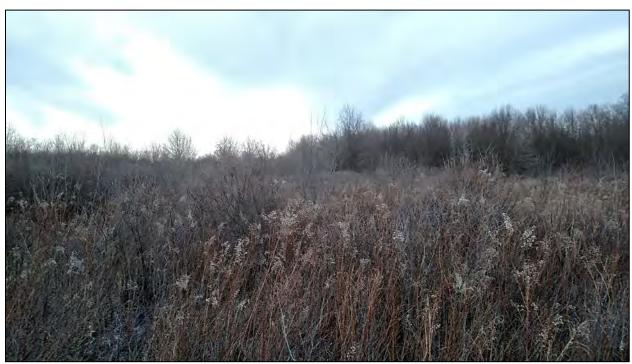
43. Looking north along a boundary from a corner on the eastern portion of the Protected Property. A survey pin and flagging tape was found.

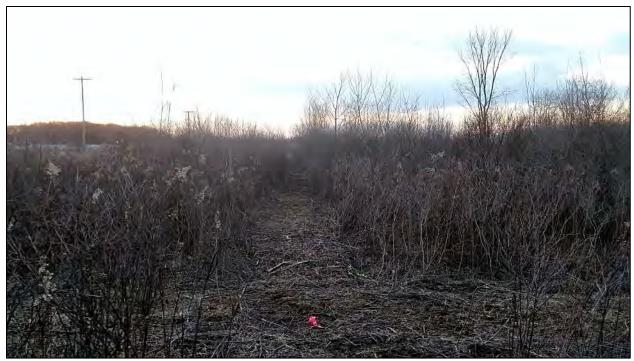
44. Looking west along a boundary from a corner on the eastern portion of the Protected Property. A survey pin and flagging tape was found.

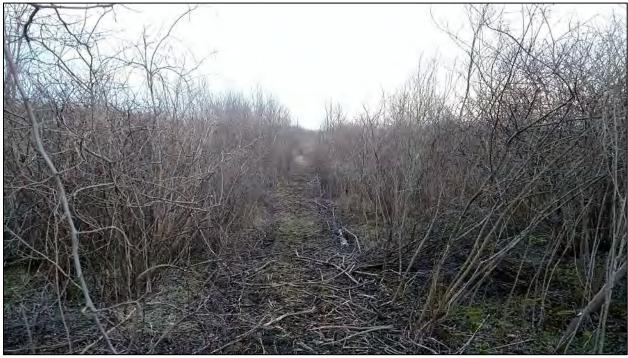
45. Looking east along a boundary from the southwestern corner of the eastern portion of the Protected Property. A survey pin and flagging tape was found.

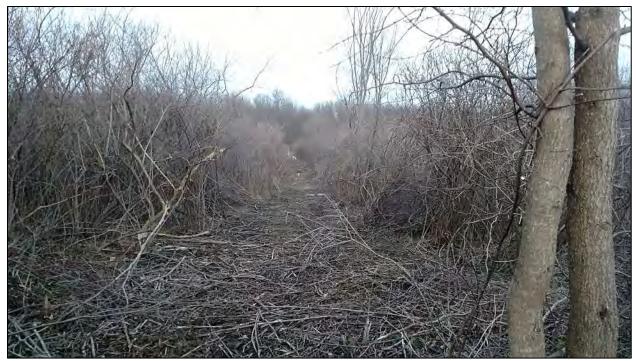
- 46. Looking northeast along the western boundary from the southwestern corner of the eastern portion of the Protected Property. A survey pin and flagging tape was found.

46. Looking northeast along the western boundary from the southwestern corner of the eastern portion of the Protected Property. A survey pin and flagging tape was found.

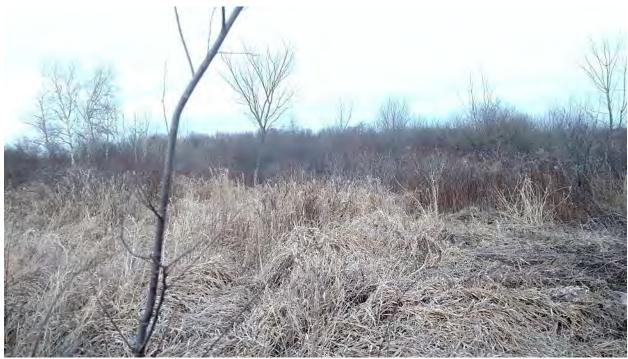
47. Looking northeast along the eastern boundary from a corner on the western portion of the Protected Property. Yellow flagging tape was found.

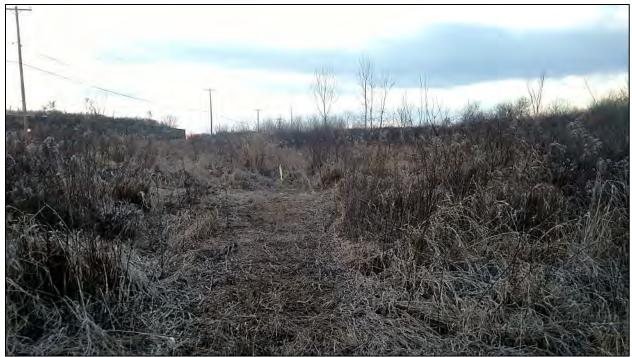
48. Looking west along a boundary from a corner on the western portion of the Protected Property. Yellow flagging tape was found.

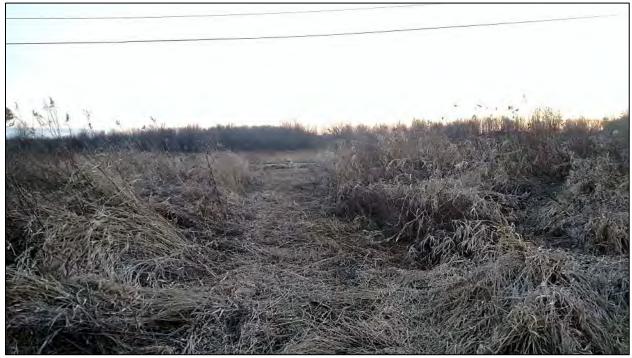
49. Looking south along a boundary from a corner on the western portion of the Protected Property. A survey pin and flagging tape was found.

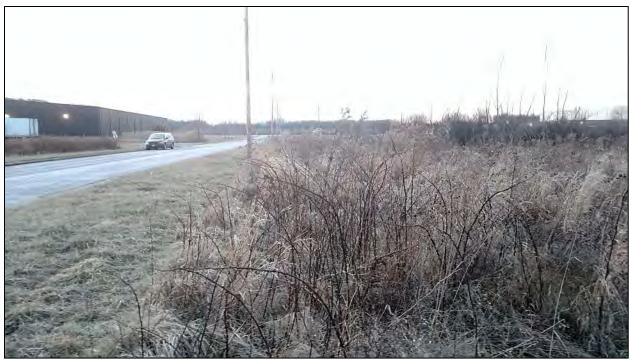
50. Looking west along the southern boundary along Henn Parkway from a corner on the western portion of the Protected Property. A survey pin and flagging tape was found.

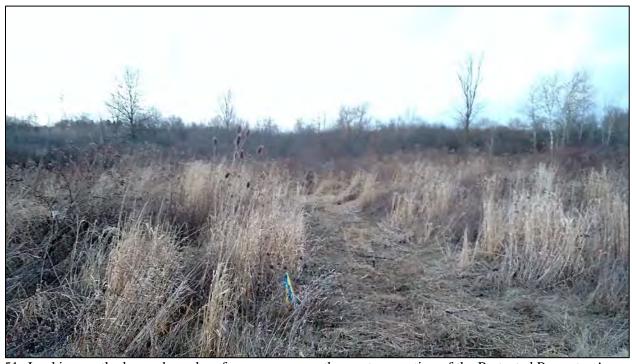
51. Looking north along a boundary from a corner on the western portion of the Protected Property. A survey pin and flagging tape was found.
