Helmet Creek Restoration & Monitoring Work Plan

Adak Petroleum Diesel Spill

April 13, 2013 Final

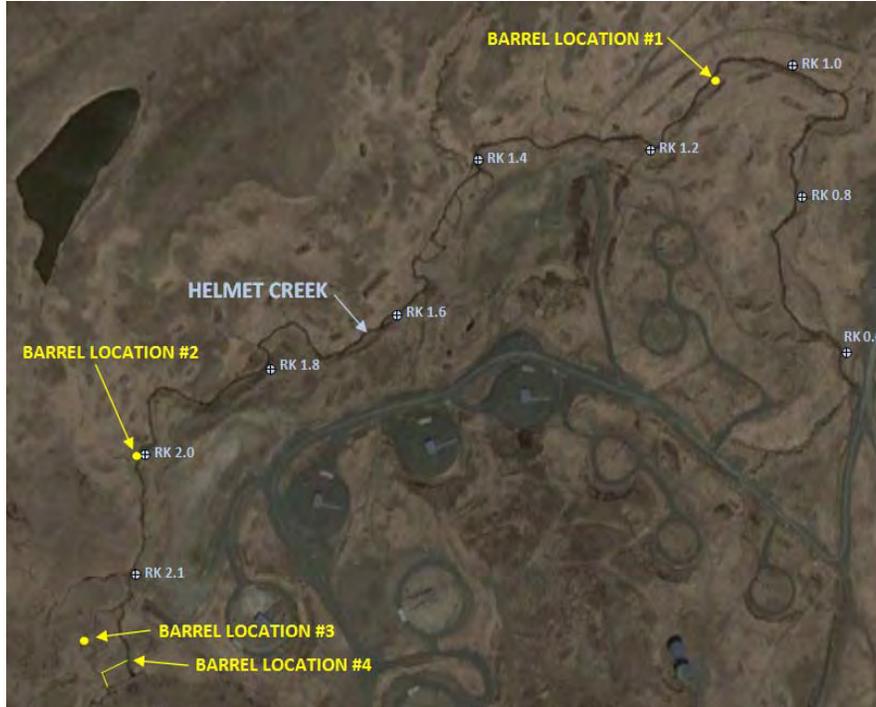
Figure 2: Upper Helmet Creek showing structures

- 1) Barrel Location #1;
- 2) Barrel Location #2; and
- 3) Barrel Locations #3 and #4 (see Figure 2).

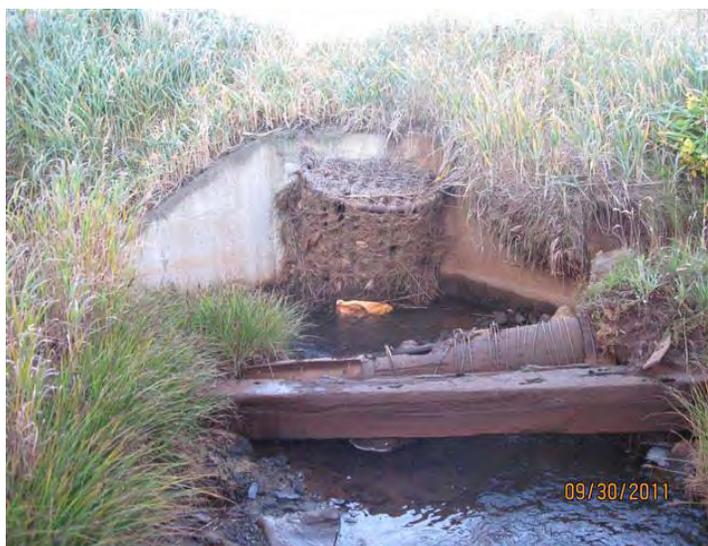
Figure 3: Wood stave pipe and timber

Roughly 15 to 20 pieces of anthropogenic debris (plywood, scrap metal, etc.) were noted in the creek during the various surveys. There is some risk that this material could adversely influence habitat quality or potentially shift and cause future fish passage blockages. Virtually all of the material can be easily removed by hand in a day. A team of two or more people shall walk the channel from the small boat harbor to the spill origin site -- collecting and hauling away all anthropogenic material located within or immediately adjacent to the creek. On future monitoring trips, this exercise will be repeated to remove any future accumulations. A wood stave pipe and timber are located immediately above Culvert #2 (Figure 3). This wood stave pipe and timber may require mechanical effort to cut away the objects close to both banks.

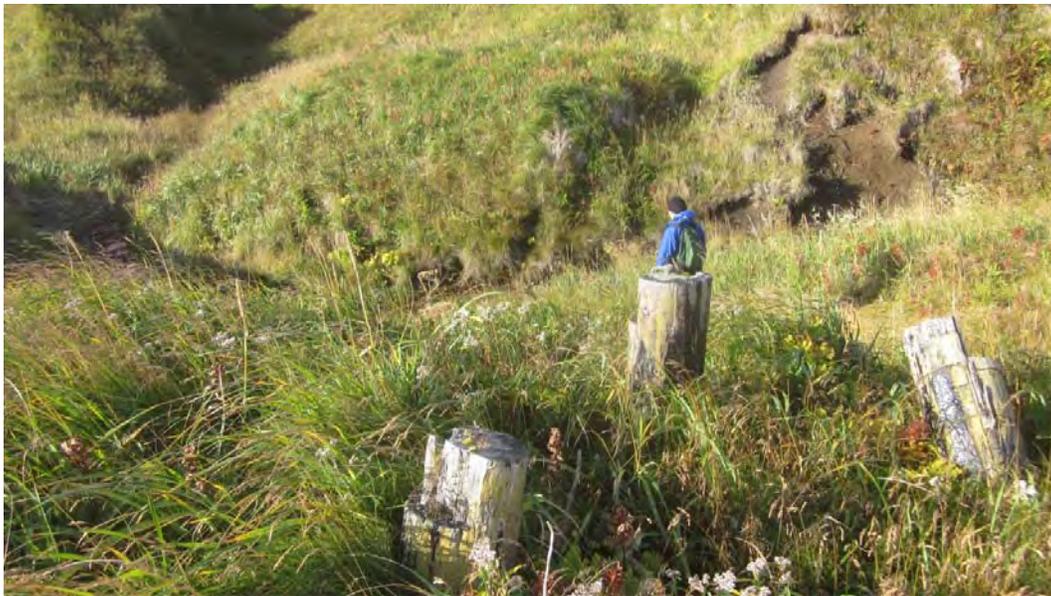
Figure 7: Upper Bank Pilings

Three additional pilings exist on the upper bank near the road. Again, due to close proximity of the road, removal can be conducted with machinery that is road-based. The pilings are above the high-water mark of Helmet Creek, but drainage into the creek would be affected by the creosote coating on the pilings. Piles that cannot be readily removed from the road will be cut off at ground level and the surface capped with clean soil and native seed or vegetation mat, if available (See Figure 7).
