Cullinan Ranch Restoration Project

Monitoring Report: 2015-2017

March 31, 2018

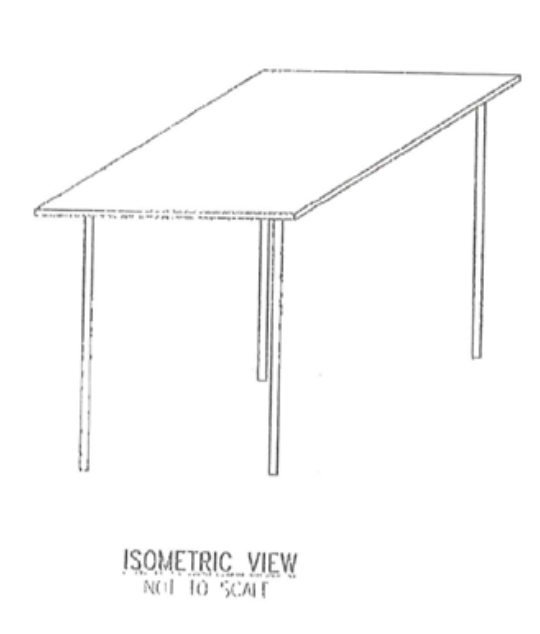
Figure 3. Sedimentation plate design

To measure deposited sediment within the site, plates were installed to serve as a fixed elevation at the onset of restoration to measure sedimentation amounts as the site restores. The 12"x12" stainless steel plate was welded to 4-12" legs and embedded into the ground so that the top plate was flush with the ground surface (Figure 3). Each plate was surveyed in using Trimble RTK GPS to establish horizontal and vertical locations. To facilitate locating the plates in the future, they were marked with 2 T-posts on either side of the plate and can be found by locating the "hard surface" in between the posts.

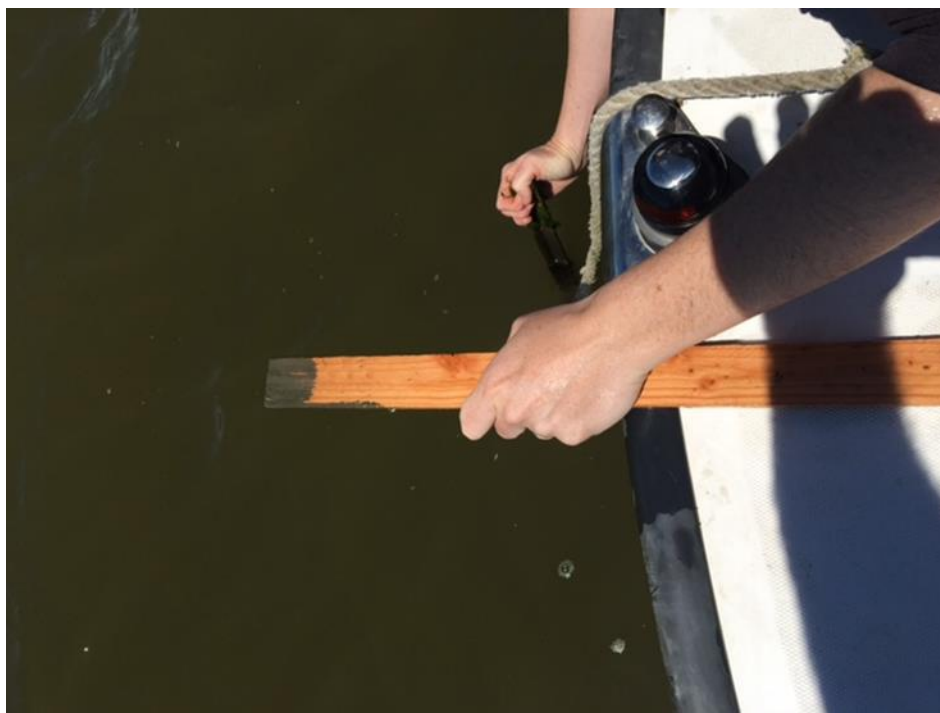
Figure 4. Field method for measuring sediment accumulation on plates

Four plates were installed in May 2015 and surveyed again in May 2017. The actual surface of sediment was difficult to detect because it is several feet below the water's surface and consists of fine, soft sediments. Since sediment was too difficult to measure with GPS, we used a field survey stick method. This method involved lowering a wooden survey stick straight down to reach the surface of the sediment plate, then measuring the length of the sediment residue (Figure 4). Three to four samples were measured in the field at each plate and the average for each plate is reported here. Monitoring data show that 2 years after breaching, some areas within Cullinan have as much as 13 centimeters of sediment accumulation (Table 2). Sediment accumulation varied across the site.
