**River Restoration Plan  
For The  
North Fork Roanoke River Fish kill**

**Prepared by:**

**Blacksburg Country Club**

**December 2011**

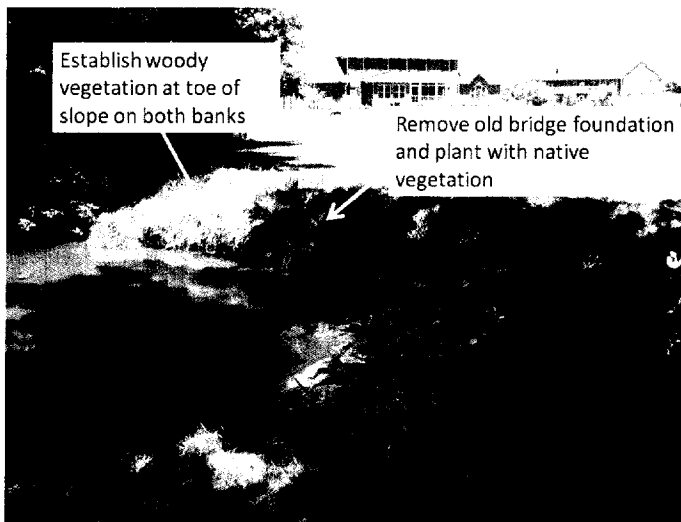
Figure 1. Proposed bank stabilization upstream of Tee #3 bridge.

Approximately 100 ft upstream of the bridge at Tee #3, on the north side of the river, erosion is occurring around an old concrete bridge foundation. The concrete bridge foundation will be removed from the river and the river bank planted with deep-rooted, native herbaceous vegetation. Additionally, small shrubs will be established at the river bank toe between the bridge and the upstream edge of the golf course property boundary (Figure 1). Just downstream of the #3 Tee bridge, extensive bank retreat is occurring along the southern bank due to flow expansion and turbulence around several large trees just downstream of the bridge, as well as tile drainage from the golf course (Figure 2). The section is predominantly a long pool before entering a compound bend where bedrock control occurs. A single arm rock vane will be constructed just downstream of the bridge to redirect flow away from the south bank toward the center of the channel. The design and construction of the rock vane will follow specifications found in "The Virginia Stream Restoration and Stabilization Best Management Practices Guide" 2004 (BMP Guide),

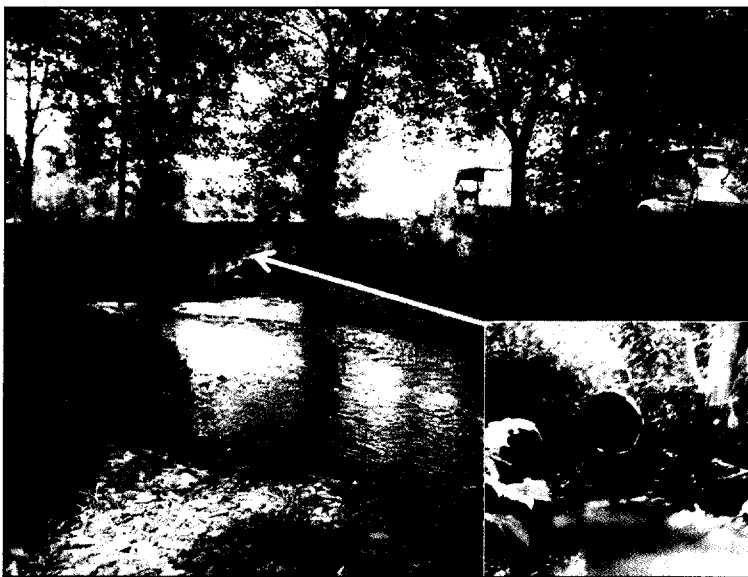
Figure 3. Corrugated plastic pipe storm drain outlet.

A corrugated plastic pipe discharges storm water runoff into the river on the north bank approximately 250 ft downstream of the #3 Tee bridge (Figure 3). Discharge from this culvert has created a scour pool with a gravel outlet. To minimize future erosion, the scour pool and outlet channel will be lined with riprap, underlain by filter fabric. Pool depth and the outlet channel invert will be maintained at the existing elevations to maintain the energy dissipation provided by the existing pool.

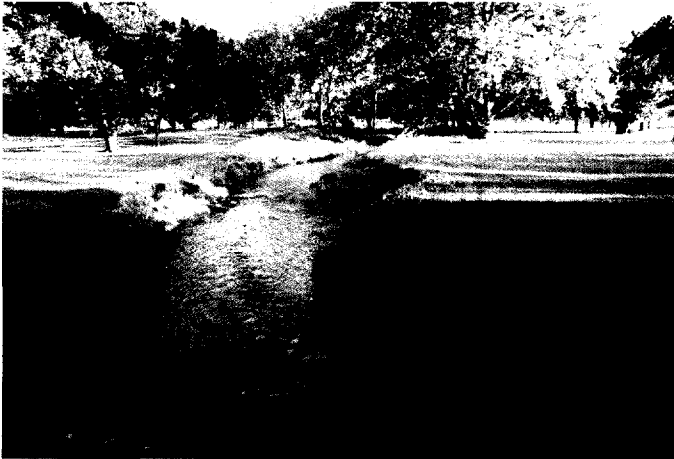
Figure 4. Proposed bank stabilization downstream of #2 bridge.

Restoration Project 2 runs along the surveyed reach from 1,040 ft to 1,893 ft; at the start of the reach a compound bend exists that is bedrock controlled. The first bend is stable due to sycamores along the bank and the bedrock control. The second meander downstream of the bridge at Fairway #2 is actively eroding and will be re-graded and planted with deep-rooted herbaceous perennials and low woody plants that can be sheared several times per year. The meander bend will be graded to a 3:1 slope on the outside and a 7:1 slope on the inside of the meander bend. Areas not in play will be planted with native trees.

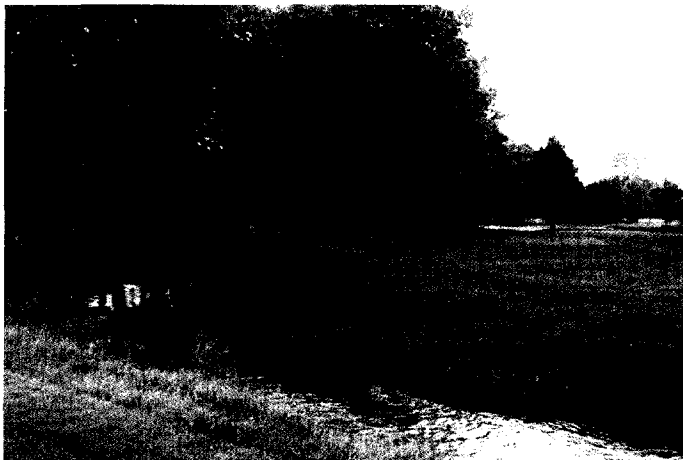
Figure 6. Riverbank by #13 green and #12 Tees

Below cross-section 21+51 (see Appendix A, Run Cross-Section 21+51), a 176-ft long stretch of river bank on the eastern bank (#13 green) will be re-graded to a 7:1 slope, where not currently vegetated with woody species, and planted with woody riparian vegetation. The costs for this portion of Restoration Project 3 are given in Table 8.

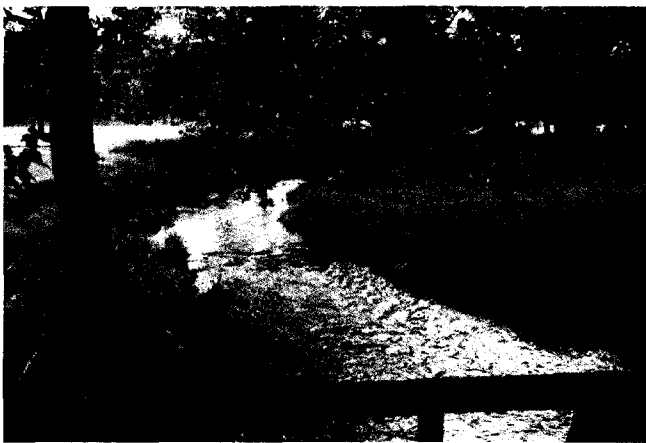
Figure 7. Riverbank curvature in front of #12 Tee

on the outside of the meander bend will be cut back to a 3:1 slope and planted with native woody vegetation. Where woody vegetation will interfere with the play of golf, deep-rooted herbaceous material will be used.

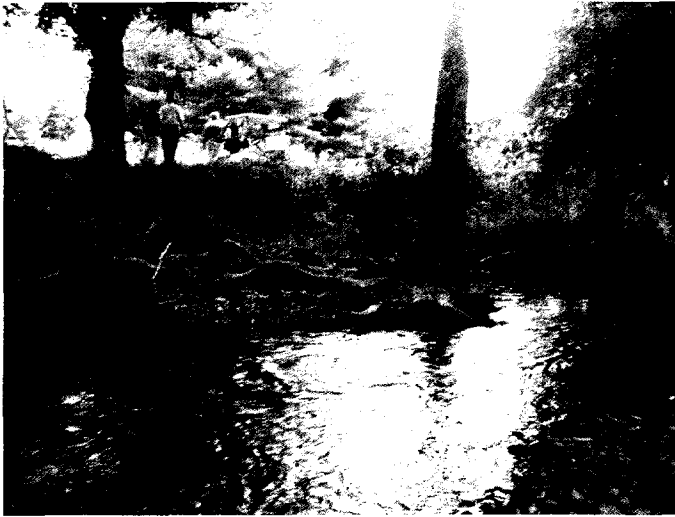
Figure 9. Sycamore to be removed near #12 tee box.

Additional erosion is occurring near the #12 tee due to a large sycamore tree protruding into the river (Figure 4). This tree will be removed and used to reinforce the river bank. As many roots as possible will be cut and the tree pulled down at a 30 degree angle to the river bank. The root wad will face upstream and will be pulled toward the scoured zone behind the tree which now contains a pool. The tree will be topped and a minimum of 15 ft of tree bole will be buried in the river bank. The area between the root wad and the bank will be filled in and planted with woody vegetation. The toe of the slope that is filled will be reinforced with coir fiber logs.

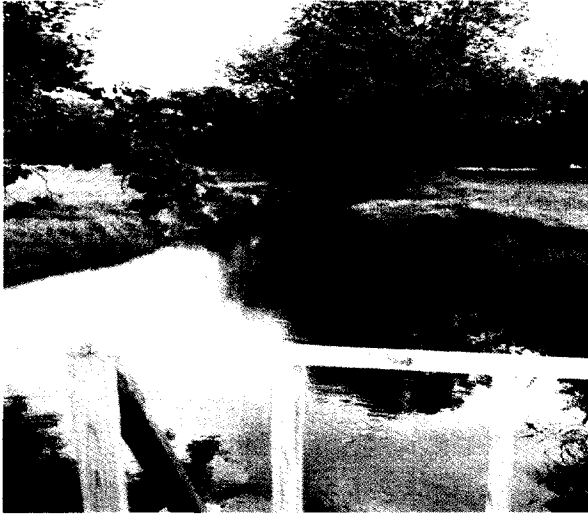
Figure 10. Downstream of #12 Second Bridge

Downstream of the second bridge at #12 hole, additional bank erosion is occurring due to flow expansion following the bridge. At this site, the river banks on both sides of the river will be graded to a 3:1 slope and planted with woody vegetation where practical. During grading, the channel will be narrowed from the bridge opening to the downstream riffle, providing a smooth bank transition from the bridge to the riffle to minimize the occurrence of eddies during high flows. In this transition area the bank toes will be protected using large boulders.
