**Preassessment Screen and
Determination: Rio Algom Mines
and Quivira Mill Site,
McKinley County, New Mexico**

New Mexico Office of Natural Resources Trustee
Albuquerque, New Mexico

September 2010

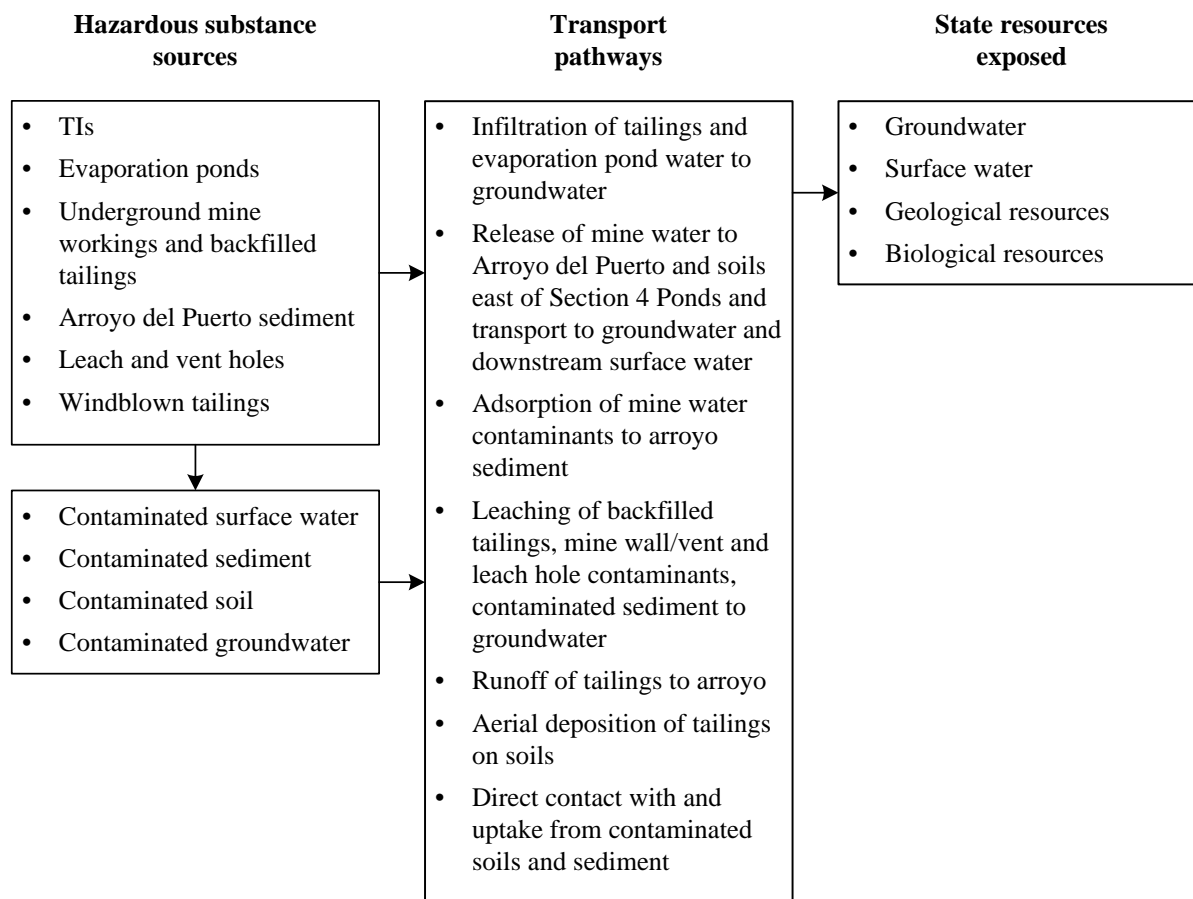
Figure 3.1. Preliminary identification of pathways by which State resources may be exposed to hazardous substances from the Site.

As described in Chapter 2, actual or potential source areas of hazardous substances at the Site include mine and mill process liquids, the TIs, evaporation ponds, soils in the mill area, discharged mine water, areas with windblown tailings, Arroyo del Puerto, vent and leach holes, and the underground workings. Hazardous substances deposited on soils or arroyo sediment also can serve as sources when the hazardous substances are mobilized and re-released. Hazardous substances released from sources may be transported to State natural resources by direct contact, surface water and sediments, groundwater, aerial transport, soil, and food chain pathways (Figure 3.1). Pathways of hazardous substance transport at the Site are described briefly in the sections below.

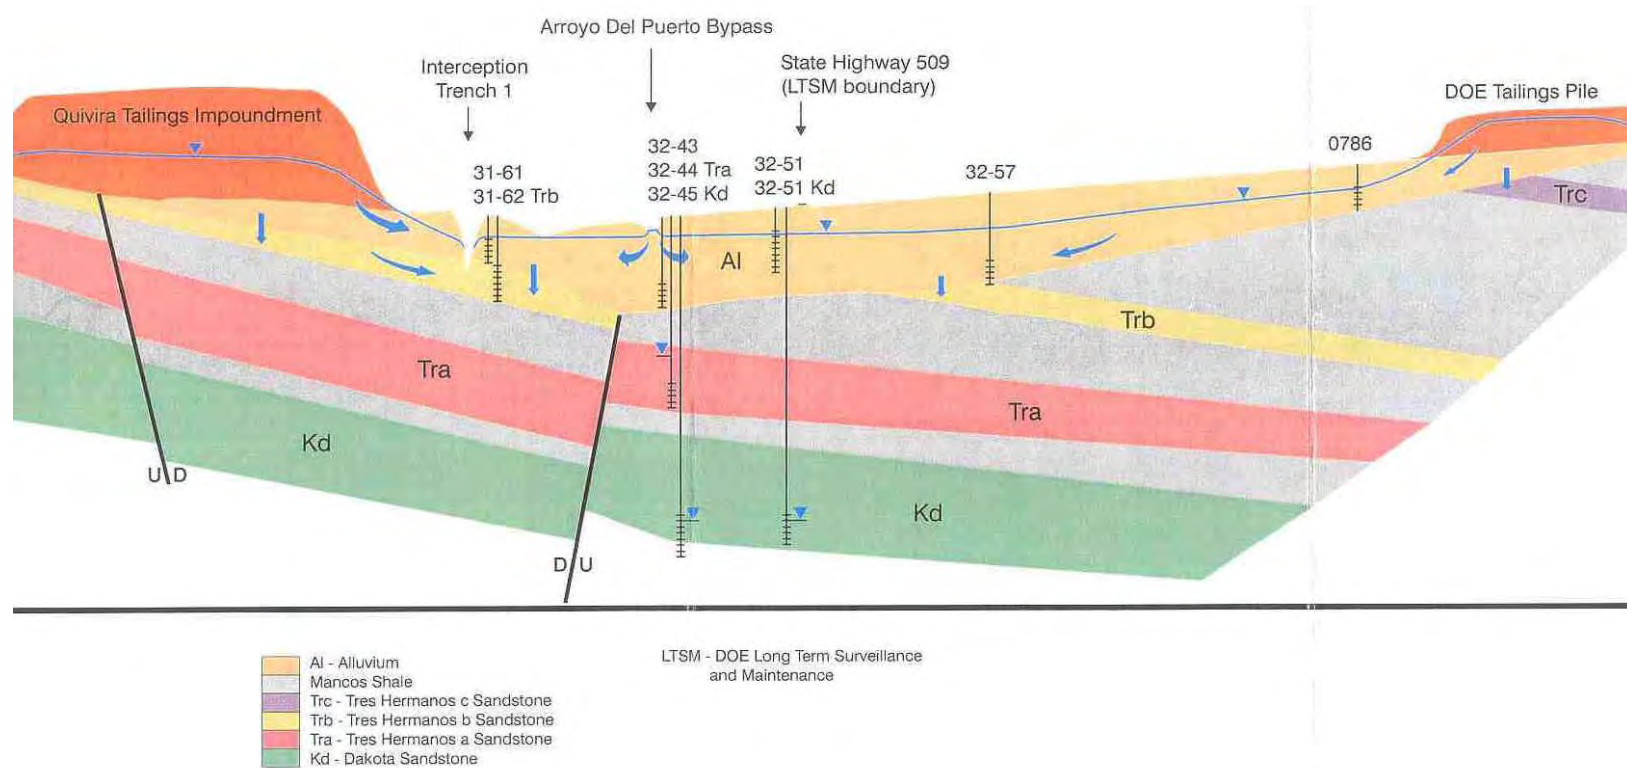
Figure 3.2. Geologic cross-section at the Site.

The major geologic units at the site are Quaternary alluvium in the Arroyo del Puerto streambed (Figure 3.2) and sedimentary formations of Cretaceous and Jurassic age. The Quaternary alluvium is characterized by tan to gray silts, sands, gravels, and some sandstone cobbles and boulders. The alluvium ranges in thickness from a thin layer to over 100 ft (Purtyman et al., 1977). In order of increasing depth from the surface, the sedimentary units are Mancos shale, Tres Hermanos sandstone (C, B, and A units), Dakota sandstone, all of Cretaceous age (Figure 3.2), and the three Morrison Formation units of Jurassic age: Brushy Basin, Westwater Canyon, and Recapture (Figure 3.3). The Westwater Canyon member of the Morrison Formation is the ore-bearing unit and is characterized by fine- to coarse-grained, poorly sorted, cross-bedded sandstone with local conglomerate and chert lenses. The Westwater Canyon unit contains extensive deposits of uranium and vanadium ore and is also the principal aquifer in the region (Purtyman et al., 1977; Kelly et al., 1980).

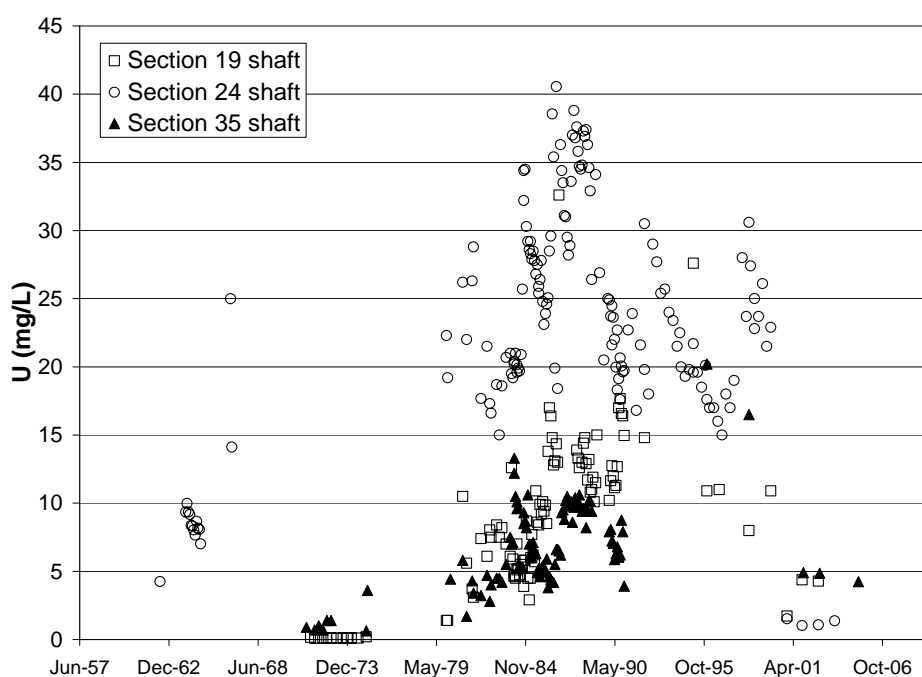
Figure 3.4. Uranium concentrations in Sections 19, 24, and 35 mine shafts from the early 1960s to 2005. The federal and State drinking water standard for uranium is 0.03 mg/L; the State standard was 5 mg/L prior to June 1, 2007 (NMED, 2007a).

The results in Table 3.2 show the presence of hazardous substances¹ in deep groundwater at the Site. Figure 3.4 shows concentrations of uranium in groundwater increasing over the course of mining. Concentrations generally peaked in the mid-1980s, possibly associated with the use of old stope mining methods. Concentrations of sulfate, radium, and selenium in deep groundwater also increased after mining began (NMED, 2007b).

Existing data suggest that contaminants in bedrock groundwater collected from mine shafts are the result of releases from mining operations. Uranium concentrations over time show a pattern of increasing concentrations after mining commenced, maximum concentrations after old-stope leaching began in the mid-1980s, and decreasing concentrations after old stope leaching stopped in 2000 (see Figure 3.3).
