Enbridge Natural Resource Damage Assessment – Fort Custer State Recreation Area Oak Savanna Enhancement

Final Project Report October 8, 2021

Greg Norwood, Ecologist Michigan Department of Natural Resources Parks and Recreation Division Stewardship Unit

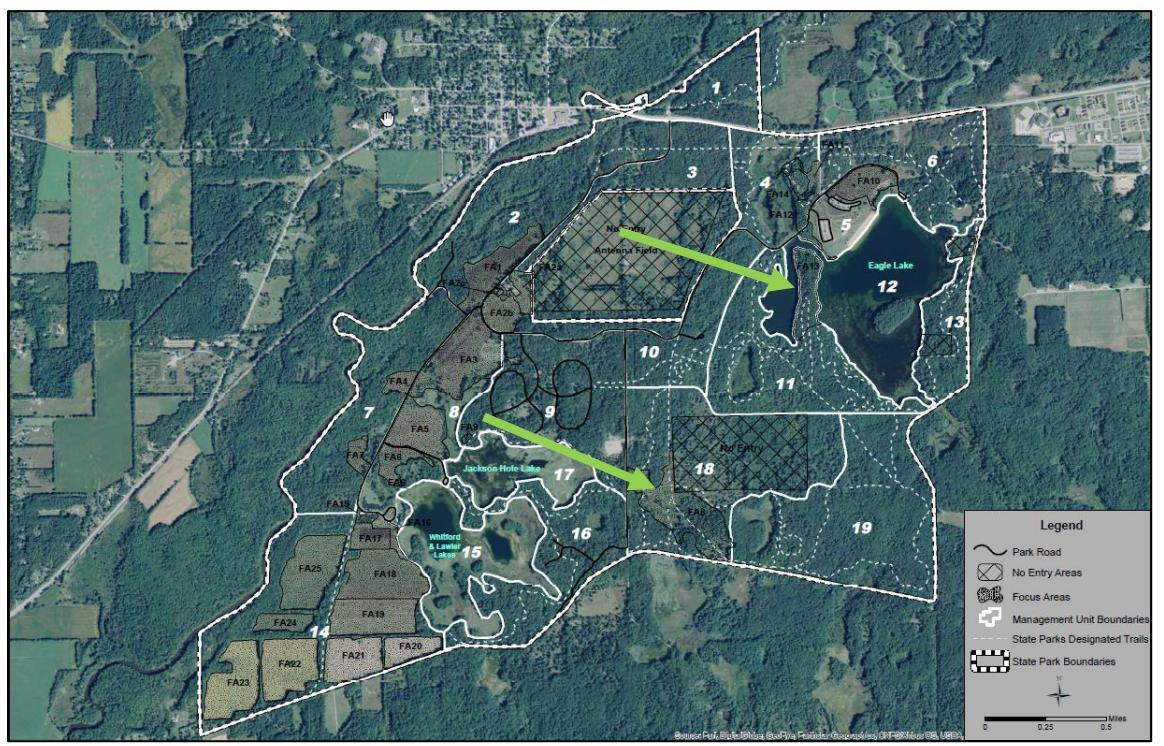
Figure 1. Fort Custer Recreation Area. The land clearing of both native and non-native shrubs occurred in priority areas of Management Units 18 and 11. Intensive work occurred within Focus Areas 8 and 13 (green arrows) within those two management units totaling 67 acres of restoration.

The 67 acres included the following actions.

- 67 acres of invasive species control work.
- 25.4 acres land clearing (machine work)
- 41.6 acres of invasive tree and shrub herbicide treatments (hand work)

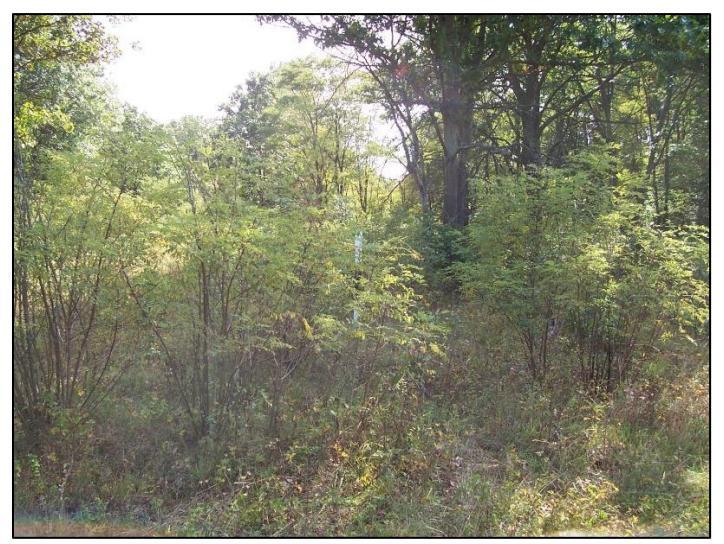
Figure 2A. 2009 Fort Custer photopoint 18A prior to clearing. Locust is abundant and lacks oak "grubs" and characteristic wildflowers.

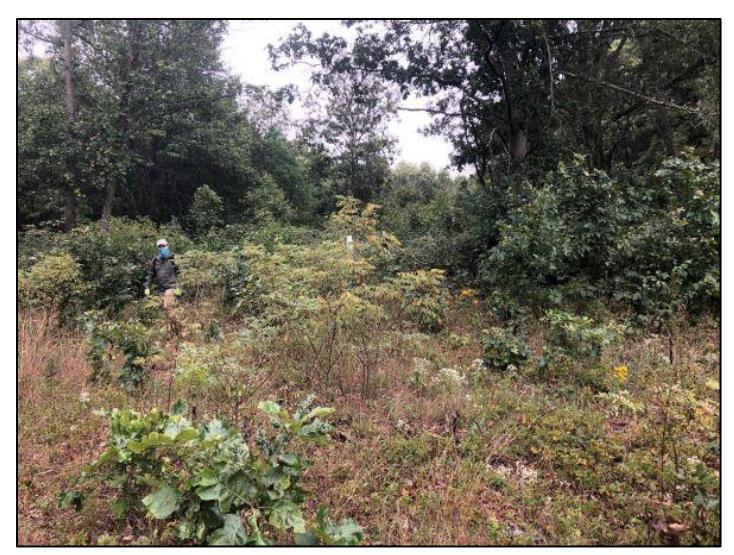
Figure 2B. 2020 Fort Custer photopoint 18A after clearing. Locust is negligible with abundant oak "grubs" and characteristic wildflowers.

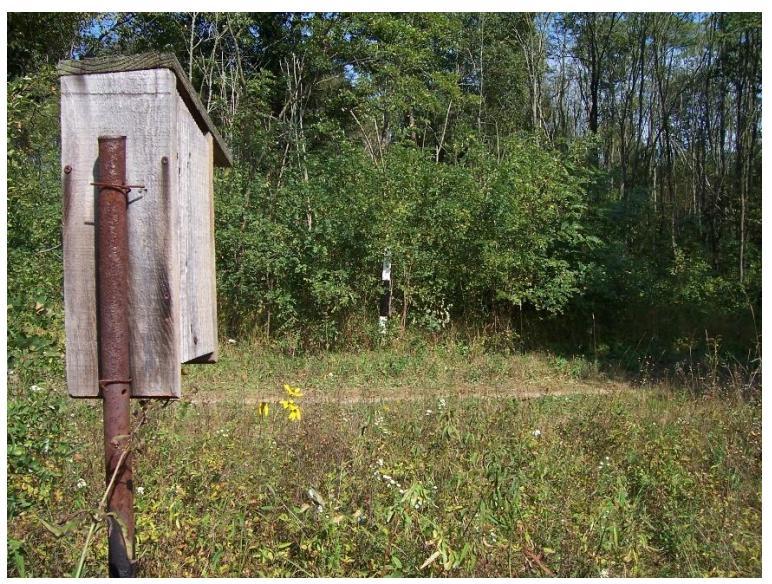
Figure 3A. 2009 Fort Custer photopoint 18C prior to clearing. The area is a forest.

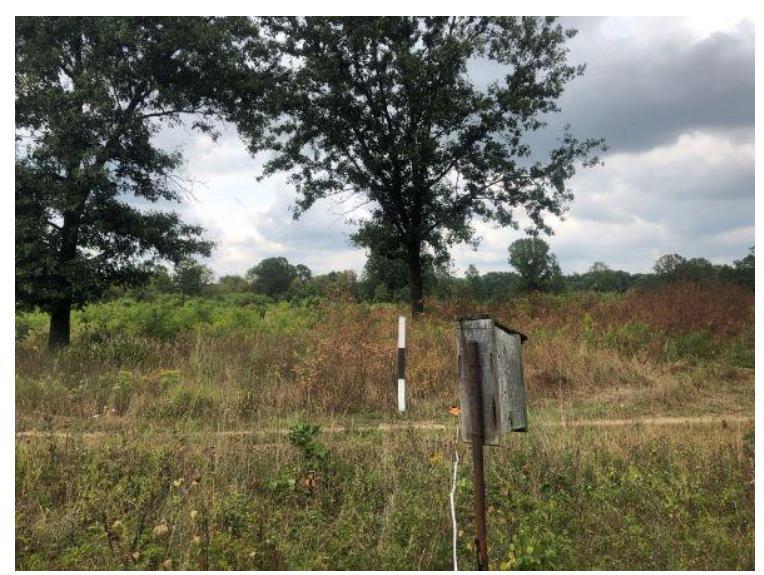
Figure 3B. 2020 Fort Custer photopoint 18C after clearing. The area is open and developing characteristic structure and oak savanna species.
