Ecological Performance Evaluation Report

Alcoa Constructed Oyster Reef in Lavaca Bay

Ecological Performance Evaluation Report
 Alcoa Constructed Oyster Reef in Lavaca Bay
 September 20, 2005

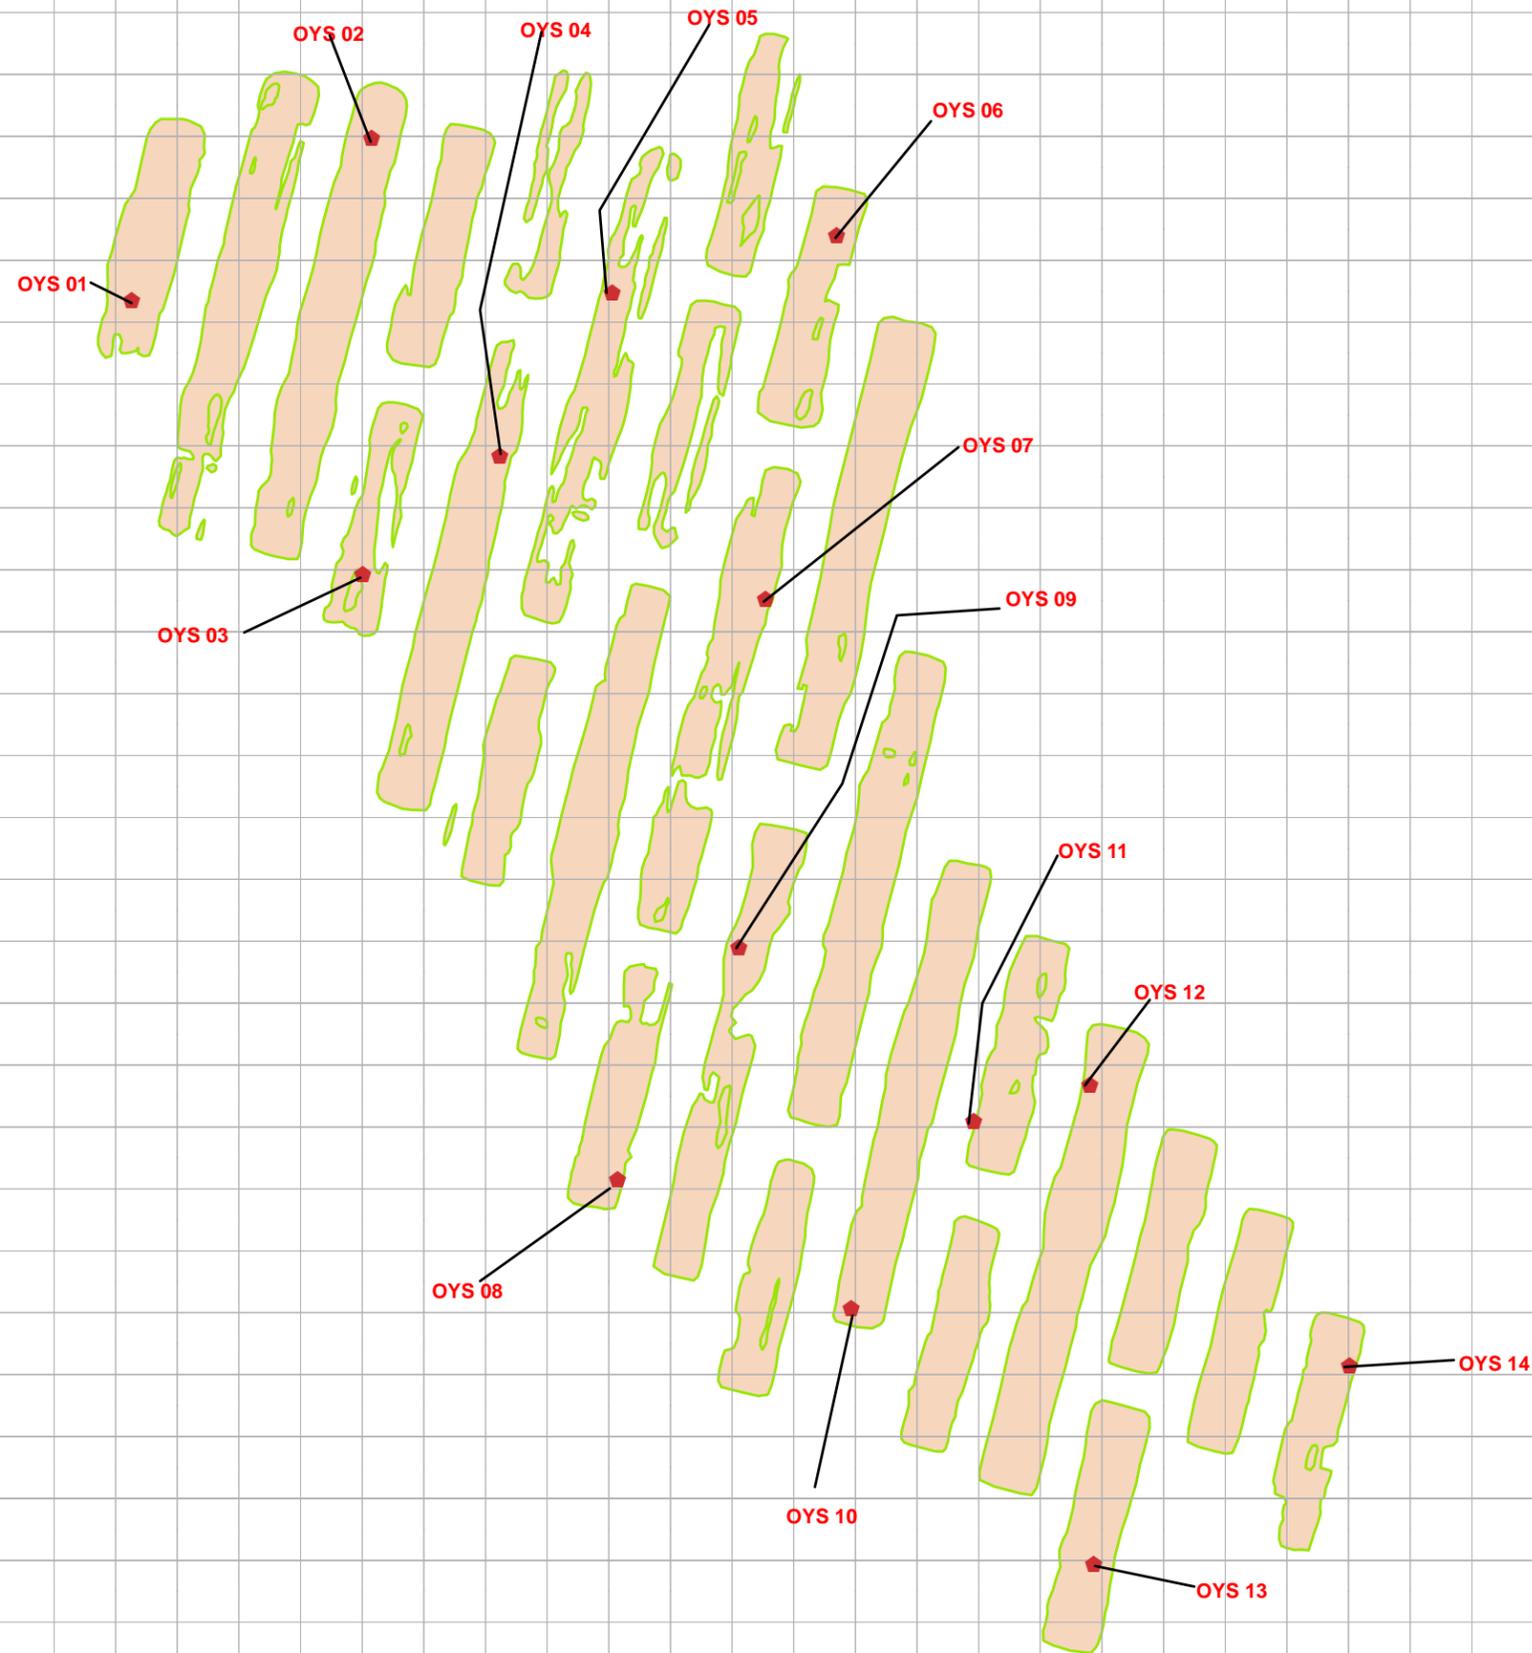
Reef construction was initiated on 13 April 2005 and was completed on 2 May 2005 (20 work days). The reef is composed of 27 parallel segments separated by 50 ft wide (approximate) gaps of open bay bottom. Reef construction progressed from the southeast end to the northwest end (Figure 1).

A 20 meter grid was established over a map of the constructed reef segments. Sample stations were established at gridline intersections that fell on portions of reef segments that were selected for evaluation. Ten perimeter stations and four interior stations were sampled. Sample stations are shown in Figure 1 and station coordinates are listed in Table 1.

Oyster Reef
Monitoring Stations

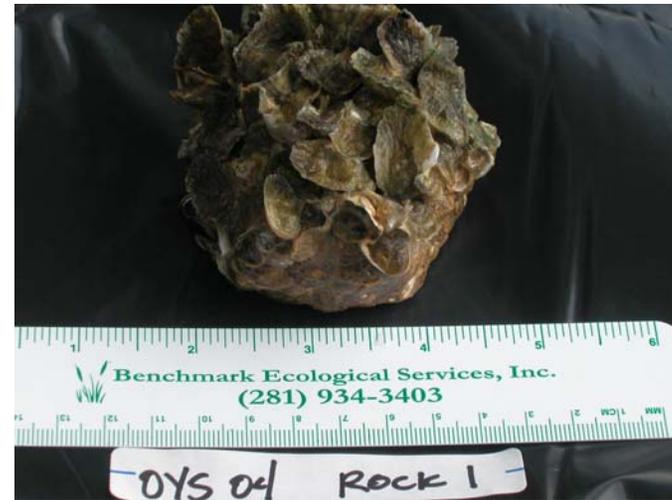
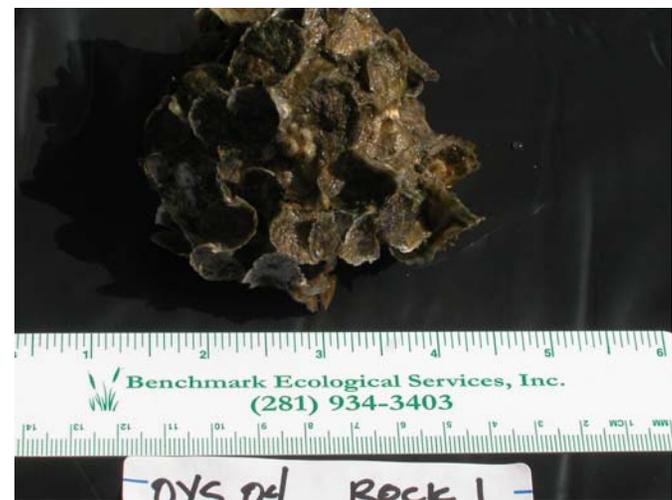
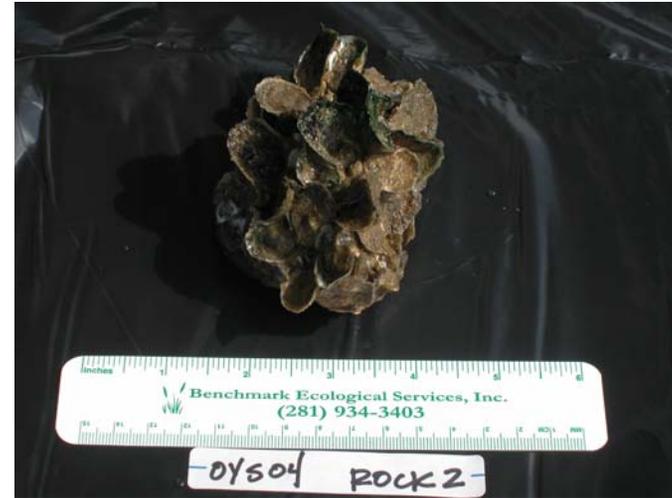
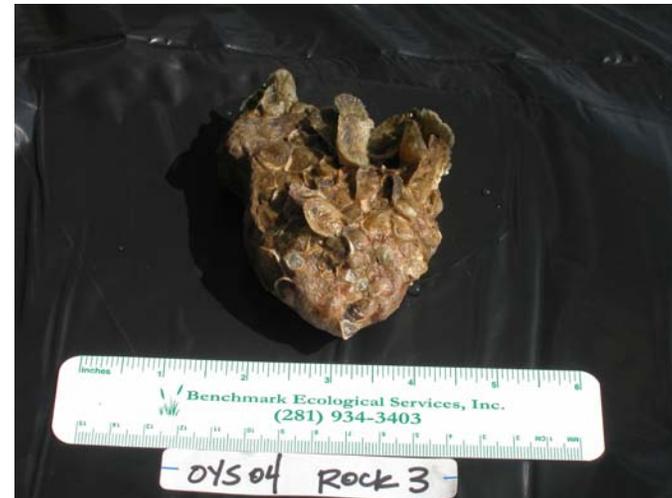
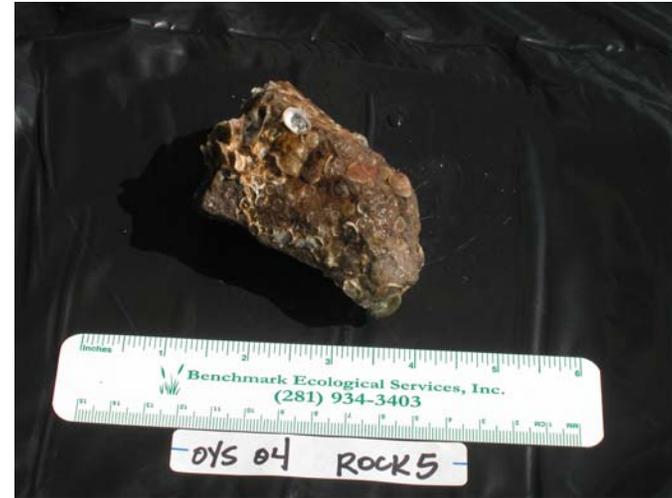
Alcoa Oyster Reef Ecological Monitoring Study
Station OYS 04 Photos

Total Number of Oysters and Oyster Spat 48
 Percent Cover of Oyster and Oyster Spat 25-50
 (0-25%) (25-50%) (50-75%) (75-100%)
Area not covered on reef.
