**RESTORATION ACTIONS WITHIN THE
SAN LUIS OBISPO CREEK WATERSHED**

UNOCAL OIL SPILL, AVILA BEACH, 1992

June 1999

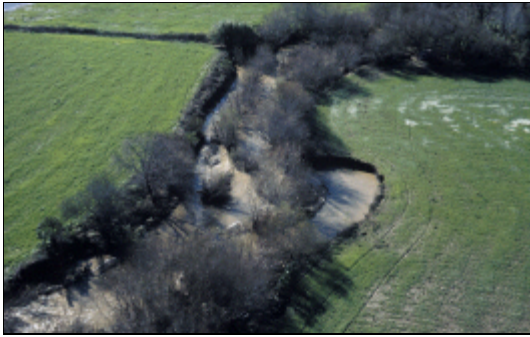
Site SL-3-1R

Figure 3. Photograph of Project Site SL-3-1R.

Problems: Bank failure at this site is the result of past vegetation removal that has left an insufficient vegetation buffer. While some willow is colonizing the site, the single layer of vegetation is insufficient to withstand high winter flows. Much of the erosion is caused by return flow of water during frequent

floods. Secondary deficiencies on this site include the absence of overhead canopy and lack of a vegetative filter strip to catch sediment from overland run-off. This site would benefit from additional vegetation to help cool water temperatures and act as an enhanced vegetative filter strip.

Project	Project Type	Description of Problem
Lower DeVincenzo (SL-2-1R) Cont.	Riparian Corridor Revegetation	this is a somewhat experimental approach, results would be monitored to evaluate the effectiveness of these methods.
Kruse (SL-3-1R)	Riparian Corridor Revegetation	Problems include bank failure due to past vegetation removal and to water diversion resulting from vegetated mid-channel gravel bars. A secondary problem is the absence of an overhead canopy. The project concept is to stabilize the banks with larger trees and willow material and to remove willows from within the channel.
Upper DeVincenzo (SL-4-1R)		Sections of this reach have been artificially straightened and protected with riprap, that has lead to channel incision, bank erosion, and degradation of riparian vegetation. Project concept calls for a one-acre corridor planted with large canopy trees and minimal grading.
Bunnel/Rothman (SL-5-1R)	Riparian Corridor Revegetation	This section of the creek is experiencing willow encroachment that aggravates localized flooding and erosion and contributed to the collapse of the Highway 101 bridge during the 1955 floods. Project concept may involve moving mid-channel willows against the banks where they can contribute to bank stability.

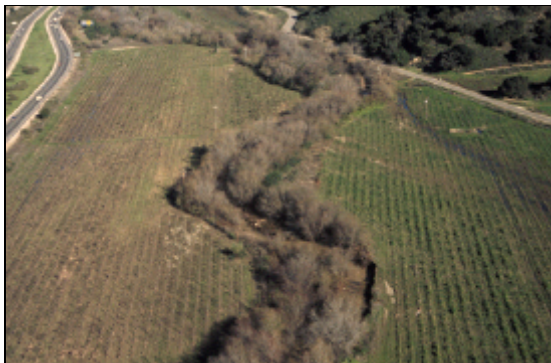
Site SL-4-1R

Figure 4. Photograph of Project Site SL-4-1R.

Problems: Sections of this reach have been artificially straightened and protected with concrete riprap that has led to channel incision, bank erosion, and degradation of riparian vegetation. These factors contribute to sedimentation of fish habitats. Frequent flooding also contributes sediment as the water returns to the creek. Much of

this site is in stable condition however and enhancing the vegetation diversity while repairing the damaged areas would be a positive step toward establishing a long reach of high quality fish and wildlife habitat.

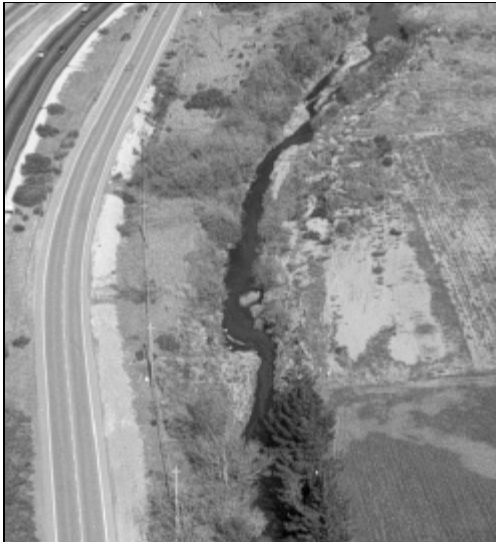
Site SL-6-1R

Figure 5. Photograph of Project Site SL-6-1R.

Problems: This site exhibits several problems that are common in the San Luis Obispo Creek watershed. Riparian vegetation on this site is highly degraded, leaving banks vulnerable to erosion. Fine sediment from eroding banks settles downstream and contributes to degradation of fish spawning gravels. Degraded riparian vegetation also decreases the in-stream cover that provides fish with safe havens and velocity breaks. In addition, exposed oil pipelines divert water into banks and pose a potential for oil spills. The “San Luis Obispo Creek Steelhead Trout Inventory and

Exposed oil pipelines at this site represent a significant threat to the riparian corridor as they are occasionally active and are subject to washout during high water flows. Exposed pipelines should be re-buried or otherwise removed from the active channel as part of this project. The current pipeline owner (Tosco) has expressed interest in a cooperative project on this site. The LCSLOC is working with Tosco to solve the problem. Tosco would be responsible for costs related to the pipe re-burial or removal and repair of the immediate construction area. Trustee Council funds would be expended for areas immediately upstream and downstream of the pipeline location. The Trustee Council will not spend restoration funds to reposition oil pipelines as part of the proposed project.

Filliponi/Maino (SL-6-1R)		Problems include degraded riparian vegetation, eroded banks, and high water temperatures from wastewater effluent. Project concept calls for bank revegetation on the inside of bend of the stream. Some structural work and gradient control structures as well as the development of habitat structures are considered.
Upper Hayashi	Riparian Corridor	Problems include degraded riparian vegetation, bank failure, erosion and

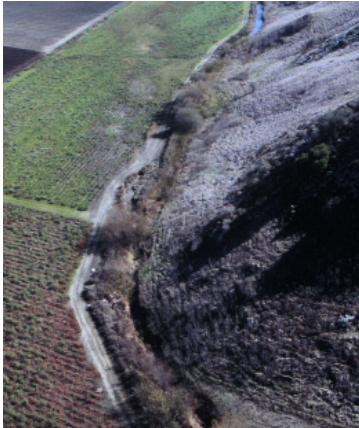
Site EF-1-1R

Figure 7. Photograph of project site EF-1-1R.

Problems: Problems on this site include degraded riparian vegetation and alteration of the natural creek channel. The result is an extremely unstable bank and stream channel that regularly causes severe erosion and sedimentation of San Luis Obispo Creek.

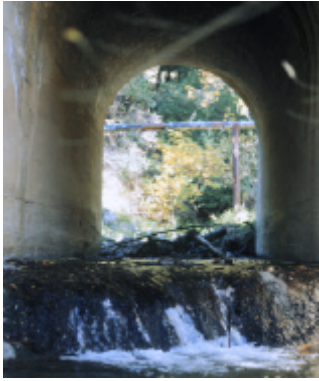
Site SL-16-1B, San Luis Obispo Creek at Stagecoach Road

Figure 9. Photograph of San Luis Obispo Creek, Fish Barrier SL-16-1B.

Problem: This is a large concrete culvert that has a drop of approximately 2 feet at the downstream end, creating a velocity barrier at high flows and a sheeting depth barrier at low flow.

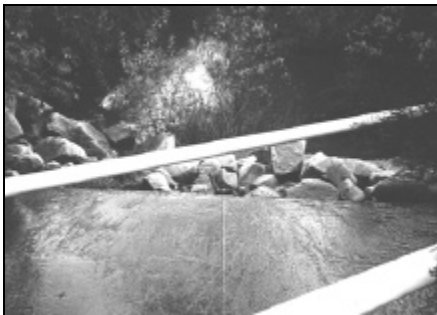
Site PR-1-1B, Prefumo Creek at Highway 101

Figure 10. Photograph of Prefumo Creek, Fish Barrier PR-1-1B.

Problem: This culvert has a drop of approximately 3 to 4 feet at its outlet and poses an elevation barrier during high flows and a shallow water depth barrier during low flows. In addition, low flows travel under the riprap apron. This barrier inhibits fish access from San Luis Obispo Creek to the entire

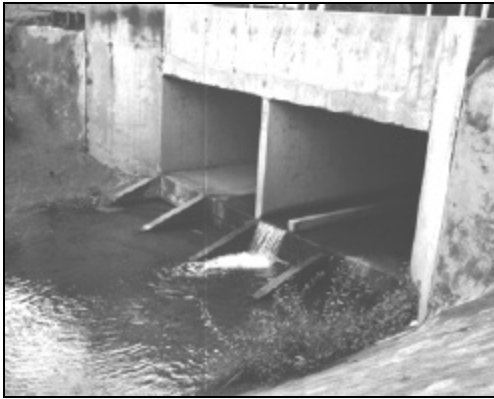
Site PR-1-2B, Prefumo Creek at Calle Joaquin

Figure 11. Photograph of Prefumo Creek, Fish Barrier PR-1-2B.

Problem: This barrier is a concrete box culvert that has a low flow channel constructed on the bottom through the use of concrete curbs. The culvert has a drop of approximately 3 to 4 feet at its outlet and poses an elevation barrier during high flows and a shallow water depth barrier during low flows.

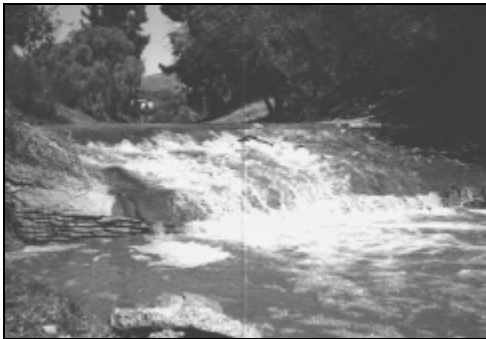
PR-1-3B, Prefumo Creek Agricultural and Sewer Line Crossing

Figure 12. Photograph of Prefumo Creek, Fish Barrier PR-1-3B.

Problem: A 5-foot high grouted rock dam constructed to protect a sewer line poses an elevation barrier to fish passage. Fifty feet downstream is an armored section of the stream bed used as an agricultural equipment crossing.

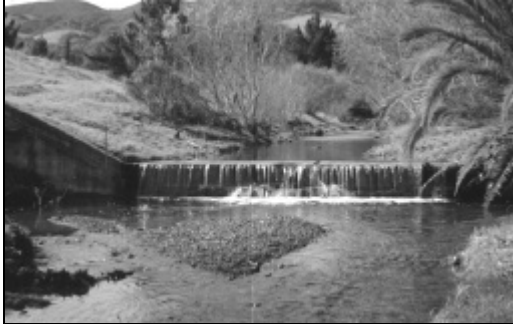
Site PR-2-1B, Prefumo Creek Golf Course Dams

Figure 13. Photograph of Prefumo Creek, Fish Barrier PR-2-1B

Problem: Two small check dams create a change in grade of approximately 3-feet each. These structures impede the upstream passage of adult salmonids under low flow conditions and juveniles under all flow conditions.

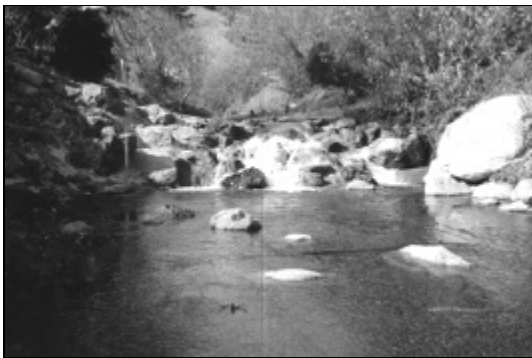
Site PR-2-2B, Prefumo Creek Riprap Barrier

Figure14. Photograph of Prefumo Creek, Fish Barrier PR-2-2B.

Problem: This is a grouted riprap dam approximately 5-feet in height and 40-feet wide. This structure is a migration barrier for adult and juvenile salmonids under all flow conditions and is the uppermost obstacle preventing fish migration to an extended range of upstream habitat.

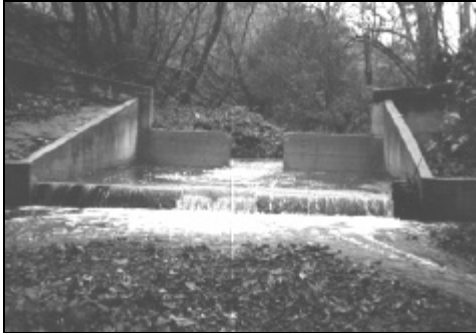
Site ST-2-3B, Stenner Creek Agricultural Dam at Cal Poly

Figure 17. Photograph of Stenner Creek, Fish Barrier ST-2-3B.

Problem: This is a concrete flash board dam that is no longer used for stream diversion. The barrier has a partial opening broken out, but continues to prevent free upstream passage for adult and juvenile salmonids during low flows due to an abrupt elevation change.

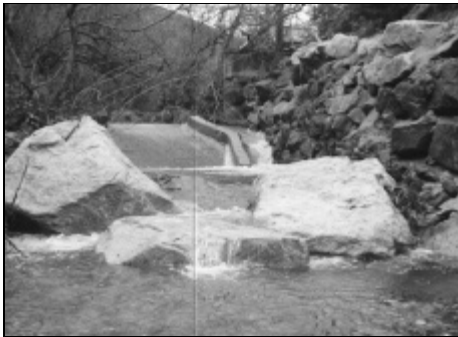
Site ST-3-1B, Stenner Creek at Cheda Pond Diversion Fish Barrier

Figure 18. Photograph of Stenner Creek, Fish Barrier ST-3-1B

Problem: This is a small concrete diversion dam that provides water to Cal Poly. Three boulder weirs were previously added to the channel below the dam to provide fish passage, but one more weir is needed to complete the job.
