**MACALLOY RESTORATION PROJECT**  
**Intertidal Oyster Restoration Project**

**Year 2 Interim Progress Report**  
**Submitted by SCDNR**  
**January 2013**

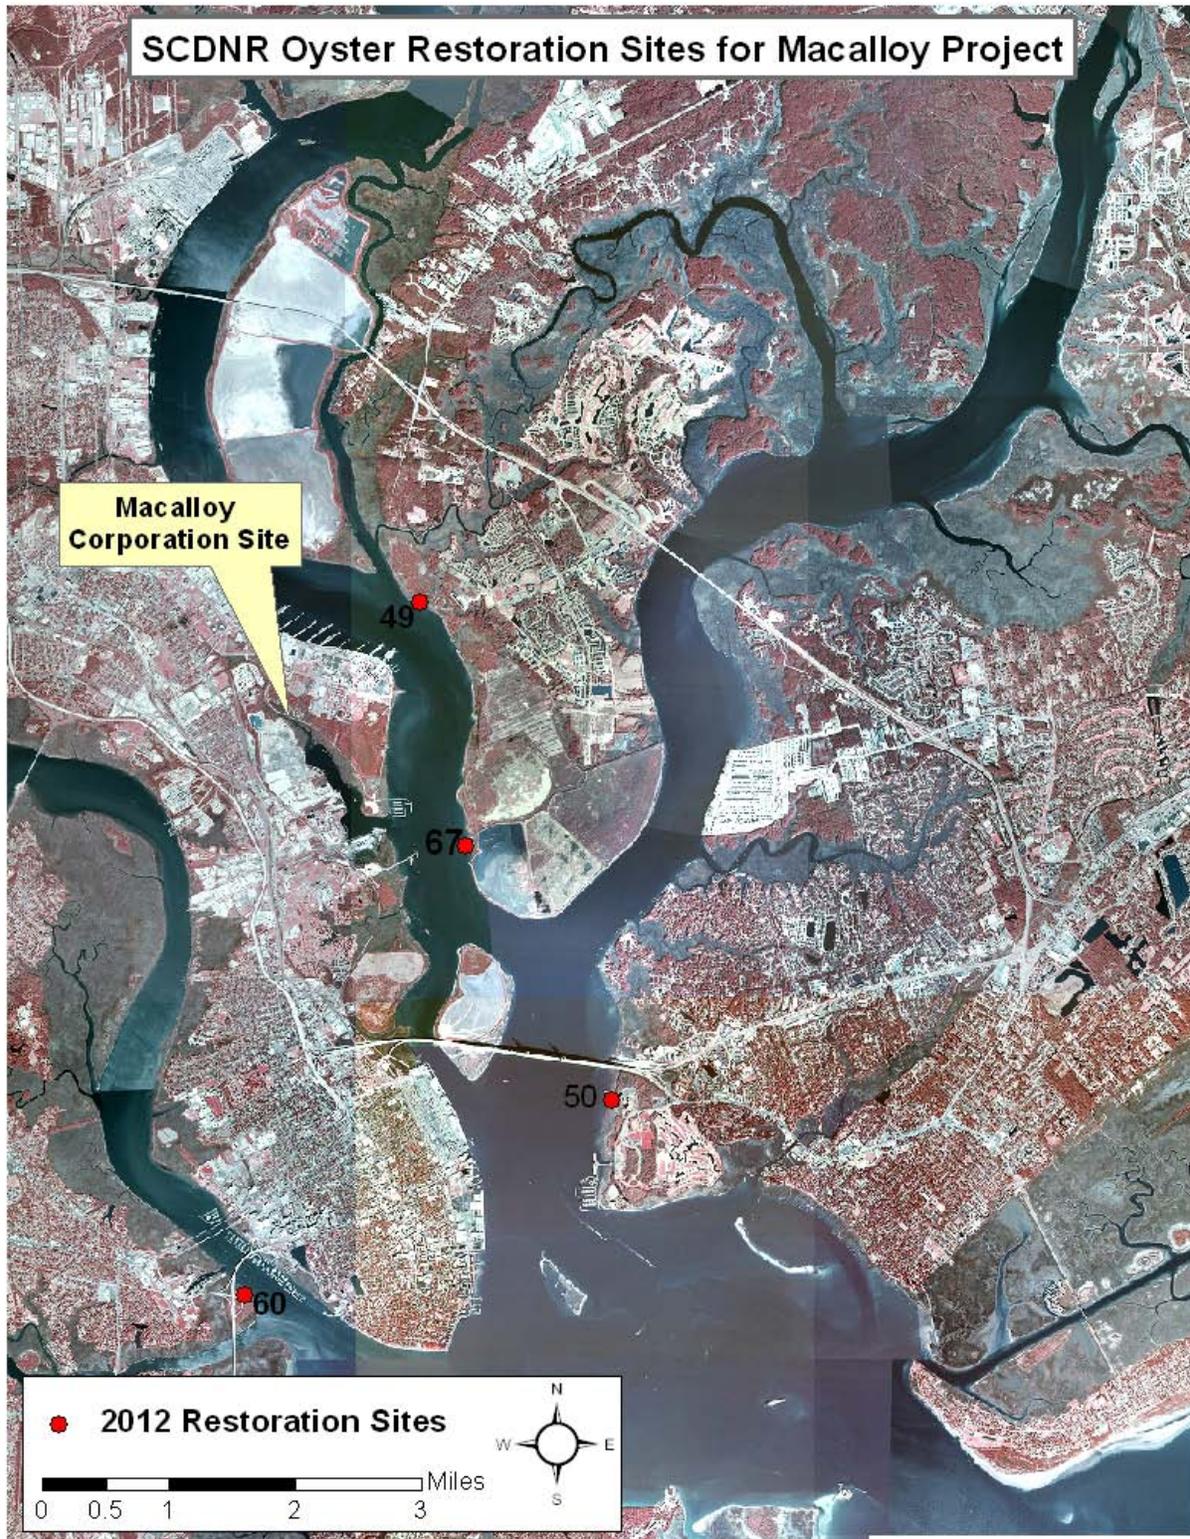
Figure 1: Restoration sites planted in 2012 for Macalloy Project (see Table 1 for creek names)

Prior to the oyster recruitment season (April – September), DNR biologists identified and measured four restoration sites in the Cooper River, Ashley River and Charleston Harbor (Figure 1, Table 1).. Target shell planting depths of 3-4” and 5-6” were determined based on bottom type and energy potential of shorelines, with higher energy areas receiving greater planting depths. One inch diameter PVC poles were used to demarcate areas where shells were to be deployed and the volume of shell required to achieve the target planting depth was calculated. Shell was delivered from shucking houses out of state and quarantined at the SPA’s Veteran’s Terminal for 3-6 months before use.

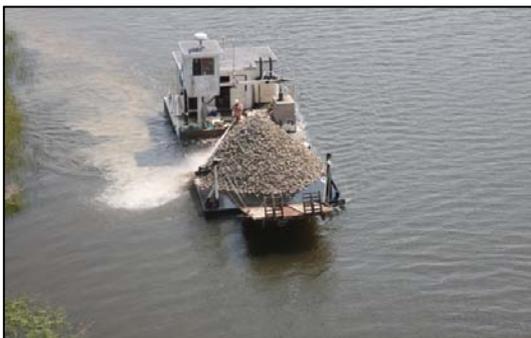
Figure 2: Oyster shells deployed by contractor with high pressured water cannon

DNR contracted with a private company to plant oyster shell for this project. DNR biologist loaded shells onto the contractor’s barge via conveyor. Each barge load of oyster shell (960-1,140 bushels) was transported to the predetermined restoration site and washed overboard onto intertidal shorelines using a high-pressure water cannon (Figure 2). Shells were planted in the selected areas approximately one hour before and after each high tide, depending on the day’s diurnal tidal range. PVC stakes that demarcated shell placement during the planting process were removed after planting and sites were mapped by walking the perimeter or “footprint” using a Trimble® XP Pro GPS (Figure 3). Polygons were downloaded into DNR’s Shellfish Management Database. In 2012, a total of 24,240 bushels of shell were deployed on 1.884 acres of shoreline (Table 1).

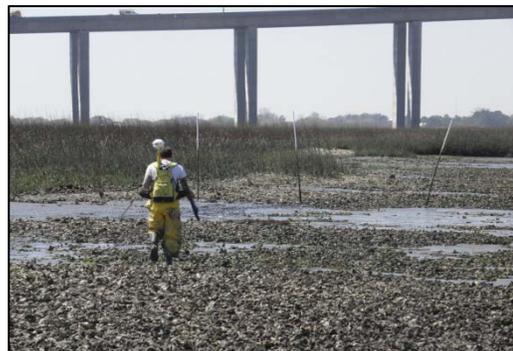
Figure 3: Oyster planting being mapped using Trimble XP Pro GPS

SCDNR is monitoring restoration site development to ensure that we are reaching target goals as set forth in the Oyster Restoration Plan and to evaluate the need for adaptive management. Each year perimeter footprints of the planted sites are mapped with Trimble® XP Pro GPS to accurately document restored area. Oyster recruitment potential is monitored with trays of shell deployed each spring and retrieved after 10-12 months. Preliminary assessments of actual recruitment and growth are made by subsampling restored areas at approximately 1 year post-construction. Reefs constructed in 2012 will be sampled in spring 2015 when they are approximately three years old. This will be our first opportunity to evaluate restoration success using the criteria outlined in the Statement of Work. Three years is the minimum time required for a restored reef to begin to display population characteristics typical of a natural reef.

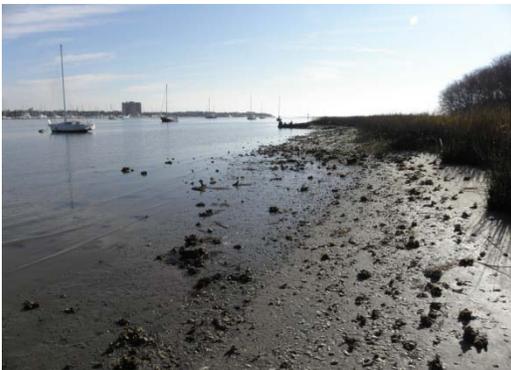
Figure 4: Ashley #60 before shell planting

All sites are documented with digital photos of shorelines pre and post shell deployment (Figure 4 and 5). Trays of oyster shell are deployed at restoration sites each year to evaluate recruitment potential. Trays have been used to assess recruitment potential at natural and restored sites in South Carolina since 1998. Fifteen trays were deployed in the Charleston Watershed in April 2012 and will be retrieved and processed in March 2013. Spat on each shell will be counted and measured. Recruitment to the fifteen shell trays will be averaged and compared to recruitment monitored at other sites state-wide for the same time period. A preliminary assessment of oyster population development on planted shorelines will be implemented by taking replicate  $\frac{1}{4}$  meter quadrant samples from the four 1-year old reefs planted in 2012. All live oysters in the each sample will be counted and measured. A more thorough sampling to evaluate restoration success will occur in 2015 when the reefs are approximately three years old. Three years is the minimum time required for a restored reef to begin to display population characteristics typical of a natural reef.

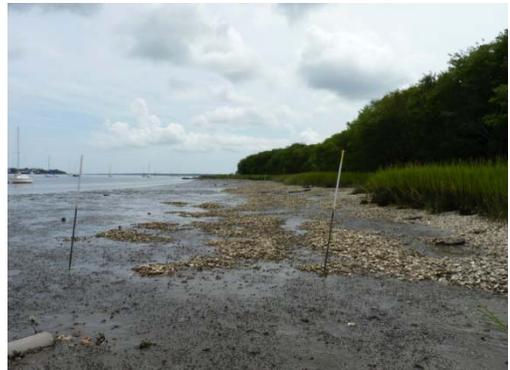
Figure 5: Ashley #60 post shell planting
