**The Ozarks Environmental and Water Resources Institute (OEWRi)
Missouri State University (MSU)**

Big River Mining Sediment Assessment Project

Big River Borrow Pit Monitoring Project

FINAL REPORT

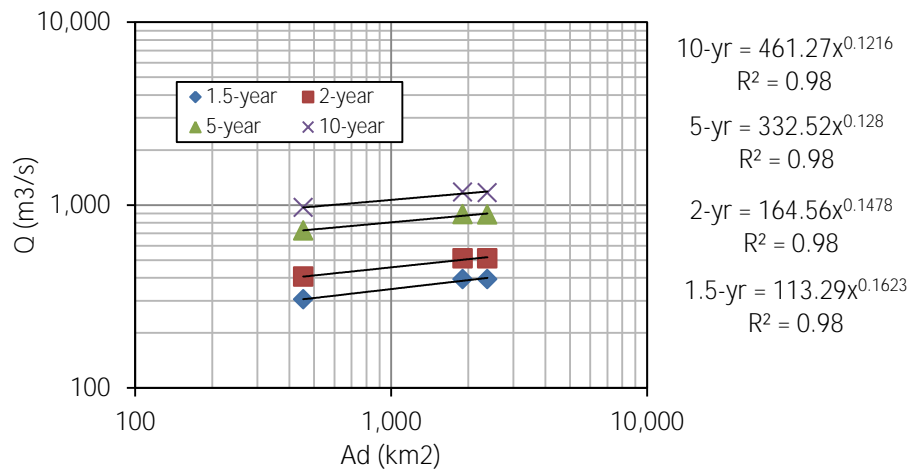
Figure 6. Downstream Flood Frequency Analysis for Big River Gages.

Flood frequency was estimated for the Bar Site using regression equations based on interval discharges and drainage area relationships at the three USGS gages for the 1.5-yr, 2-yr, 5-yr, and 10-yr floods (Figure 6).

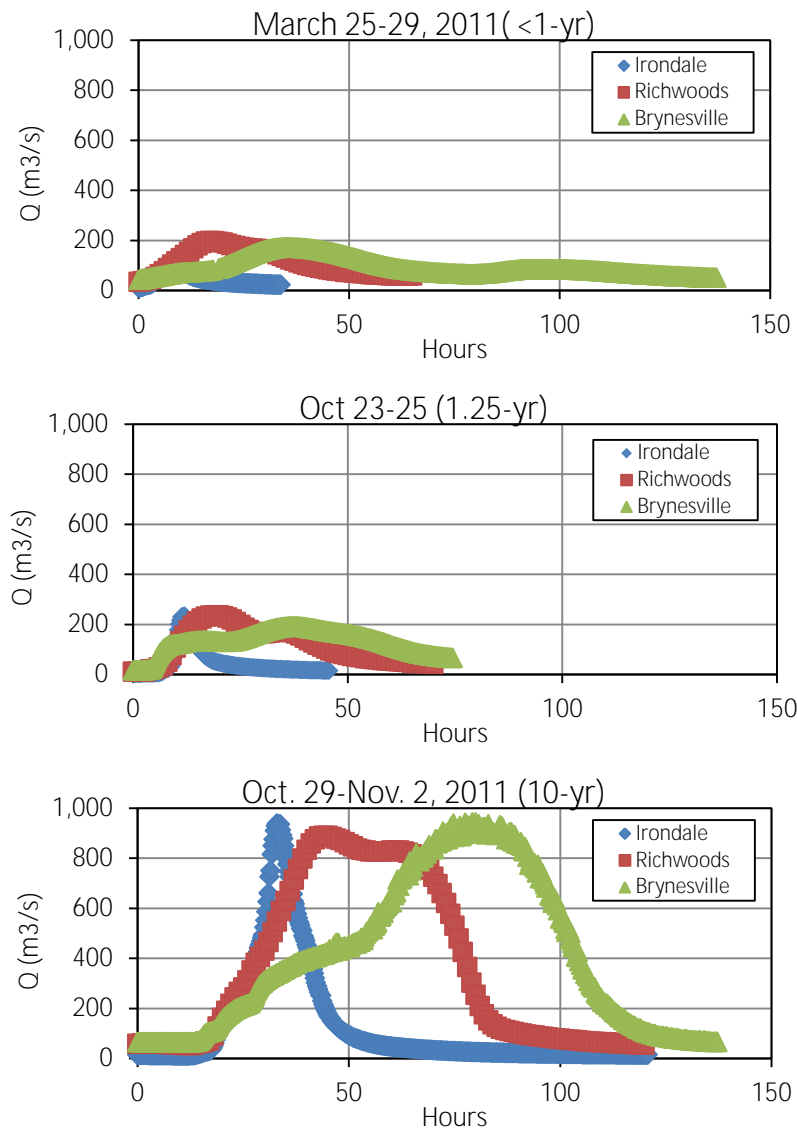
Figure 7. Flood Hydrographs Used to Establish Drainage Area-Duration Relationships.

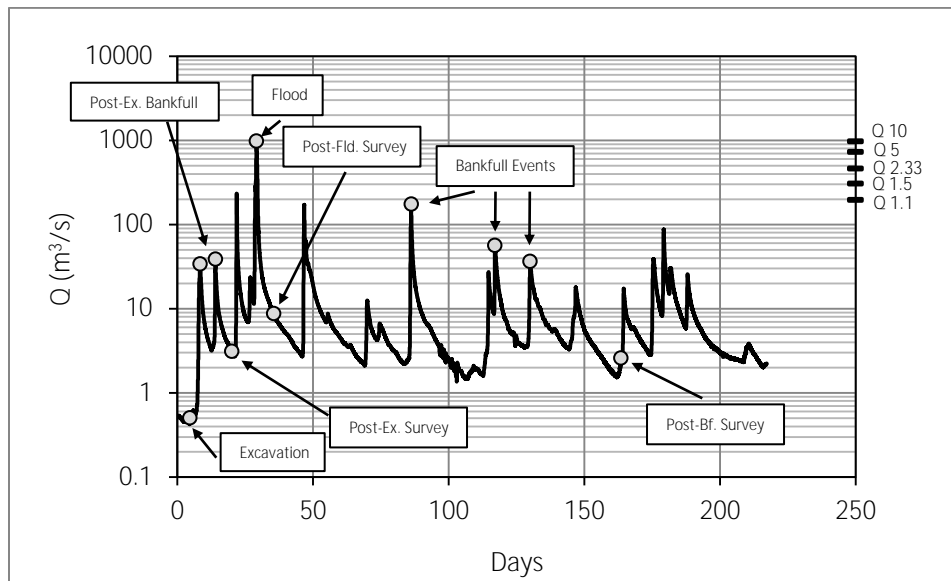
Figure 9. Hydrograph at the Irondale Gage Located 30 km Upstream of the Bar Site With Flood Frequency.

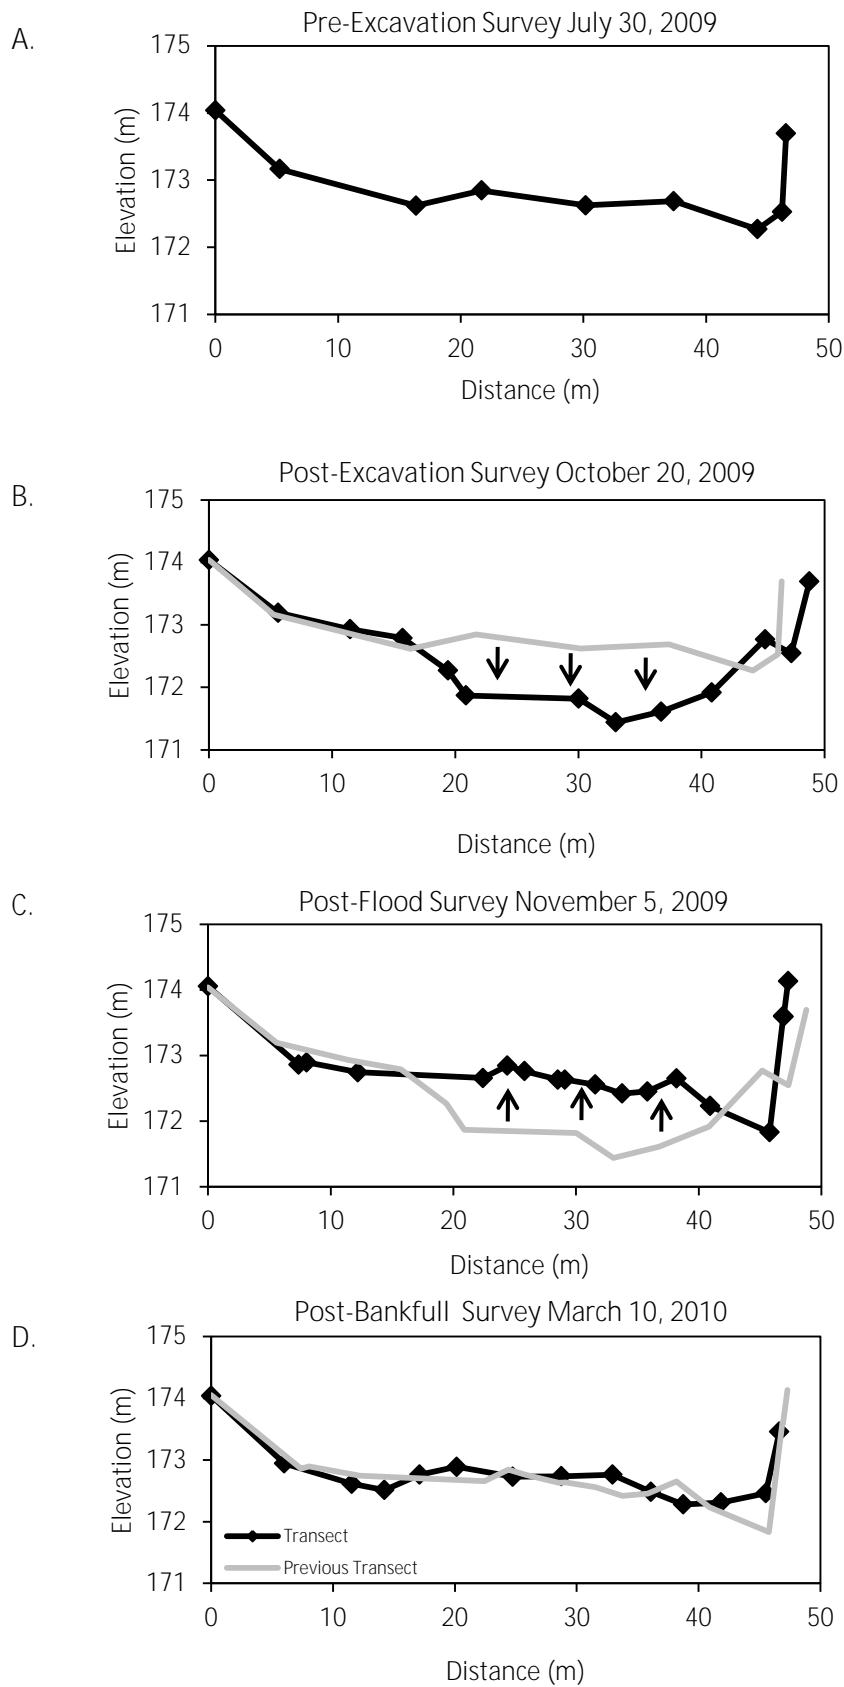
Figure 10. Changes in Bone Hole Cross-Section at Station R-km 165.4 in the A.) Pre-Excavation Survey, B.) Post-Excavation Survey, C.) Post-Flood Survey and D.) Post-Bankfull Survey.

Pre-Excavation Survey. On July 30, 2009 the pre-excavation survey was performed at the Bone Hole. Without prior knowledge of the specific location and extent of the excavation, the survey extended from just above Owl Creek confluence to the low-water bridge, assuming that excavation activities would not occur upstream of the tributary. Channel deposits tend to accumulate as aggraded channel fill upstream of low-water bridge dams where the channel is relatively wide with low slope. As the flow shallows and spreads over the bridge, turbulence appears to cause scour along the sides of the channel in the bank toe area resulting in deposition of a center bar (Figures 4 and 10a). This split thalweg pattern is typically formed where diverging flows occur in over-widened channel sections, particularly where slope breaks and transport capacity decreases behind the dam (Rosgen, 1996; Knighton, 1998). In addition, a small scour pool has formed immediately below the confluence of Owl Creek near the southwest edge of the survey area and may also contribute to the divergent flow pattern indicated at this site. The bed conditions along the western portion of the survey area are transitional and grade from a relatively deep pool located upstream of the survey area into a pool tail and depositional zones within the project area (Figure 10a).

larger scale changes in sediment supply and transport in the Big River. However, it appears the channel in the vicinity of the excavation pit has returned to its pre-excavation condition indicating that borrow pit recovery by sedimentation occurred in less than 9 months at this site, albeit most of the re-deposition was associated with one 10-yr flood event, which would not be expected in an “average” year (Figure 10d).

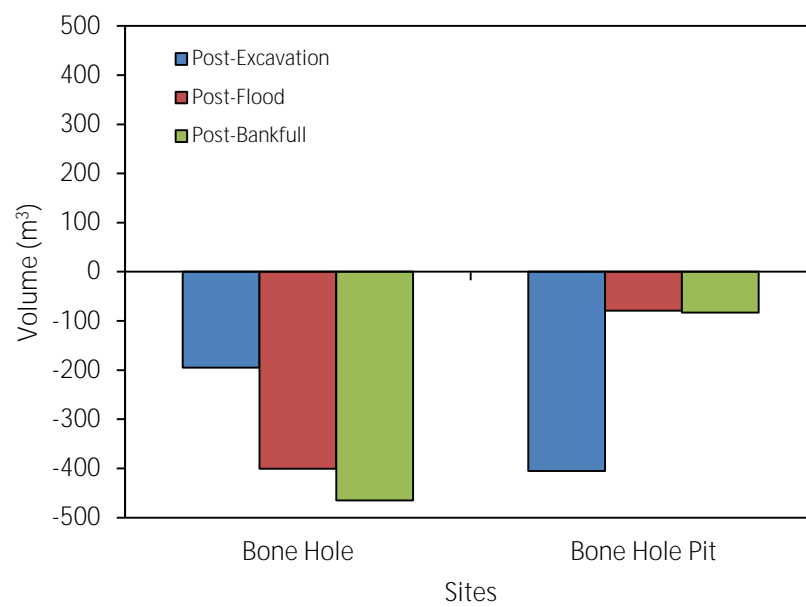
Figure 11. Absolute Volume Changes Measured at the Bone Hole Relative to Pre-Excavation Condition.

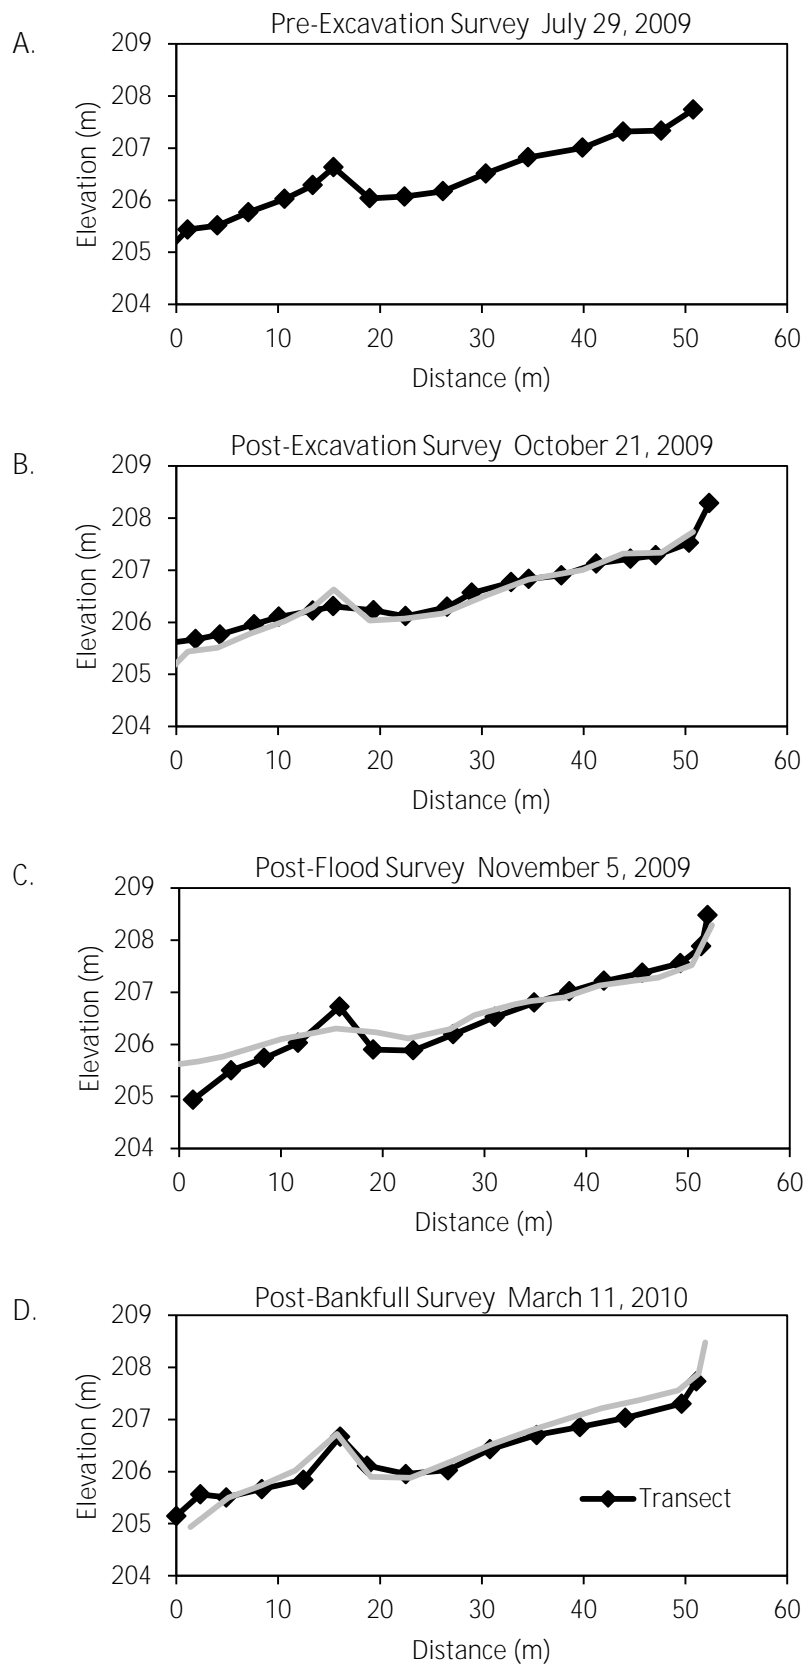
Figure 14. Changes at the Bar Tail, Cross-Section at Station R-km 163.4 in the A.) Pre-Excavation Survey, B.) Post-Excavation Survey, C.) Post-Flood Survey and D.) Post-Bankfull Survey.

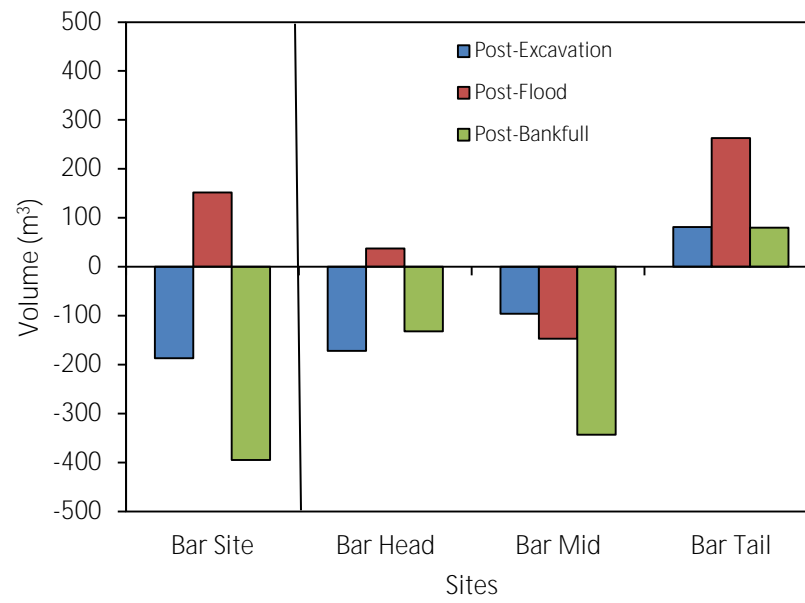
Figure 15. Absolute Changes in Measured Volume at the Bar Site Relative to Pre-Excavation Condition.

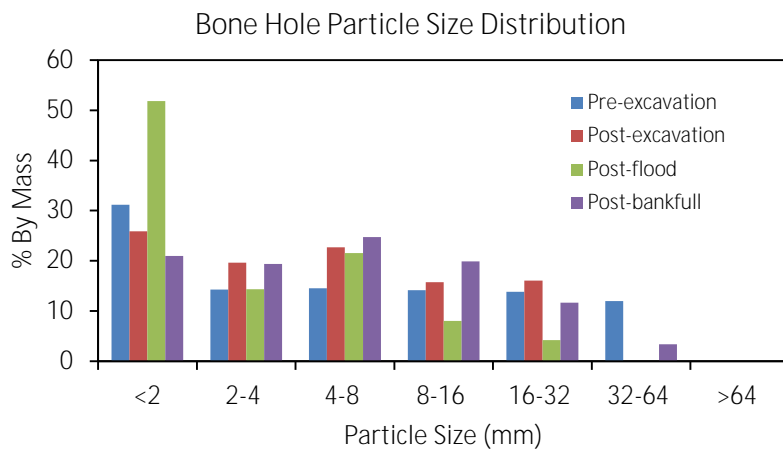
Figure 16. Average Particle Size Distribution from Samples Collected From the Bone Hole.

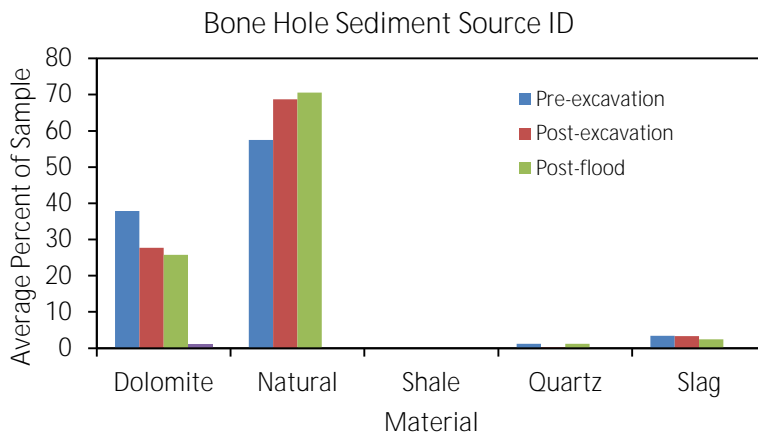
Figure 17. Sediment Composition of Samples Collected From the Bone Hole.

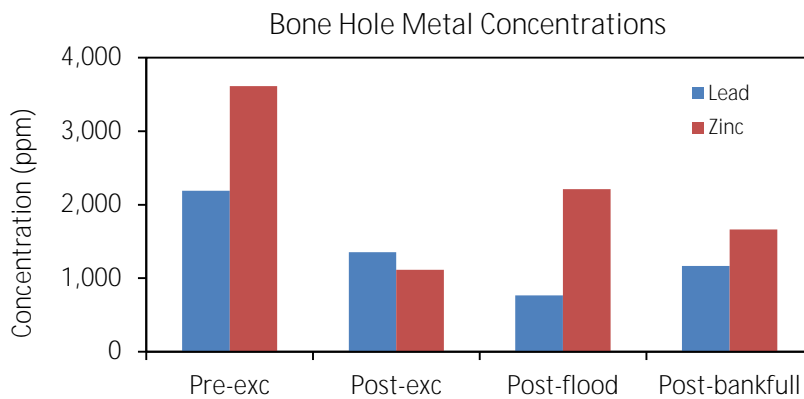
Figure 18. Average Concentration of Metals in Samples Collected From the Bone Hole.

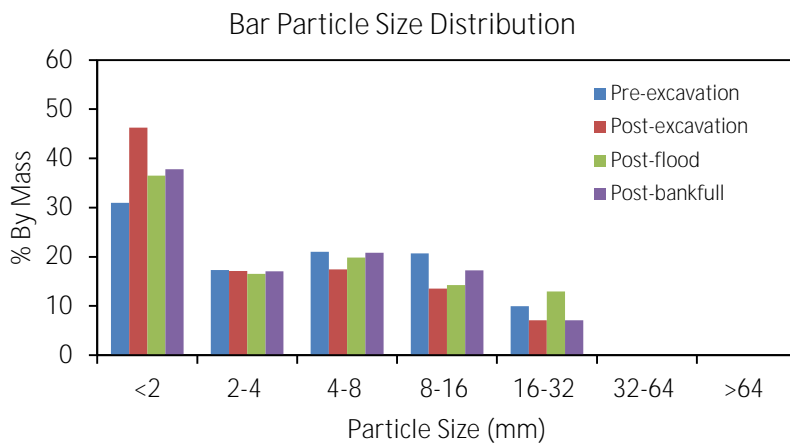
Figure 19. Average Particle-Size Distribution From Samples Collected at the Bar Site.

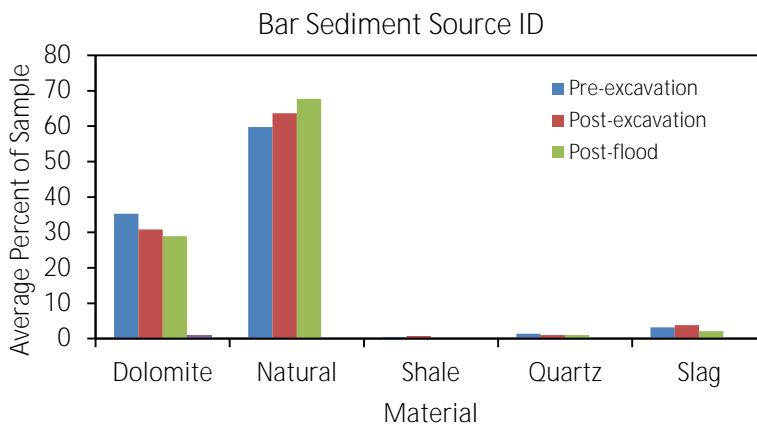
Figure 20. Sediment Composition of Samples Collected at the Bar Site.

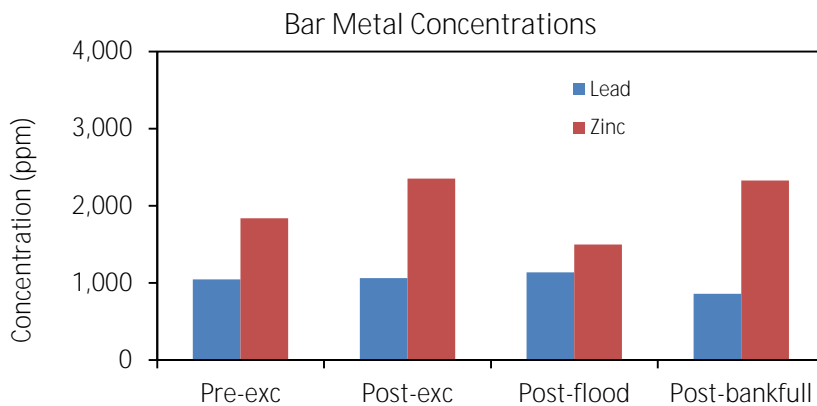
Figure 21. Average Concentration of Metals in Samples Collected From the Bar Site.

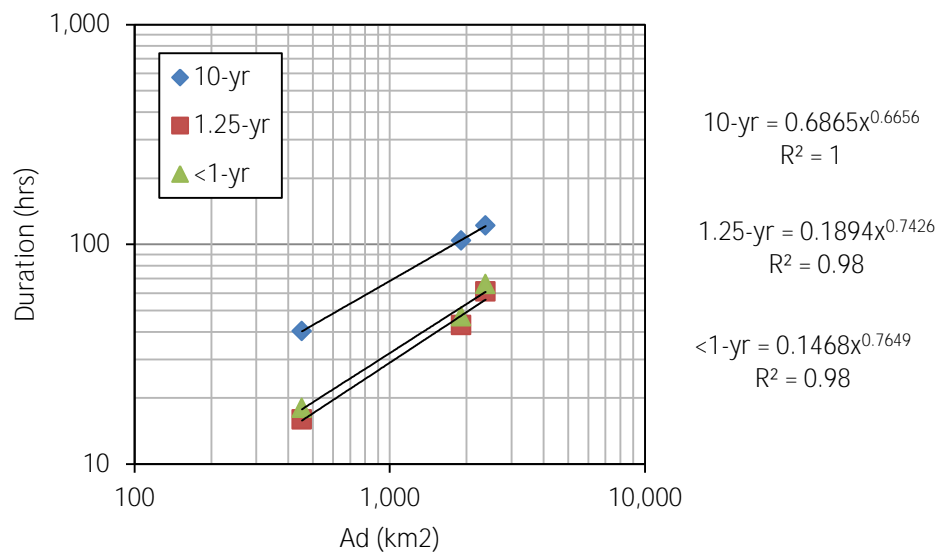
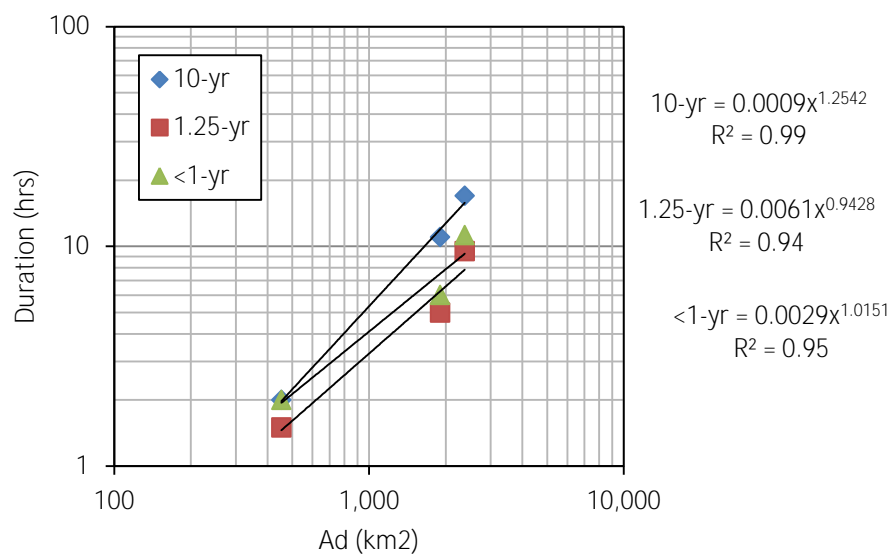
Figure 22. Drainage Area-Duration Relationships the A.) Base and B.) 95% Peak from Hydrographs for Selected Floods at Big River Gages.

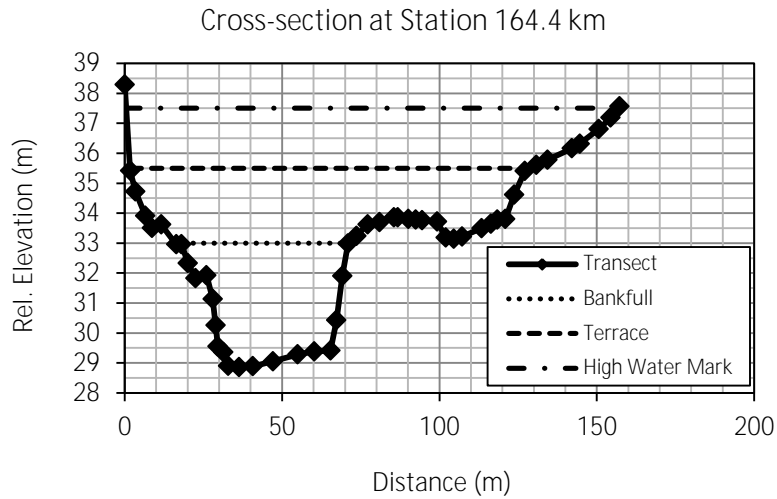
Figure 23. Channel Hydrologic Characteristics at Station R-km 163.4 Near the Bar Site Cross-Section.

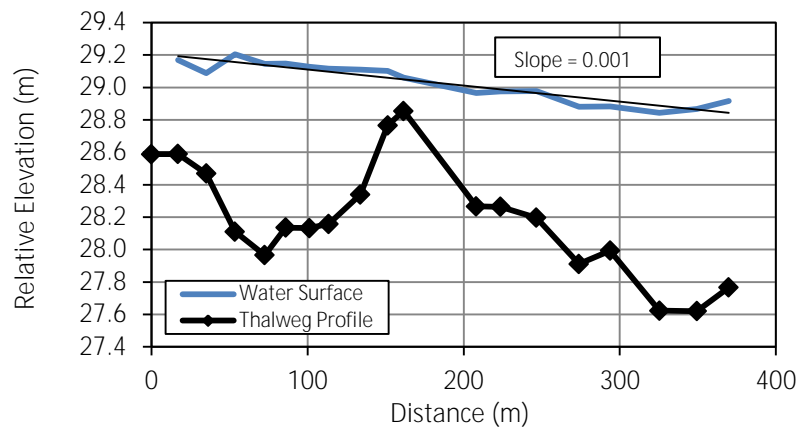
Figure 24. Longitudinal Profile at the Bar Site.

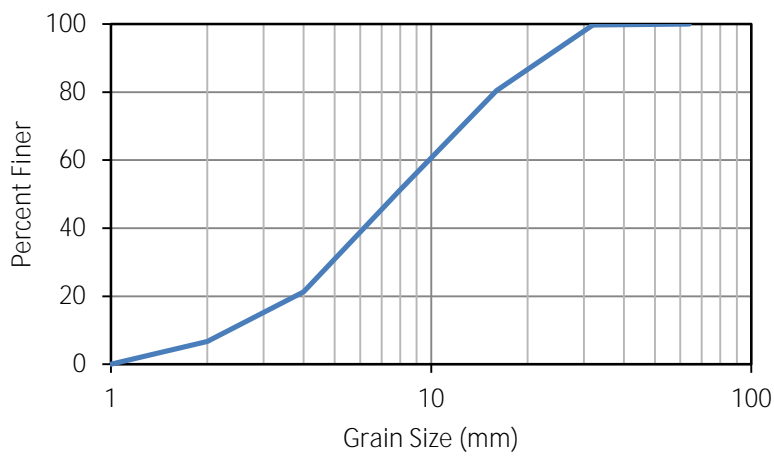
Figure 25. Grain-Size Distribution at the Bar Site.

Bed particle size ranged from sand (<2 mm) to very coarse gravel (32-64 mm) throughout the entire reach (Figure 25). Grain size data from the pebble counts is entered into the BAGS model and the software provides grain size distribution statistics. The median grain-size for the entire reach is 8 mm with a geometric mean of 7 mm (Table 8). The full set of grain-size data collected during pebble counts can be found in Appendix F.

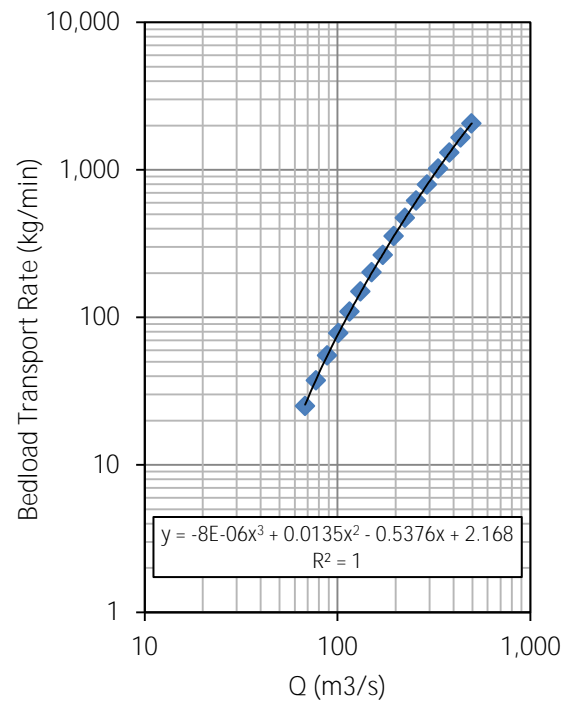
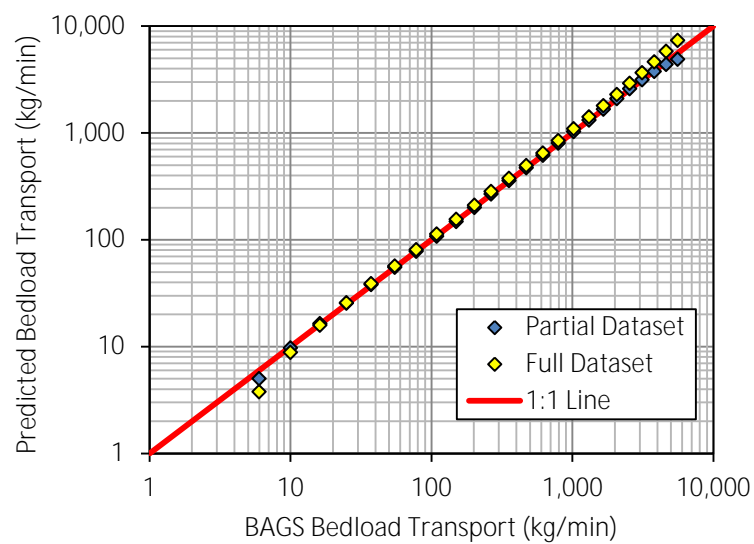
Figure 26. Bedload Transport Rating Curve Evaluation A.) Rating Curve and B.) Analysis of Model Fit Comparing Both Full and Partial Datasets.

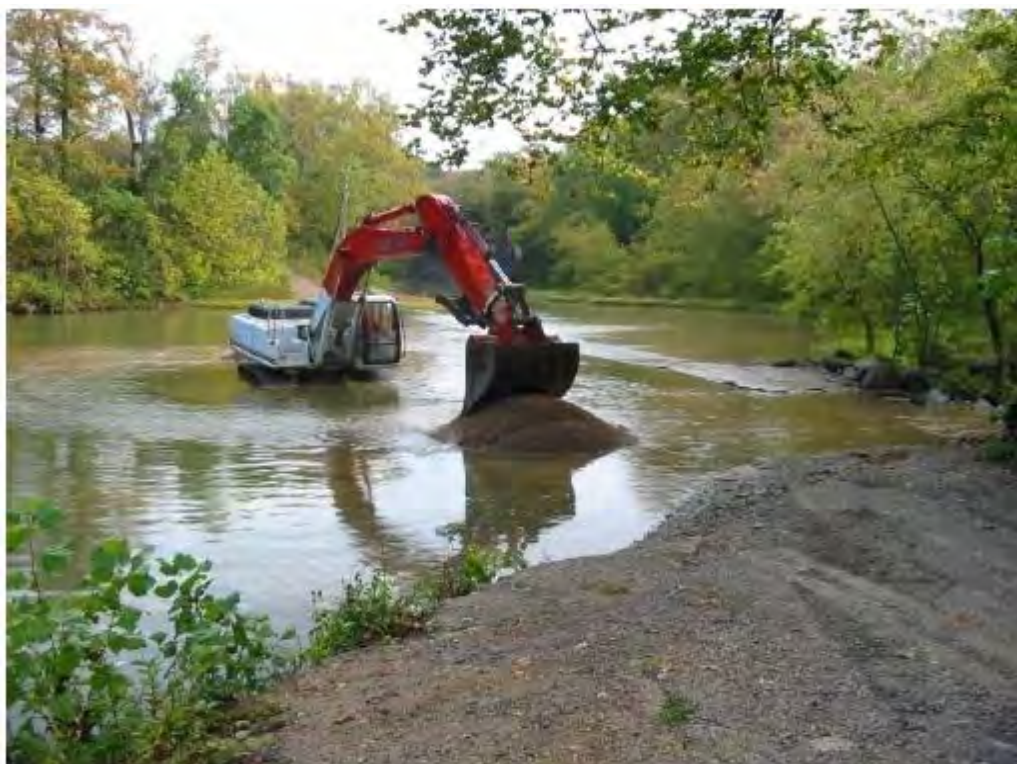
Excavation activities at the Bone Hole site are consistent with post-excavation survey results. (Photos from HGL Field Oversight Report).

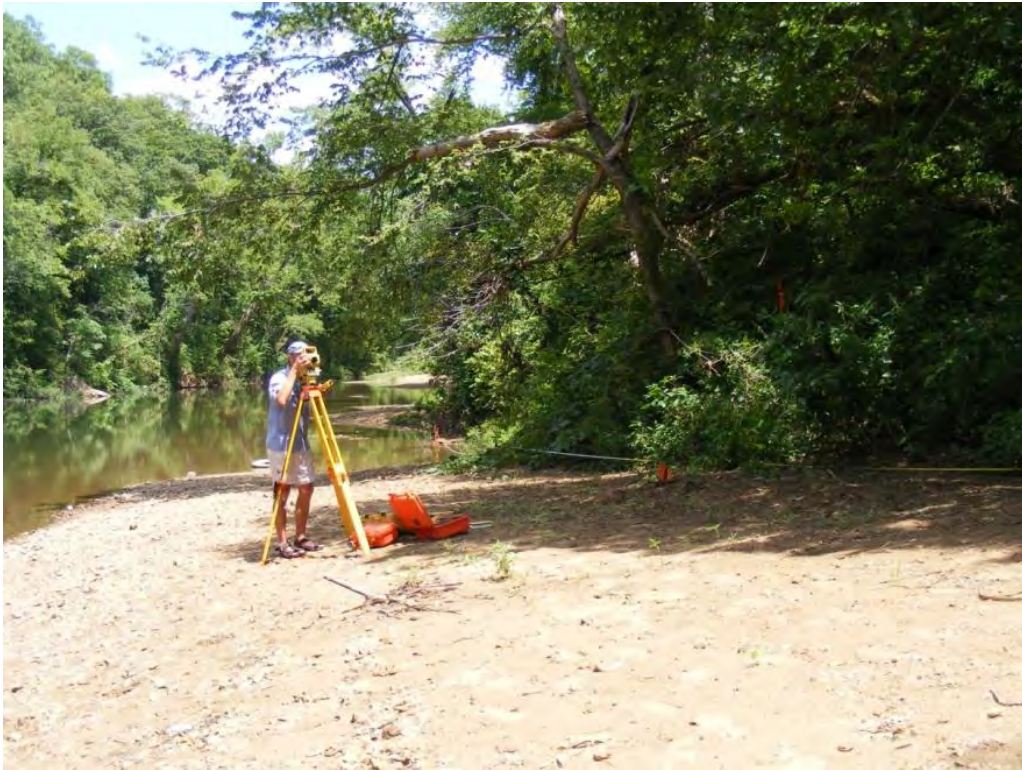
Surveying at Site #2 Bar. Notice survey tape and orange flags marking the 10m increment cross-section

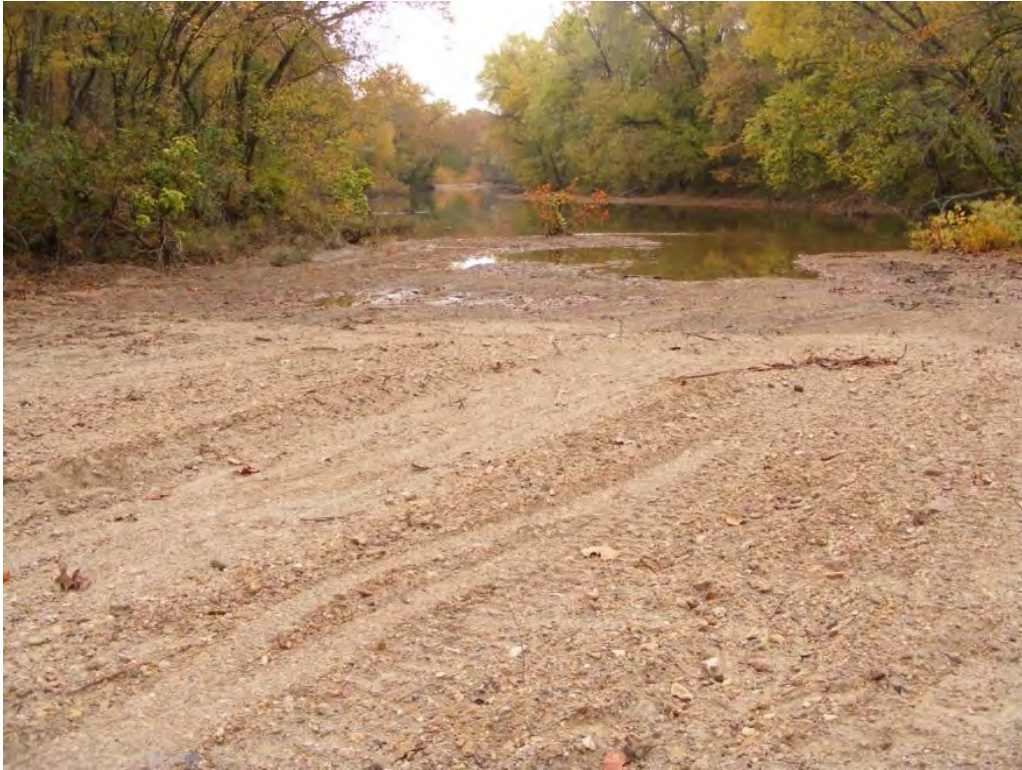
Looking upstream across excavated bar head. Notice excavator tracks and flat topography.
