Preassessment Data Report #2
M/V *Selendang Ayu* Oil Spill
Surveys of Intertidal, Subtidal, and Anadromous Stream Habitats

NOAA
Damage Assessment, Remediation, and Restoration Program

January 2008

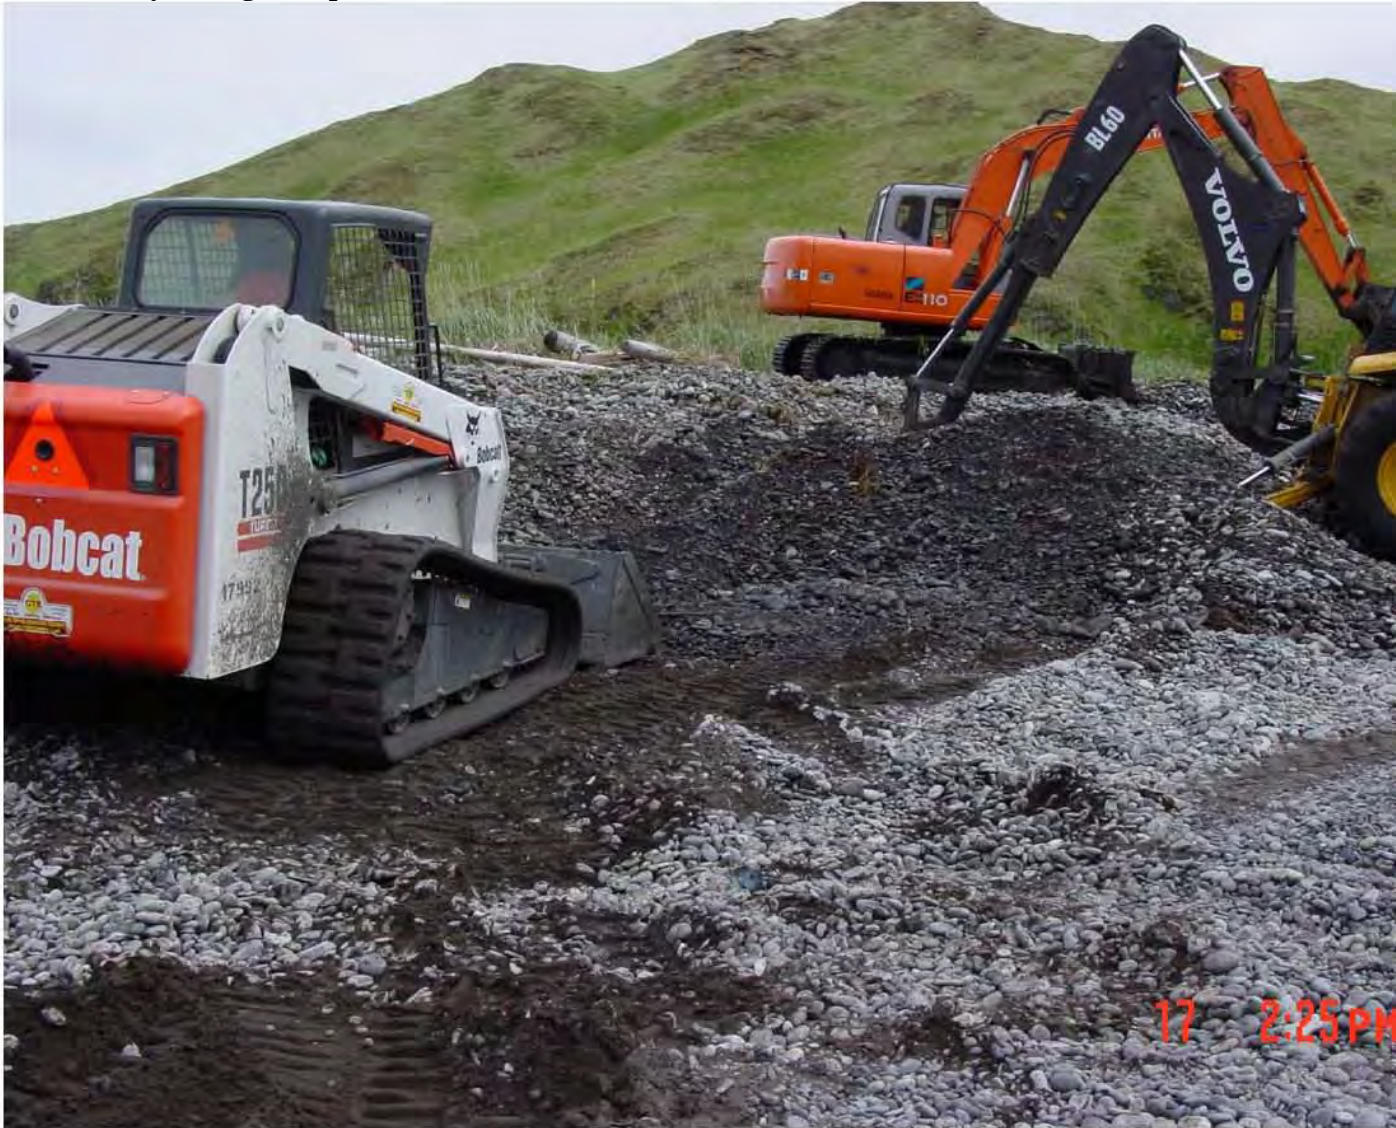
Photo of Dry Tilling to Expose Buried Oil at HMP-12 (2 December 2005)

The stream at HMP-12 was examined on 20 June 2005, when clean-up crews were working on a deposit of oil from the adjacent beach at HMP-11b. The high intertidal area at HMP-12 had been tilled to expose the buried oil to removal by natural factors after bulk removal of oil deposits by hand, which includes remobilization by wave action, according to information posted on the Unified Command website (http://www.dec.state.ak.us/spar/perp/response/sum_fy05/041207201/041207201_index.htm). Oil-stained rocks and tar balls mixed with sediment were found along portions of the stream bank, where Iadanza reported 100% cover of oil on stream banks on the lower 100m of stream during a 19 January 2005 site visit. In the second trip to HMP-12 (23 June 2005), a 60% cover of oil was observed deposited on a gravel berm adjacent to the salmonid stream at a distance of 80 - 100m from the stream mouth. On both visits to HMP-12 (20 and 23 June 2005), oil sheen was seen in the intertidal areas of the beach on both sides of the stream mouth, below the location where beach materials had been redistributed. There was oiled wrack near the stream mouth and oil-stained rocks in the stream mouth.
