Restoration Plan and Environmental Assessment Addendum

**Sharon Steel Natural Resource
Restoration Plan**

Salt Lake County, Utah

**Sharon Steel Natural Resource
Trustees**

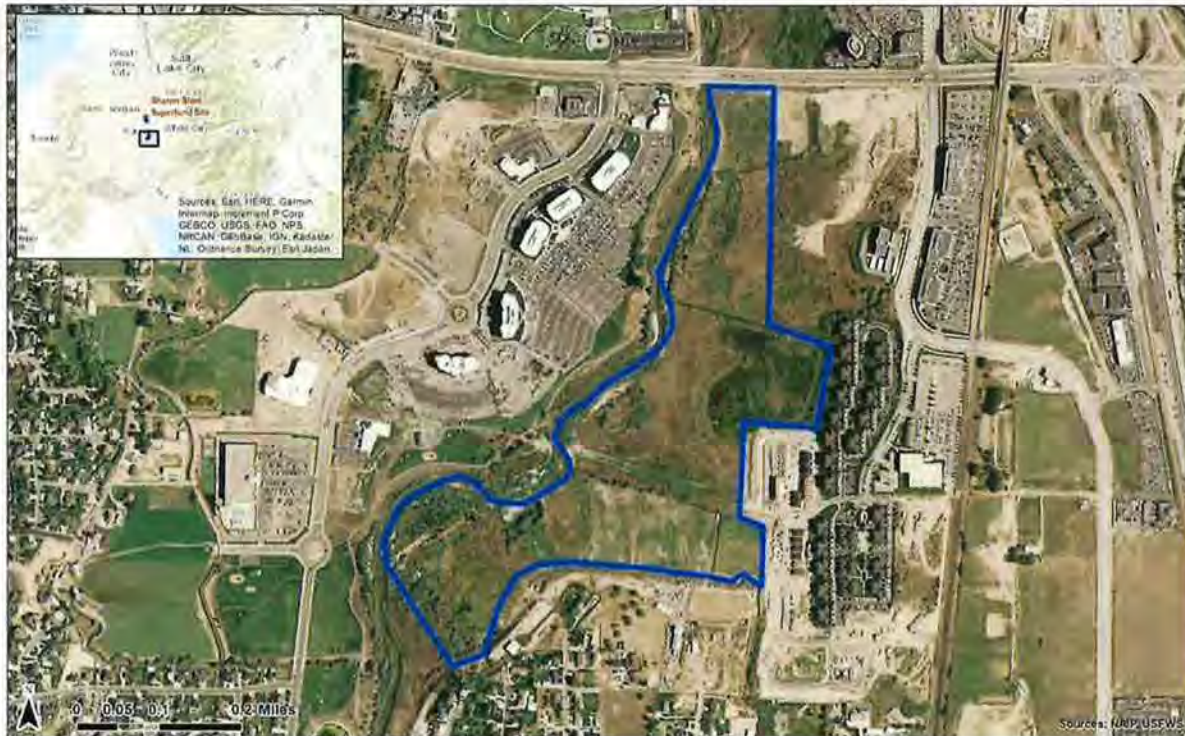
Figure 1. South Jordan Riverway Wildlife Enhancement Project. Project area proposed in 1998 (80 acres). Photo from 2004.

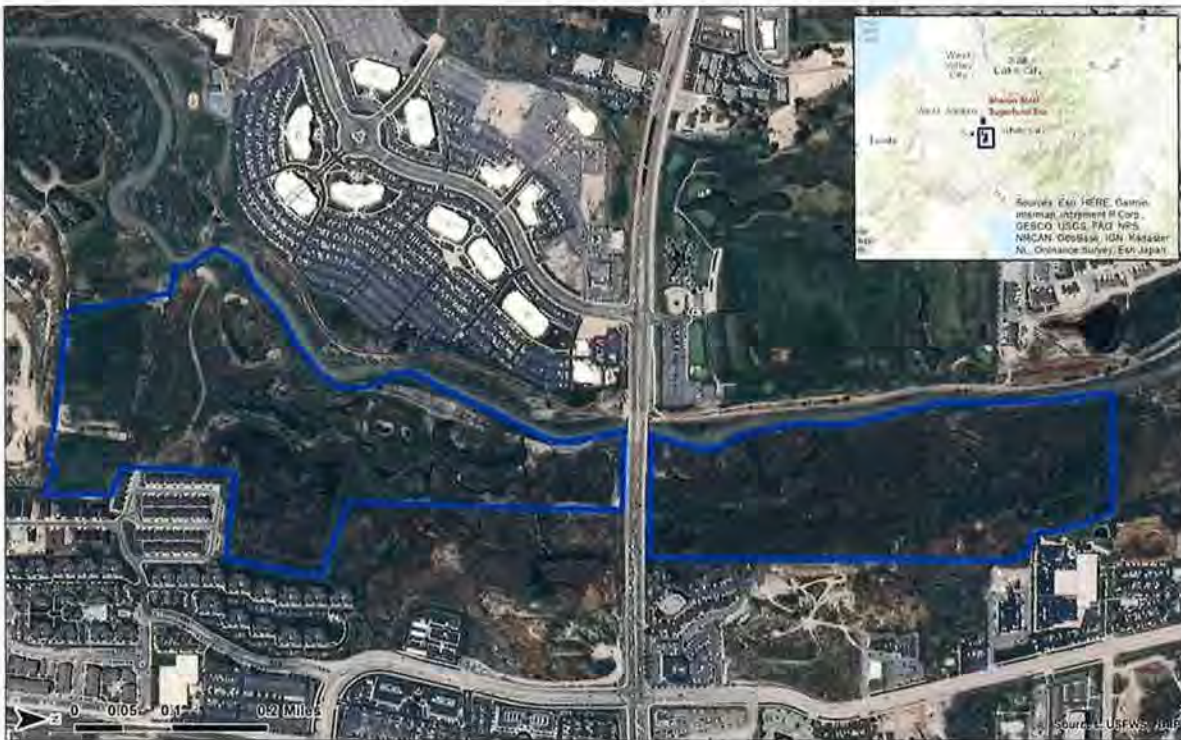
Figure 2. Great Salt Lake Audubon-Tree Utah Jordan River Migratory Bird Reserve. Project area as implemented. Total area about 180 acres. Photo taken in 2009, after Willow Creek Restoration had been completed (on the southernmost parcel on left of photo).

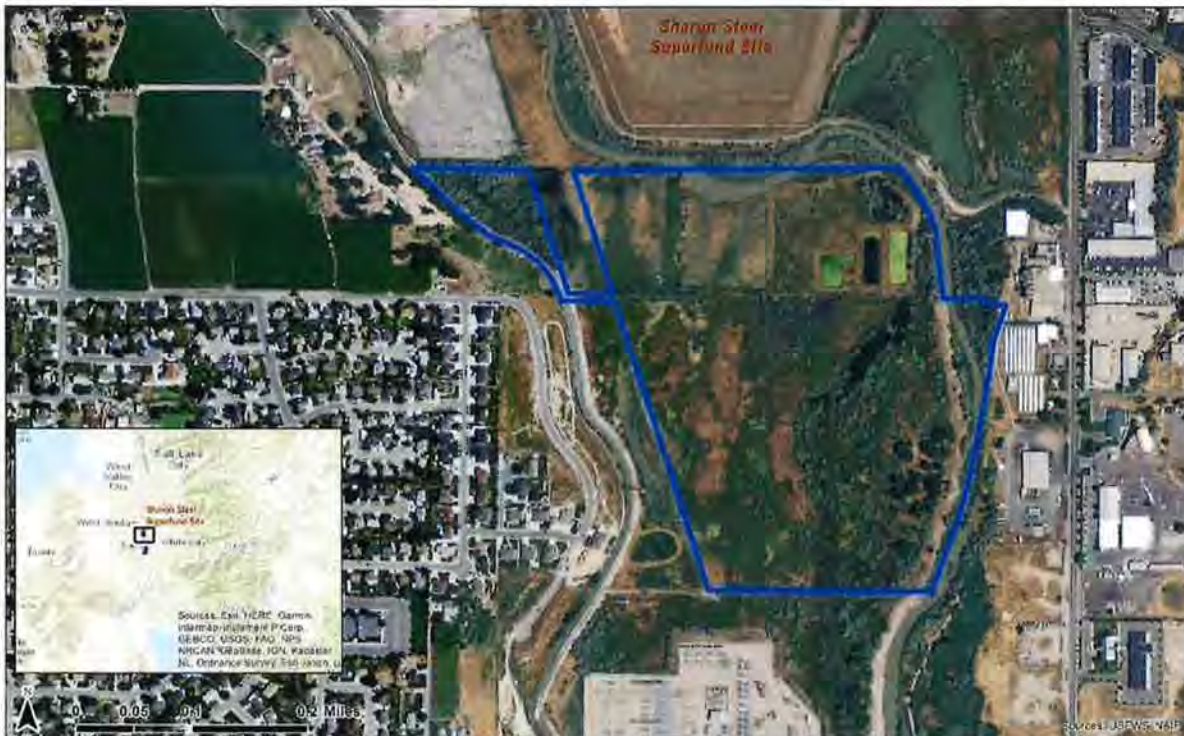
Figure 3. City of West Jordan Natural Habitat Restoration Project Area (Big Bend Project area). Total area is 68 acres. Photo taken in October 2011, during a record high-water year, with water (at the level of the river's water table) present in remnant oxbow channels and ponds on the former floodplain.

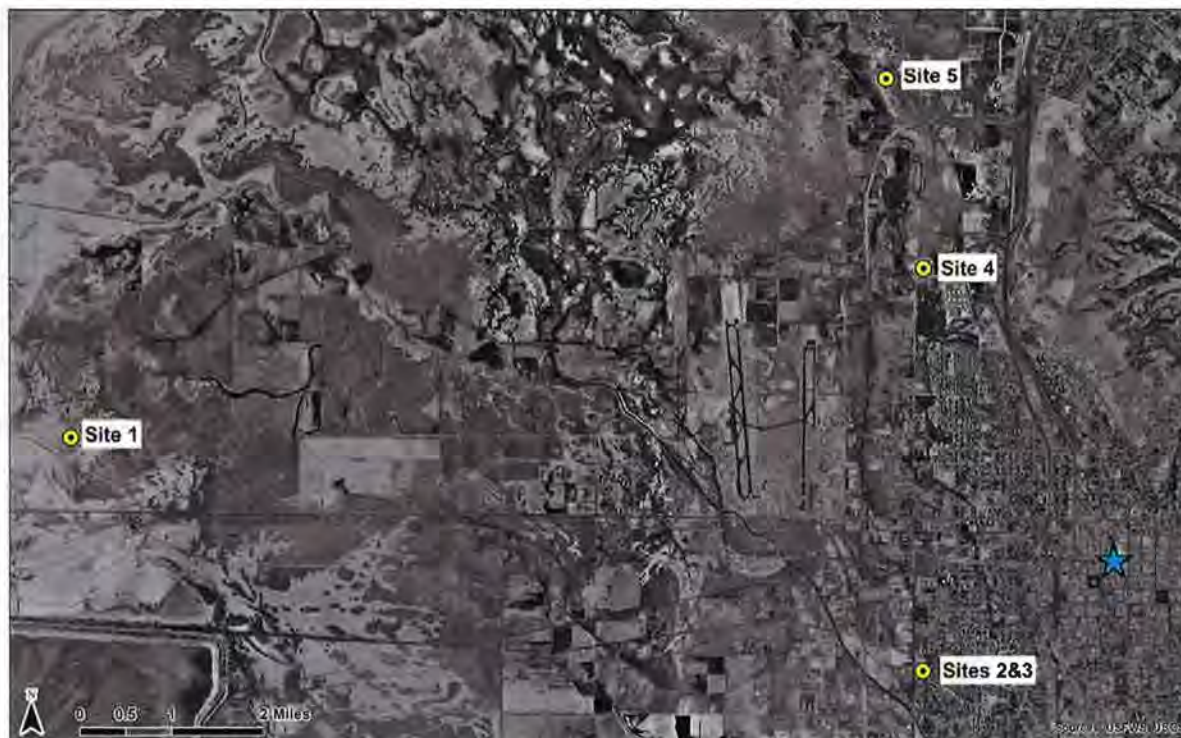
Figure 4. Vicinity of Portland Cement Kiln Dust Sites 1, 2 & 3, 4 and 5 in northern Salt Lake City, Utah. Blue star is downtown Salt Lake City. Photo taken in 1977.

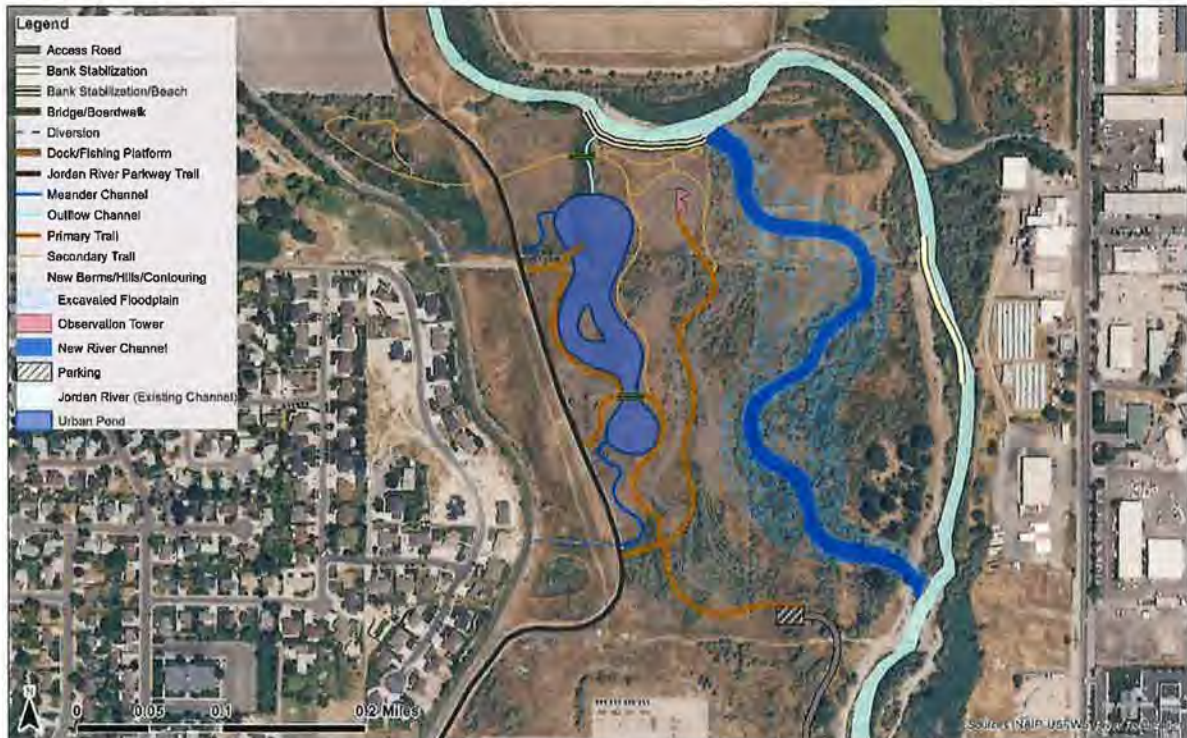
Figure 5. Preferred Alternative “Lowered Floodplain with Meandering Channel” Restoration at the Big Bend site, identified by the Utah Reclamation Mitigation and Conservation Commission in their “*Big Bend of the Jordan River Habitat Restoration and Federal Land Transfer Environmental Assessment*” conducted under the National Environmental Policy Act.

- Hydrologic restoration of the Jordan River by redirecting it into a new channel across the Big Bend Project area. This channel will be excavated and constructed so the river flows within an approximately 300 foot wide floodplain, with gradually sloping banks leading back up to the current floodplain level. In addition to providing suitable conditions for riparian vegetation, the new channel will let the river spread out as its discharge volume increases, which will reduce the bed and bank erosion that is a major issue with the river's current alignment. At high (flood) flows, both the new and old channels will be able to convey water and hold water in the floodplain, which will provide the benefit of reducing downstream flooding. This restoration will improve the stability and hydrologic function of the river throughout the project area, which will allow it to support other natural resource services that are required by migratory birds and other wildlife.

- The designation of the northeastern portion of the project area (within the area defined by the old and new river channels) as a migratory bird and wildlife reserve, with limited human use and access. This area will be planted with riparian, wetland, and upland vegetation as appropriate to conditions and hydrology that will provide nesting areas, forage, and cover for birds and wildlife.
