**FINAL RESTORATION PLAN AND  
ENVIRONMENTAL ASSESSMENT:**

**Burgess Brothers, Inc. Superfund Site**  
Bennington and Woodford, Vermont  
**and**  
**Tansitor Electronics, Inc. Superfund Site**  
Bennington, Vermont

**Lead Administrative Trustee: U.S. Department of the Interior,  
U.S. Fish and Wildlife Service**

Issued: January 20,2005

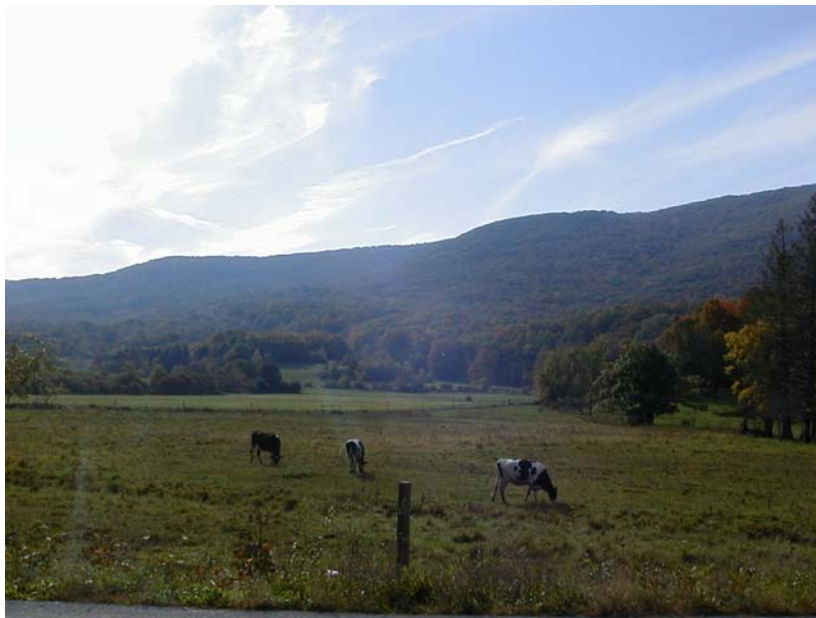
Figure 2. Beal Site.

This site is located on Monument Avenue Extension, southwest of the city proper. The site consists of two areas of wet pasture totaling about 13 acres and is situated on northeast facing slopes at the base of Mount Anthony. Cows graze in the pasture and utilize a small stream which drains into a small pond before draining to the Walloomsac River, approximately one mile downstream (Figure 2).

Restoration options at the site include excavating and expanding the existing wetland areas, including eliminating grazing and replanting with wetland-specific woody and herbaceous vegetation. Ditches that presently drain the site could be filled to restore a more permanent water regime.

The Beal Site offers opportunities to excavate and expand existing wetlands as well as to re-engineer drainage ditches to restore wetlands. One area of approximately four acres could be expanded to about six acres through excavation and re-engineering. Another area of approximately nine acres runs parallel to Monument Avenue Extension. This area could also be excavated, expanded and planted with wetland woody and herbaceous vegetation to improve wildlife habitat. The two areas are somewhat separated by the road that traverses the property. The largest drawback associated with the Beal Site is that the habitat on the property is mostly wet meadow. This differs from the forested and scrub-shrub wetlands and stream habitats impacted at the Burgess and Tansitor Sites.

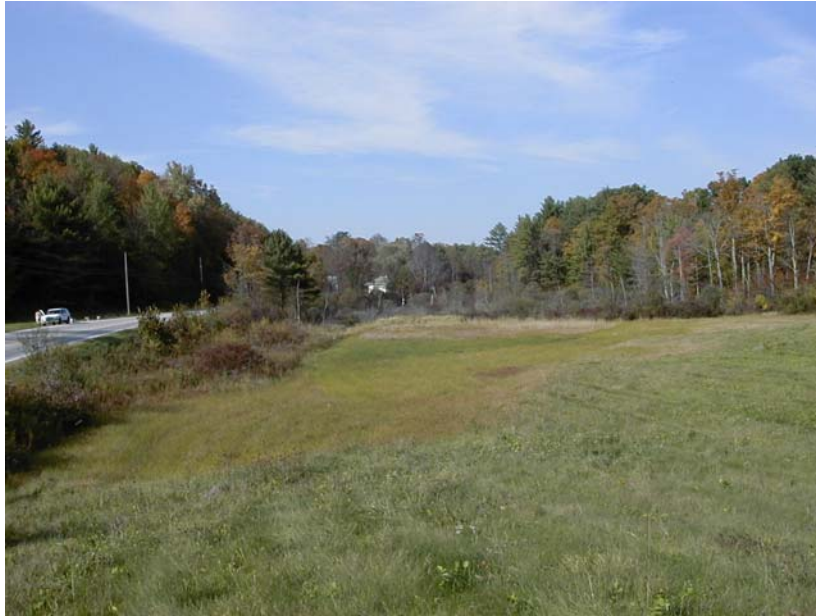
Figure 3. Wood Site.

This site straddles Route 7 south of Bennington village. The site, which is about four acres in size, is currently being used as a hayfield (Figure 3). A drainage ditch/stream crosses the western section of the site, flows under the road and then crosses the eastern portion of the site. Discontinuation of mowing would allow natural succession and possibly restore scrub-shrub wetland habitat adjacent to the stream. Excavation of the hayfield adjacent to the stream on the eastern side of Route 7 could create additional wetland habitat. Opportunities for excavation are limited and unlikely to create more

than 0.5 acres of habitat.

Totaling approximately four acres in size, this site offers limited restoration opportunity. Simple measures such as discontinuing haying of the property could enhance wildlife habitat; however, more extensive wetland expansion would be infeasible due to the limited size of the area and its proximity to Route 7. The existing wetland, which drains in a northerly direction towards Jewett Brook, is also fairly isolated from other wetlands. Moreover, the quality of the wetland is diminished due to the proximity of Route 7. The Wood Site is also primarily wet meadow which differs from the impacted habitats at the Burgess and Tansitor Sites.

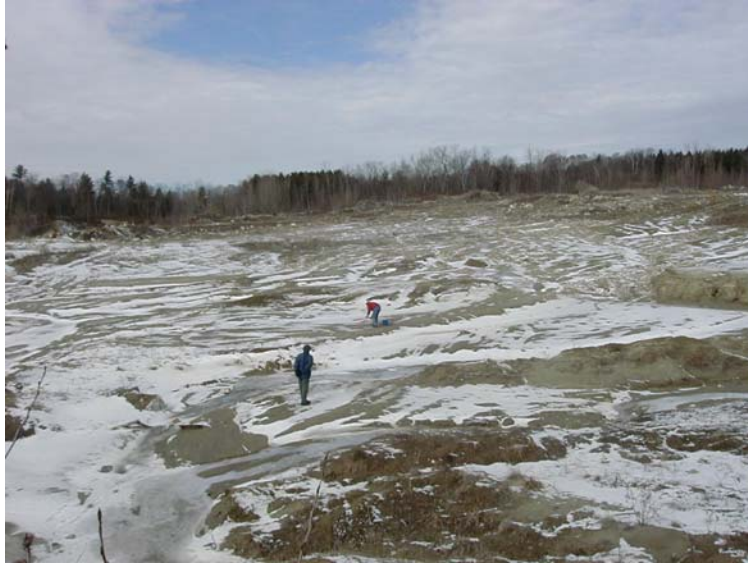
Figure 4. Gravel pit.

This site is located in northeast Bennington, north of the Bennington Landfill Superfund Site on Houghton Lane and south of the Shaftsbury town line. There are approximately 13 acres of abandoned gravel pit land which grade downwards to a mostly forested and scrub-shrub wetland that forms the headwaters of Hewitt Brook (Figure 4). Unknown parties deposited clean, coarse fill in various locations throughout the wetland. There are scattered piles of rock and loose boulders as well as larger areas of finer materials (Figure 5). A breached berm at the base of the gravel pit and erosional processes during periods of high precipitation and spring snowmelt are responsible for the majority of finer fill material in the wetland.

During the spring of 2003, the Natural Resources Conservation Service (NRCS), an agency within the United States Department of Agriculture, began restoration of the gravel pit in cooperation with the Town of Bennington and a private landowner. The group succeeded in grading and seeding approximately six acres of the former gravel pit. Funds for the initial restoration effort have been exhausted, but a number of additional restoration activities are possible at the site. These include: 1) removing fill from the wetland area and using it to grade slopes in the adjacent gravel pit, 2) restoring wetland grades and hydrologic regimes in the area of removed fill, 3) seeding the remainder of the gravel pit to reduce erosion and transfer of fill to the wetlands and to create nesting/foraging habitat for passerine species, 4) repairing the breached berm and constructing a water control outlet for surface water flowing from the gravel pit, and 5) expanding existing areas of wetland habitat. The focus of this project would be to restore approximately two acres of wetlands degraded with fill material and to

restore grassland habitat to approximately seven acres of gravel pit to prevent additional degradation of downslope wetlands.

This site offers several good opportunities for restoration. Removing fill from the wetland down-gradient of the gravel pit would restore at least two acres of wetland. Adjacent degraded wetland acreage could also be restored by excavating additional fill. Restoration of the adjacent upland gravel pit and berm would create approximately seven acres of grassland migratory bird habitat and prevent future degradation of the downslope wetland. Over the long term, unchecked erosion and sedimentation from the gravel pit will continue to degrade the downslope wetland.

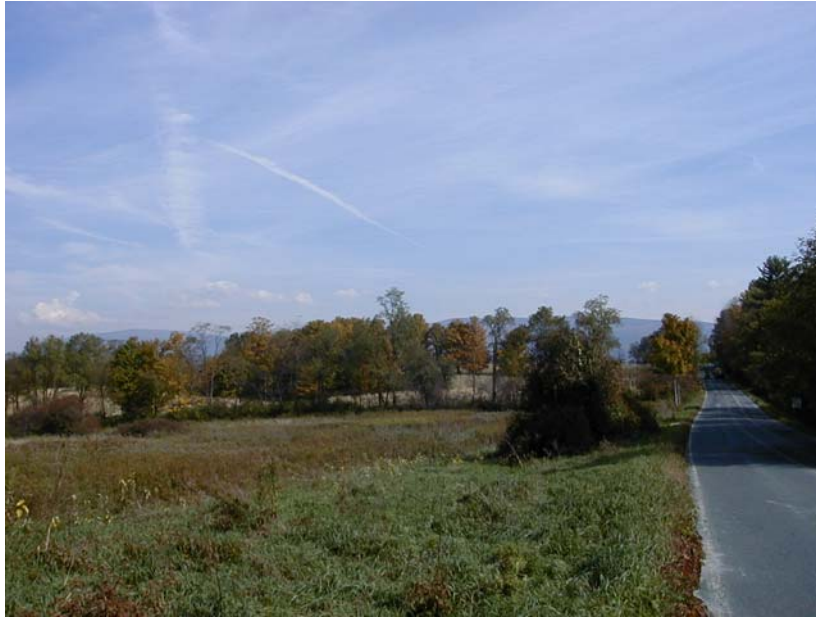
Figure 5. Murphy Road Farm.

The Murphy Road Farm parcel is approximately 60 acres in size. It is located south of Route 67 and north and west of Murphy Farm Road in North Bennington. The parcel has approximately 1,500 feet of frontage along the Walloomsac River. Much of the land is designated as prime agricultural land and the majority of the parcel was used to grow corn in 2003 (Figure 5). Scattered trees in the interior of the parcel provide some shelter and habitat for wildlife. Development projects have sought to locate on the parcel in the recent past. Protection of wetland and wildlife habitat along the Walloomsac River would be the focus of this acquisition.

The Murphy Road Farm was considered as a candidate for habitat protection because it provides wildlife habitat, abuts adjacent wetland and riverine habitat, and it is highly developable. Protection of this property would promote the long term viability of the adjacent Walloomsac River.
