Kalamazoo River Oil Spill Restoration

Fish passage project in tributary of the Kalamazoo River first project implemented from oil spill restoration plan

September 2016

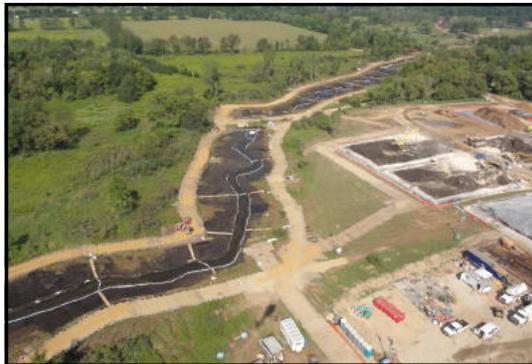
Figure 1. Talmadge Creek in August, 2010 depicting the on-going cleanup.

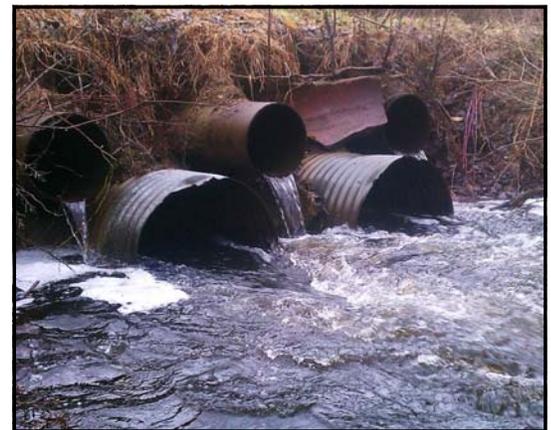
Figure 2. The culvert system at E Drive on Pigeon Creek, a tributary of the Kalamazoo River, prior to restoration of fish passage.

This aquatic passage project represents the first implemented project from the restoration plan for the 2010 Enbridge Oil Spill on the Kalamazoo River. Prior to replacement, the stacked five-culvert system inhibited the passage of aquatic organisms and did not adequately accommodate seasonal floods associated with storm events (Figure 2).

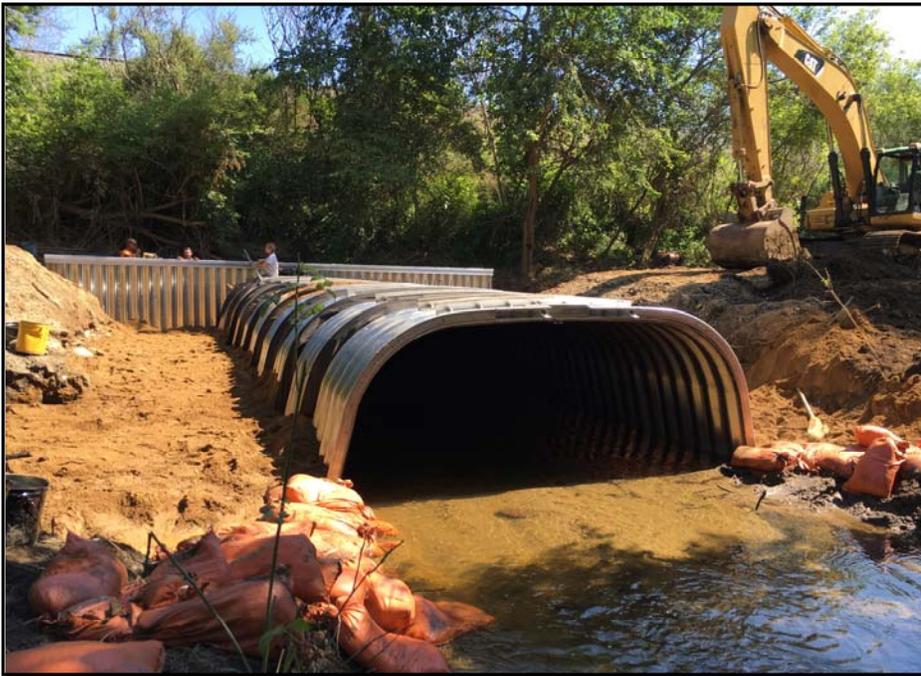
Figure 3. New culvert installation on Pigeon Creek, Calhoun County, Michigan.

The Calhoun Conservation District, led by Director Tracy Bronson and Project Manager Brett Riser, directed the replacement of the inadequate structure with a single bottomless culvert (Figures 3 and 4). The Conservation District partnered locally with the Calhoun County Road Department, Civil Engineers, Inc. of Battle Creek, Michigan, and Sebastian Trucking and Excavating, Inc. of Springport, Michigan to plan, design, and install the new culvert.

To facilitate fish passage and use by other aquatic organisms, the new culvert was designed to use a bottom of natural cobble. To further improve fish passage, an in-stream rock ramp (Figure 4) was incorporated to dissipate the force of water flowing through the culvert. Within a week of completion, fish were observed moving through the new culvert system. The Conservation District has already collected several years of data to characterize the fish communities above and below the E drive crossing. They will now

In addition to improving habitat, the new culvert is sized to accommodate seasonal flooding.

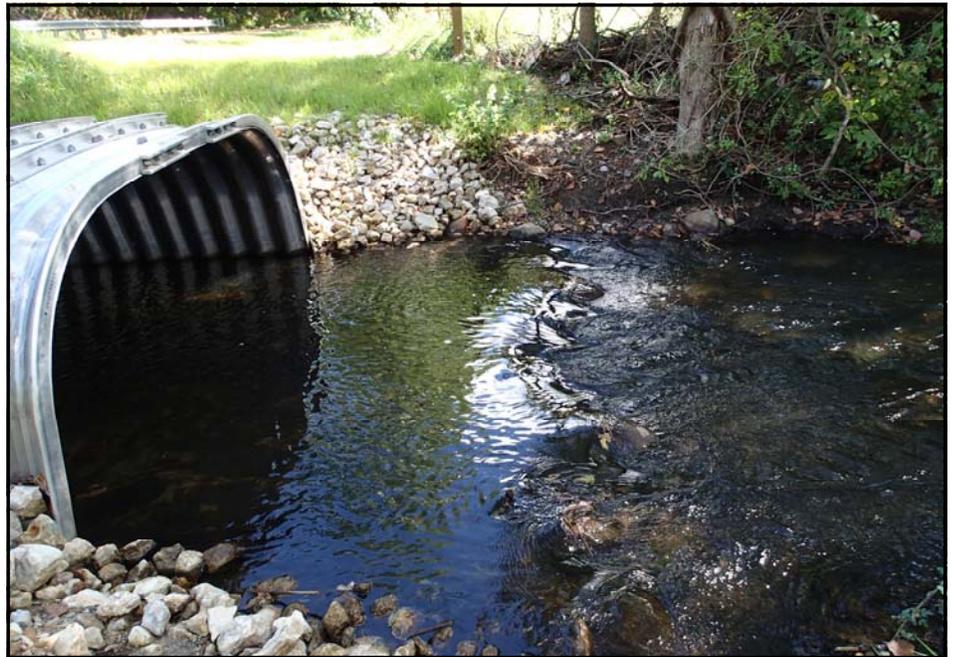
Figure 4. Rock ramp structure below the new culvert on Pigeon Creek.
